Summary Investigation Report 115/06

Serious marine casualty

**Collision of CMV NYK ESPIRITO
with a quay wall
at Hamburg on 27 March 2006**

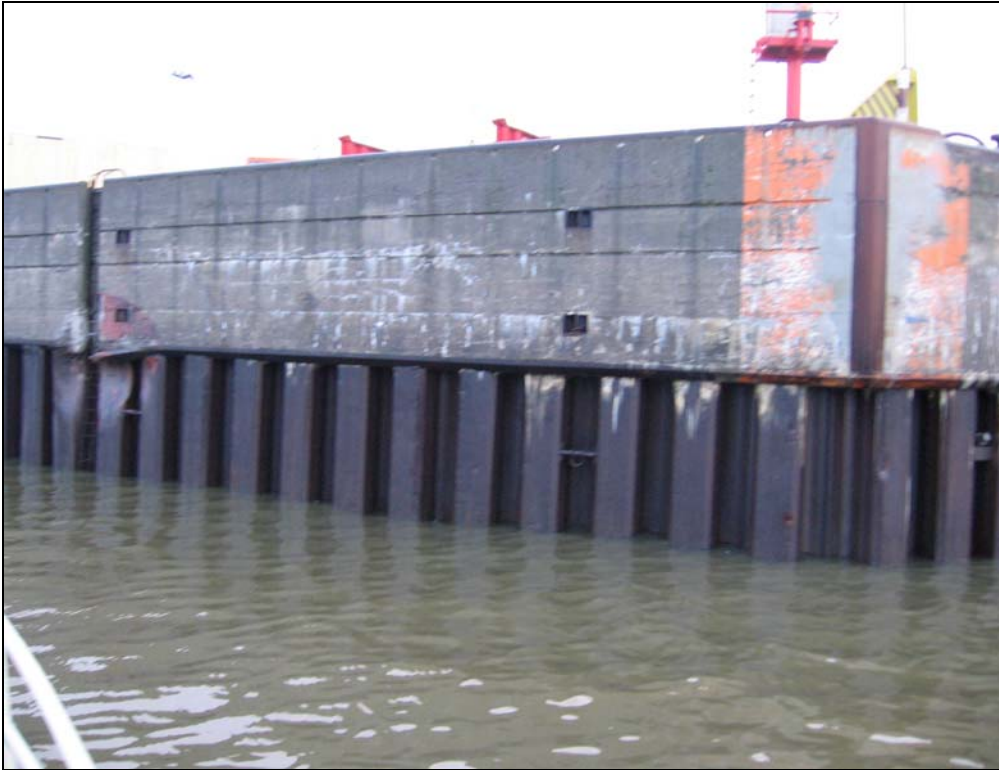
Figure 3: Damaged Quay

The quay was damaged quite extensively due to the collision (see Fig. 3 and 4). Parts of the supporting structure of steel pales as well as the ladder were considerably deformed. Even the concrete wall lying over it was damaged. The property damage was assessed to a total of about 280,000.00 EUR.

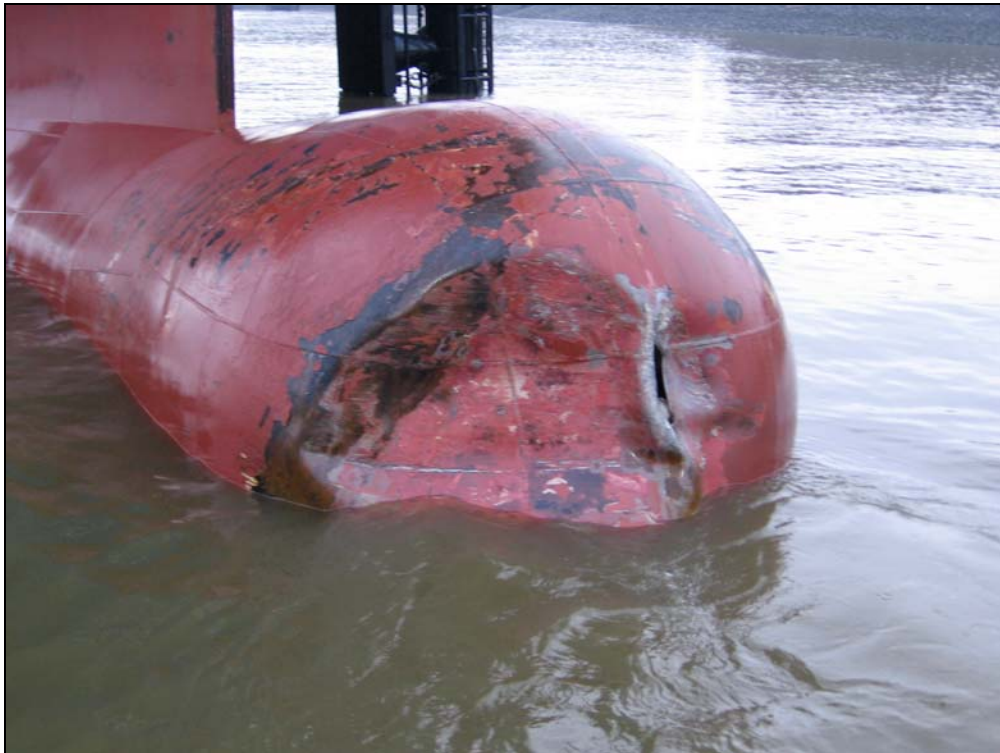
Figure 5: Damaged Bulbous Bow of NYK ESPIRITO

The bulbous bow of NYK ESPIRITO was incised on the starboard side due to the crash. In the centre of the hull of the bulbous bow, a crack about 50 cm long was

formed (Fig. 5). According to the shipping company, the amount of the property damages was about 130,000.00 EUR.

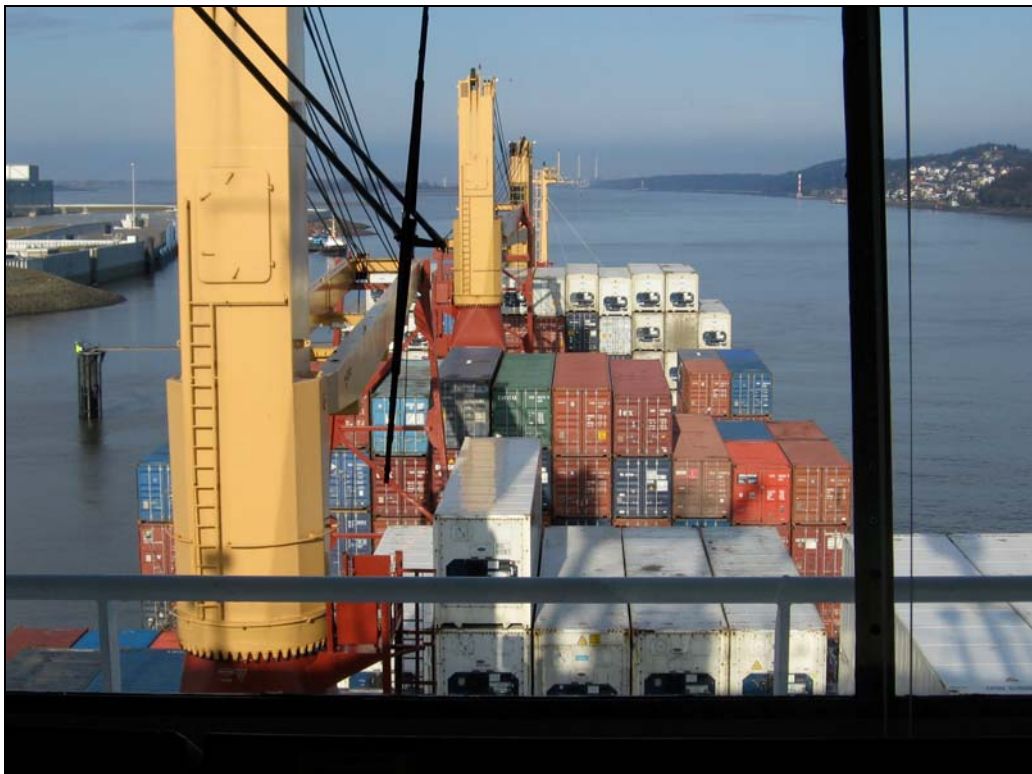
Figure 6: View from the Bridge at the Morning of the Accident

The photo documentation gives, among others, an impression of the cargo on deck at the day of the accident (Fig. 6).

The turning manoeuvre was performed using the vessel’s radar and without the active involvement of due lookouts. The radar scan could not picture the area in front of the containers in the foremost bays due to the height of the deck cargo (cf. Fig. 6). Even if radius of the variable range marker on the radar of 0.1 nm chosen before laying off had been exactly equal to the distance between the bridge and the fore-castle, completing the manoeuvre only via the observation of the radar could not rule out the risk of collision.

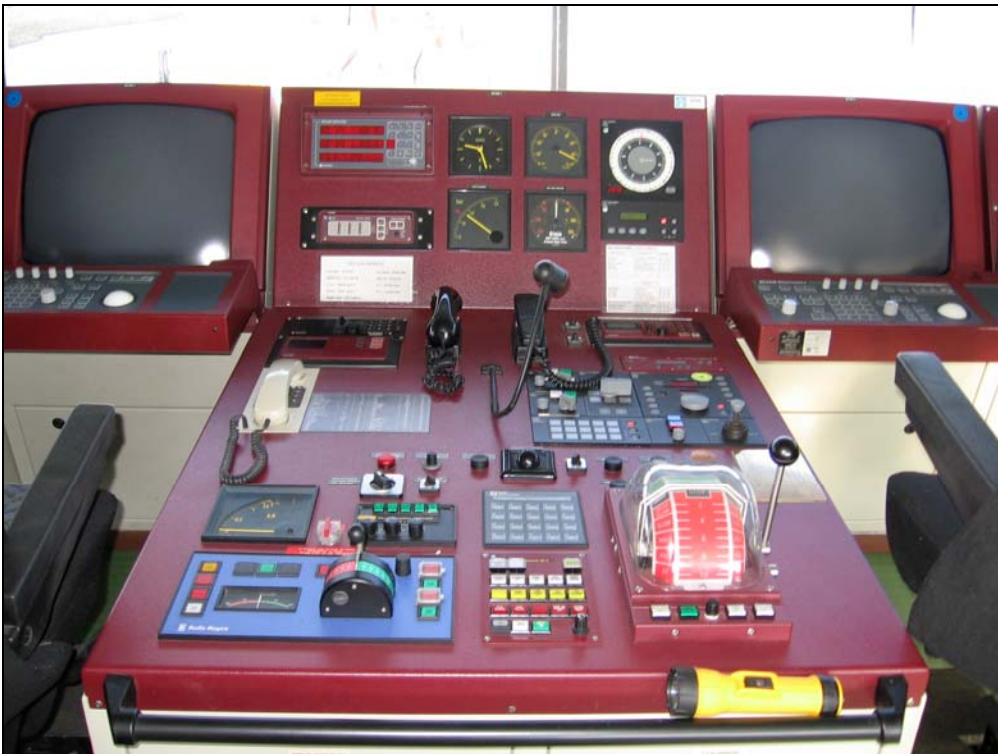
Figure 7: Central Control Position on the Bridge

On 10 July 2006, NYK ESPIRITO was inspected by two inspectors of the BSU. The following situation was observed: The hand wheel of the helm is located on the left of the central control position. Diagonally above the rudder angle indicator is mounted onto the bridge ceiling, which can be read off from any position on the bridge. At the central control position (Fig. 7) the steering mode selector switch has five switching positions. Via the positions "PORT WING" and "STBD WING" on left centre and left bottom the steering can be switched to the respective wing of the bridge, which have each one secondary control position (Fig. 8).

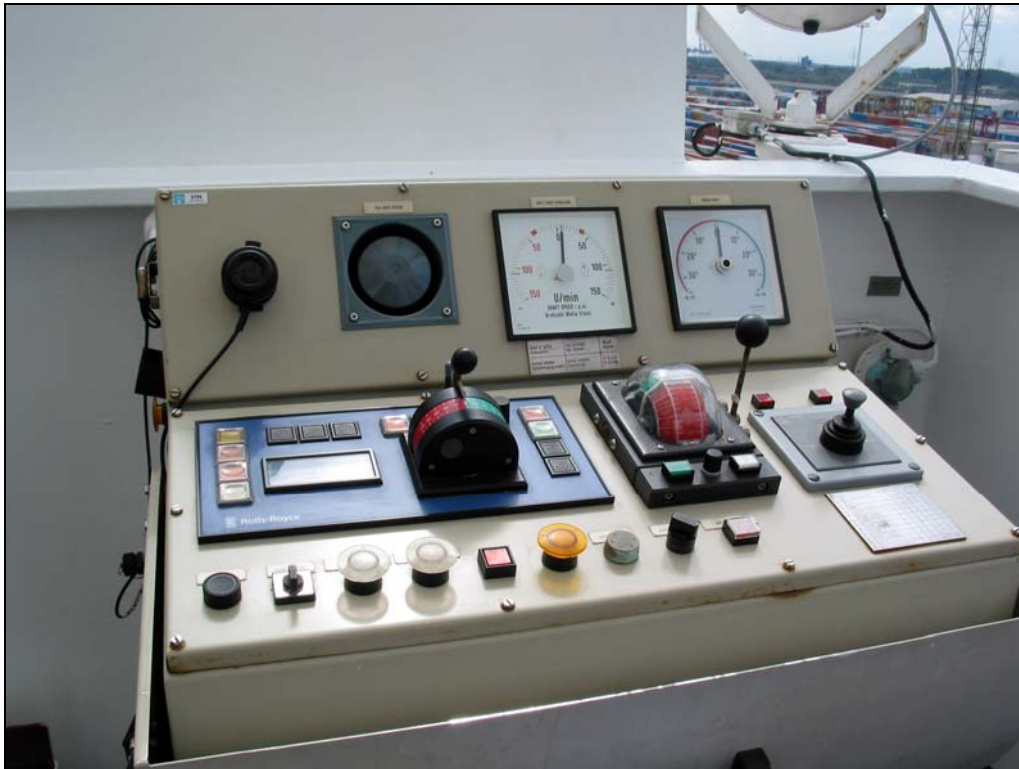
Figure 8: Secondary Control Position in the Starboard Wing of the Bridge

The central control position on the bridge as well as the secondary control positions have their own indications of the rudder angle.

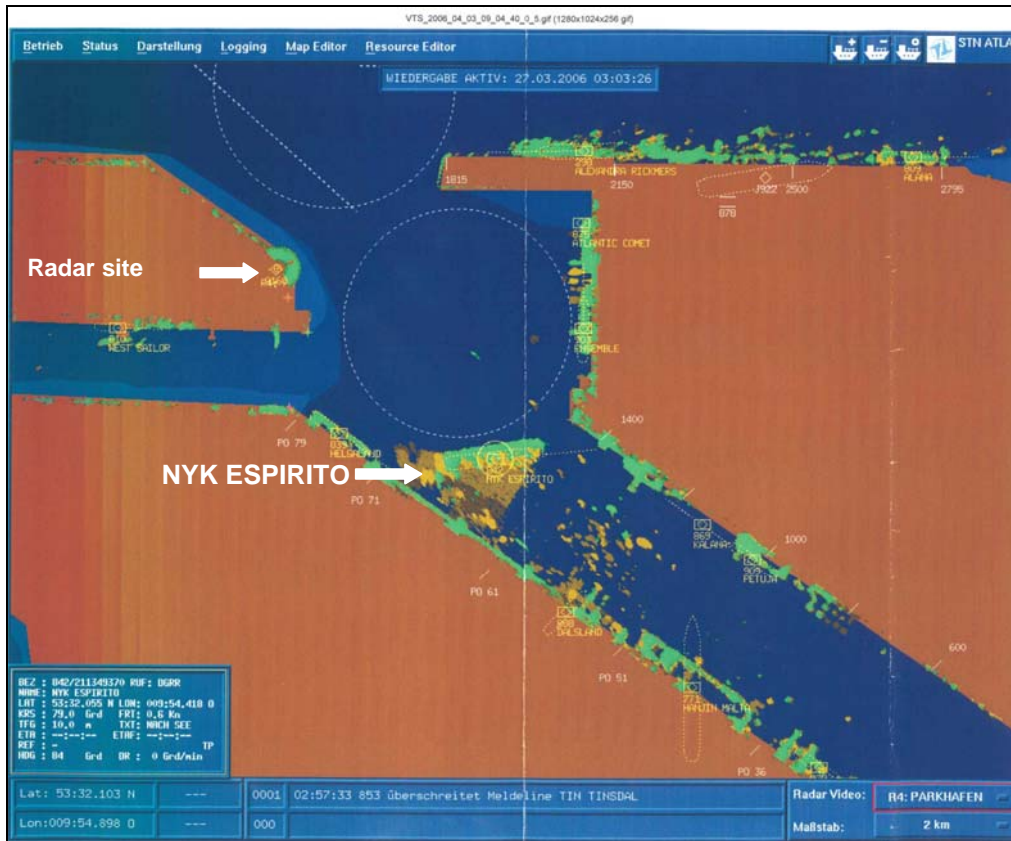
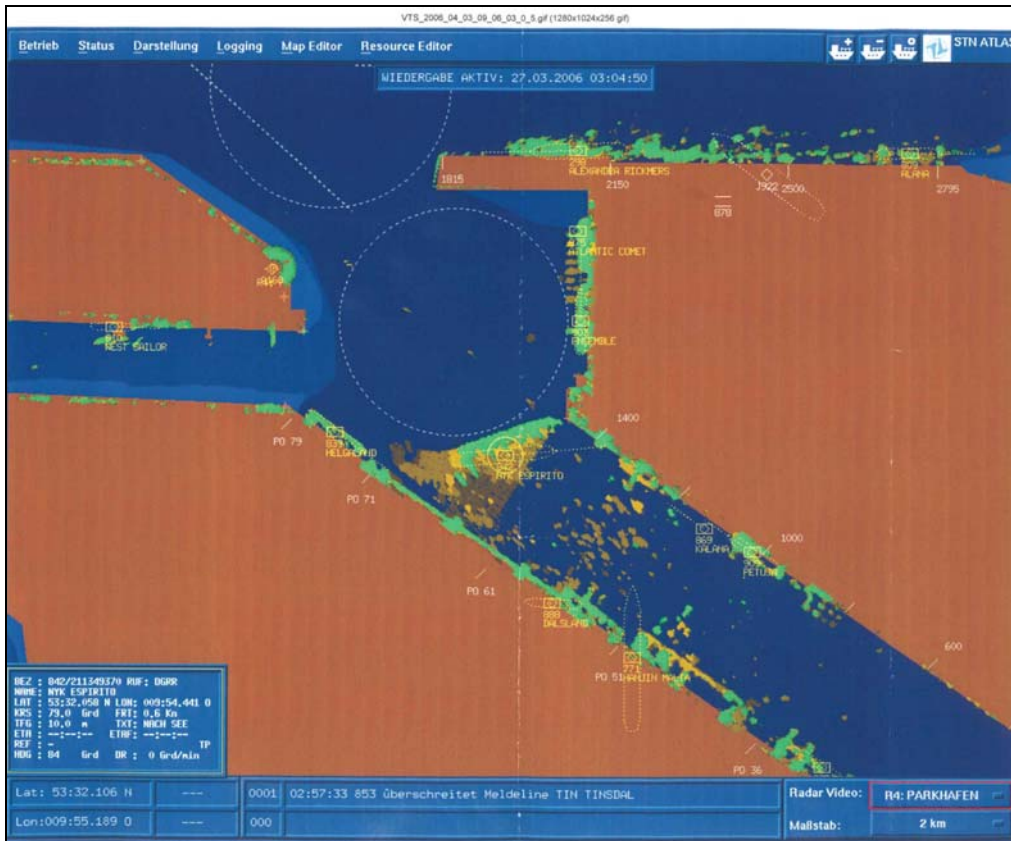
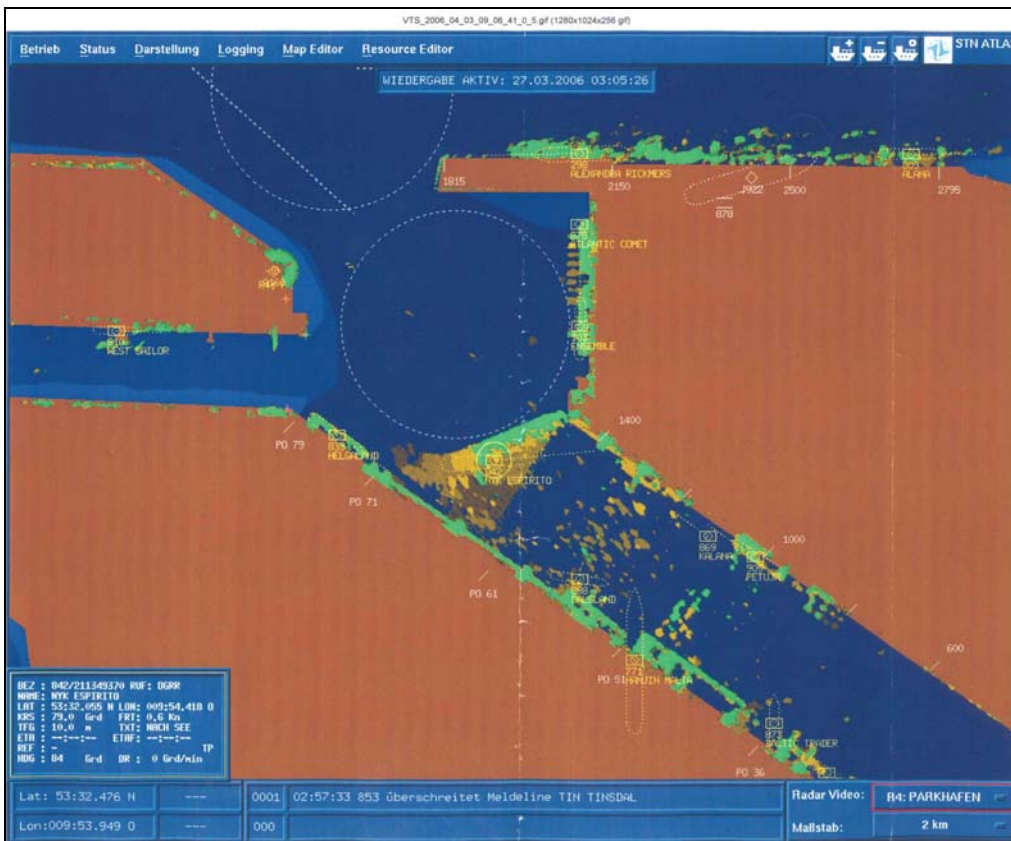
The recordings of speed and rudder angles of NYK ESPIRITO of the day of the accident were not available to the BSU, as the vessel does not provide such devices on board. According to the radar recordings by VTS Hamburg, the speed over ground during the turning manoeuvre was 0.6 knots, equal to a speed of about 0.3 metres per second (Fig. 8, 9, 10).

During the whole turning manoeuvre, the distance between the bow of NYK ESPIRITO and the quay was clearly less than two ship's lengths, so that during this stage the quay was always within the blind sector.
