**Investigation Report 149/05**

**Very Serious Marine Casualty**

**Loss Over Board and Subsequent Death  
of the Skipper of SY INA 2 North of Wustrow  
on 1 May 2005**

1 April 2006

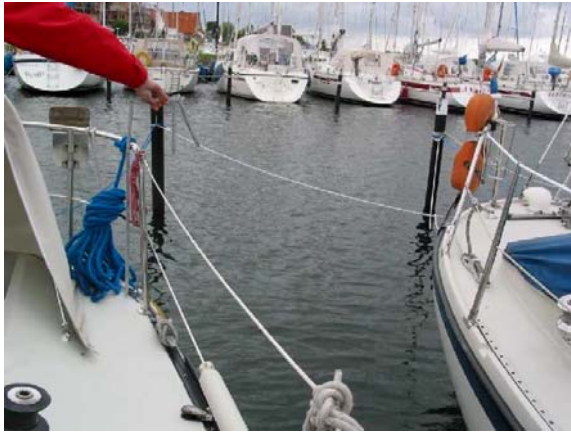
Figure 3: Height of pushpit INA 2

He had only been able to hold him firmly by his vest. All attempts to get hold of his body and pull him up had failed as he had been unable to lift the weight over the boat ladder (see Figures 3 and 4). That is why he had secured the man in the water with the boathook by his vest and secured this to the cockpit with seizings. His head had been above water. Further attempts to use the life-collar secured to the railing and a further life line had failed, as a helping hand was always lacking.

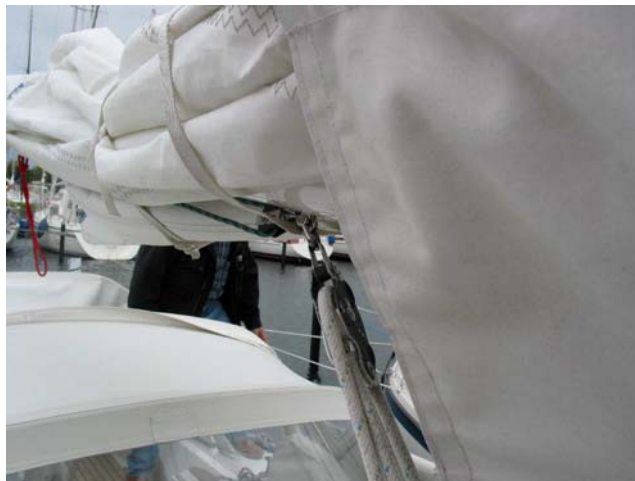
Figure 7: View from mast foot INA 2

On 13 August 2005 two staff members of the BSU visited the INA 2 in Lemkenhafen. Initially the daughter and co-sailor of the accident victim were present, as well as two friends. In the presence of the BSU and a friend, the co-sailor then described the course of the accident, starting from the time at which he was at the foot of the mast engaged in taking down the sails.

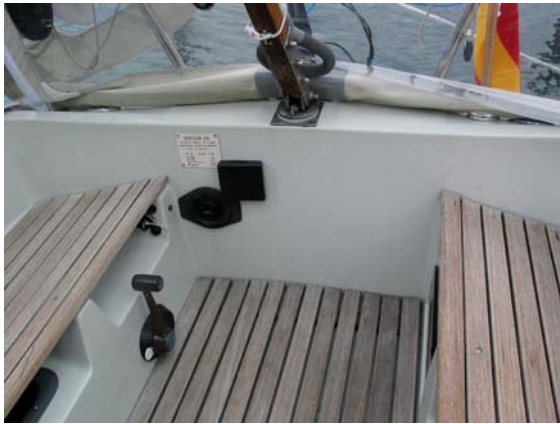
Figure 8: Cockpit INA 2

As a result of the high freeboard of 90 cm, there had always been one hand lacking to help him in his attempt to rescue the accident victim so that he could hold fast onto the boat himself and on the other hand hold the man in the water by the boat ladder (see Figures 8 and 9). The accident victim had already been lifeless at this time. He had tried to secure the man in the water to the boat ladder using lines and a boathook in order to call for help by radio. It did not appear possible to him to try and use the life-collar that was mounted on the railing on the starboard side aft.

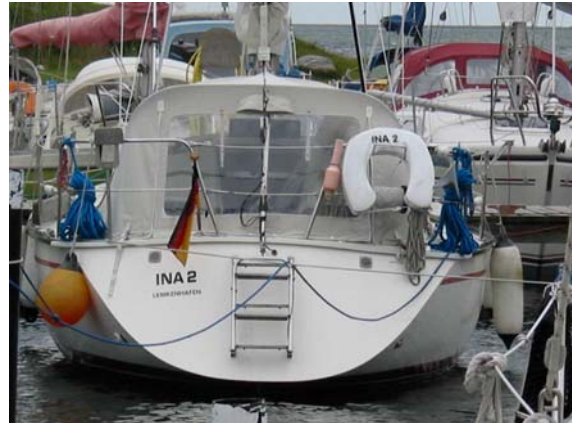
Figure 9: Stern from behind, INA 2

He had been unable to pull the man in the water, who weighed approx. 70 kg, on board by himself. He had taken the lines to secure the man in the water from the port and starboard side of the companionway. He might possibly also have used a sheet to secure him. He had had to go down onto the boat ladder in order to hold the head of the man who had sustained the accident above water. Here the linkage of the sun-sail (Kuchenbude)<sup>5</sup> and the outboard engine mounted aft on the port side had been a hindrance to him. When ENFORCER 2 was alongside the crew had tried to draw a line under the armpits of the man in the water in order to pull him up with the end of the line and the running part. Here the arms of the man in the water had folded upwards and the line had partly been tight round his neck. That is why he had called upon the BGS crew to be careful.<sup>6</sup> Ultimately the man in the water had drifted off again and been recovered by the inflatable boat of the WSP. During the voyage the physical constitution of the skipper had been normal and not irregular. He had been surprised at the alcohol content measured during the post mortem. He had no explanation for this. The boat had been equipped as usual at the start of the season. They had taken the basic necessities of foods, beverages and items of equipment from their home to Lemkenhafen before the start of the voyage. Some of the alcoholic beverages had originated from the remains of the last season. Before the boat was taken into winter storage at the end of the season the beverages and provisions left behind were cleared out, taken home, and if expedient used again for the next season. That had been the procedure followed over the last years. The crew had not been wearing life-jackets during the voyage because the sea had been smooth as a mirror.

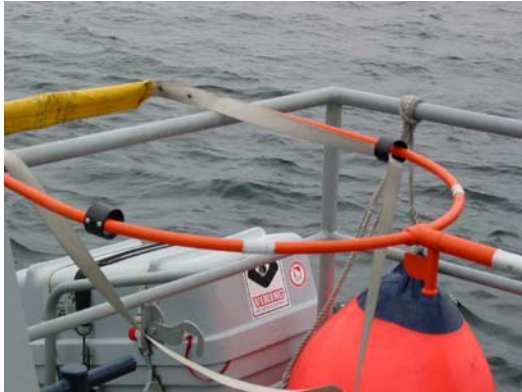
Figure 10: Rescue rod ENFORCER 2

ENFORCER 2 has two inflatable life-rafts, each for six persons, secured aft on the port and starboard sides next to the platform. On the boat deck a rescue rod with a fixed ring and loop and a life-ring with 28 m of line are mounted on the port side. If a lifeless person were to be recovered with the rescue rod, one crew member would have to go into the water to fasten the loop in the ring to provide support to the lifeless person. For its own rescue purposes, the crew has inflatable life-jackets, solid jackets and immersion suits as well as the two life-rafts. No rescue boat, life-collars/life buoys, a climbing rescue net or a stretcher for bringing a person in the water on board are available.

The BSU acknowledges that rescue assignments are not among the primary tasks of the Federal Police. Despite this, due to their presence in coastal waters vessels of the Federal Police are frequently among the first at the scene. In so far the BSU recommends that the Federal Police Office in Rostock as operator of ENFORCER 2 and the Federal Ministry of the Interior as owner of the vessels of the Federal Police should review existing life saving appliances for its expediency and if appropriate take suitable measures to improve the equipment in order to facilitate recovery of persons who have fallen over board.

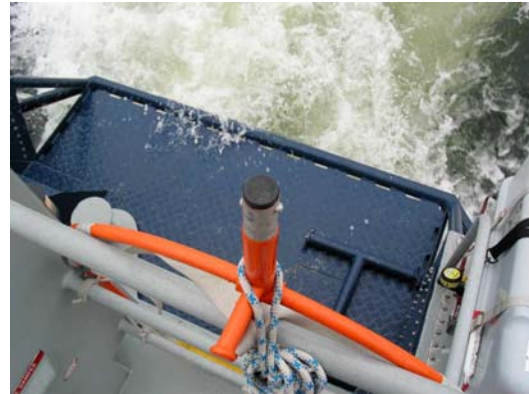
Figure 11: Platform ENFORCER 2

The attempt to pull the accident victim on board over the boat ladder with the aid of the co-sailor and a crew member of ENFORCER 2 also failed. This may have been possible under certain circumstances, if an additional person in the water had assisted. For reasons of individual security, at a water temperature of 8°C to 9°C it would first have been necessary for the crew member of ENFORCER 2 to put on an immersion suit.

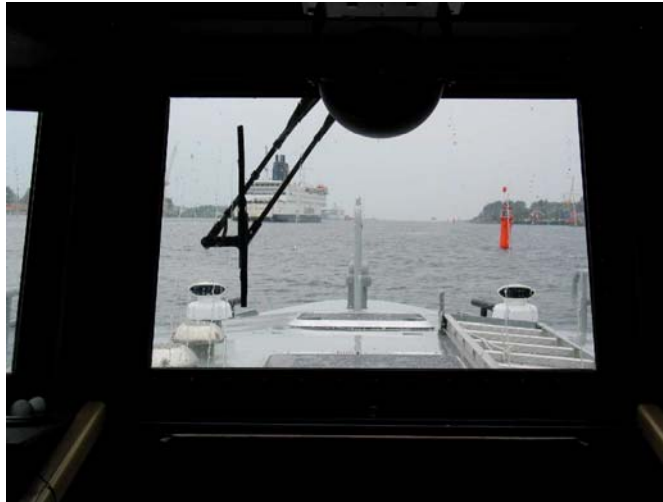
Figure 12: Bridge window ENFORCER 2

ENFORCER 2 has a length over all of 16.1 m and a draft of 0.9 m with a freeboard of 1.0 m at the aft ship. With its water-jet drive and engine power from two turbo diesel engines each with 653 kW (875 hp) it can reach a maximum speed of 45 kn. It has good manoeuvring properties and can turn almost on the spot. Its sea behaviour is good. The BSU observed that during the trip on the estuary with a calm sea and at slow speed, permanent helm movements were necessary to hold the boat on course. There are four high-level seats with seatbelts installed in the wheelhouse. Due to the firmly fixed seat positions all-round vision is limited during travel (see Figure 12). The two forward places are designed for operating the navigation and radio equipment. The helm, consisting of a hydraulic steering system with swivel water jet drives, is operated from the starboard side. VHF Channel 16 is permanently monitored.
