**Bundesstelle für Seeunfalluntersuchung**  
**Federal Bureau of Maritime Casualty Investigation**  
Federal Higher Authority subordinated to the Ministry of Transport,  
Building and Urban Affairs

Investigation Report 164/06

**Serious marine casualty**

**Accident involving personal  
injury on board the Traditional Vessel  
LISA VON LÜBECK  
in the port of Hel/Danzig  
on 19 April 2006**

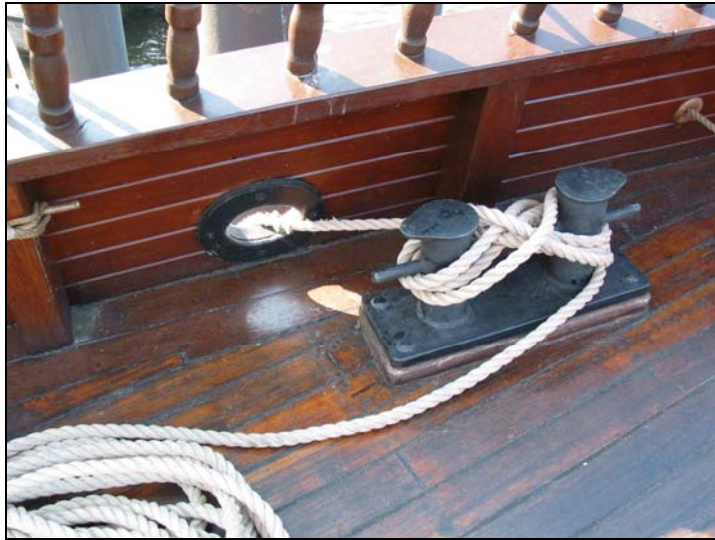
Figure 3: Bollard aft

LISA VON LÜBECK was inspected by three staff members of the Federal Bureau of Maritime Casualty Investigation (BSU) in Hamburg on 5 May 2006. The vessel was in a very good general condition and cleared. The scene of the accident (aft deck) is clear and visible in all directions.

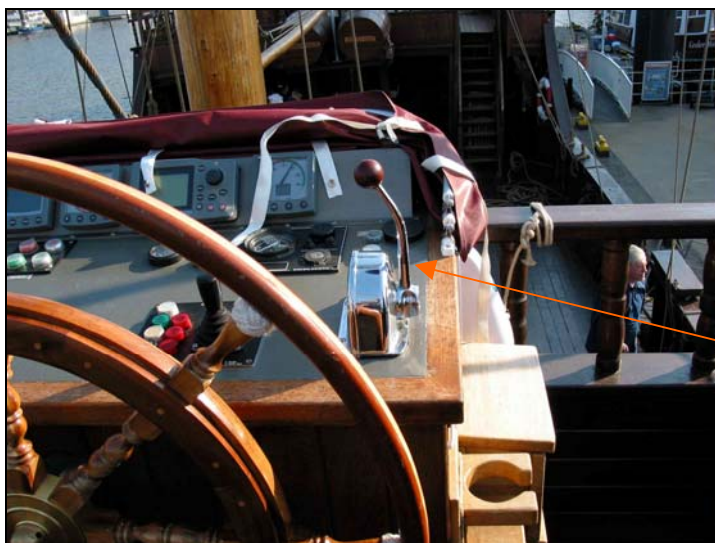
Figure 4: Control position

The engine installation is run with a single lever switching with just one gear shift lever from the control position on the aft deck. The lid of the control console at the control position can be folded up completely and can also be opened and closed constantly during ship's operation.

Gear shift  
lever

The BSU recommends that the owners and operators of the Traditional Vessel LISA VON LÜBECK should check the securing of the pressure control cables at regular intervals. The control lever at the control position is to be installed firmly and separately from the lid of the control panel to avoid crushing or bending movement of the pressure control cables when the lid of the control panel is opened and closed.

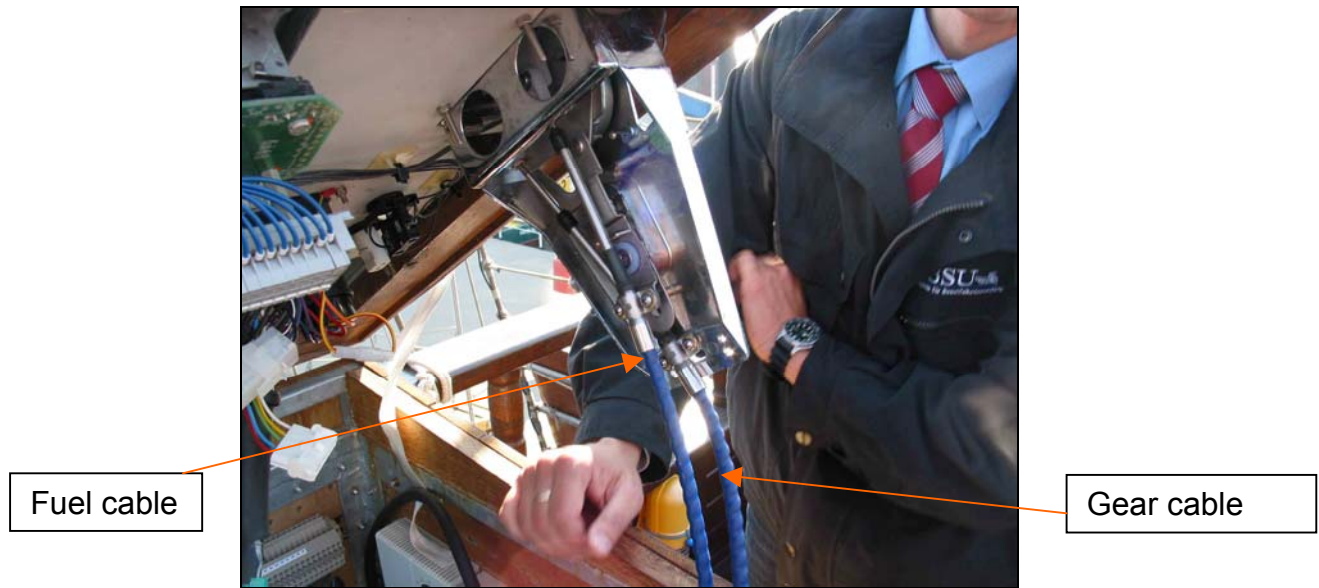
Figure 5: Control wires with lid folded up

After the accident the crew quickly identified the cause of the technical failure of the main engine reversing control. When the lever was pulled aft, the control cable for controlling the gear lever became unhooked; however, the gear was still coupled in the "ahead" position. When the lever was switched to „astern“ the transmission was no longer switched over and „more speed astern“ ultimately meant that the vessel only picked up more speed forward.

The operating and gear shift cables on board LISA VON LÜBECK are highly flexible pressure control cables from Messrs. Remote Control Systems GmbH (RCS). These cables are characterised by very high load capacities and a very small radius of bending if properly fitted and laid. The assembly instructions of the manufacturer state the end parts are to be secured safely so that they cannot move or even twist under load. To secure them safely, a cable clamp with base (clamp assy) that engages in a groove in the forced draught cable is used.

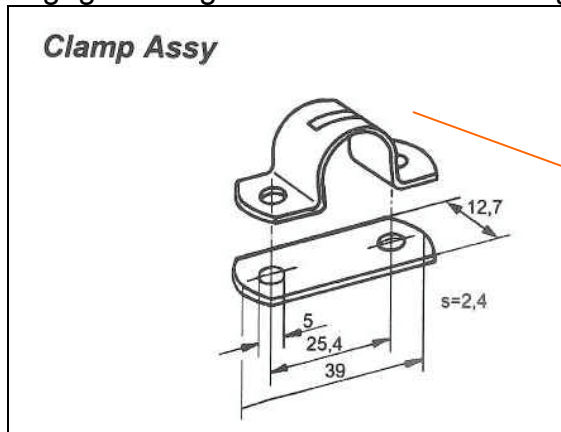
Figure 6: Clamp assembly

The two M5 screws of the clamp fastening had evidently come loose during operation on board. While the gear was switched in the forward position, the control cable slipped out of its fastening. As the control cable was loose, it was no longer possible to uncouple the gear or switch over to "reverse".

The serious marine casualty is attributable to the fact that the pressure control cable for the gear transmission had come loose and the gear remained coupled in the "forward" position. This was evidently caused by the fact that the screws of the clamp assembly were not correctly tightened or secured. The loosening of this connection was probably also promoted by the fact that the lid of the control position with the single lever control could be opened and closed during ship's operations. Thus contrary to the instructions for use issued by the manufacturer, a torque/bending movement acted on the end of the pressure control cable.

After the technical defect was identified, the crew tightened the screws again and secured them additionally with a bonding agent.

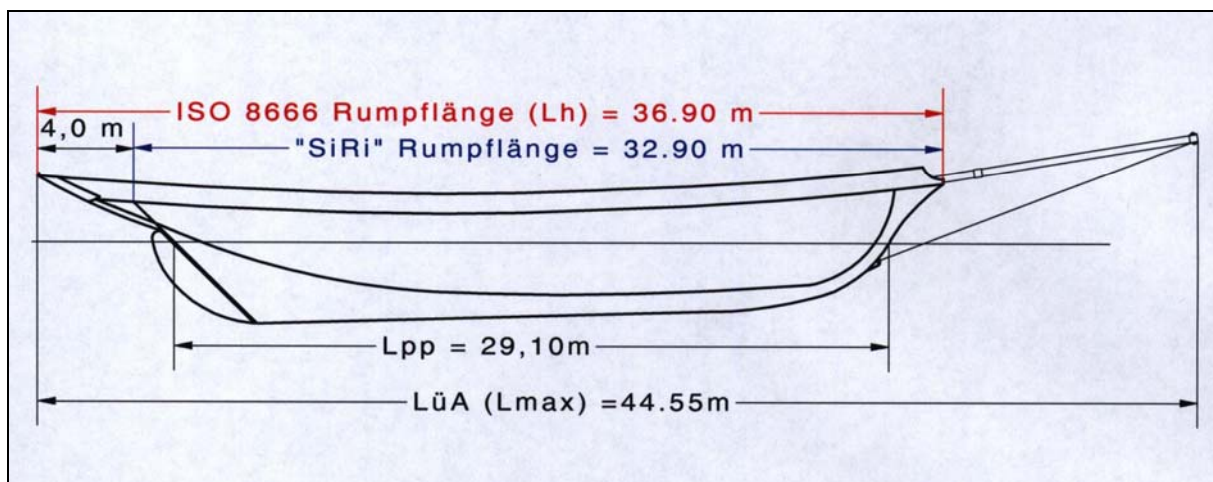
Figure 8: Survey lengths

Possibilities of comparing vessels with each other more precisely exist if the hull length ( $L_h$ ) is measured in accordance with DIN EN ISO 8666, such as is the case for example in the comparison of length in the following sketch of a licensed traditional vessel with a "SiRi" hull length of 32.90 m:

When measuring the "hull length" in accordance with SiRi, the 4 m overhang at the stern is not included in the length.

The measurement of the hull length in accordance with DIN EN ISO 8666 only provides for applications on vessels up to a length of 24 m, however. Yet it is to be recommended that this method should be introduced for all traditional vessels as a binding, easily verifiable and comparable measuring length. The hull length ( $L_h$ ) in accordance with DIN EN ISO 8666 "*comprises all structural or integrated constituents of the water craft, e.g. forward post and aft post made of wood, plastic or metal, bulwark and hull/deck connection. Parts that can be removed without destruction and without impairing the structural integrity of the water craft such as spars, jib boom,*

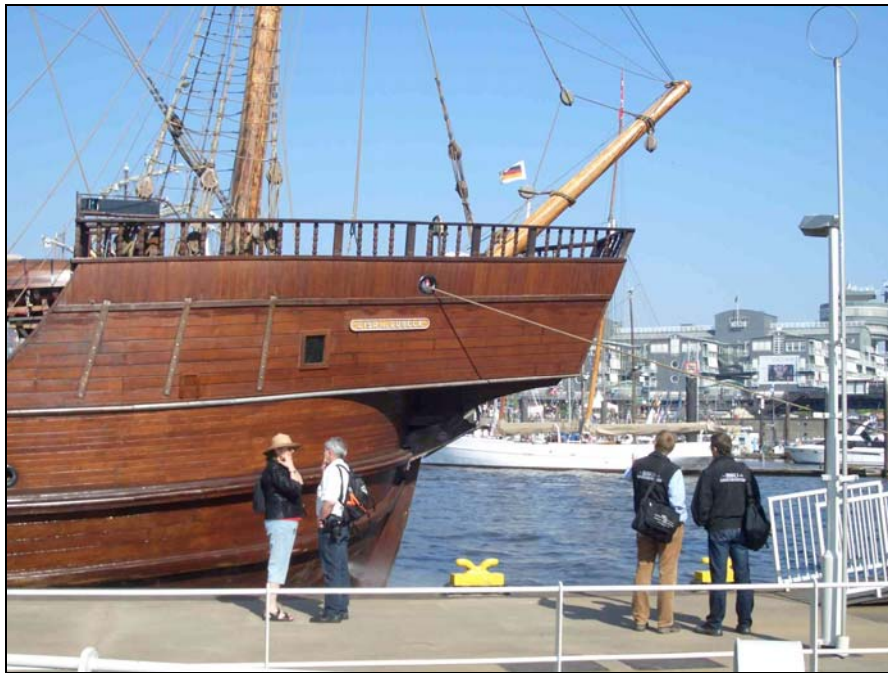
Figure 9: Projection forward

With this length measurement according to DIN EN ISO 8666, the long, permanently installed overhangs forward and aft, known as castles, on LISA VON LÜBECK would be included too. If this measuring method is applied, a hull length of 30.12 m would result.

Independently of the measuring method, LISA VON LÜBECK has a hull length of over 25 m. The statement of 24.31 m in the safety expertise by the expert for traditional vessels and the Safety Certificate for Traditional Vessels issued on this basis by the See-BG (Marine Insurance and Safety Association) with the "selected hull length" are wrong.
