Investigation Report 166/05

**Very Serious Marine Casualty**

**Fatal Sailing Accident on Board  
SY SINFONIE SYLT  
in the Flensburger Förde  
on May 5<sup>th</sup>, 2005**

**1 June 2006**

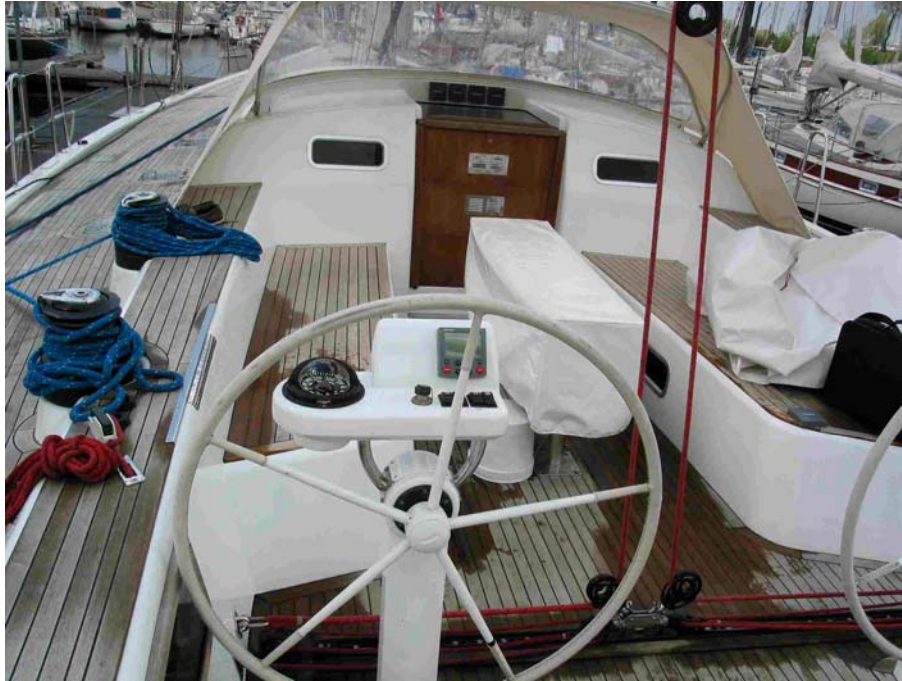
**Figure 3: Port side steering stand**

Towards 09.00 a.m. the skipper went below deck, in order to prepare breakfast. At first the helmsman navigated the yacht from the port side control. The joint-sailor was sitting immediately next to it on the bench in the cockpit on the port side (cf. fig. 3).

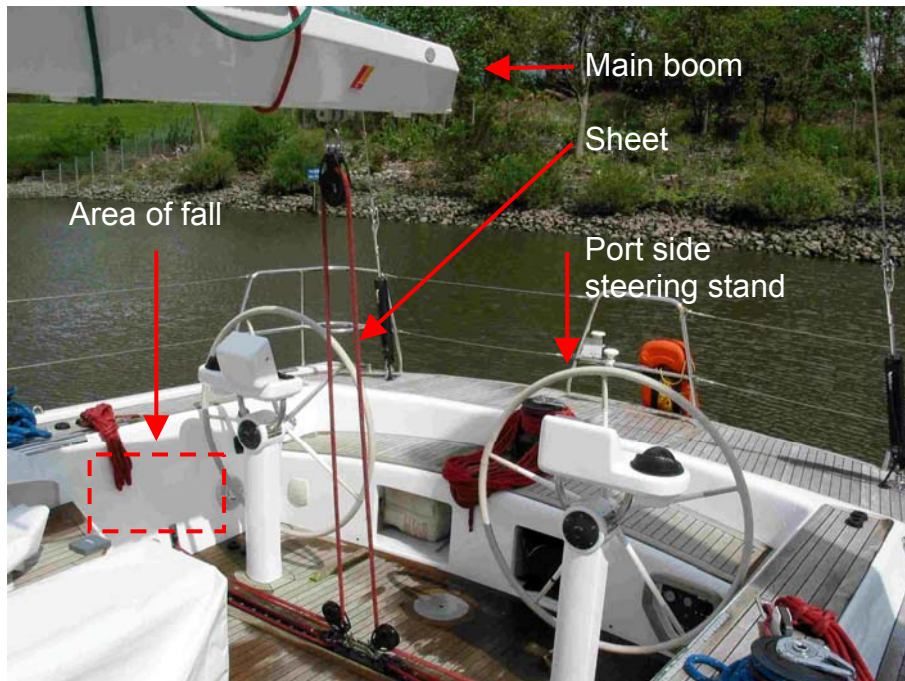
**Figure 4: Position of the fall**

between the two steering wheels, he was hit by the sheet and thrown into the area of the starboard cockpit between the bench and the steering wheel (cf. fig. 4).

- while the helmsman was on his way back to the control stand, the main sail turned from port side to starboard. On this occasion the helmsman was hit by the sheet and suffered fatal head injuries as he fell into the cockpit.

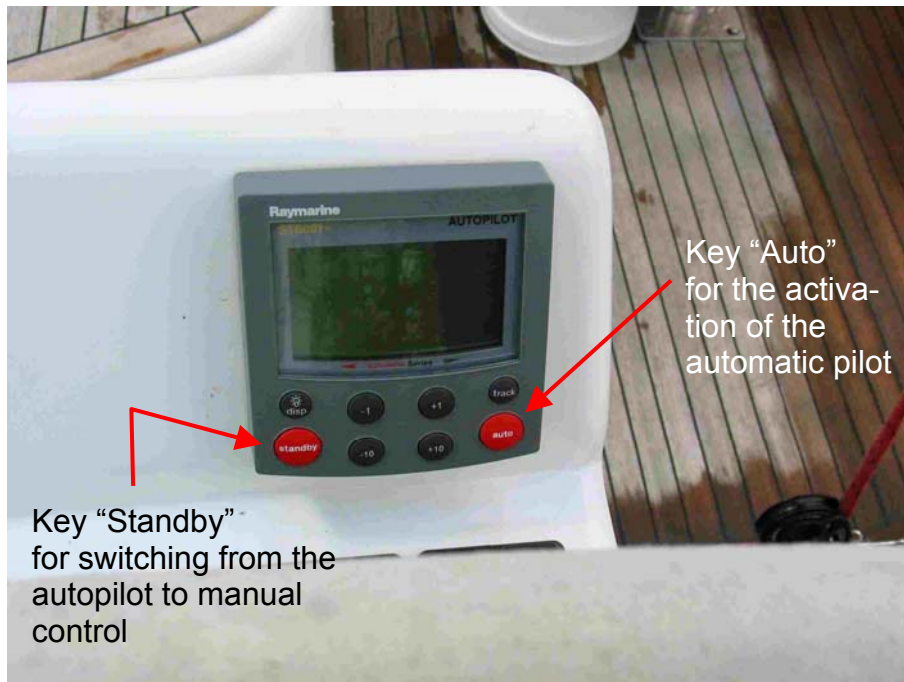
Figure 5: Control unit of the automatic pilot<sup>15</sup>

Indeed it was intended to activate the automatic pilot, but the (red) automatic key (cf. fig. 5) has not been operated to a sufficient extent. A louder receipt signal for the confirmation of the (real!) switching to automatic control might possibly have prevented this maloperation.

However, what has to be considered as very probable in the present case, as far as this can be attributed to the fact that the helmsman only believed that he activated the automatic pilot, the risk of such a maloperation could clearly be reduced by technical means, like, for instance, a loud and clear receipt signal and/or visual indicators.<sup>17</sup>

<sup>17</sup> Note: On the autopilot installed on board the SINFONIE SYLT, activations of keys are confirmed acoustically, however, only in a loudness generally usual for technical devices, i.e. relatively low.

5. **The manufacturers of nautical and technical equipment for operation on board** are recommended to check the control units of the devices for the functionality of the control units for each operation mode. In particular for the use of LCD displays, illuminated switches and acoustic signals it must be taken into consideration that their perception when used in unprotected areas on deck can be greatly limited by external influences (for instance wind sounds, sunbeams).
