**Bundesstelle für Seeunfalluntersuchung**  
**Federal Bureau of Maritime Casualty Investigation**  
Federal Higher Authority subordinated to the Ministry of Transport,  
Building and Urban Affairs

Summary Investigation Report 190/07

**Personal injury accident on the  
MS EMUNA on 5 May 2007  
at the South Quay in Brunsbüttel**

1 September 2007

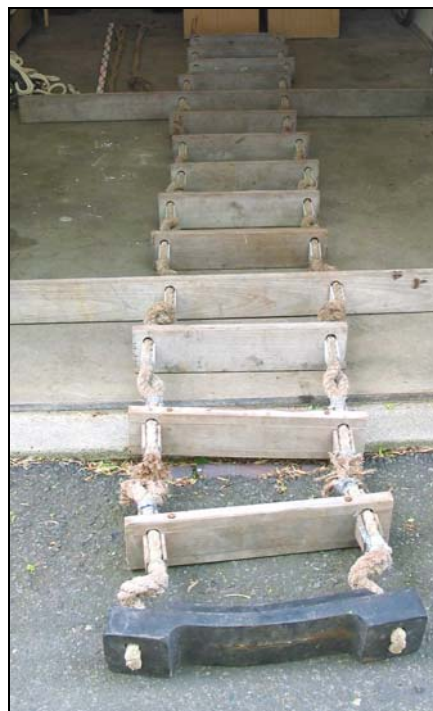
Figure 3: Overall view of the pilot ladder

The pilot ladder has a total of 15 steps; two of these are spreaders that prevent the ladder from twisting. Except for the bottom step, which is made of rubber, all other steps are made of knot-free hardwood.

The length of the ladder is 4.20 m from the first step including the two lowest steps removed before the accident, and 3.60 m without these two steps. The steps measure 550 mm in length on the outside and 400 mm on the inside, and are 25 mm deep. The distance between steps is 305 mm. The spreaders measure 1.80 m.

The side ropes consist of non-coated natural fibres. The ropes were hawser-laid (z-lay). The length of the side ropes above the first step is 1.60 m on one side and 1.80 m on the other. The ladder has two ropes on either side, which are separated above and below each step by plastic wedges, and wooden wedges in the two steps before the last. Each wedge has a metal clamp at the pointed end, which brings the ropes together again.

Both the construction of the ladder and its dimensions in principle meet the requirements for pilot ladders set out in Rule 17 of the International Convention for the Safety of Life at Sea (SOLAS) as well as those of the International Standard for Pilot Ladders pursuant to ISO 799.<sup>1</sup>

<sup>1</sup> At 1.60 m and 1.80 m the length of the upper ends of the side ropes does not meet the international standard according to ISO 799, which requires a minimum length of 3 m.

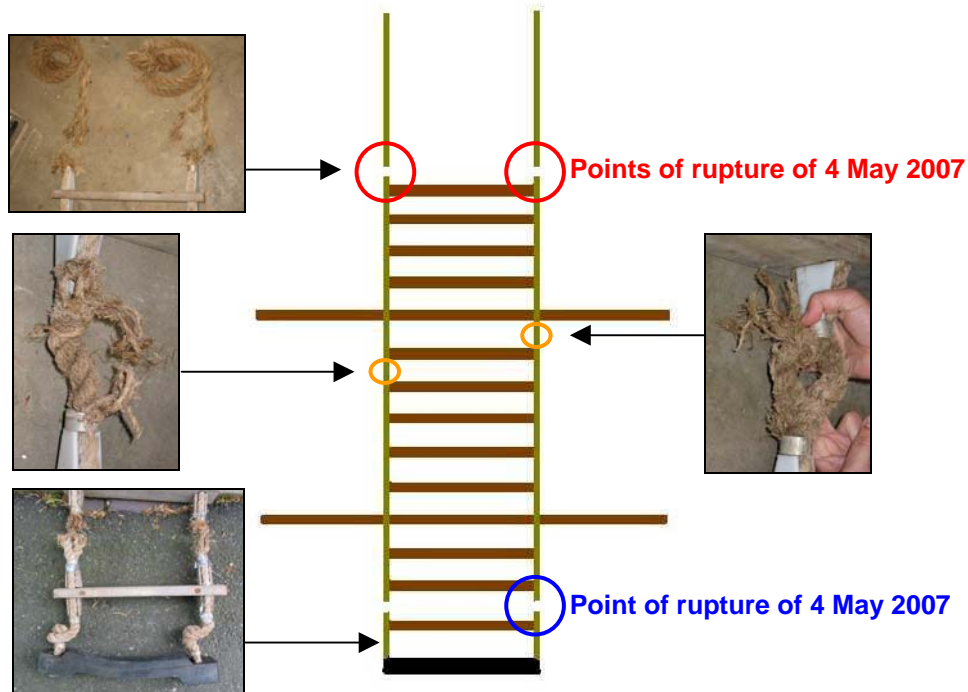
Figure 4: Illustration of pilot ladder with damage

Further damage was found on the EMUNA's pilot ladder in addition to the tearing sites dating from the incident in the UK on 4 May 2007 and to the accident related damage of 5 May 2007. The following illustration clearly shows the location and nature of the damage.

This marine casualty is due to the use of a damaged pilot ladder. In spite of the significant material stress due to the preceding entangling of a pilot boat and externally perceptible damage the ladder was once again used on the day of the accident in order to allow the canal pilot to disembark.

With the exception of the removal of the two lowest steps, no further measures had been taken on board the EMUNA to verify the resiliency of the pilot ladder after the incident. The ladder was considered to be fully fit for use.

The EMUNA's command immediately replaced the pilot ladder at Rostock, its next port of call. As a result of the accident, the entire crew was sensitised to the issues of material stress on pilot ladders.

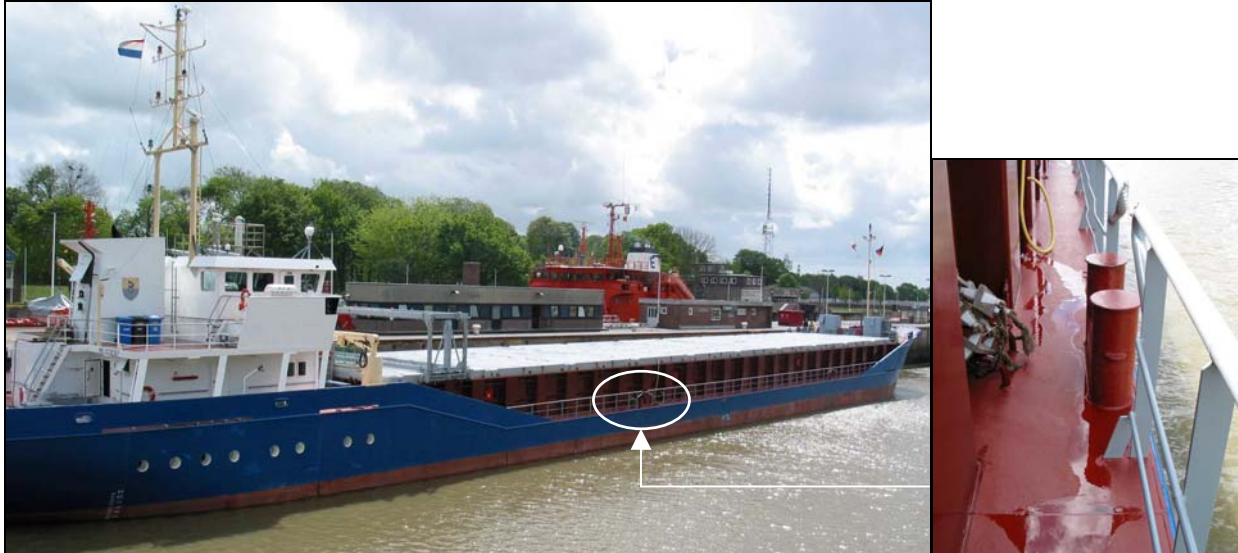
Figure 5: Accident scene on board, taken on 9 May 2007

The pilot ladder was deployed amidships on the EMUNA's starboard side (cf. Figure 5).

On the day of the accident the pilot ladder was not affixed to the eyes by means of its side ropes, but, instead, directly tied to the bulwark grab rails aft of the bulwark gate (cf. Figure 5). In this way the canal pilot could step through the bulwark gate and onto the pilot ladder.

The draught of the EMUNA on the day of the accident deviated from that shown in Figure 5 and corresponding to the day of the inspection in that it was 1.30 m forward and 3.00 m aft instead of 3.60 m forward and 4.20 m aft. According to the measurements taken during the inspection of the EMUNA on 9 May 2007 and taking into account the draught of 5 May 2007 it can be assumed that the freeboard was of approx. 4 m on the day of the accident.

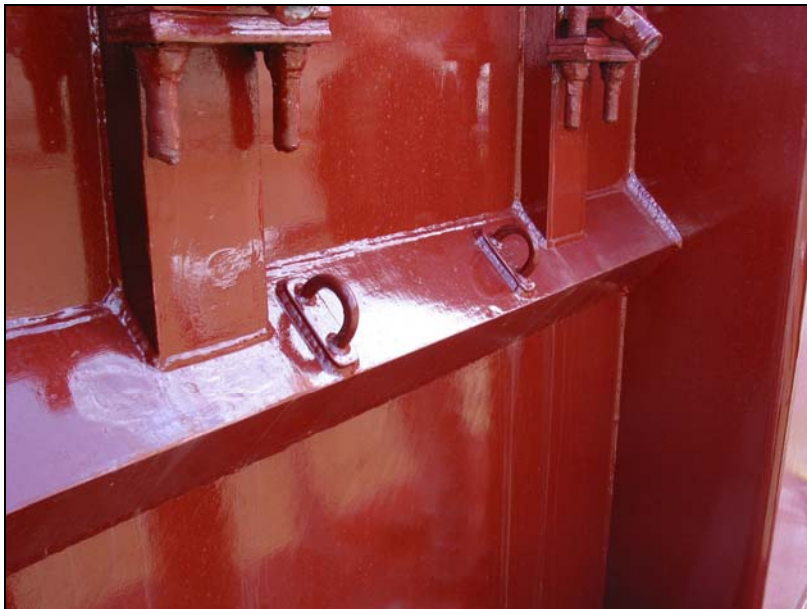
Figure 6: Pilot ladder attachment eyes

On the day of the accident, the pilot ladder hung entirely outboard. No bulwark ladder was used. Two eyes, on which a pilot ladder can be secured, are fitted on board the EMUNA opposite the bulwark gate (cf. Figure 6).

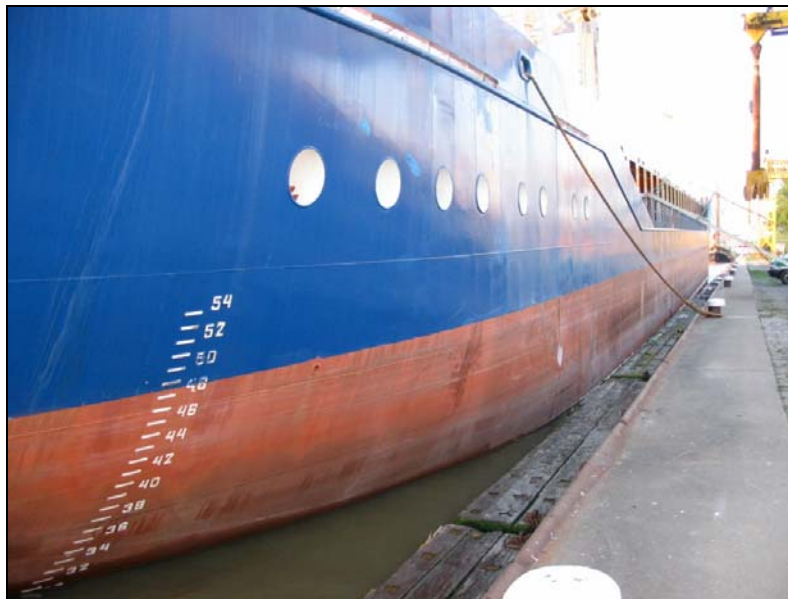
Figure 7: Scene of the accident, land side, taken on the day of the accident

The fact that on the land side wooden fenders are affixed to the concrete quay wall minimised the consequences of the accident for the canal pilot (cf. Figure 7).
