Investigation Report 191/05

Very Serious Marine Casualty:

**Loss Over Board of the Skipper
SY ANDREA
on 28 May 2005
in Swedish Waters Near Ellös**

15 March 2006

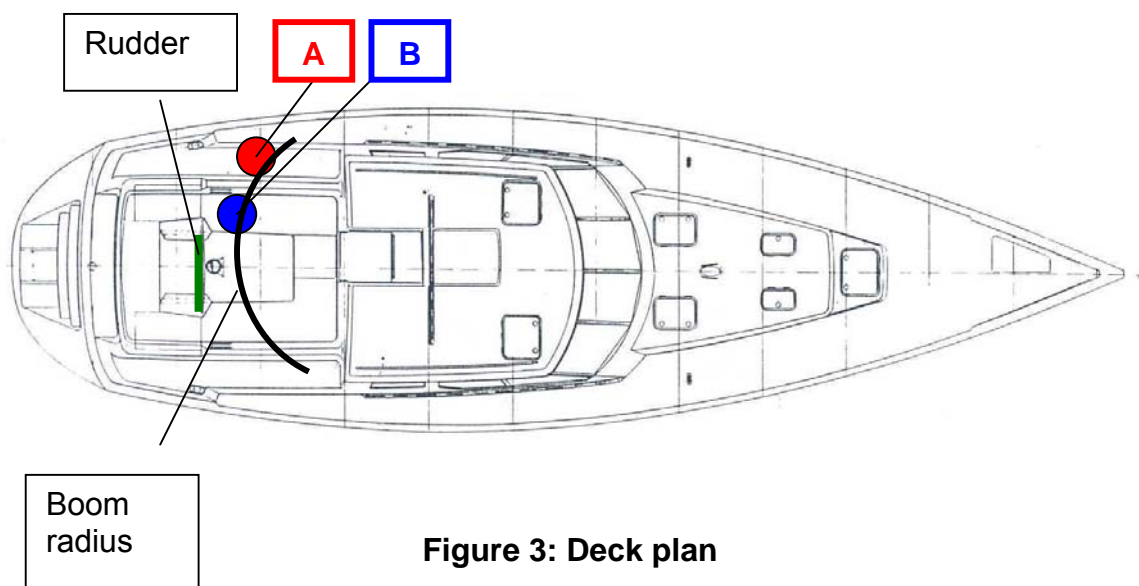
Figure 3: Deck plan

The radius of the boom (5.40 m) is shown in the drawing. Points A and B are the possible places where the skipper can have been standing. Point A (the winch deck) is approx. 0.50 m above the cockpit deck. A person standing upright there would not have been hit on the head, but at most on the shoulder.

Point B (the bench seat) is approx. 0.40 m above the cockpit deck. The boom would hit a person standing there on the head if such a person were standing upright. If the person wanted to reach back to the helm at the same time, the person would have to lean back strongly and could then not be hit by the boom.

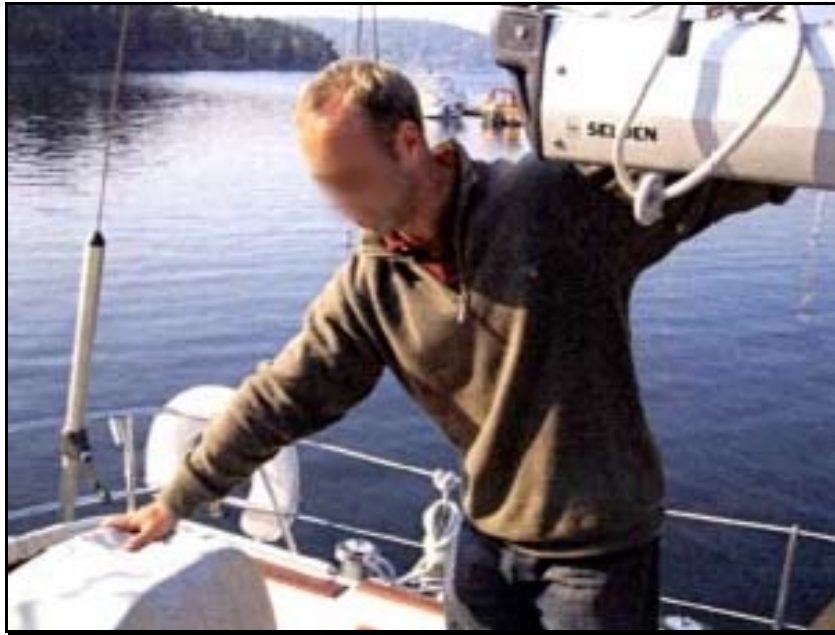
Figure 4: Reconstructing of the accident position

The investigation by the Swedish authority comes to the conclusion that it is not possible to steer the yacht and be hit on the head by the boom at the same time. It is therefore assumed that the skipper was standing in a position in which he could have been hit on the head, but was not holding the wheel in his hand at the time.

Furthermore, the BSU recommends that all persons on the deck of sailboats should be constantly aware of the danger of beating sails and should avoid danger areas as far as possible.

The BSU recommends that skippers of crafts under sail maintain control over the course of the boat at all times. Special attention is necessary in areas where changing winds are known. Above all, when crafts are sailing with aft winds there is always a danger of sails beating over.
