Investigation Report 21/06

Very serious marine casualty

**Death of two crew members
following the crash of a lifeboat of
MT OLIVER JACOB
during a lifeboat manoeuvre
off the coast of Cameroon on
21 January 2006**

1 December 2007

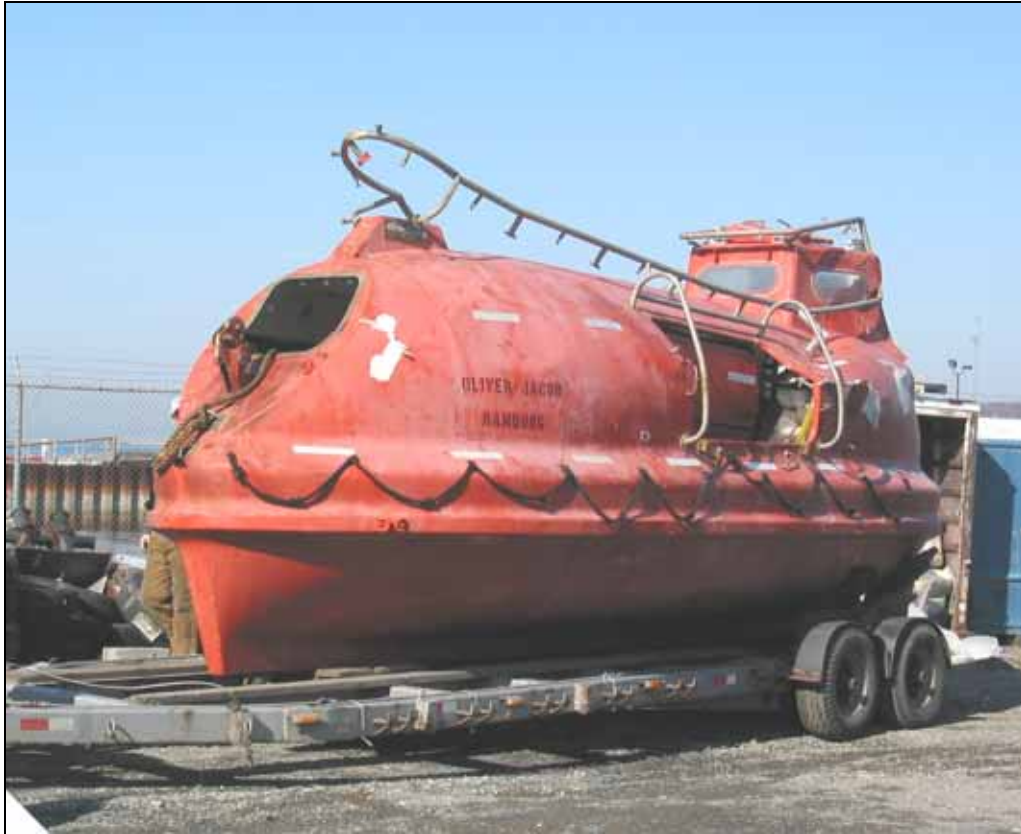
Figure 4: Port rescue boat of OLIVER JACOB when landing in USA

The following further damage was ascertained during the investigation of the lifeboat in the USA (Fig. 4):

- fractures over the entire upper shell (roof) of the lifeboat,
- roof ripped off at the steering stand,
- bending at the frames of the two window hatches in the way of the heaving hooks,
- window flap ripped off at the forward hatch,
- piping system of the outer sprinkler system almost completely ripped off,
- deformation in the inner piping.

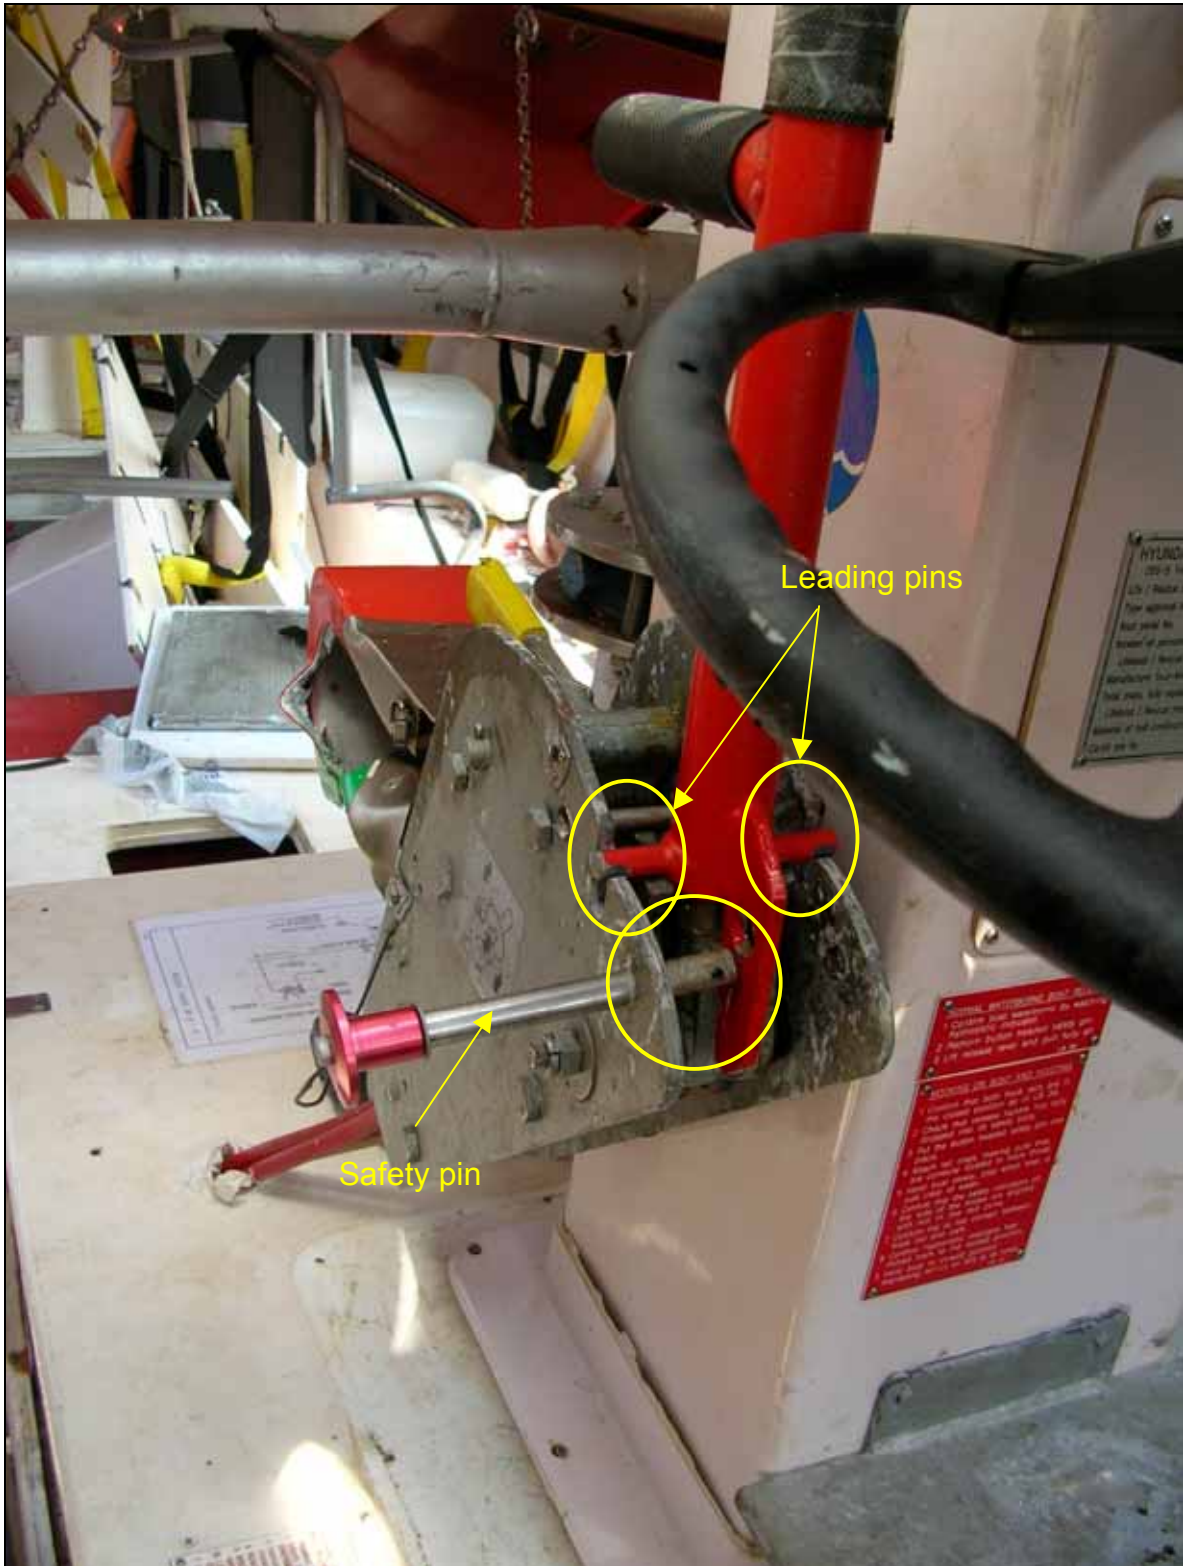
Judging by the photos made available, the Federal Bureau of Maritime Casualty Investigation assumes that at the time of the examination in the USA the release unit was in the situation in which it was found after the accident (Figure 10). During the examination it was ascertained that the release handle was in the angle position "secured", but was not engaged in the safety slots (grooves) in the foundation plates. Engaging of the leading pins on the release handle was prevented by the aft operating quadrant lying beneath it. It was also ascertained that the safety pin was only inserted through the forward foundation plate. It was not possible to introduce it completely. This could only have been done if the release handle had been fully engaged (Figures 10, 11).

Figure 10: Release unit after the accident; leading pins not in the safety slots in the foundation plates, safety pin not inserted

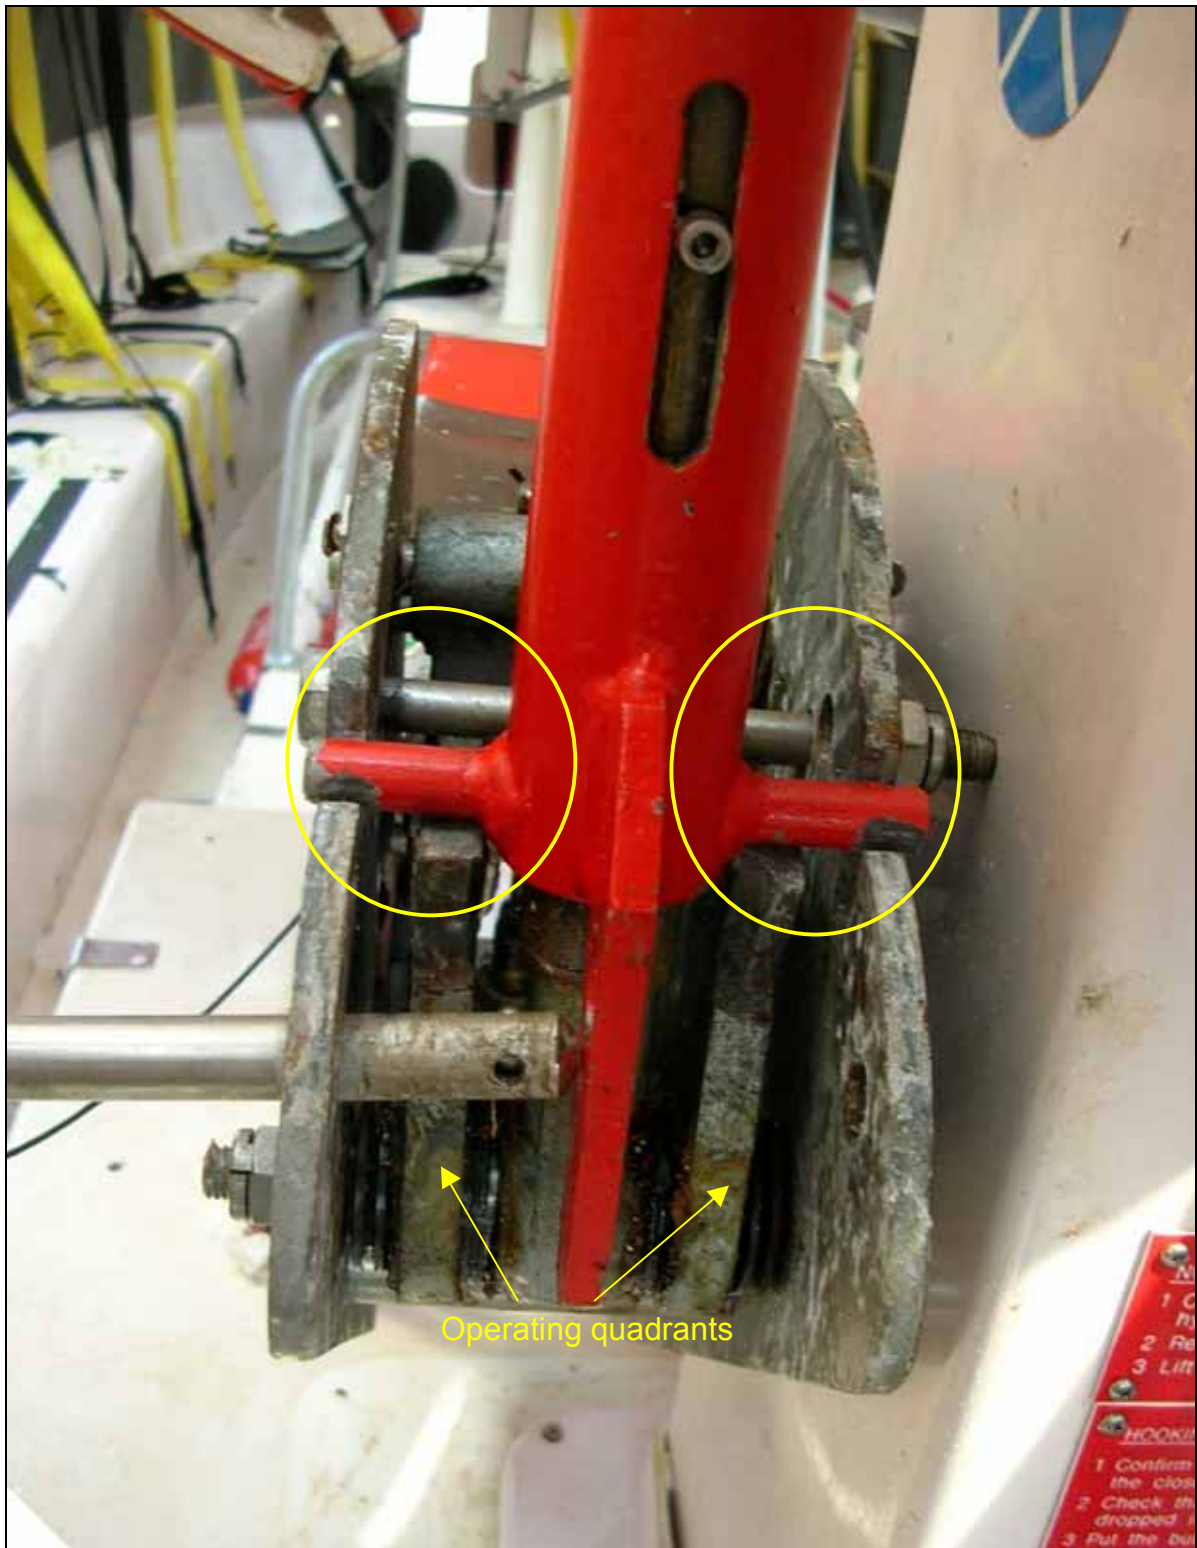
Figure 11: Release unit after the accident; the leading pins resting on the operating quadrants

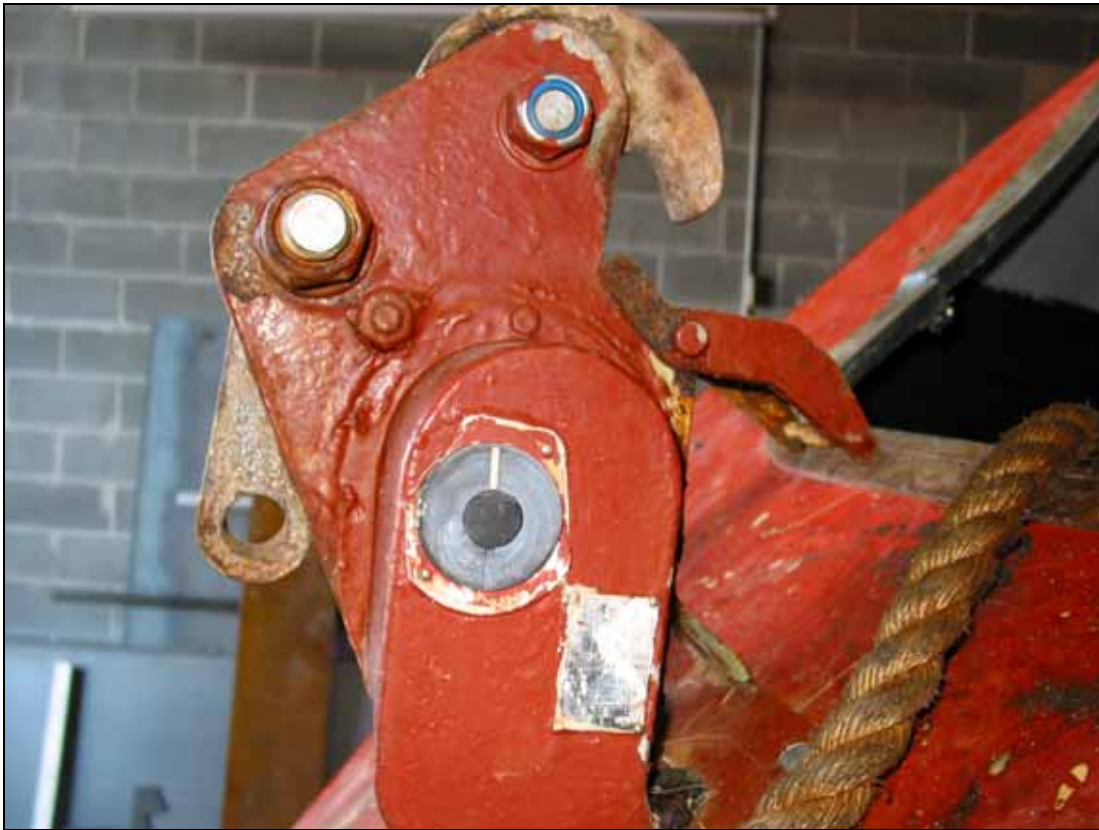
The hooks and foundation plates of the releasing hooks of OLIVER JACOB were made of galvanised steel. They showed signs of corrosion. The cover of the bowden cable at the aft releasing hook had evidently been exchanged, as it was less corroded. The foundation plates had a coloured coat of paint on the outer sides⁵. The marks displaying the holding position, in other words flat-to-flat contact of hook tail and cam and hence the secured position of the releasing hook, was only present at the aft releasing hook and there only on one side (Figures 14 and 15).

The forward hook tail appeared to have been subjected to wear at the contact place with the bolt. An irregular gap was ascertained between the hook and the bolt.

Figure 14: Forward releasing hook, port side, with red and white sector lacking on the cover

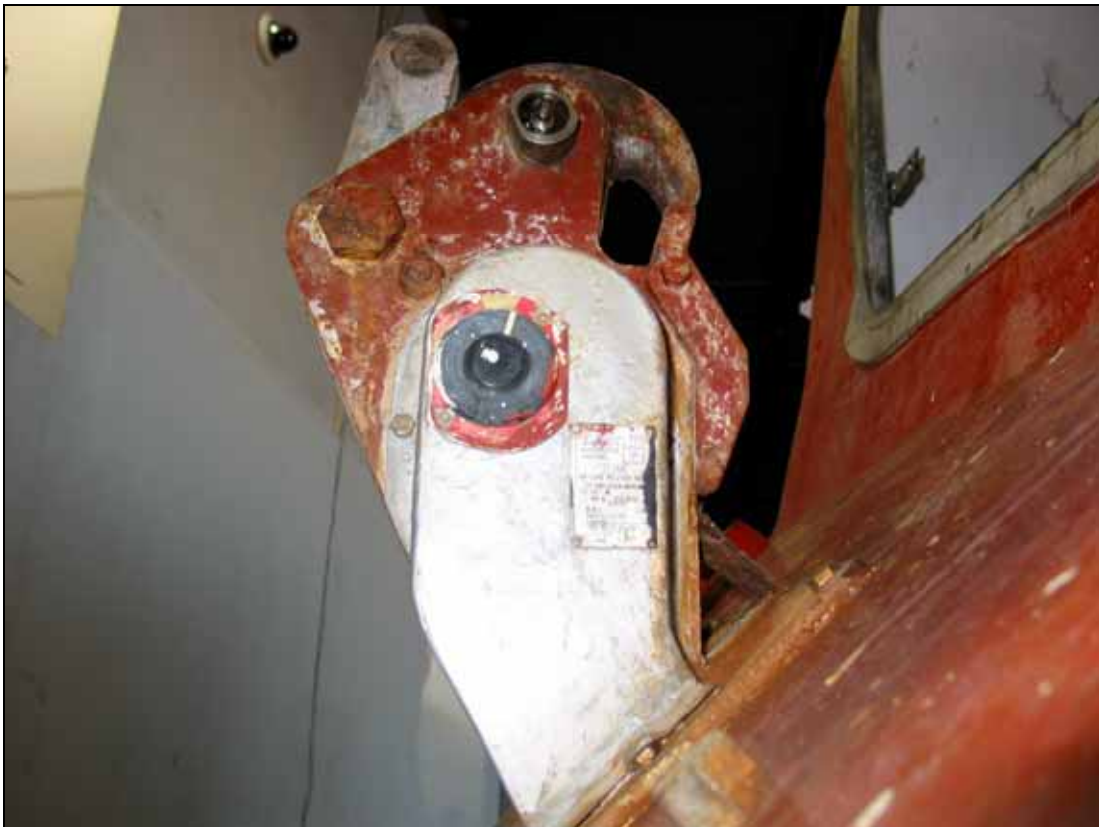
Figure 15: Aft releasing hook, starboard side, with renewed cover

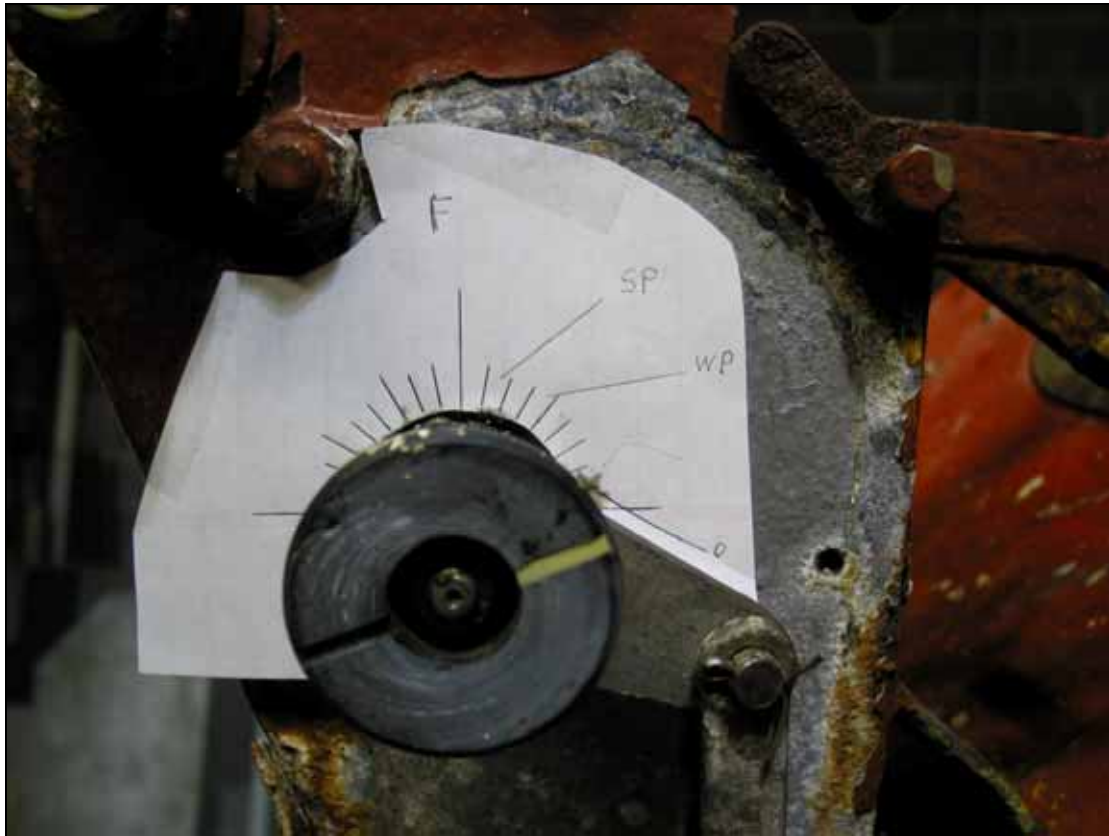
Figure 16: Forward releasing hook with graphometer and recorded angles

The figures 16 and 17 indicate, that the angles for „SP“ with approx. 53° on the forward hook and approx. 55° on the aft hook, as well as for „O“ with 120° on the forward hook and 118° at the aft hook were almost the same. However, the angles for „WP“ strongly deviated on the forward and aft releasing hook. On the aft hook the angle for „WP“ was the same as the angle for „SP“. On the forward hook the angle for „WP“ was about 81°. Therewith it was possible to move the cam release pin at the forward releasing hook by the exertion of a relatively low force $\frac{1}{3}$ in the direction of the release.

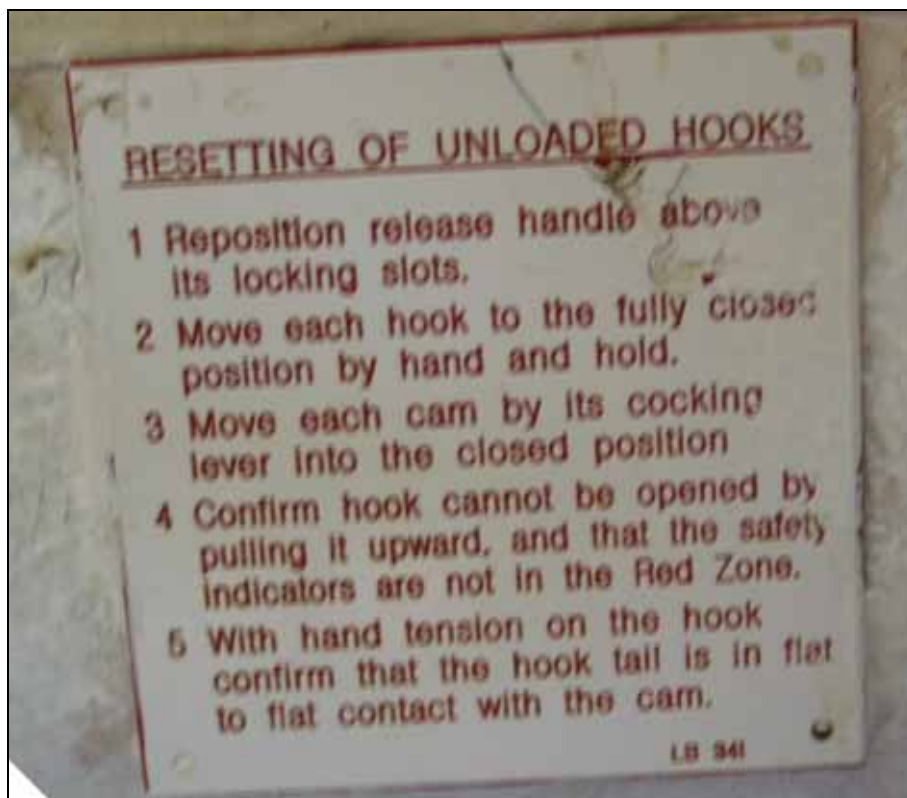
Figure 18: Description of the handling of the releasing hooks, plate LB 34i

There were no drawings or pictographs illustrating the necessary actions on the releasing hook system in the boat⁷. According to Umoe Schat-Harding this should have been identified at a service.

Except for one plate with the circuit diagram of the auxiliary system for starting the engine with compressed air, none of the other actions such as fastening safety belts in the boat or starting the engine were explained by pictographs. All the signs were written in English.

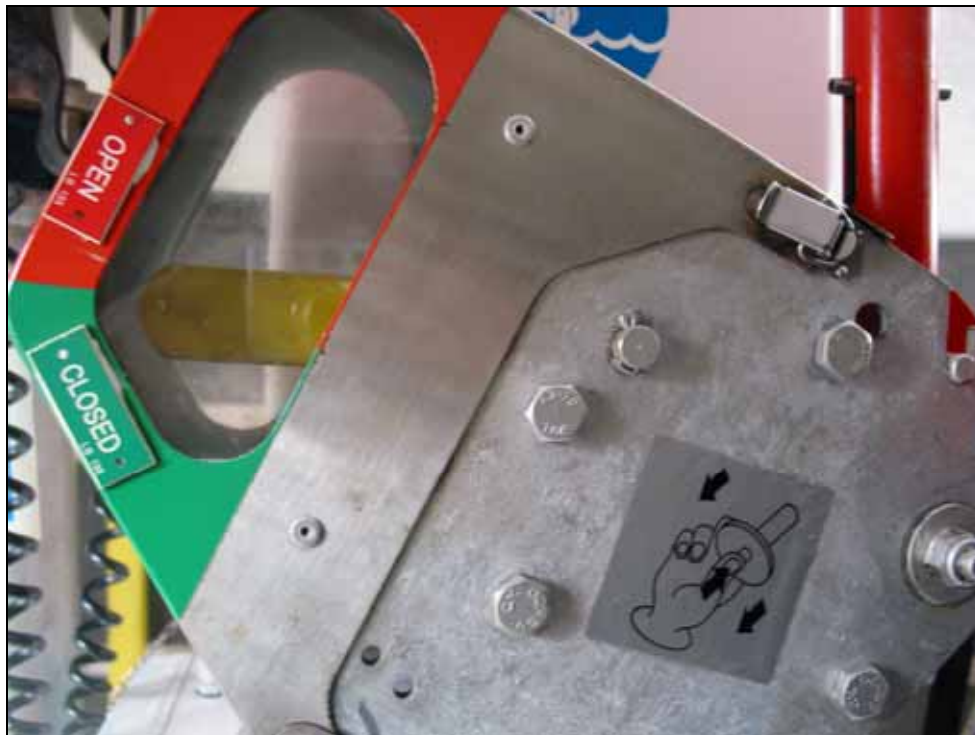
During the visit to OLIVER JACOB the remaining boat was inspected. It was ascertained that the manual lever of the hydrostatic interlock on the release unit was not clearly in the green area and thus did not clearly indicate the secured condition (Figure 21).

Figure 21: Release unit of the starboard boat of OLIVER JACOB; here cover of the lever of the hydrostatic interlock with marks and yellow manual lever of the hydrostatic interlock

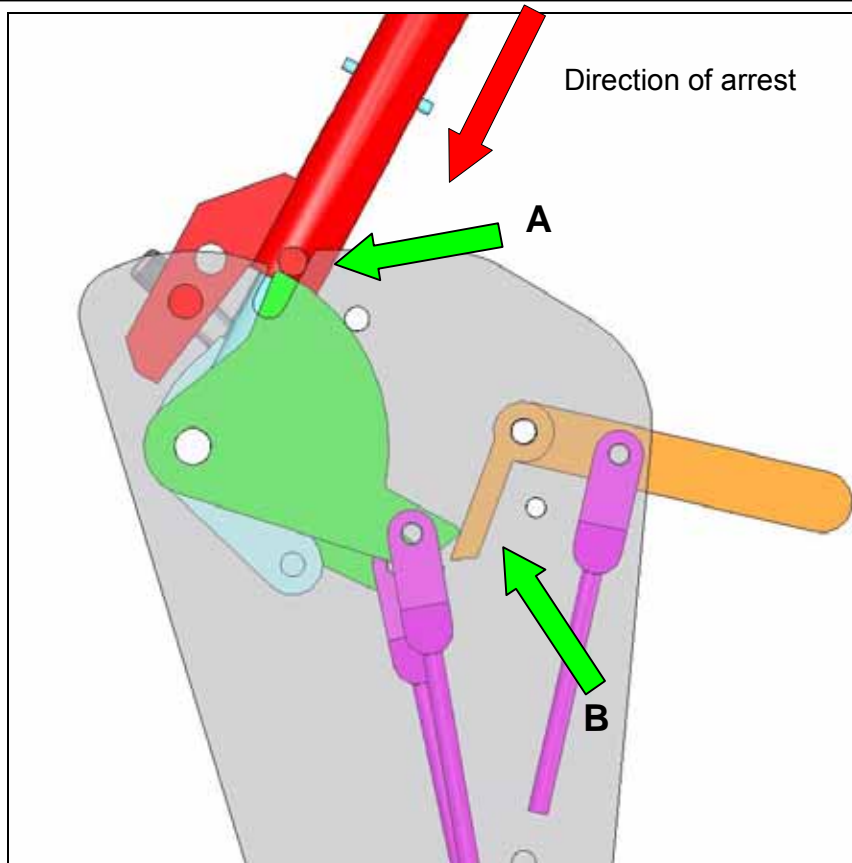
Figure 23: Release unit

During the investigation it was ascertained that the system could not be secured by the hydrostatic interlock. This was caused by the aft operating quadrant that was not turned back completely and that had already prevented complete engaging of the release handle.

The forces leading to release of the forward hook were lying in the range of 39.00 kN with the release handle resting on the operating quadrant (see "A" in figure 23) and at 16.51 kN when the release handle was lifted; at the aft hook the forces were 36.55 kN and 55.6 kN¹⁰ in the contact position of the lever and 26.85 kN with the lever raised.

- A: The side leading pin of the release handle rests on the aft operating quadrant.
- B: The hydrostatic interlock can not secure the two operating quadrants as it rests against the aft operating quadrant and against the aft release cable respectively.

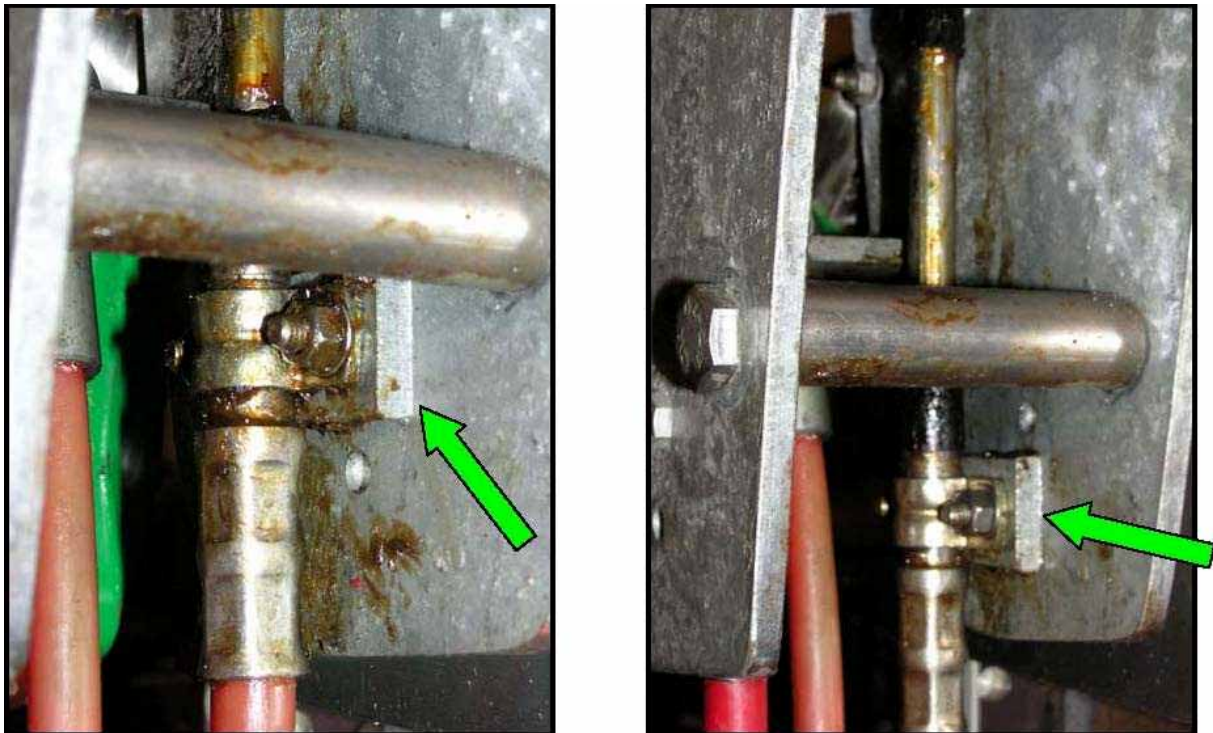
Figure 24: Mounting point of the bowden cable at the foundation plate; original left, modified right

In the course of the examination the expert then adjusted the position of the bowden cable to the aft operating quadrant in order to achieve complete turning back of the aft operating quadrant. For this the fastening of the bowden cable on the foundation plate was offset downwards by using the second mounting point which laid 22,5 mm below and the hitherto fully turned in forked head was turned out by 4.73 mm (Figure 24). This modification led to the desired result. The aft operating quadrant turned back completely. The release handle could be engaged completely, the hydrostatic interlock secured the system and the safety pin could be inserted as specified. In the subsequent experiment simulating the load of a completely manned boat with all safeguards in place, the load was held.

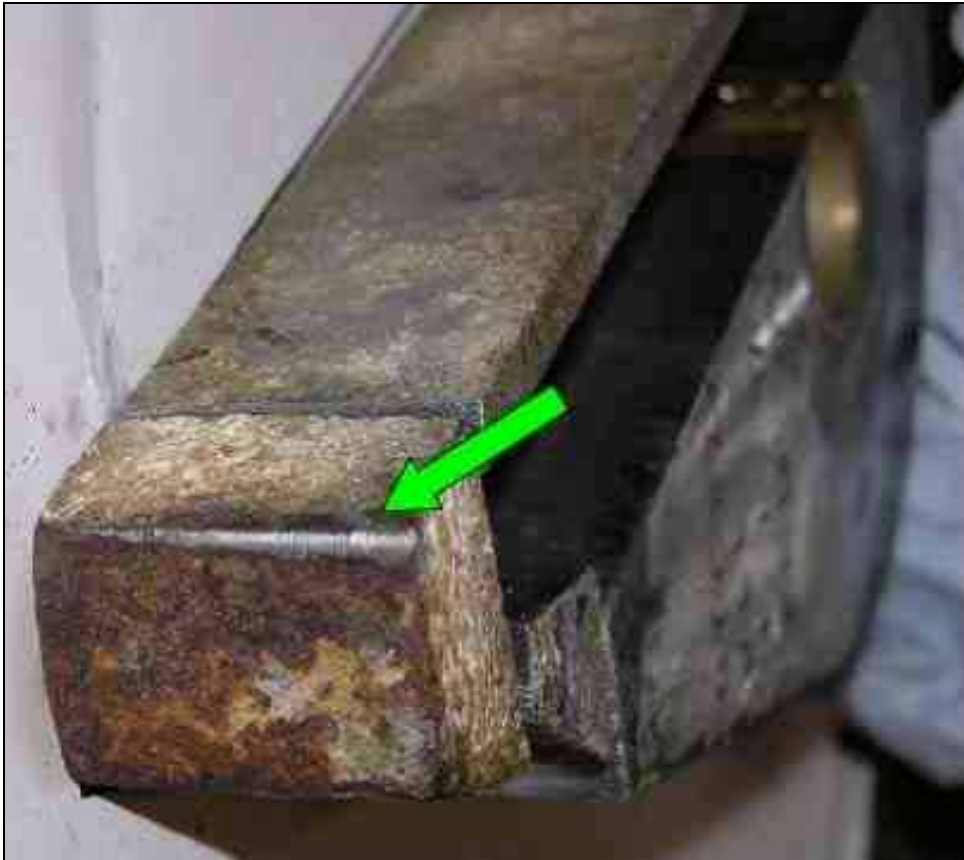
It was possible to see strong wear of the edge of the releasing hook in contact with the cam release pin with the naked eye (Figure 25). The hook was affected by corrosion.

Figure 25: View of the forward hook; asymmetrical rounding, wear edges, strong corrosion

Both hooks showed signs of strong wear at the contact point hook tail/cam release pin (see also Figure 25). The investigation by the Federal Bureau of Maritime Casualty Investigation was unable to clarify the cause for the wear.

In the maintenance manual from William Mills (Marine) which was not on board, excessive wear has to be assumed when the radius of the rounding is more than 1 mm. The radii measured during the investigation at 1.75 - 3 mm at the forward hook and 1.75 - 2.25 mm at the aft hook were well above this figure.

The maintenance manual also describes the allowed distance between the hook tail and release bolt. According to the manufacturer the distance may not be more than 1.8 mm. Values of 1.9 - 2.0 mm were measured at the forward hook and of 1.8 - 1.9 mm at the aft hook.

Therewith the hooks were excessively worn at a crucial position and should have been replaced (Figure 26).

After two years in use both hooks showed signs of strong corrosion. The hot galvanising had not provided sufficient protection against this. It is questionable whether hot galvanising is expedient at a place subject to such loads as the contact area between the hook tail and the release bolt. It would be advisable to use higher-grade stainless steels here.

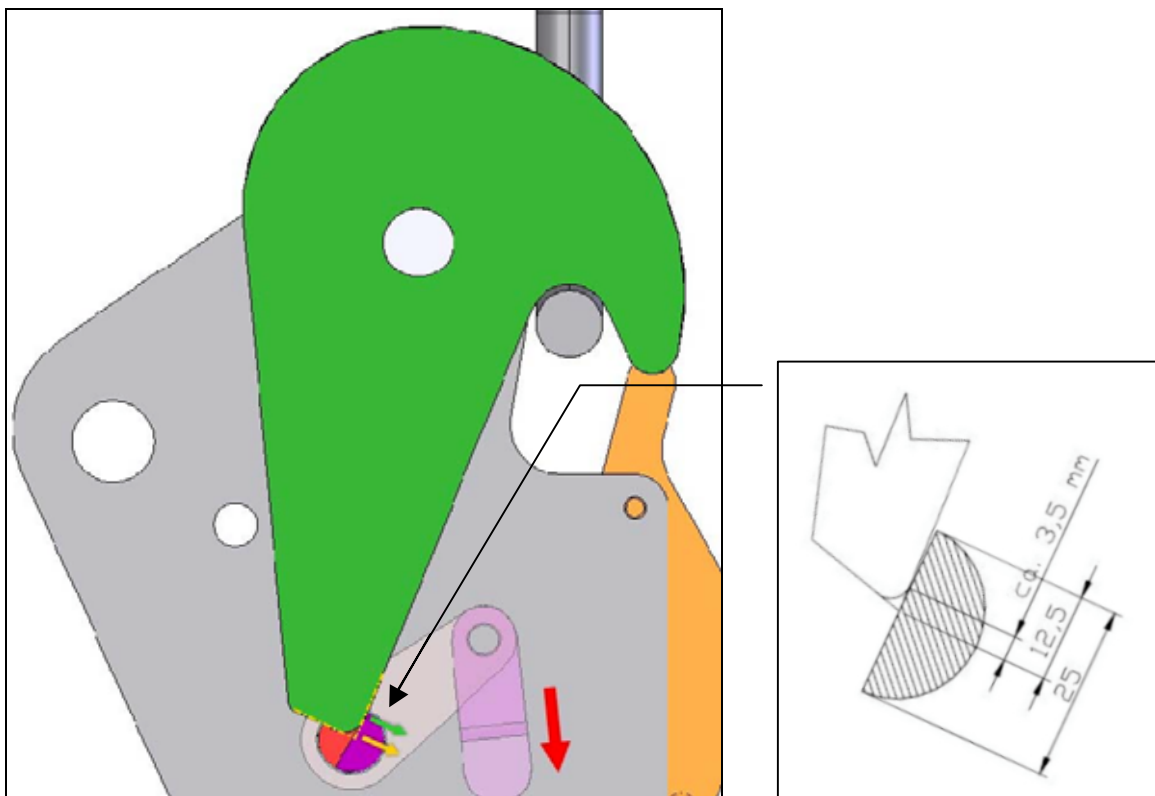
Figure 27: Presentation of the leverarm and the torque on the release bolt

The wearing of the hooks had a crucial influence on the accident. As a result of the wear at the hook tail there was a shift in the point at which force is exerted on the cam release pin. This resulted in a torque on the bolt that, on the one hand, led to the release bolt being able to turn so far that it released the hook. And on the other hand transferred the force to the release unit via the bowden cables and thus caused turning of the operating quadrants (Figure 27).
