Investigation Report 231/06

Collision
between MV LASS SATURN und
Sailing School Ship ROALD AMUNDSEN
on the Heikendorfer Reede
on 4 May 2006

15 February 2007

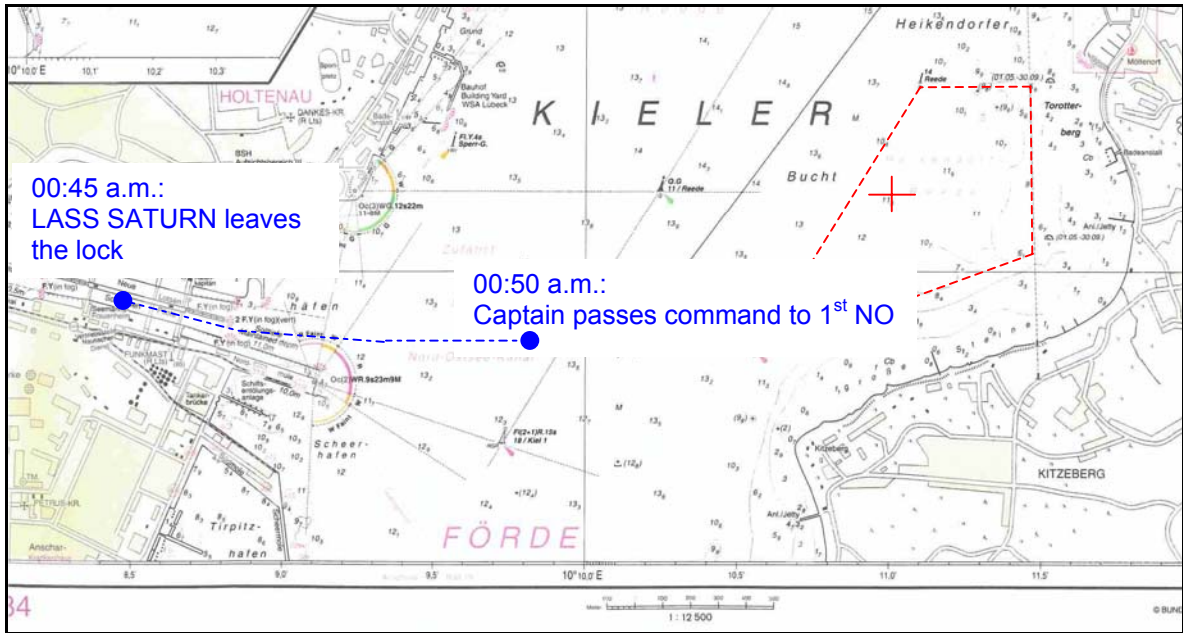
Fig. 4: Course of the voyage of LASS SATURN

A pilot was on board during the passage through the Kiel Canal. The vessel reached the lock of Kiel at 00:16 a.m. and left it at 00:45 a.m. heading for the Kieler Förde³ (to this, see also Fig. 4).

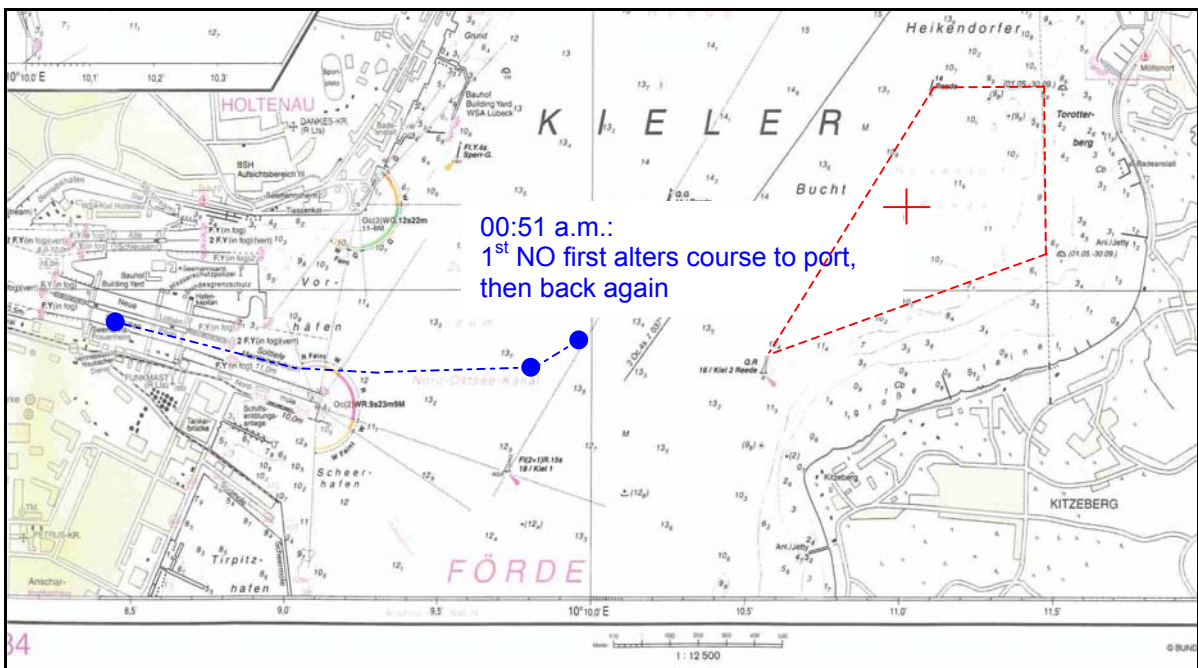
Fig. 5: Course of the voyage

As the 1st Officer had already been sailing on this type of vessel under this circumstances for two years, the Master was in no doubt about passing on the command to him already at 00:50 a.m. The 1st Officer switched on the autopilot and immediately altered the course to port side, in order to head for the next way-point drawn in by the chart (see Fig. 5).

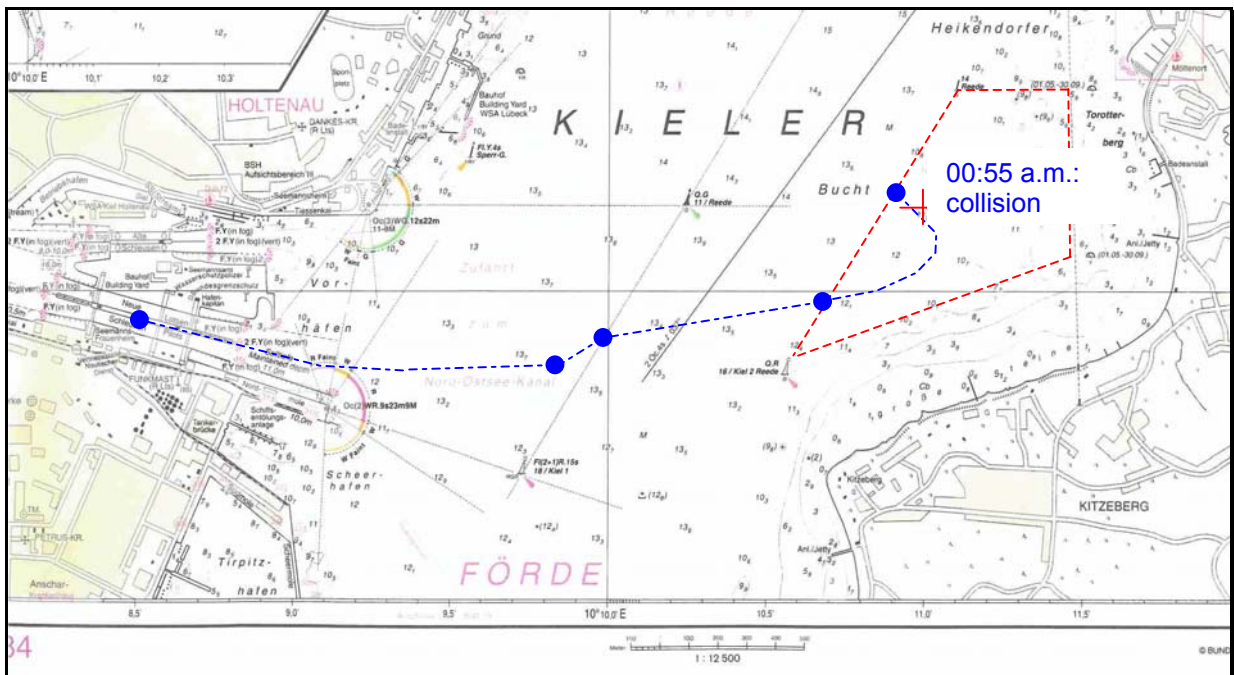
Fig. 6: Course of the voyage

Shortly after that the Master, who was still on the bridge, pointed out that the course had to be altered to starboard again, in order to follow the buoy line from Kiel 1, Kiel 2 up to buoy 14. Then he left the bridge, assuming that within the next three minutes one of the three seamen, who at this moment were still busy on deck, would go to the bridge in order to keep the lookout. Accordingly, the 1st Officer returned to the previous eastbound course, so that the Kiel 2 buoy was lying slightly to starboard (see Fig. 6). Shortly before the buoy was passed at his starboard side, he put the helm to port in order to get to the new course of 30°. Shortly after that he noticed a light on the right side ahead, which he could not identify at first. When it came near, he recognized the moored sailing ship, switched the autopilot back to manual operation and put the helm hard to port (see Fig. 6).

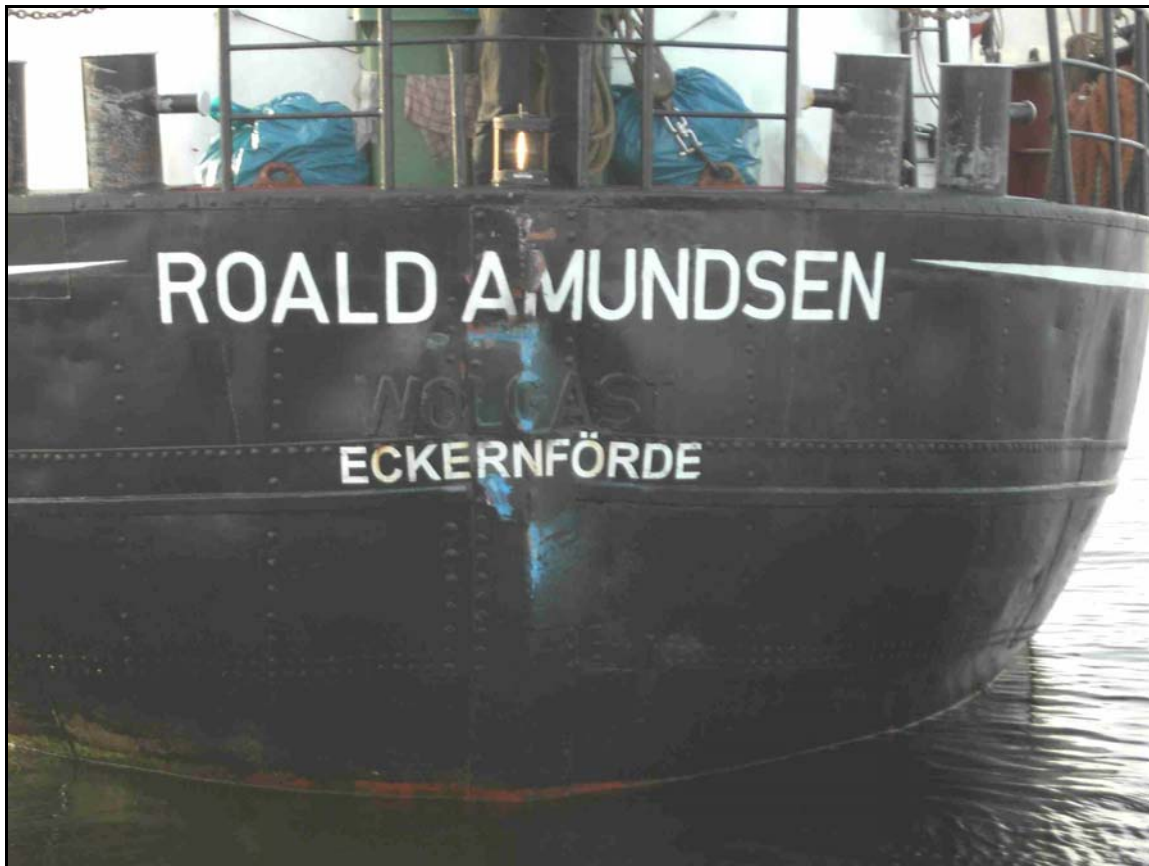
Fig. 7: ROALD AMUNDSEN – View of the damages

As soon as the starboard side of LASS SATURN was passed by the stern of ROALD AMUNDSEN, he had applied “Hard starboard“, in order to stop the port side turn of the ship, thus preventing, if possible, the own stern from a collision. However, this manoeuvre did not succeed. The starboard side of LASS SATURN grazed the stern of ROALD AMUNDSEN at 00:55 a.m.

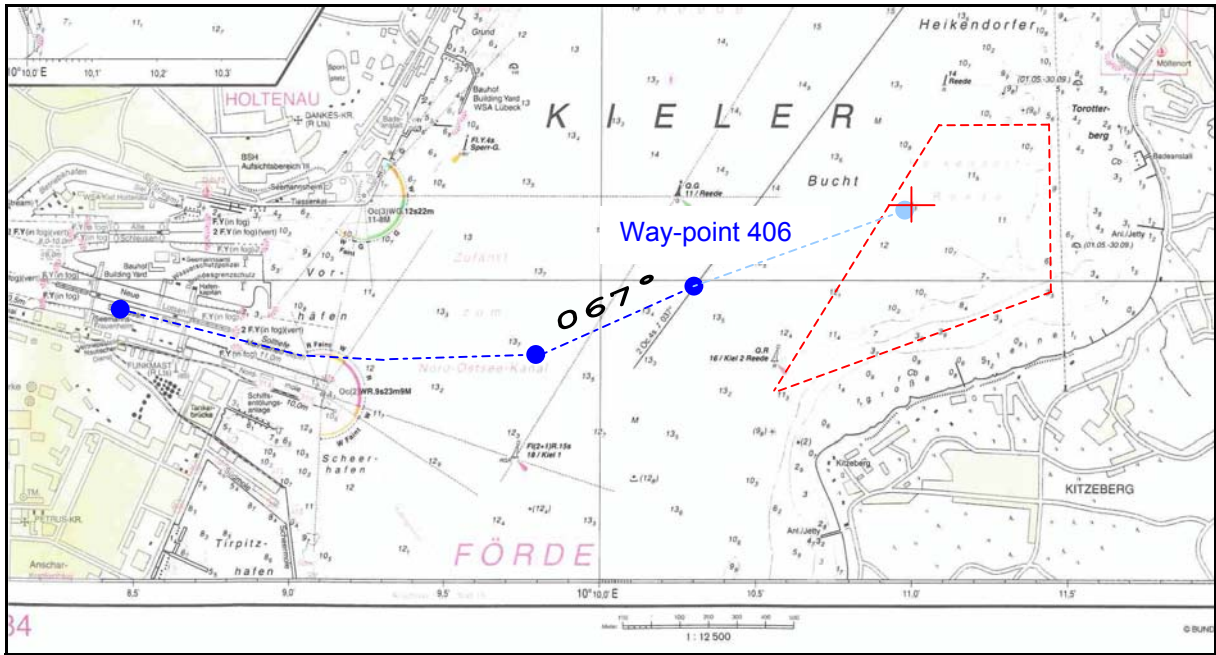
Fig. 8: Assumed course of the voyage

The chart of LASS SATURN shows that the vessel should have headed for “way-point 406” at a course of 067°, in order to subsequently continue her voyage at a course of 037° in the transit bearing to Jägersberg. If the 067° course line on the nautical chart is produced beyond the way-point, it will exactly strike the anchorage of ROALD AMUNDSEN. In this respect it is assumed that the 1st Officer followed the Master’s instruction to go farther to the east by continuing their course of 067° already set on the autopilot, instead of turning to the new 037° course. The reason why the 1st Officer did not notice the anchored vessel but at a very late stage is unknown. This might possibly be explained by the fact that from the time of taking over the watch, the 1st Officer oriented himself by the vessel sailing in front of him, but then possibly mistook its stern light with that of the moored vessel and thus headed for ROALD AMUNDSEN.

It could not be comprehended why the 1st Officer finally steered LASS SATURN into this situation. However, this evasivon manoeuvre did not prevent the collision. The lack of a proper lookout is considered to have caused the accident. Neither was there a second person present on the bridge who could exercise this prescribed function, nor did the 1st Officer notice the moored vessel by means of an appropriate observation of the radar. A promoting factor may have been that the 1st Officer took over the watch coming directly from his manoeuvring station to the bridge after leaving the lock, while the Captain was eager to pass on the watch quickly, in order to observe his own of rest period.
