Investigation Report 28/06

Very Serious Marine Casualty

**Fatal occupational accident on board
MV “Heinrich S” in the port of Koper
on 25 January 2006**

1 November 2007

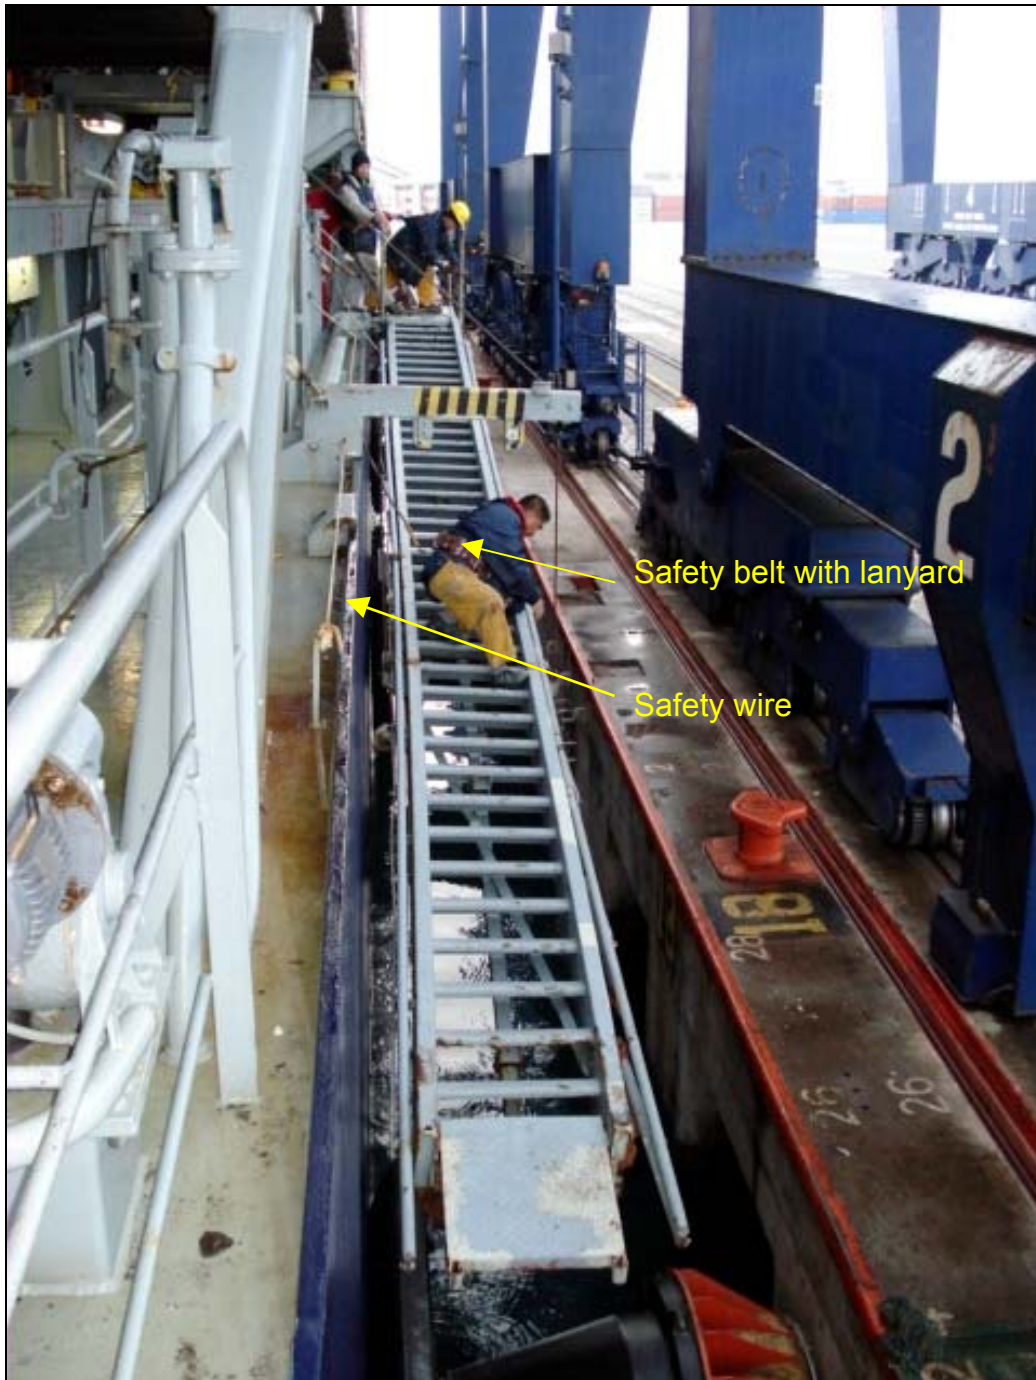
As a reaction to the casualty, the ship's operators had a safety wire installed in the gangway pocket area on all the shipping company's vessels. This wire rope stretched over the length of the gangway pocket at main deck level now enables use of safety harnesses with attached safety lanyards.

Figure 4: Unfolded gangway with safety wire ⁴

⁴ The safety belt used in Figure 4 does not meet the standards for safety harnesses set in § 5 UVV See and in Circular B 1 of the Marine Insurance and Safety Association.

- design their vessels in the gangway area in a manner such as to enable easy implementation of fall prevention measures;
 - guarantee the implementation of the requirements set out in § 9 of the Regulations for the Prevention of Accidents at Sea and § 84a of the Seamen's Act.
