Investigation Report 304/06

Marine Casualty

**Spillage of harmful substances from
a container on board
CMS HANJIN LONDON
with 8 injured persons
in the Port of Hamburg
on 10 July 2006**

15 May 2007

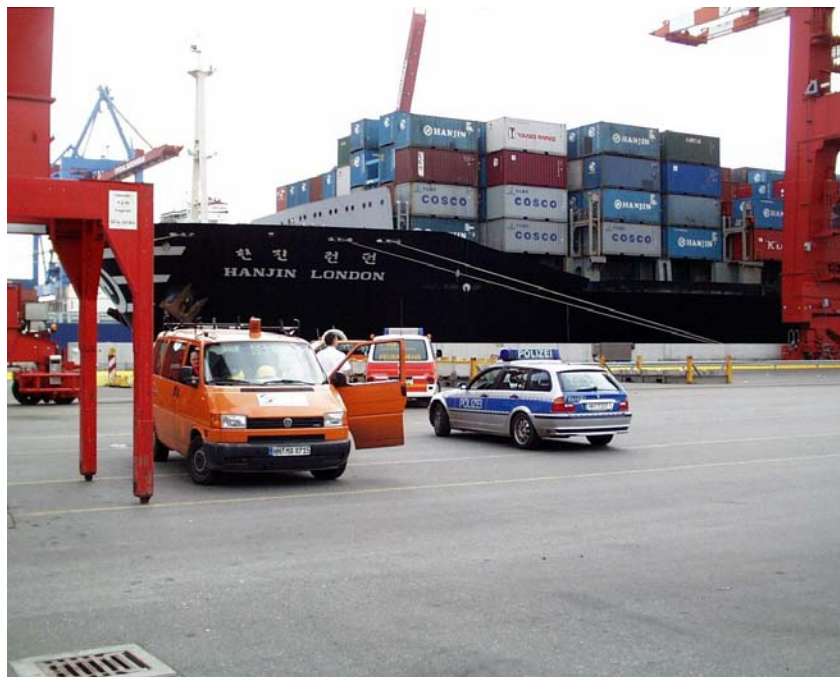
HANJIN LONDON was on her voyage from Rotterdam to Hamburg. The container, which had been filled with titanium tetrachloride (UN No. 1838) in France, was stowed on deck on the forecastle in Rotterdam (see fig. 3) and bound for Korea. When gas escaped from the container at the berth in Hamburg, the container was set ashore (see fig. 4) and deposited in a vat designated for harmful substances at the gas application site with the Eurogate company. At about 10.40 p.m. on July 11th, the company DOW Chemical started pumping off the remaining cargo. At 00.30 a.m., the pumping was completed. When measuring the cargo, a loss of 40 to 100 kg was detected. On July 12th, 2006, the damaged container was transported to the company Remain in Hamburg. There it was neutralised and cleaned under the supervision and instruction by employees of the French manufacturing company, in order to make it accessible for the inspection scheduled for July 17th, 2006. On the day of the inspection, the company Dr. Fintelmann and Dr. Meyer still detected some residues of the cargo. Therefore, for the time being, parts of the panelling and insulation (see fig. 5) of the container were removed. During this work, portions of the cargo again leaked from one of the heating pockets and from a heating tube. After repeated cleaning and disassembly of a standpipe, the container could be inspected by Germanischer Lloyd on July 18th, 2006. On this occasion, sites of previous repair work and other holes in the heating system (see fig. 7) were found in the tank (see fig. 6) and in the area of the heating pockets. Initially it was supposed that the cargo got into the heating system of the container and from there outwards through the holes. However, no statements could be made on the causes of the holes or corrosion, respectively .

Figure 3: Row of containers

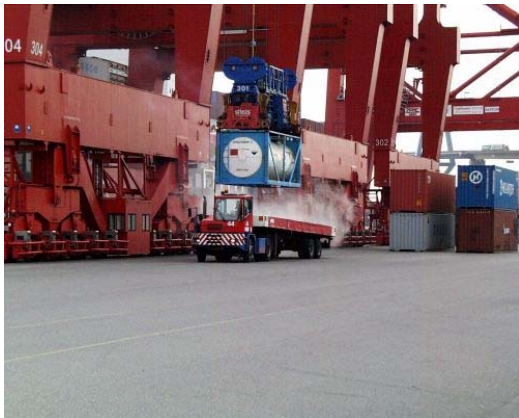
Fig. 4: Evacuation to the gas application site

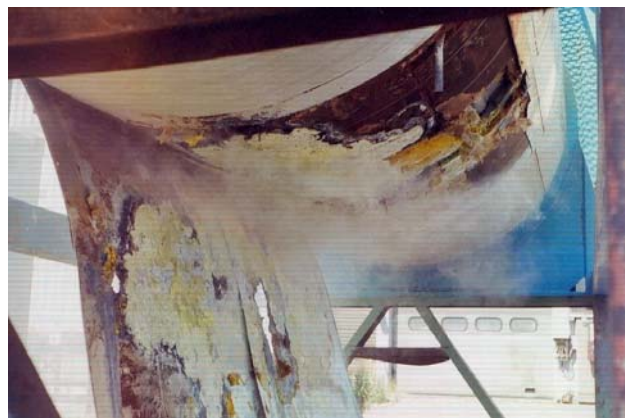
Fig. 5: Removal of the insulation

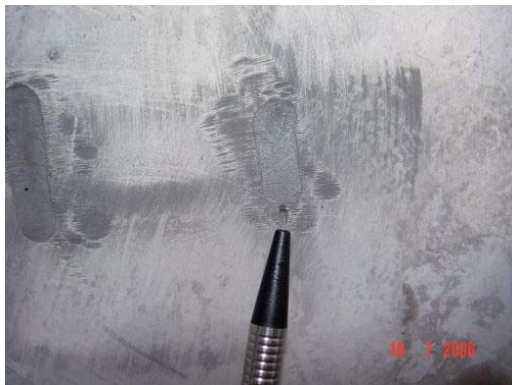
Fig. 6: Sites of previous repair work

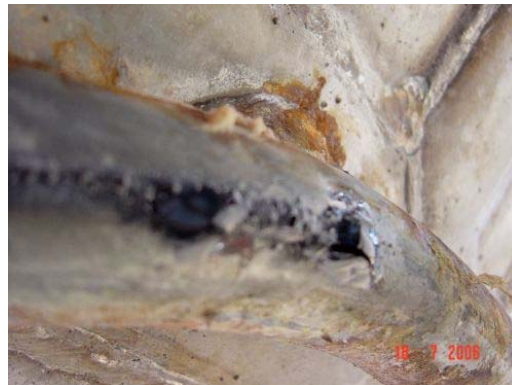
Fig. 7: Eroded pipe in the heating system

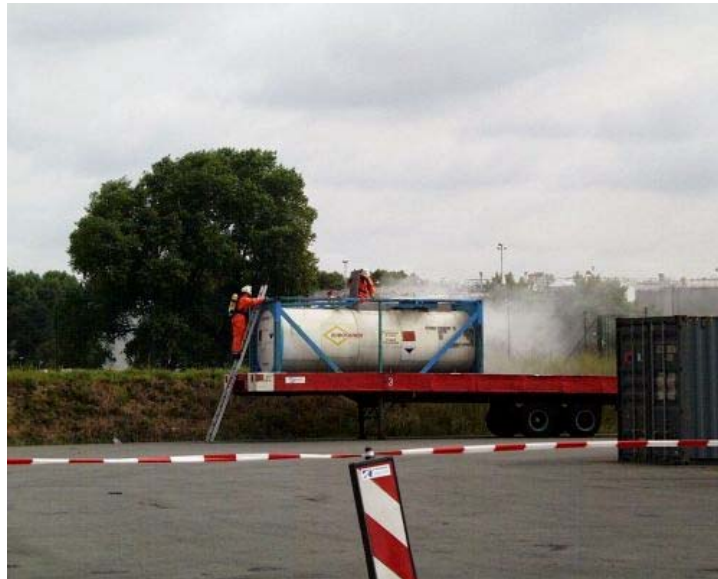
Fig. 8: Operation using protective clothing and breathing apparatus

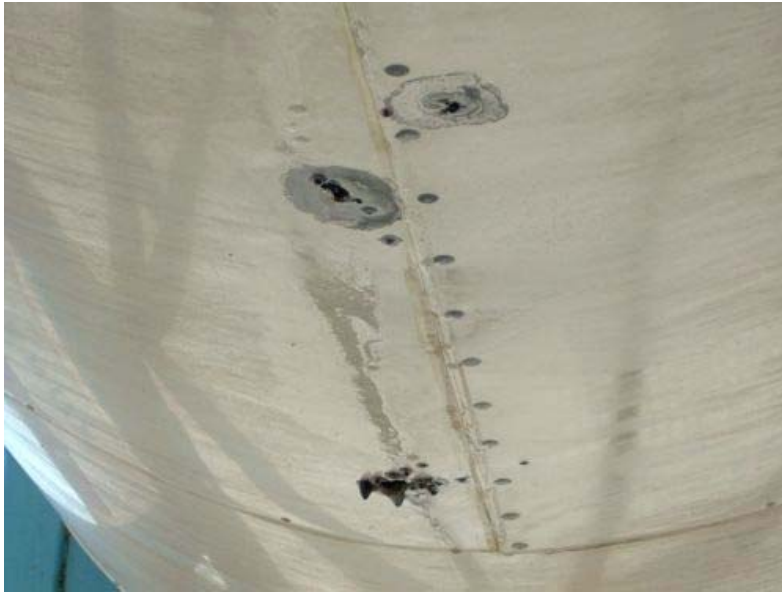
The container was located on the premises of the company Remain and had been neutralised by means of caustic soda and then flushed under high pressure. At the first visit on July 17th, 2006, 10 ppm² of hydrochloric acid portions were still found inside the container and in the insulation, in addition, some white and yellow residues on the bottom of the container and in the area of the standpipe. Therefore, the residues were washed by means of a high-pressure cleaner, and the insulation was removed as far as necessary. In addition, the standpipe was dismantled. The next day, the measurements in the interior showed 20.9 % of oxygen and 0 ppm of hydrochloric acid portions. The container was free from removable residues. Serious discolouration and erosions were visible throughout the container. Two holes were detected in the bottom (see fig. 9). On a heating channel welded onto the tank, white efflorescences and slight vapours of hydrochloric acid were visible on the outside. An attempt to purge the heating channels under high pressure failed, as the channels were obviously blocked. The efflorescences that had appeared were removed once again.

Fig. 9: Holes in the bottom

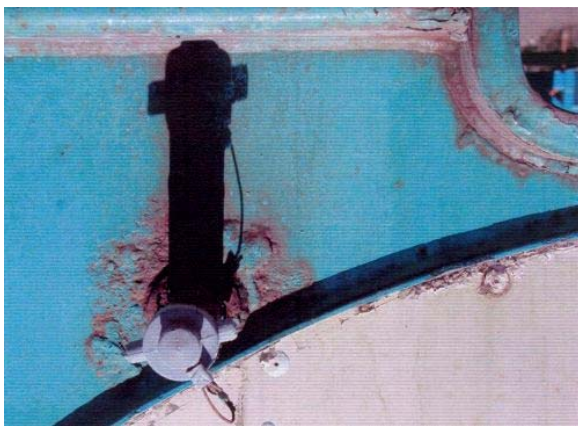
The container was empty and cleaned. The insulation and cover were removed for large areas of the surface, and the heating pipes had been purged as far as possible. Various sites of the frame, the welding seams as well as the inlet and outlet pipes were corroded (see fig. 10 and 11). The profiles of the frame showed deformations in the area of the upper and lower longitudinal beams. Cracks were detected in the welding seam and in the upper longitudinal profile at the connection with the upper transverse beam. Some welding seams in the circumferential stiffening ring of the tank body were cracked. In the area of the outer stiffening ring, the insulation and its fixation did not correspond to their original condition. 3 leakages or cracks, respectively, that could be seen from the outside were detected on the heating system. They were in the pipings in the inlet and outlet area as well as in one of the lower heating shells on the vacuum stiffening. Inside the tank, three other cracks were detected in the lower part of the heating body. During the inspection, liquid leaking from the heating shells entered the tank body and accumulated on the cylindrical floor.

Fig. 10: Inlet socket

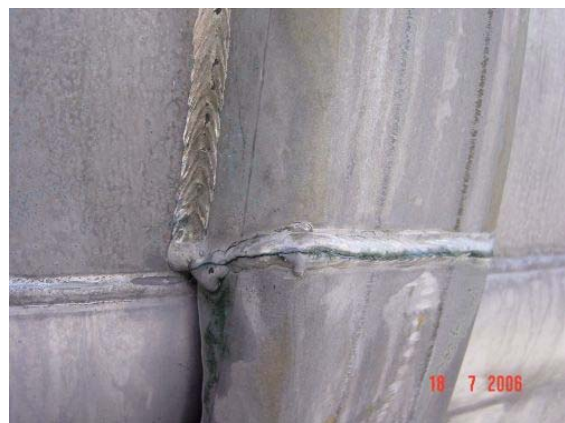
Fig. 11: Welding seams
