**Bundesstelle für Seeunfalluntersuchung**  
**Federal Bureau of Maritime Casualty Investigation**  
Federal Higher Authority subordinated to the Ministry of  
Transport, Building and Urban Affairs

Investigation Report 306/05

**Very Serious Marine Casualty**

**Foundering of the Motor Boat  
"SEEHUND I"  
on 9 August 2005  
in the Süderpiep area  
in the North Sea off Eiderstedt**

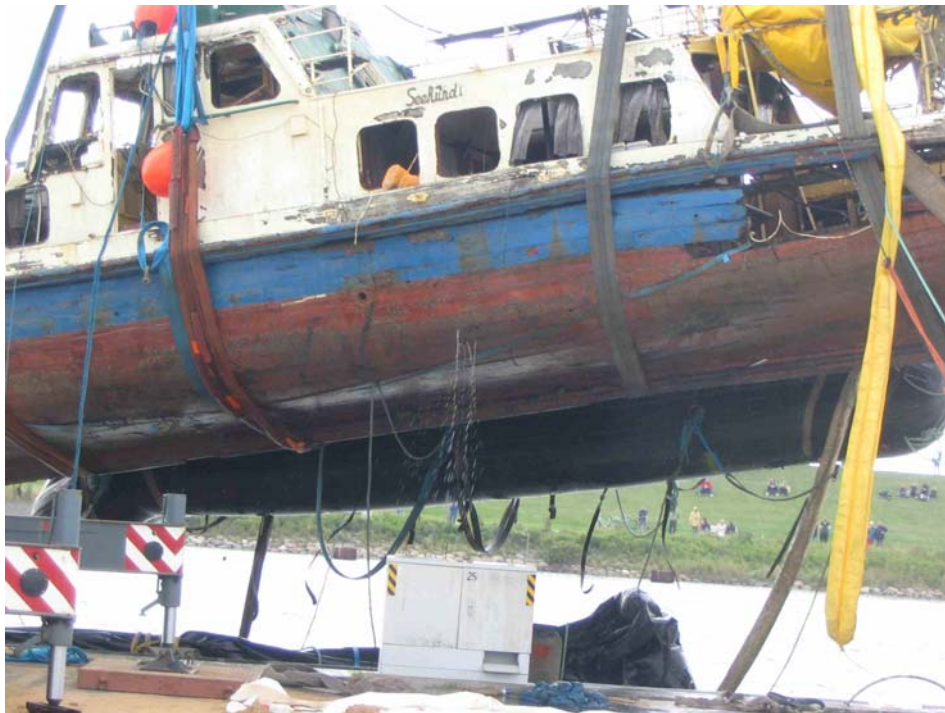
Figure 6: Salvage

The vessel was first examined by divers of a salvage firm after it had been under water for 10 days. The salvage firm stated with regard to the condition of the vessel that they had in the past salvaged many a vessel after it had been under water for a relatively long time, but that they had rarely seen one that had looked as bad as this one. The vessel had already been scrap (painted over scrap) before it had left the port.

On 20 August 2005 the vessel was lifted with lifting cushions filled with compressed air, kept afloat with these buoyancy bodies, and towed into the port of Büsum.

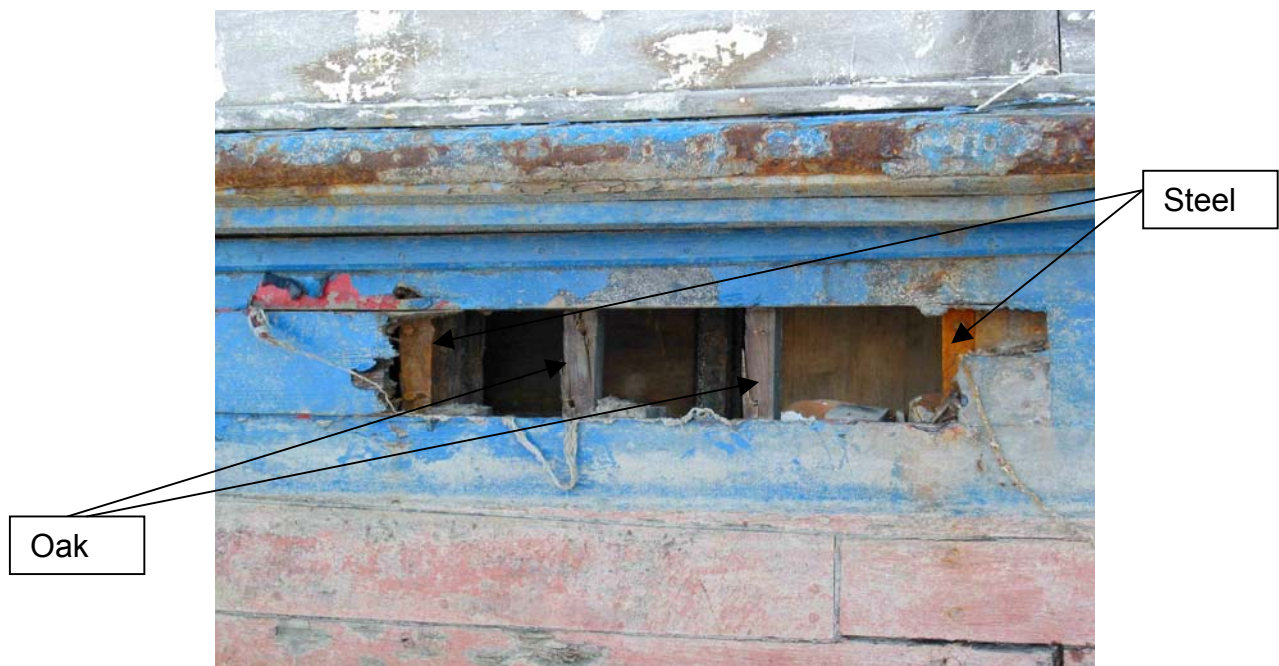
Figure 7: Construction method frames/planks

The outer shell was 20 to 30 mm thick in many places. The original thickness of the planking according to the construction drawing should have been 40 mm. The mode of construction and dimensions of the frames in the fore ship area were one 75 x 50 x 5 mm steel angle every 650 mm and always one intermediate frame in 50 x 40 mm oak. From midships to the stern the frame spacing of the steel frames was 900 mm, with two intermediate frames made of oak installed between in each case.

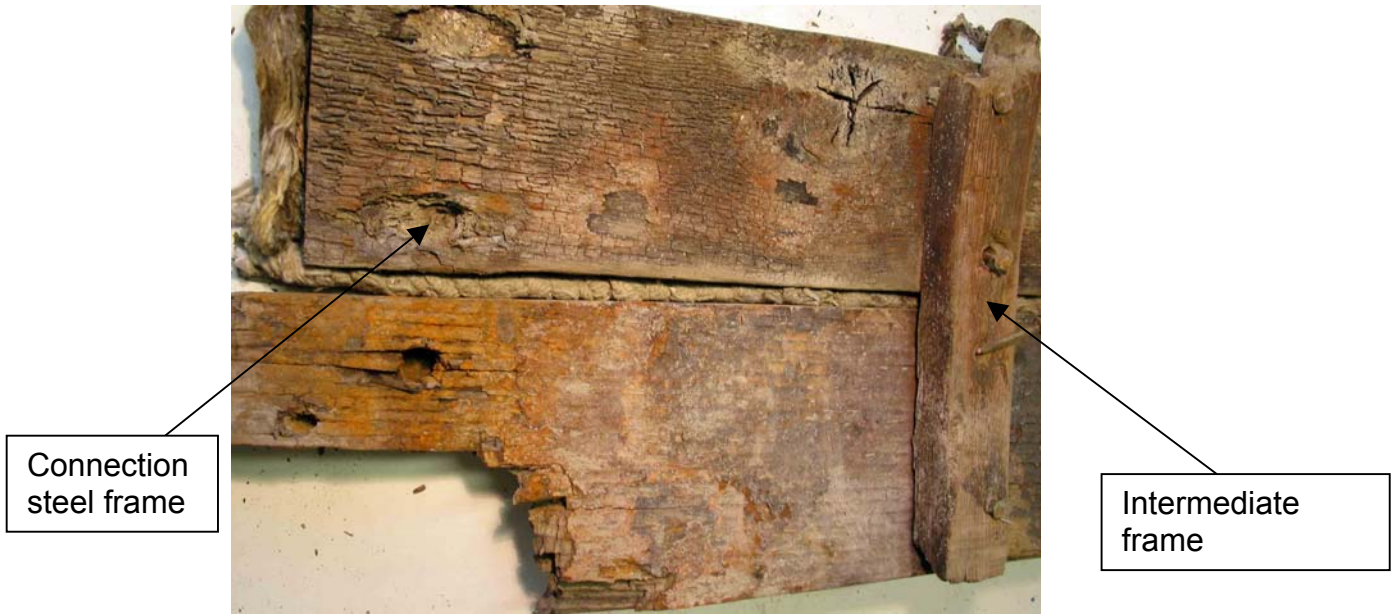
Figure 8: View of planking, interior

The planks were connected with the intermediate frames using copper nails that were still intact in many places, while the steel frames were connected with the planking with machine bolts, many of which were missing. The wooden planks had become disintegrated in the way of the screw heads. These disintegrated

connections were not evident from the exterior, as the plugs placed on top of them from the exterior looked apparently good.

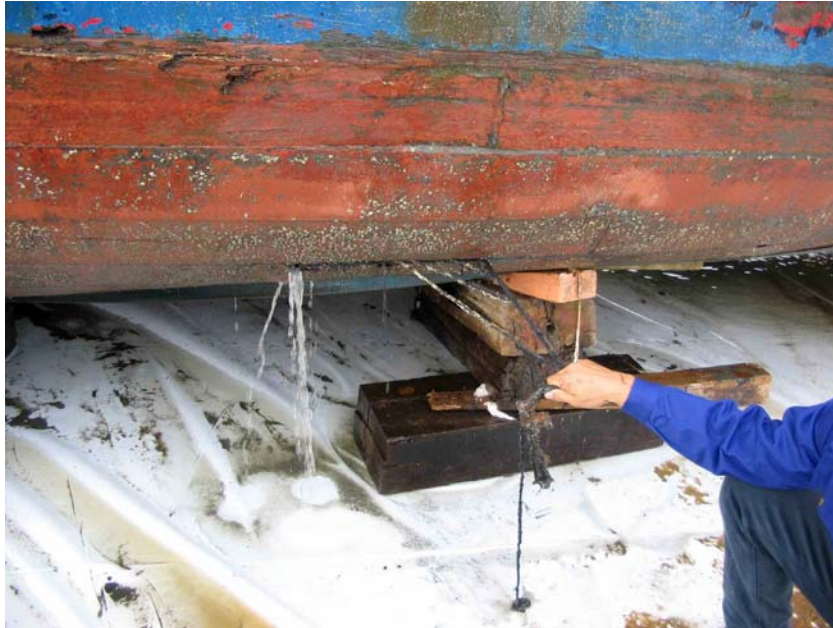
Figure 10: Under-water seams

The longitudinal seams and plank joints were caulked with cotton. The layers in the plank joints had been inserted straight. In many of the partly very wide longitudinal seams eyes consisting of caulking cotton had been placed, turned in and pushed back.

From the exterior the caulking had been sealed with sealing compound (polyurethane, trade name Sikaflex and Pantera). The sealing compound was no longer sticking to the plank joints over large areas, but instead to the caulking cotton and could easily be drawn out of the seams.

The main cause of the water ingress that ultimately led to foundering consisted of the dried out and not sufficiently caulked outer plating and deck planks. Due to lack of care and the long period out of water, the planks in the above-water area had dried out and as a result of the voyage and water on deck it was not possible for these planks to swell up quickly enough and thus make the hull watertight.

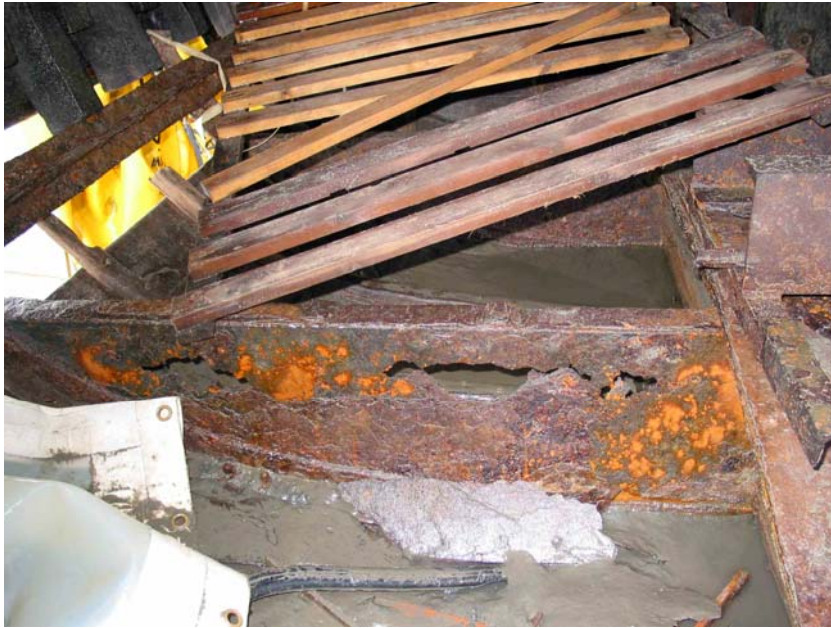
Figure 11: Floor timbers

The steel frames and steel bulkheads were very badly corroded. Several intermediate frames were broken and very badly damaged by scouring and poor conservation. The bottom beams were largely completely corroded. Although the deck was in a well-painted condition, the caulking of the deck planks was largely no longer present.

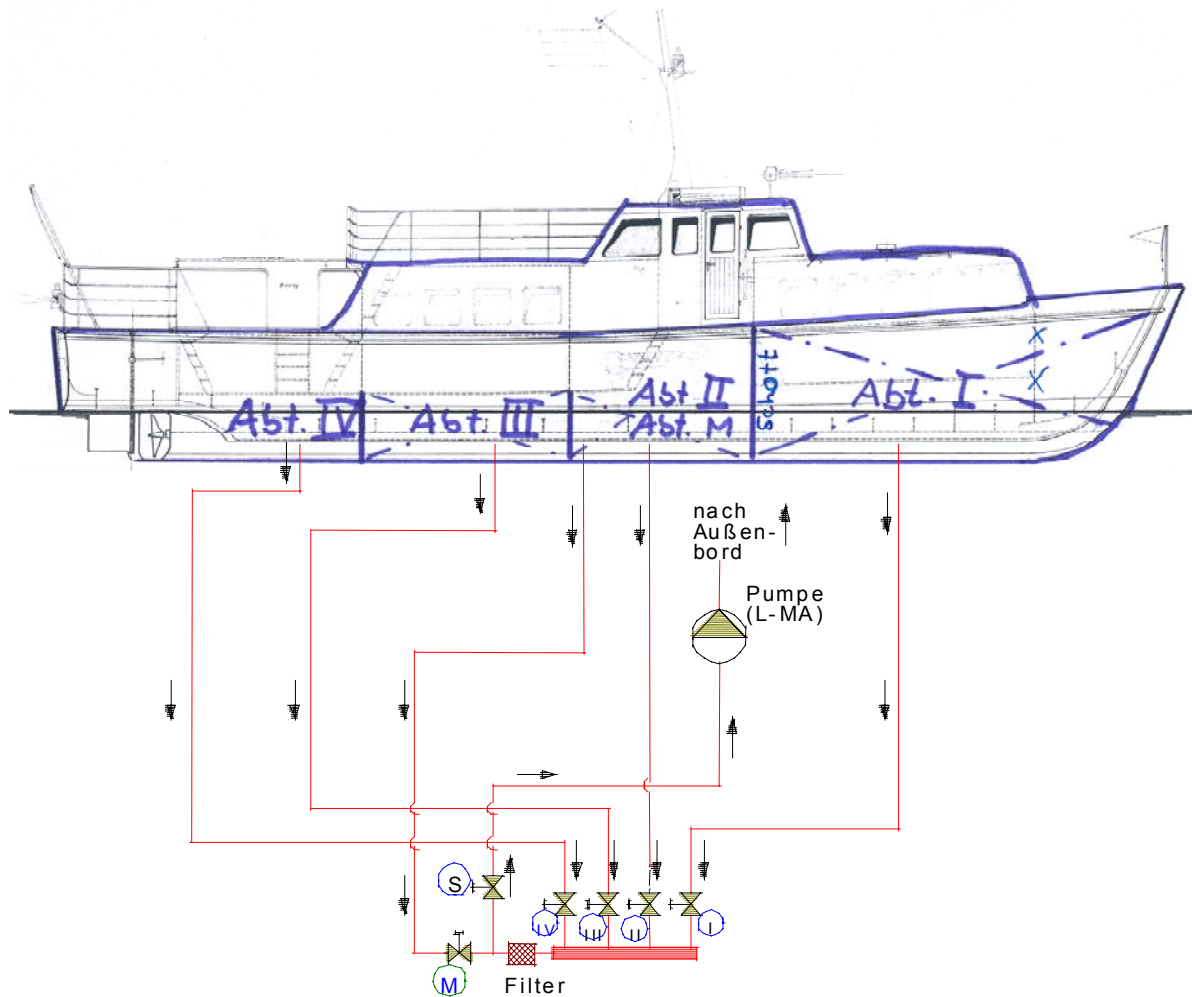
Figure 12: Main draining device

The main drainage facility had been installed when the vessel was still licensed as a passenger vessel with the See-BG (Marine Insurance and Safety Association). This drainage pump had been driven by the main engine with toothed belts and could be activated with an electromagnetic coupling that could be switched on electrically from the bridge.

The main drainage system was in an operable condition and if it had been operated correctly the vessel could have been kept afloat longer. The crew was not familiar

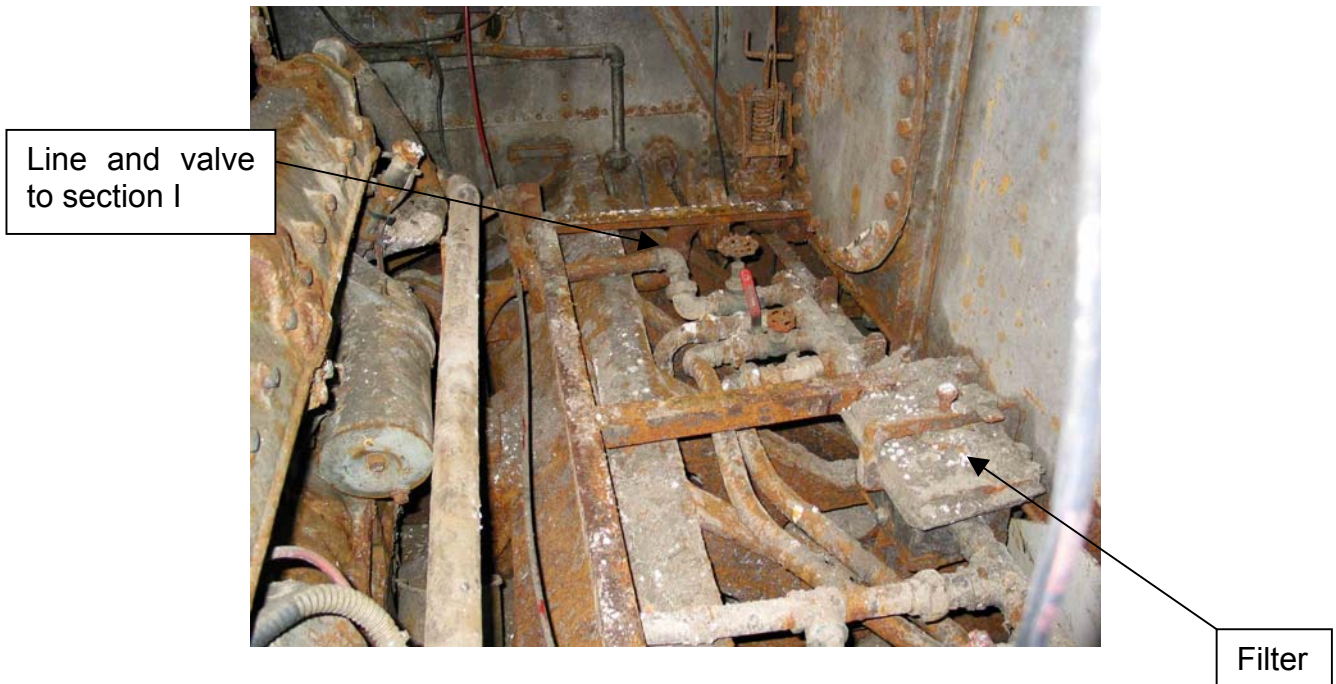
Figure 13: Valve assembly

Five different areas could be drained via a valve assembly arranged on the starboard side in the engine room under the floor plates next to the main engine. There were no drawings of the drainage system in the See-BG and GL documents or on board, so that the drawing of the main drainage facility was prepared on the basis of the facilities existing on board.

During the survey by the BSU, the valve to section I forward was open and the line to this section was through-going and not clogged. All the other valves including valve "S" in the suction line to the pump were firmly closed. Furthermore, the valve "S" did not have any hand-wheel or hand-lever to operate it.

No labelling could be found on the lines and valves.

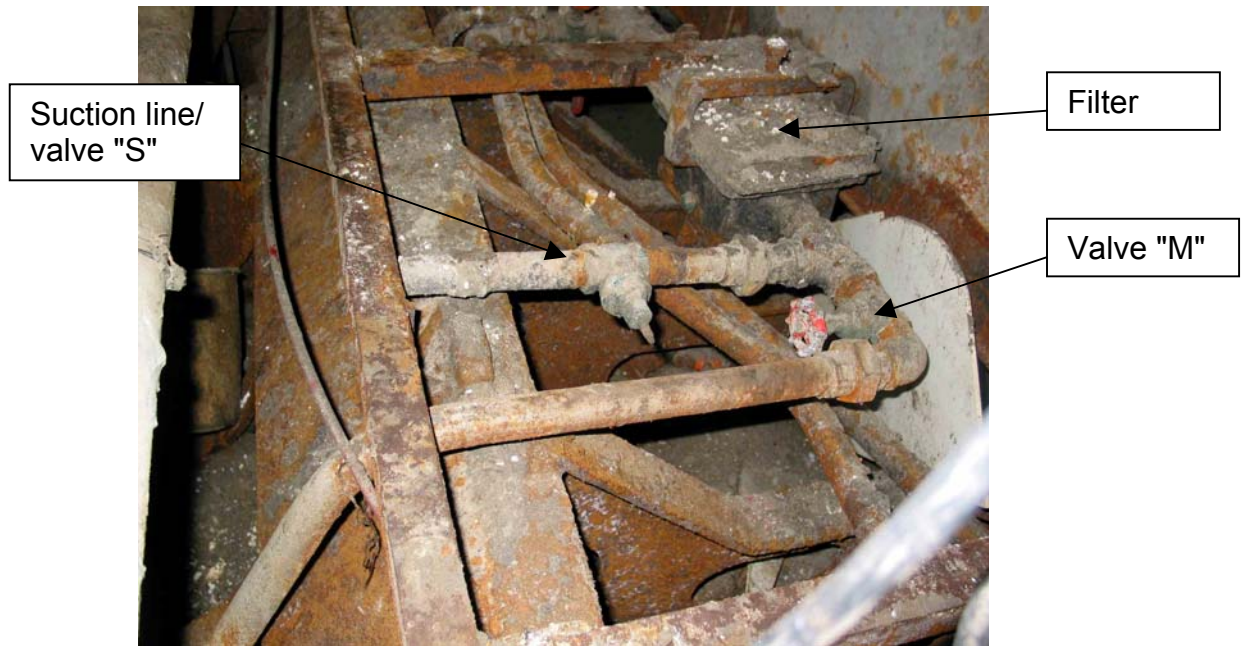
Figure 14: Suction line

According to the statements made by the transfer crew the main drainage pump had been constantly on at a valve of any optional line for drainage. Only the valve for draining from the engine room had to be maintained permanently closed. It had been explained to the Skipper before starting the voyage in Tönning that there had deliberately been no hand-wheel fitted on this valve in order to avoid unintentional drainage and hence water pollution with oil from the engine room.

During the investigation on board, the valve "M" of the suction line from the engine room area was found to be closed and with a hand-wheel fitted. The suction valve "S" of the line to the main drainage pump was closed and the hand-wheel of this valve had been dismantled. The engine room area could be drained through two lines. The first line through valve "II" drained water from the area outside the engine longitudinal beam that did not contain any oil via the valve assembly and filter to the drainage pump. With line "M" it was possible to drain the area under the main engine directly, bypassing the valve assembly and the filter.

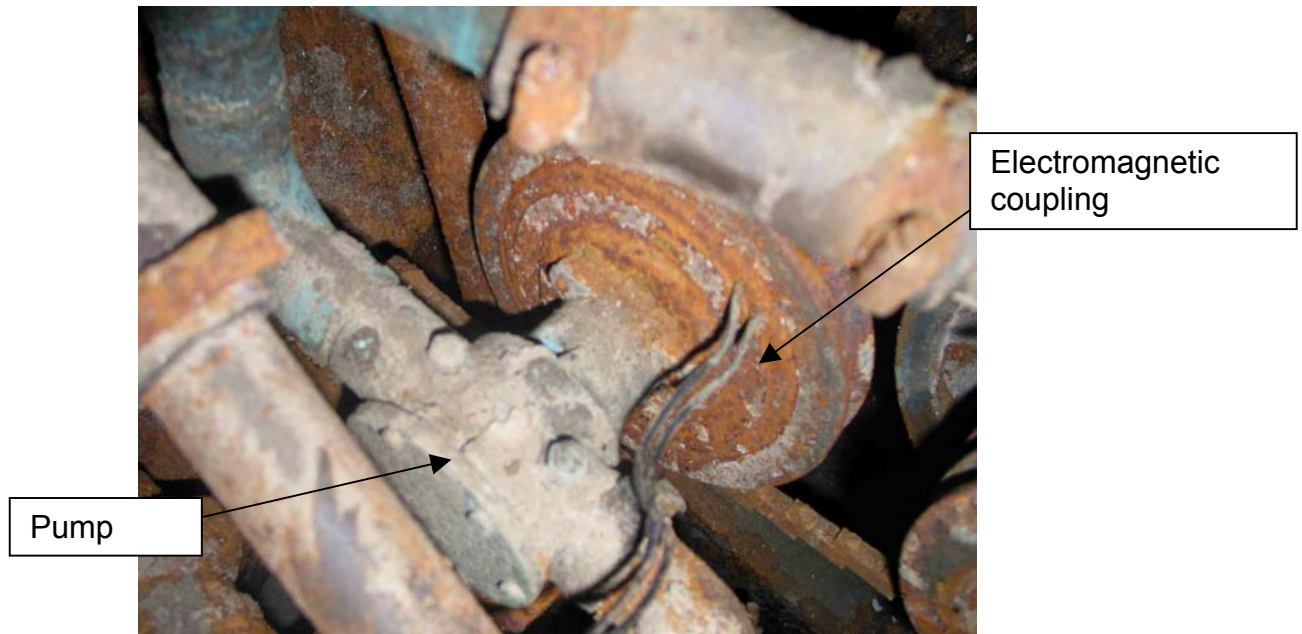
Figure 15: Main draining pump

With the 22" pipe connections and 2000 revolutions per minute at the belt pulley, it would have been possible to drain approx. 370 l water per minute out of the vessel with the main drainage pump.

The drainage facility was completely operable, but as the valve "S" was closed at the time of the accident, it was not possible to drain water from the sections.

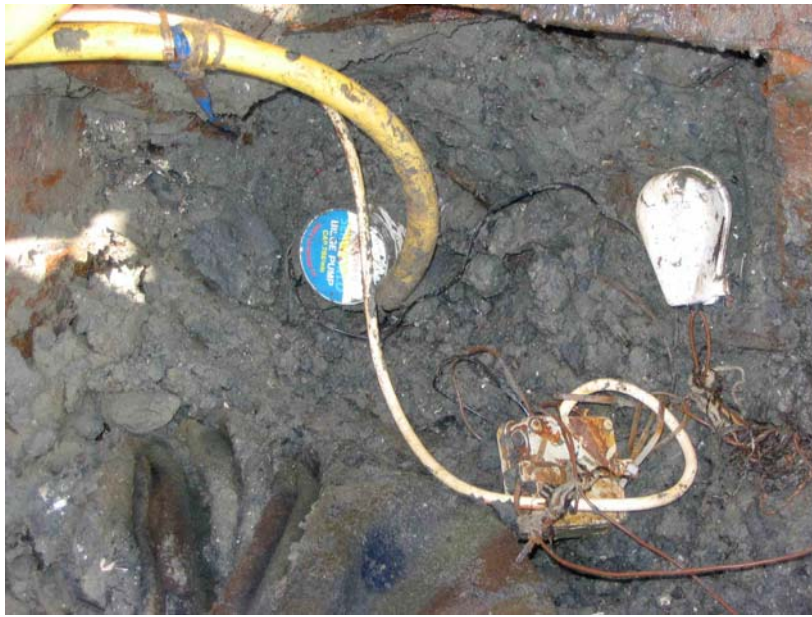
Figure 16: Draining device aft

After the vessel was no longer subject to licensing and supervision by the See-BG (Marine Insurance and Safety Association), two more 12 V "yacht drainage pumps" with automatic floater switches were evidently retrofitted in the aft sections III (passenger area aft) and IV (open, lowered deck aft) in addition to the main drainage facility in the engine room. The outlet of the drainage pump in section III was on the port side under the sheering strake and the outlet of the aft pump was connected to the dewatering from the upper deck. Its outlet was on the starboard side, also beneath the sheering strake. These two draining facilities like the main drainage pump could reportedly be switched from the switch panel in the wheelhouse.

The entire electrical wiring of the drainage pumps had been executed inexpertly with domestic cables and household distribution panels, not up to ship's standard. It was not possible to determine whether with the electrical arrangement of the floater switches automatic draining without switching from the bridge was possible. The suction intakes of the pumps were not clogged. However, none of the hose connections were secured with pipe clamps. The hoses were only plugged into each other and wrapped with adhesive tape to secure them.

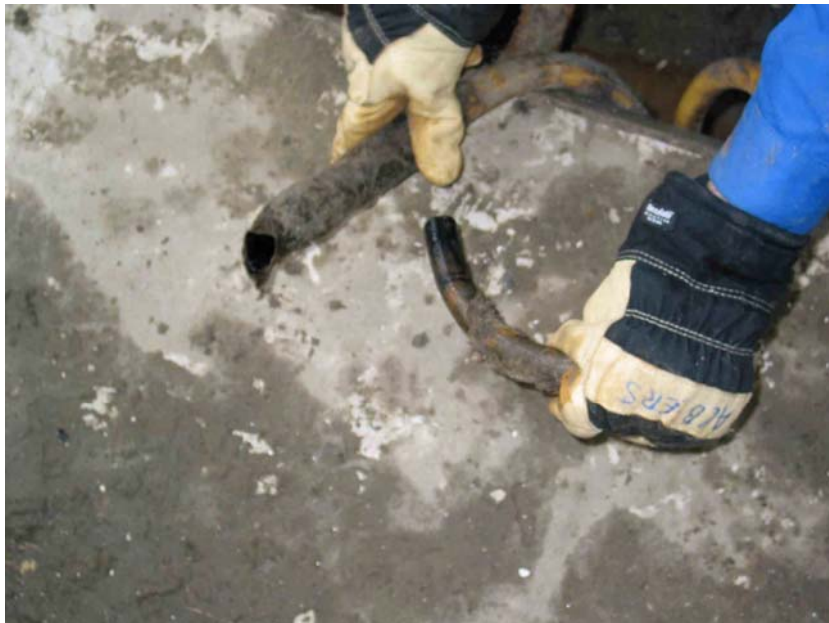
Figure 17: Loose hose connection

It was not possible to prove the operability of these two pumps.
