Bundesstelle für Seeunfalluntersuchung
Federal Bureau of Maritime Casualty Investigation
Bundesoberbehörde im Geschäftsbereich des Bundesministeriums
für Verkehr, Bau und Stadtentwicklung

Investigation Report No. 347/05

Serious Marine Casualty

**Collision of
SY ALIADO and SY KATTEGAT
in the Fairway of Rudkøbing Løb/DK
on 25 July 2005**

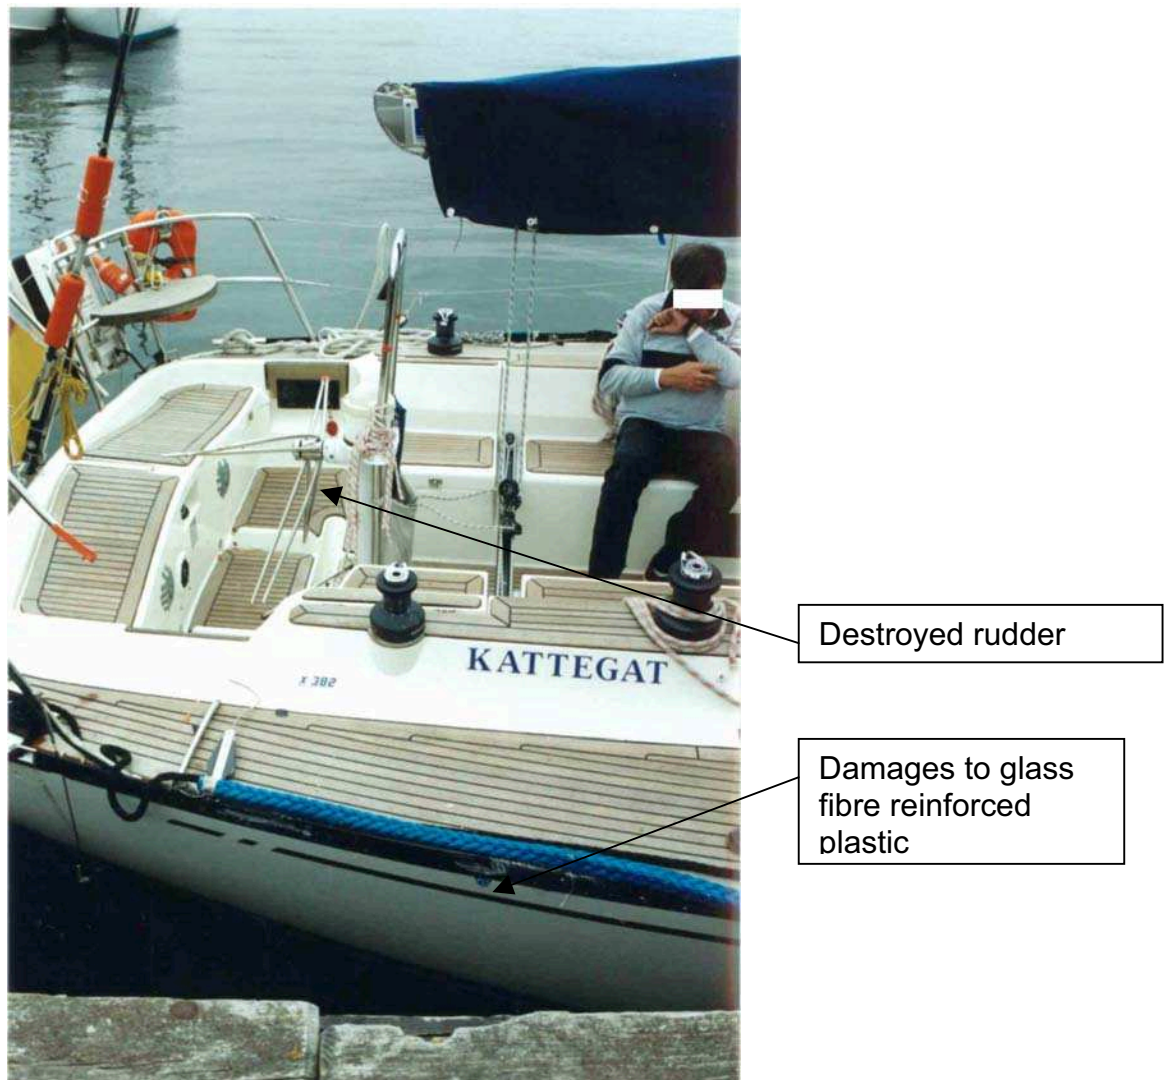
Fig. 4: Damages on board the SY KATTEGAT

The damages on board the SY KATTEGAT amounted to about 10.000.-- € . The steering wheel was completely destroyed. The stern pulpit, some railing stanchions and the railing roped as well as zones of glass fibre reinforced plastic on the hull were damaged.

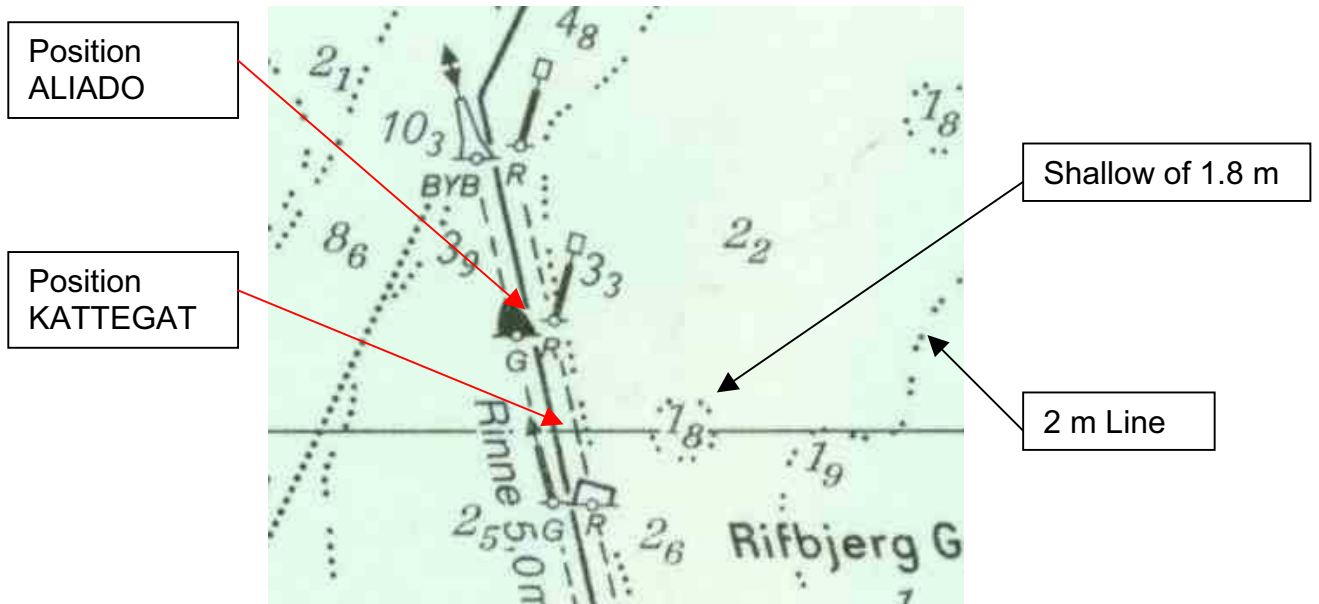
Fig. 6: BSH, Chart D15

The skipper of SY ALIADO had entered the scene of the collision with the position ϕ $54^{\circ}58,07'N$ and λ $010^{\circ}42,46'E$ near the first green stub buoy behind the shoal buoy of Naversgrund Ost into his charts by the BSH used on board.

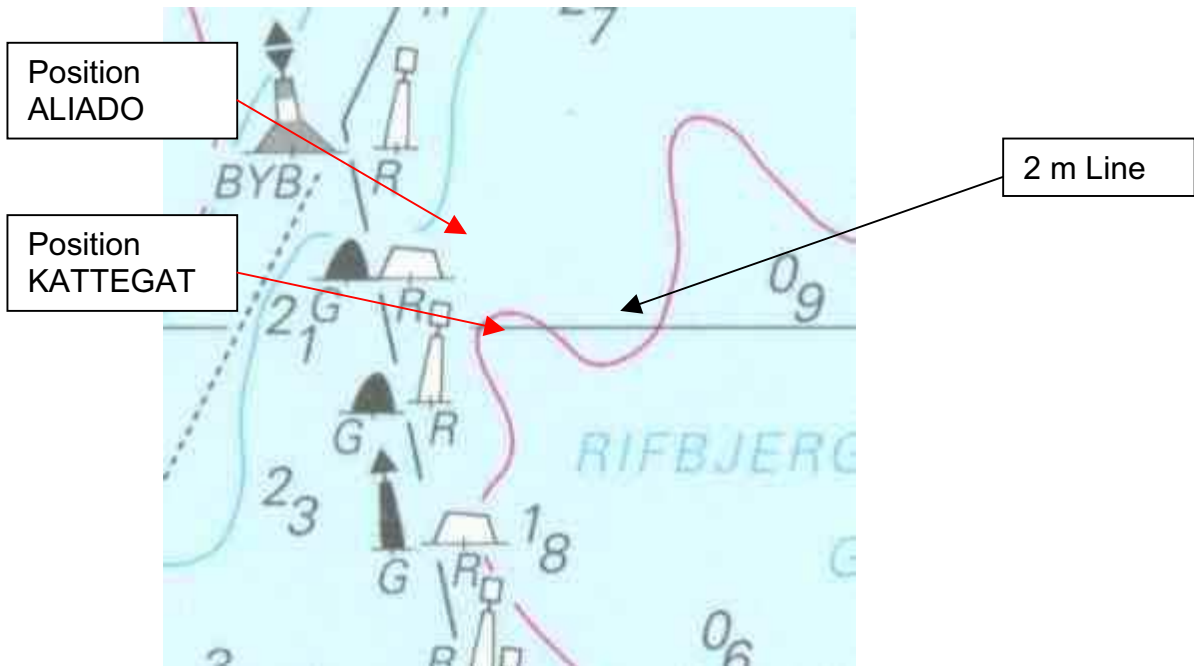
Fig. 7: NV Publishing Company Chart S5A

The skipper of SY KATTEGAT states the position ϕ $54^{\circ}58,0'N$ and λ $010^{\circ}42,5'E$ as place of the collision. This place is noted in the log-book and has been entered into a copy of the chart S5A by NV-Verlag on board at that time.

Thus, the course of the 2 m line in the chart by the NV Verlag is not in keeping with the data of the Royal Danish Administration of Navigation and Hydrography. In the chart of the NV Verlag, the 2 m line is drawn directly at the 5 m fairway, and in this respect, it is not stated correctly. In both charts the types of buoys and top signs are not identical to the Danish statements.

The Federal Bureau of Maritime Casualty Investigation recommends the manufacturers of special charts for recreational shipping to pay even more attention to the fact that in particular the shallow water zones of less than 4 m are shown exactly according to the sounding data. In particular recreational shipping is dependant upon a true representation of details, e.g. in order to leave the fairway when cruising or to seek the cover of the shore when there is too much wind.

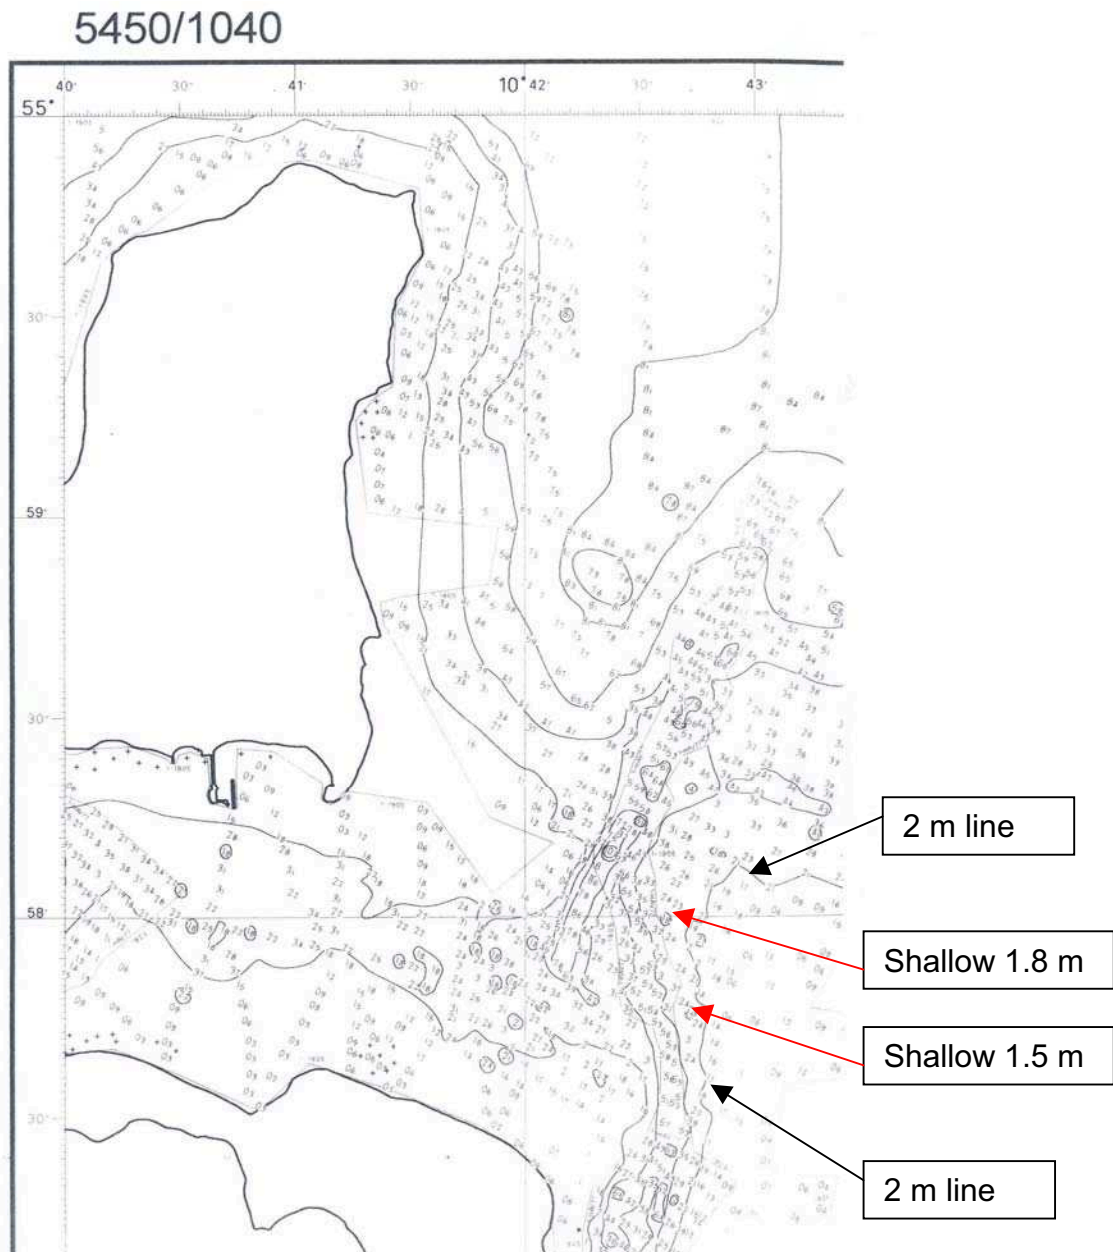
Fig. 8: Sounding Data

The sounding data of the depth of the water transmitted from Denmark are identical to the data in the BSH chart No. 15. In particular the course of the 2 m line and the position of the two shallow water areas of 1.8 m and 1.5 m on the port of the fairway coincide with the data in the chart by the BSH.

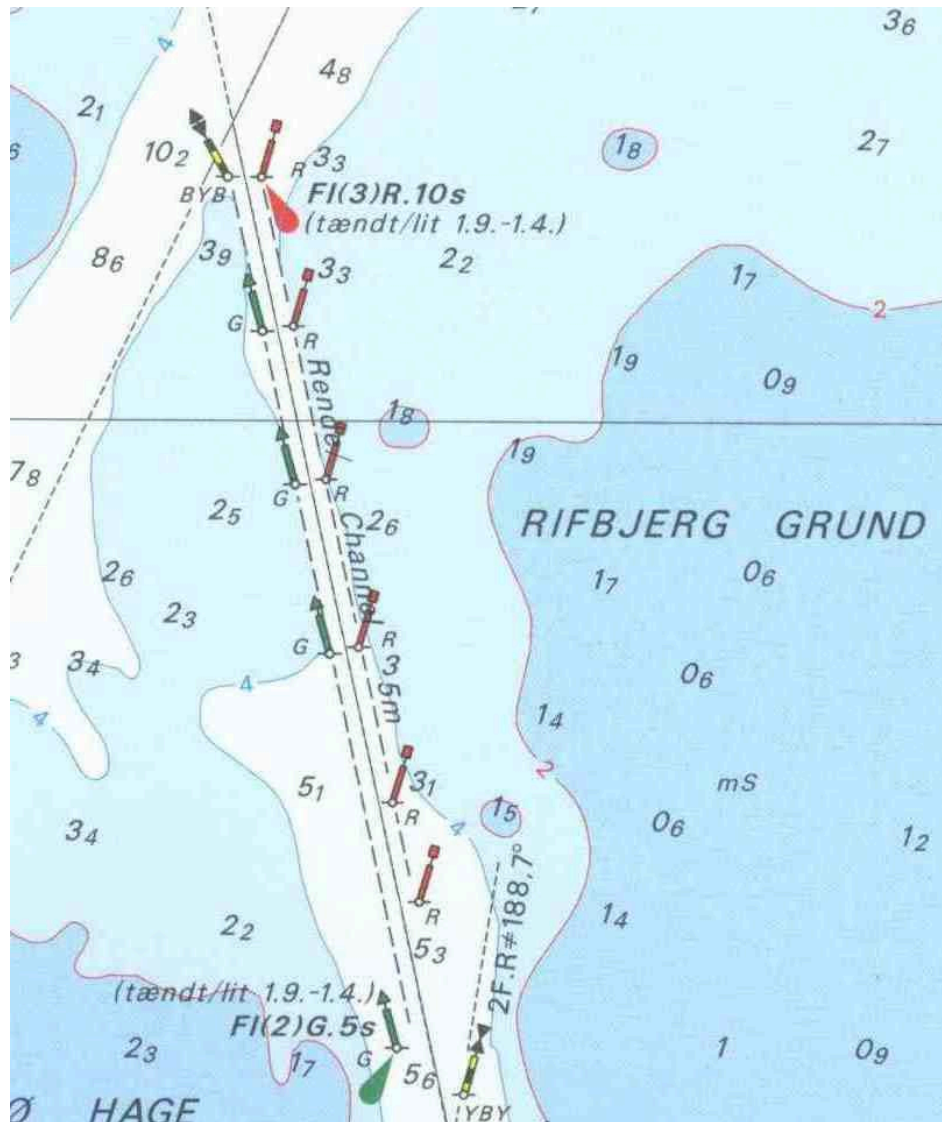
Fig. 9: Chart 318 - Delius Klasing

Besides the official leisure charts of the BSH and the leisure charts of the publishing company NV Verlagsgesellschaft mbh, Arnis, the Delius Klasing leisure charts are available on the German market. The following section from the detail chart KRT. 318 (amended in 04/2005), scale 1:15.000, is taken from set 1 - Kieler Bucht and Rund Fünen. In this chart, the course of the fairway and the data of the buoys of Rudkøbing Løb fully coincide with the Danish sounding and buoy data.

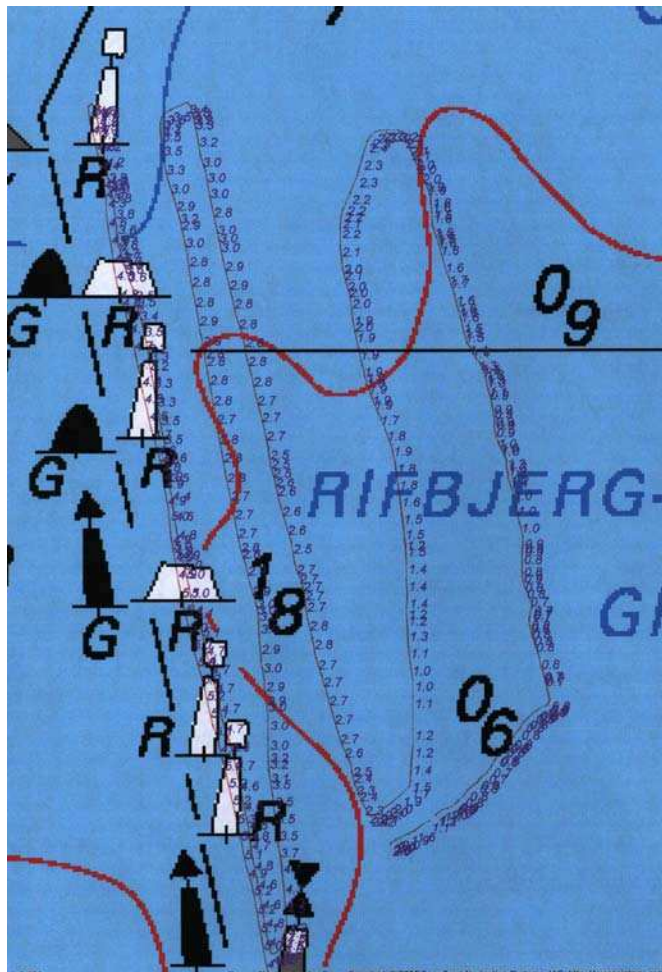
- a) *Our client has revised the Rudkøbing Løb area in a new control in particular with respect to the sea-bed contours in the Rifbjerg-Grund area. In the annex, we enclose a copy of the sounding performed on 07.06.2006 in a detail view of the chart valid so far.*

Hence results that the sea-bed contours in all three charts (Delius Klasing, BSH and nautical publications) in the relevant area are not correct. The shallow water area of 1.8 m shown in the chart of the BSH (south-east of the first port shoal buoy of Naversgrund Ost) does not exist (this shallow water area is also shown in the chart by Delius Klasing Verlag); the sounding data show a depth of the water of 2.8 m.

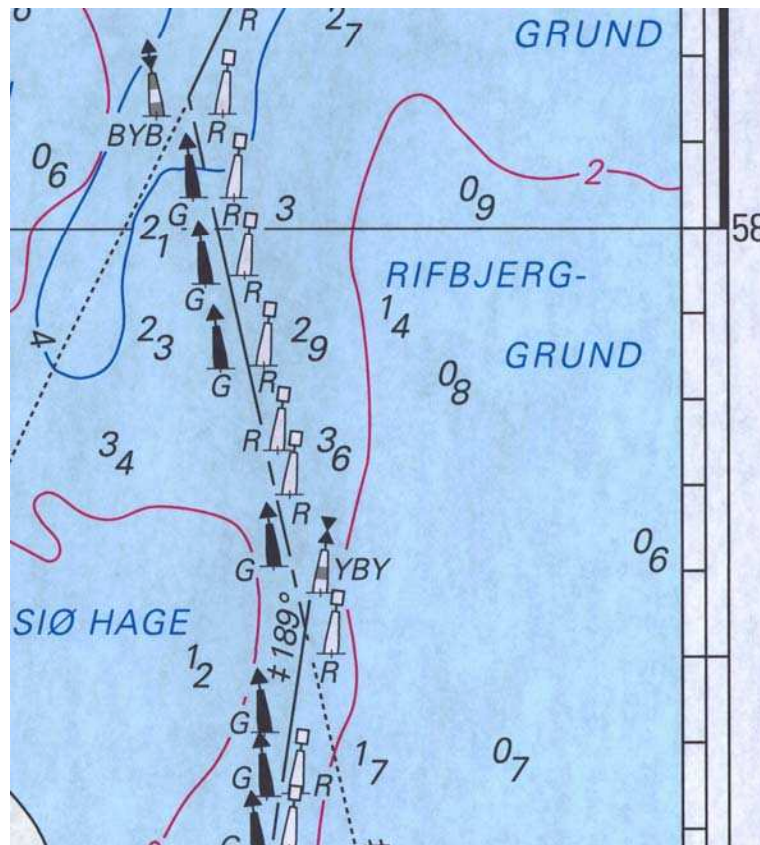
- d) The course of the 2 m line in our client's chart does not correspond to the data of the Royal Danish Administration of Navigation and Hydrography, however, the details registered there are not correct either. We submit the chart corrected based upon the survey with the most recent sea-bed contours as Annex 2.

- e) Our client has corrected her chart as shown above. A reference must be included that the chart of NV-Verlag has been updated in the meantime.
