Bundesstelle für Seeunfalluntersuchung
Federal Bureau of Maritime Casualty Investigation
Federal Higher Authority subordinated to the Ministry of Transport,
Building and Urban Affairs

Investigation Report 415/06

Serious marine casualty

**Capsizing of the Pilot Tender ELBE 3
while casting off from
MV DELTA ST. PETERSBURG
on 23 August 2006
north of Elbe Buoy (Elbetonne) 1**

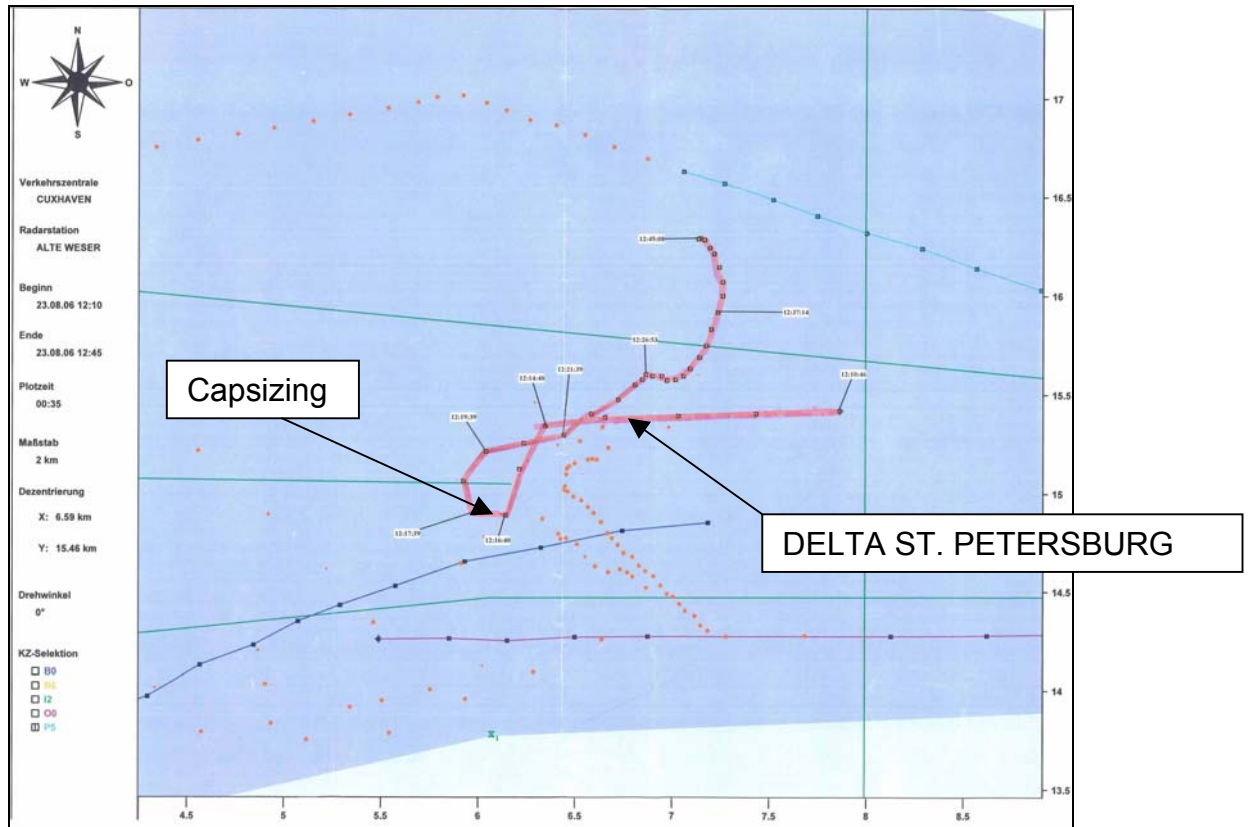
Figure 4: Radar plot of VTS Cuxhaven

The course of the voyage shows a distinct southerly course as of 12:14:40 and a reduction of speed down to 7.7 kn at 12:16:40, as well as subsequently a tight turning circle over the starboard bow.

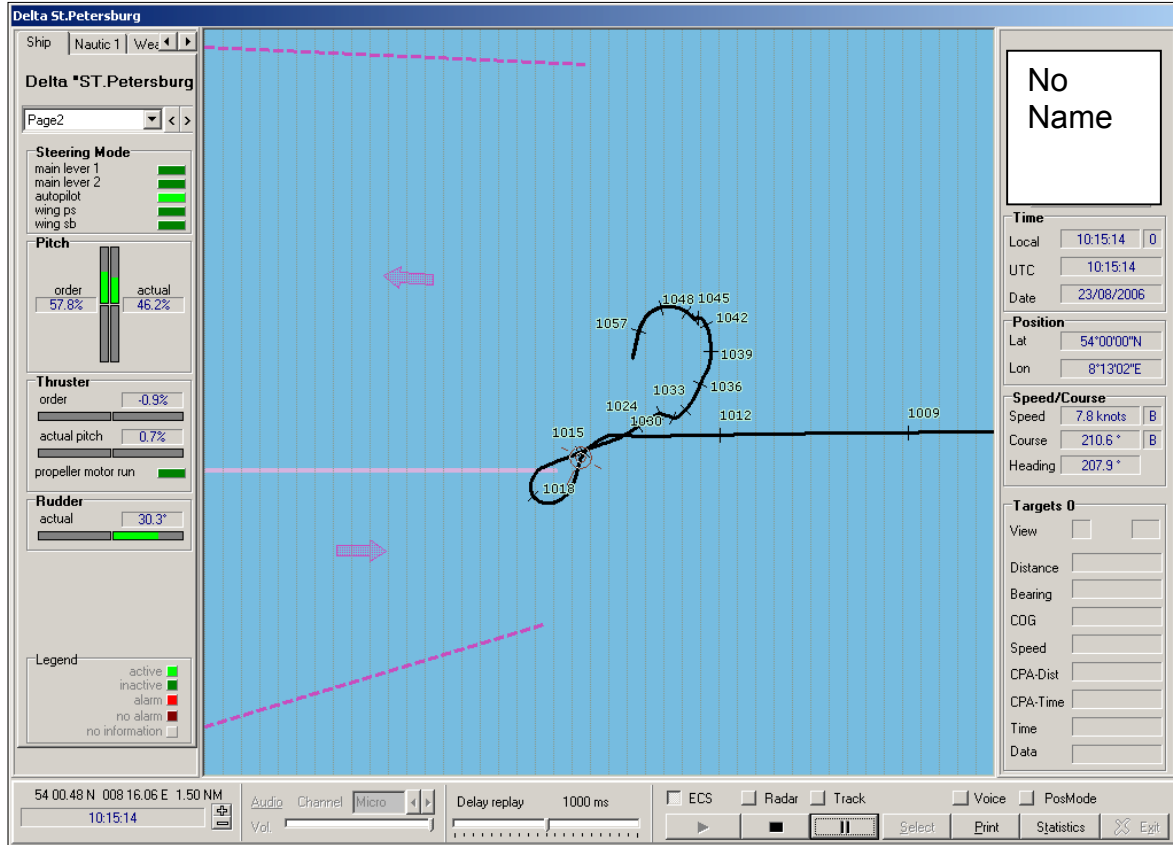
Figure 5: Plot of the course from VDR DELTA ST. PETERSBURG

The course of DELTA ST. PETERSBURG recorded by the VDR and shown above is almost identical with the recordings of the Vessel Traffic Service Cuxhaven. Up to approx. 10:15:12³ the vessel sailed a south-south-west course and according to the GPS data the speed over ground dropped to 7.8 kn. After this the vessel proceeded through a turning circle with a diameter of 320 to 360 m.

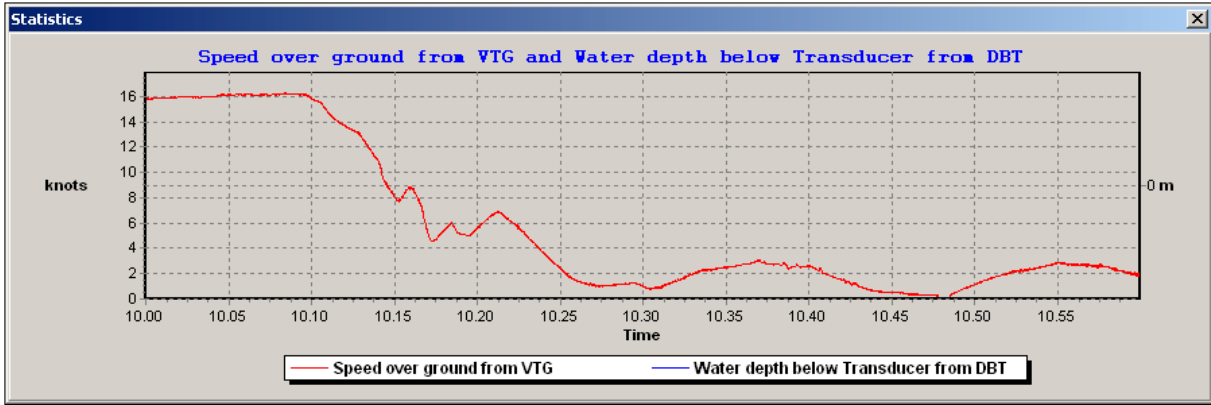
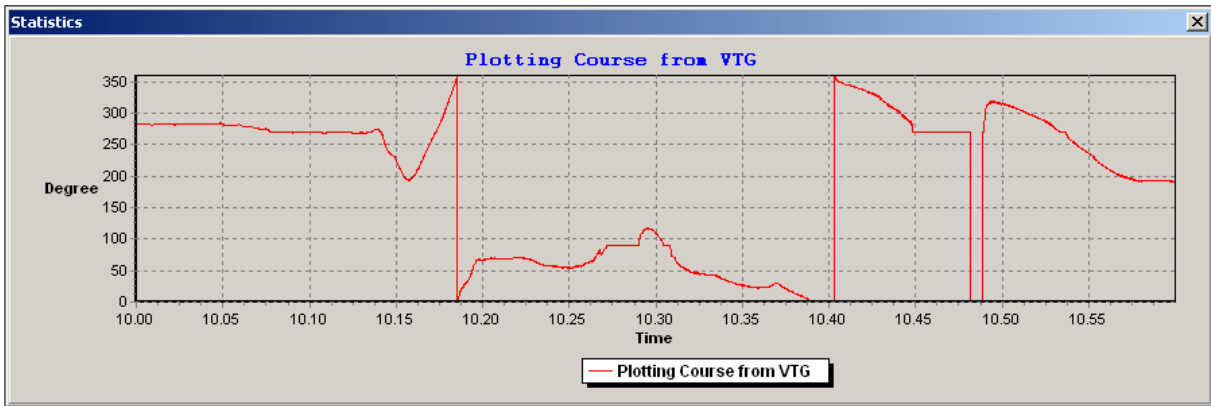
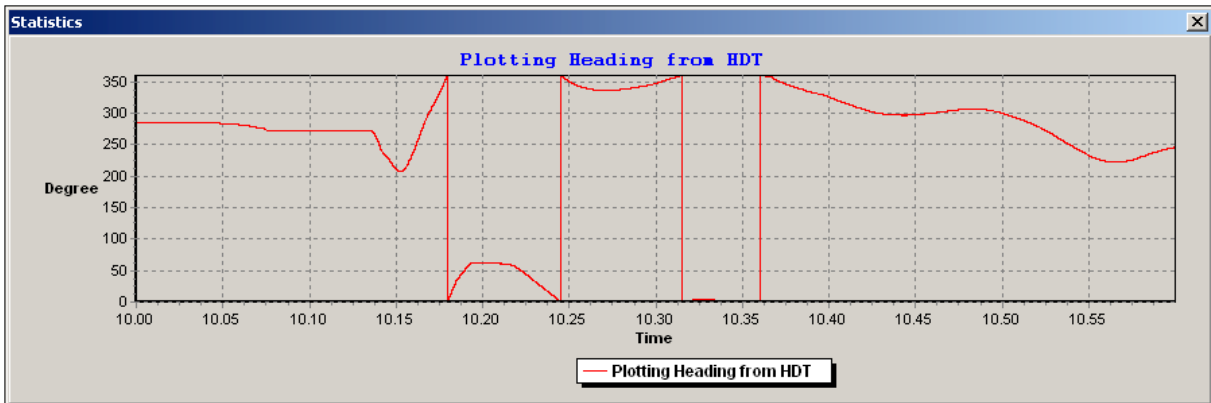
Figure 6: Speed and course according to VDR

The report that the pilot tender had capsized came over the radio channel recorded at 10:16:10.

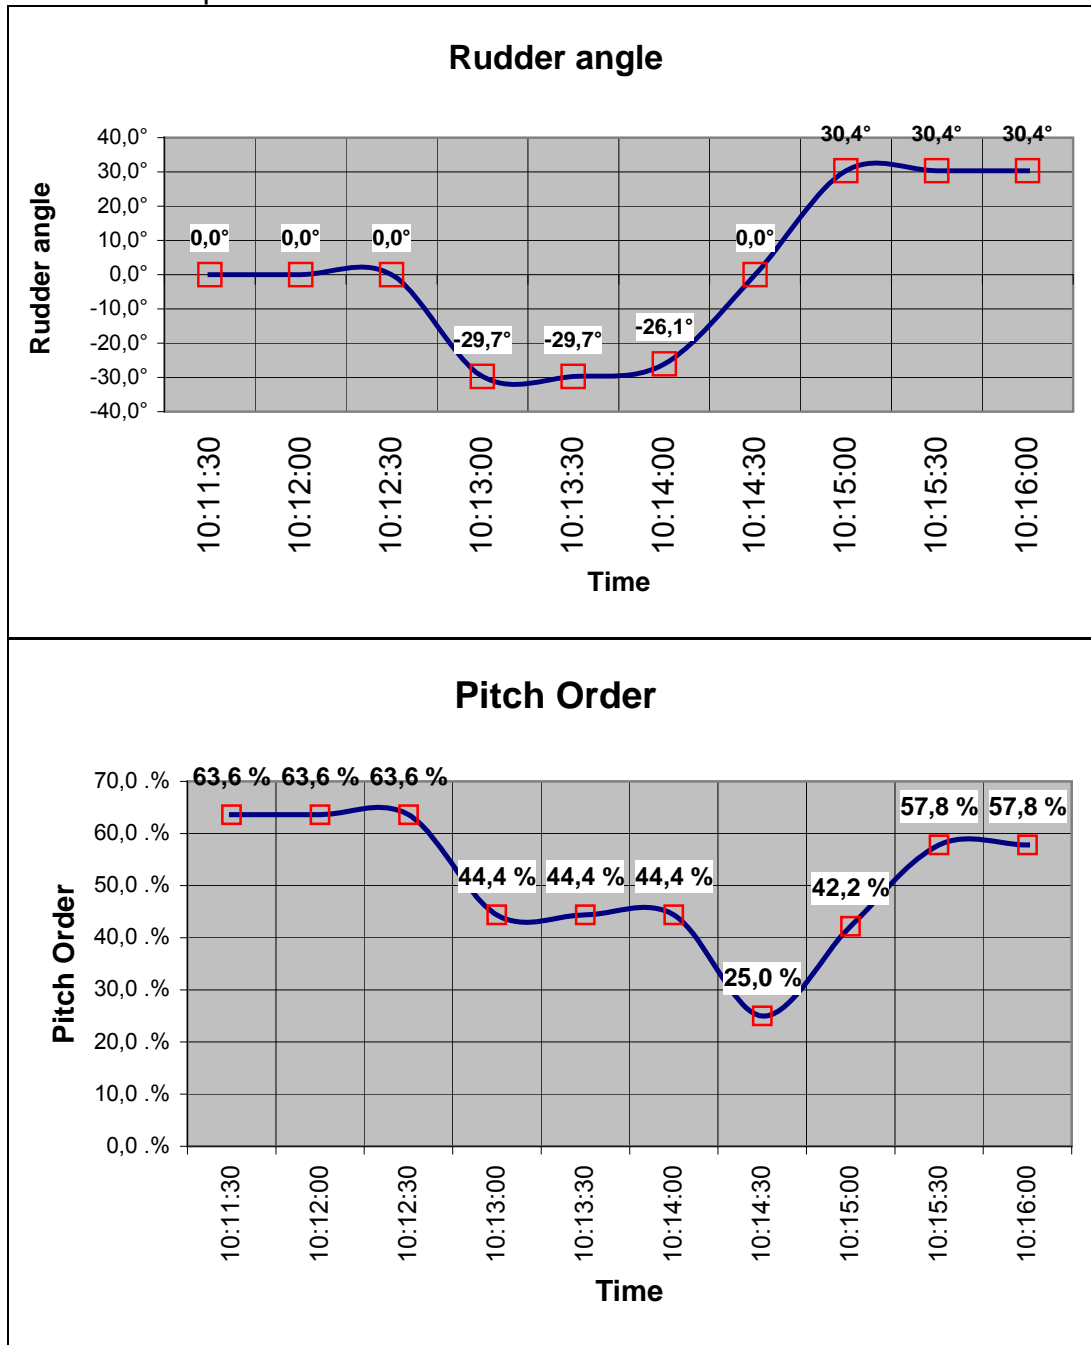
Figure 7: Rudder angle and propeller pitch according to VDR

The rudder angle and the change of the propeller pitch were also recorded by the VDR and analysed. According to the data up to 10:12:30 the rudder lay midships, and was then moved for about 2 minutes to port with 29.7° and as of 10:15:00 to starboard with 30.4°. The pitch was reduced as of 10:12:30 to 44.4%, from 10:14:30 to approx. 10:14:45 further to 25%, and from 10:15:12 the vessel ran with a pitch of 57.8 %. The starboard rudder position of 30.4° and the pitch of 57.8% were maintained until approx. 10:17:00, in other words until after the report that the pilot tender had capsized.

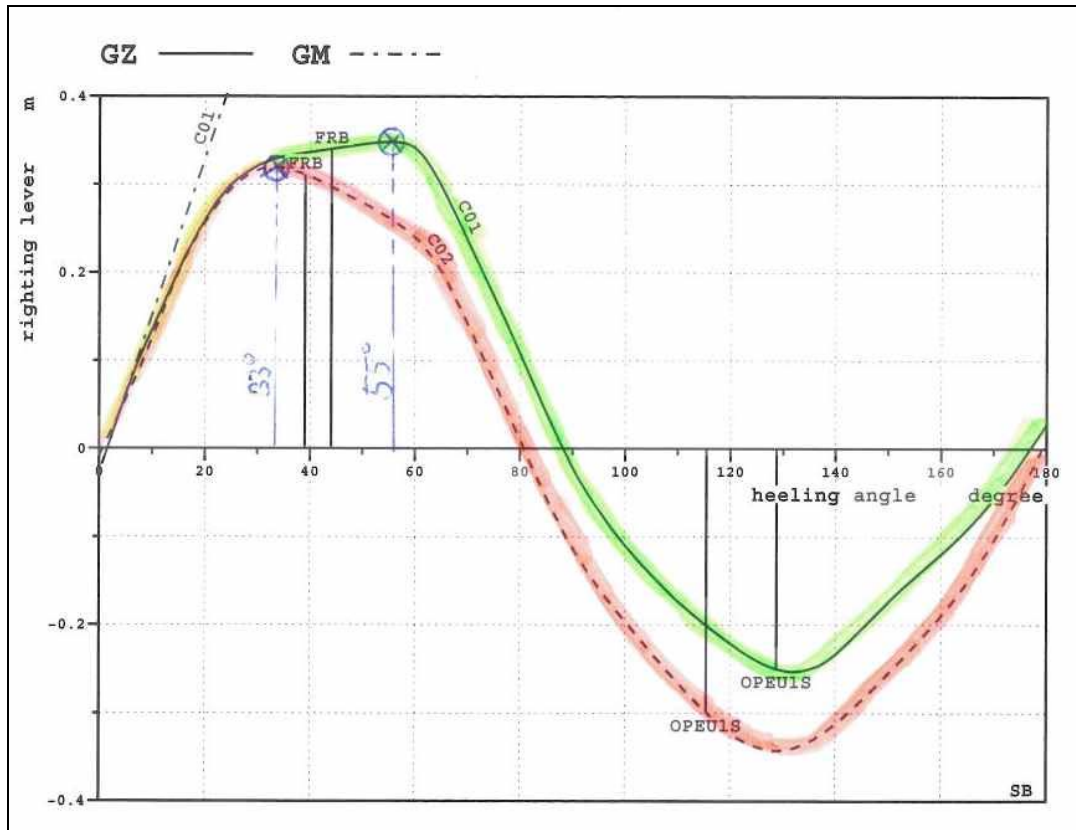
Figure 9: Uprighting statical stability curves with different ships weights

In case C01 (empty ship's weight of 1999, green curve) the maximum of the statical stability curve is approx. 55° and amounts to approx. 0.35 m.

The modifications of the superstructure and other changes in the repeat construction of the vessel and the resulting increase of the empty vessel weight and height of the centre of gravity can be ruled out as a cause of the accident.

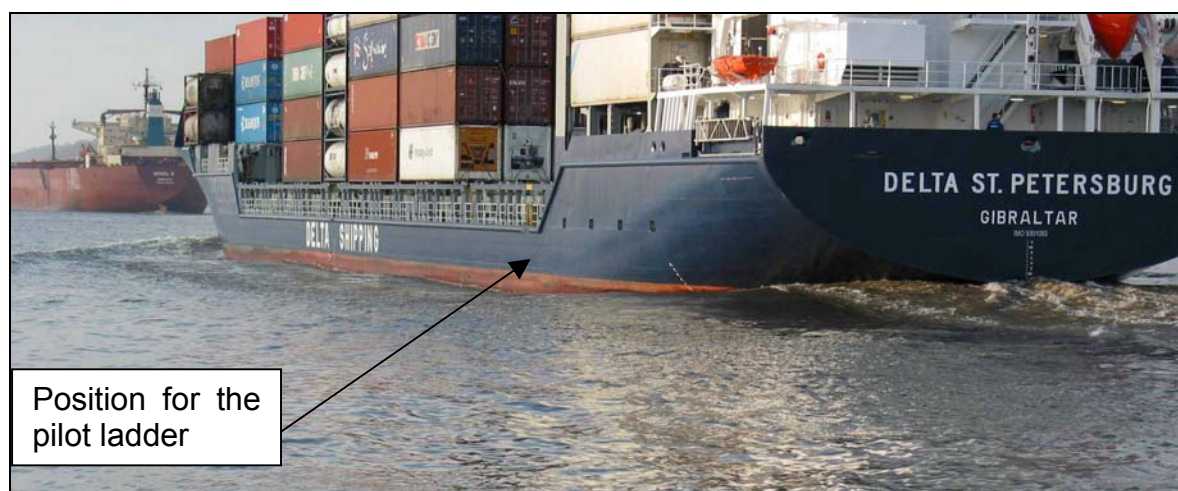
Figure 10: Wave pattern of DELTA ST. PETERSBURG

The video recordings of the voyage of DELTA ST. PETERSBURG show that at a speed of 8 to 9 kn over ground the length of the wave at the aft shoulder is at least twice the ship's length of the pilot boat and max. 0.4 m high.

The stern wave of DELTA ST. PETERSBURG can thus be ruled out as the main cause of the accident.

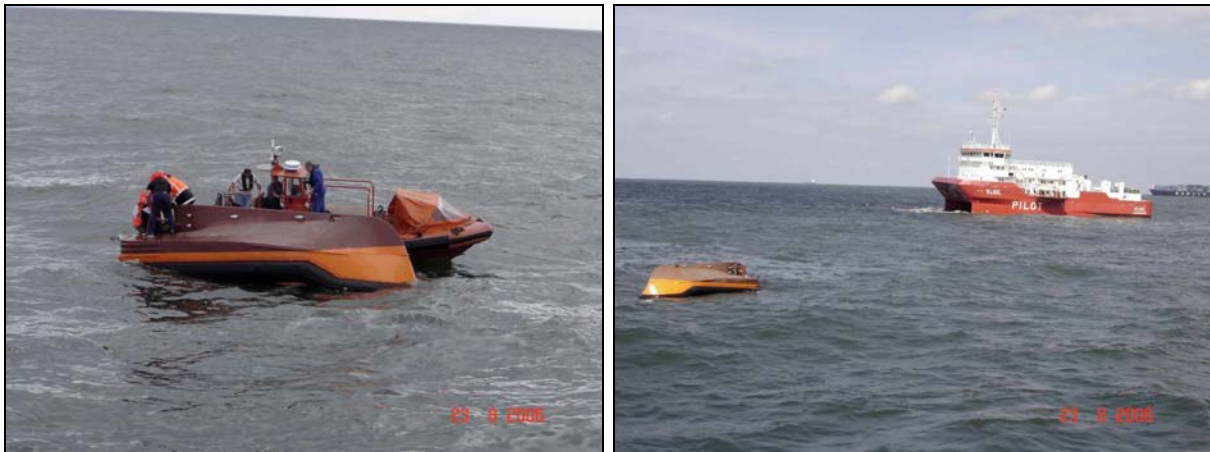
Figure 11: Upturned position

The pilot tender capsized completely in the accident and remained lying in a stable upturned position. As a result of this accident the hypothetical calculations that the boat does not upright itself and remains stable upturned were confirmed.

The boat's safety can be increased if the boat were to upright itself again after capsizing.

In order to convert this boat to a self-righting boat it would be necessary to take measures ensuring that the statical stability curve always remains positive up to 180°.

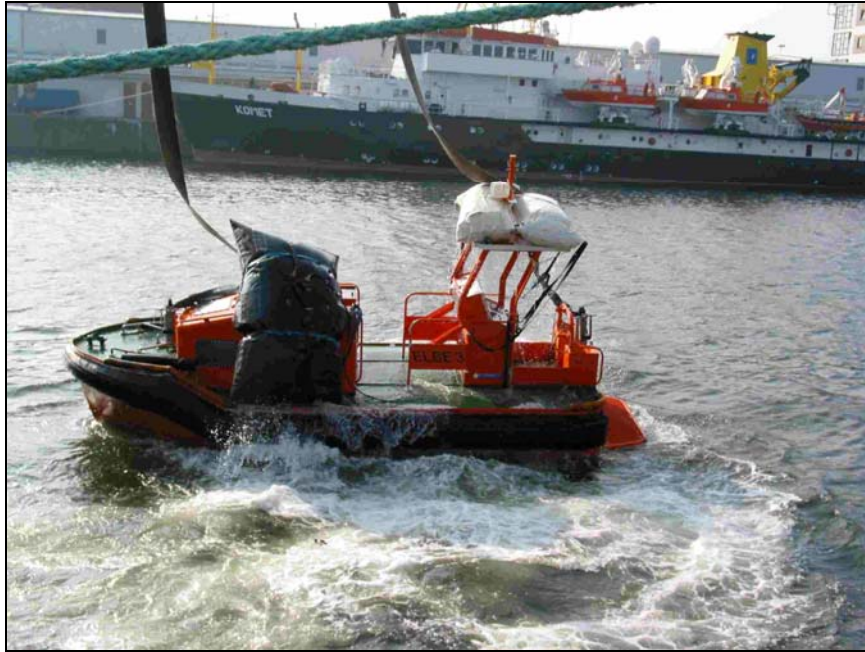
Figure 12: Experiment with buoyancy bodies

The Lotsbetriebsverein (pilots association) in Cuxhaven conducted practical tests on a conversion as self-righting boat on 13.10.2006. Various buoyancy bodies were installed on the cabin roof and the boat was turned through 180° with a crane.

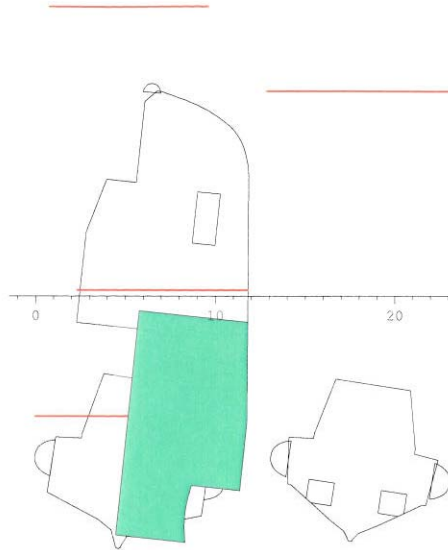
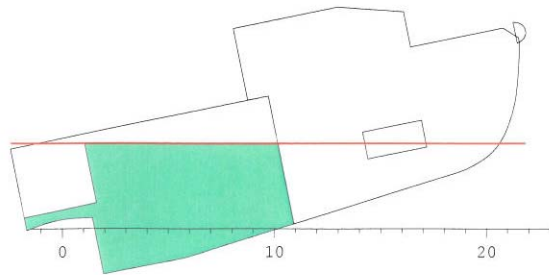
Figure 14: Floating positions in damaged condition

- Without additional buoyancy in the engine room the boat is trimmed at almost 90° and floats on the hatch to the companion-way (that is currently not executed as watertight).
- With additional buoyancy in the engine room the deck is only slightly under water aft.
- The assumption of a bulkhead at frame 10 or 11 has no major effects on the result of the calculation in damaged condition.

The calculations have revealed that the stability in damaged condition and safety in damaged condition can only be produced by installing approx. 1 m³ additional buoyancy bodies in the engine room. This buoyancy is also urgently necessary if, for instance, the 3 mm thick aluminium shell plating is damaged in a collision, as in the accident of Pilot Tender ELBE 2 on 16.12.2002 (BSU Ref. 209/02).

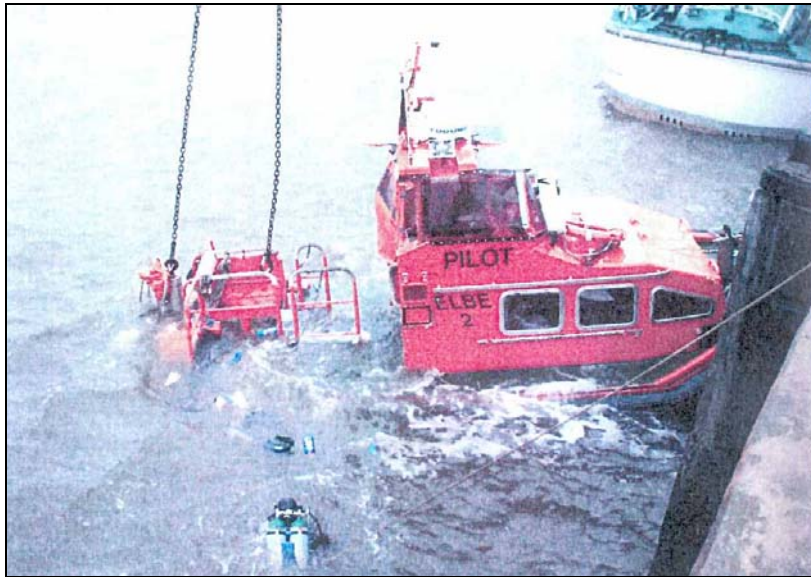
Figure 16: Accident ELBE 2

After this accident the Pilot Tender ELBE 2 was able to reach a port in time and as can be seen on the above photo could be prevented from foundering by being secured ashore.
