**Bundesstelle für Seeunfalluntersuchung**  
**Federal Bureau of Maritime Casualty Investigation**  
Federal Higher Authority subordinated to the Ministry of Transport,  
Building and Urban Affairs

Summary Investigation Report 449/07

**Personal injury accident on the  
MV KATRINE KROG on 17 September 2007  
at Rüsterbergen pilot station**

17 December 2007

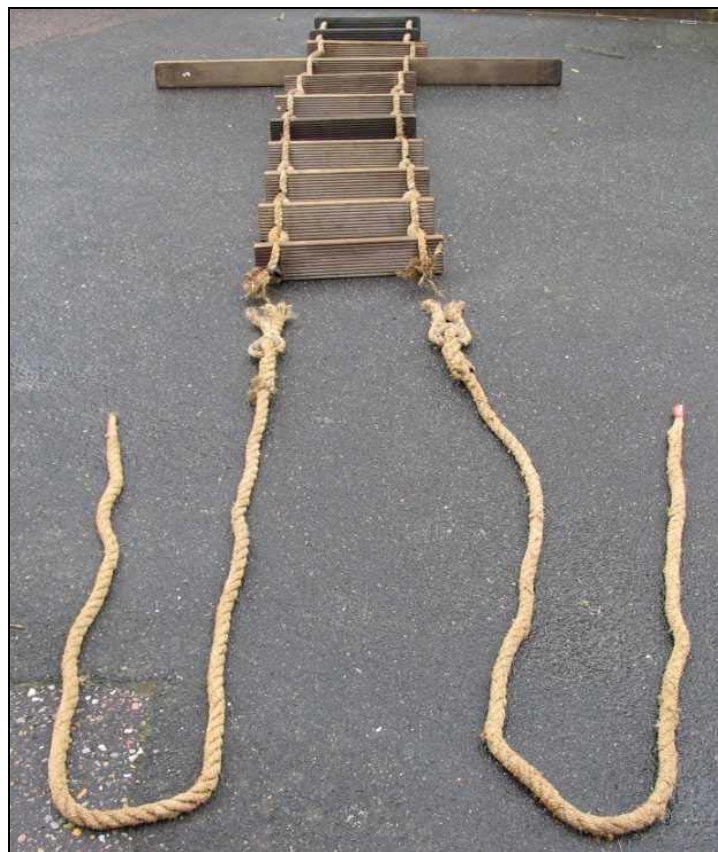
Both parts of the pilot ladder seized by the Waterway Polices Kiel and Rendsburg were united in Rendsburg. The ladder had been onboard KATRINE KROG since February 2005. The following figures 3 and 4 illustrate its general condition as well as the points of rupture.

Figure 3: General view of the pilot ladder from the top

The total length of the ladder is 6.30 m, the points of rupture are located 3 m from the bottom part of the ladder. The steps measure 550 mm in breadth, 30 mm in height, and are 120 mm deep.

Apart from the points of rupture above the top step, the ropes do not show any visibly damages.

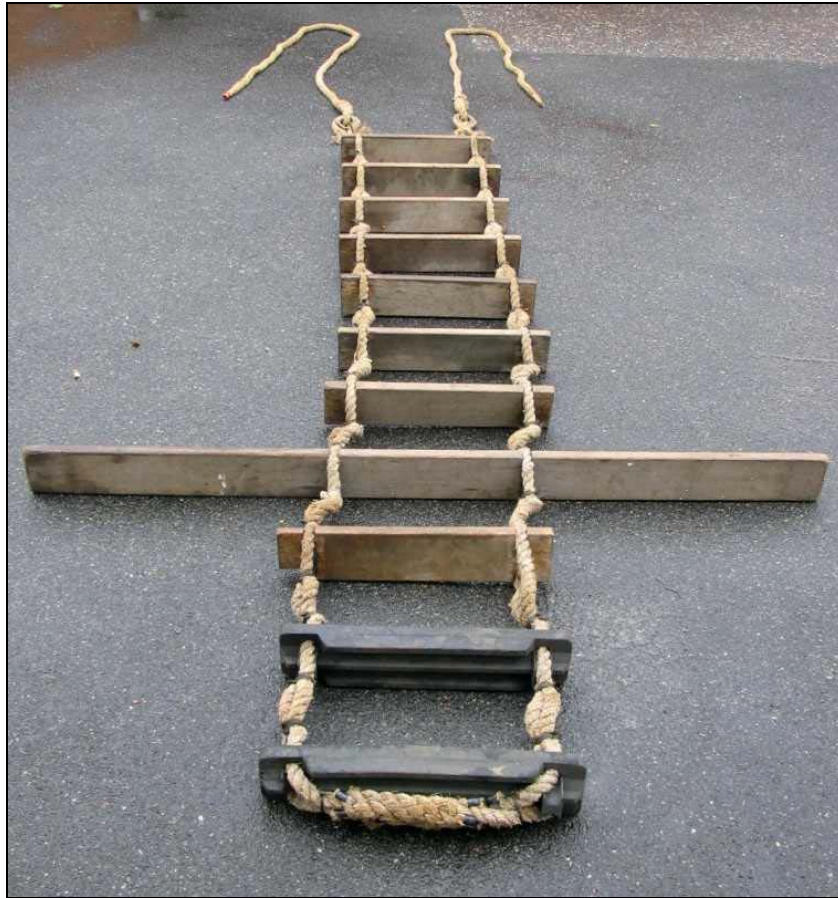
Figure 4: General view of the pilot ladder from the bottom

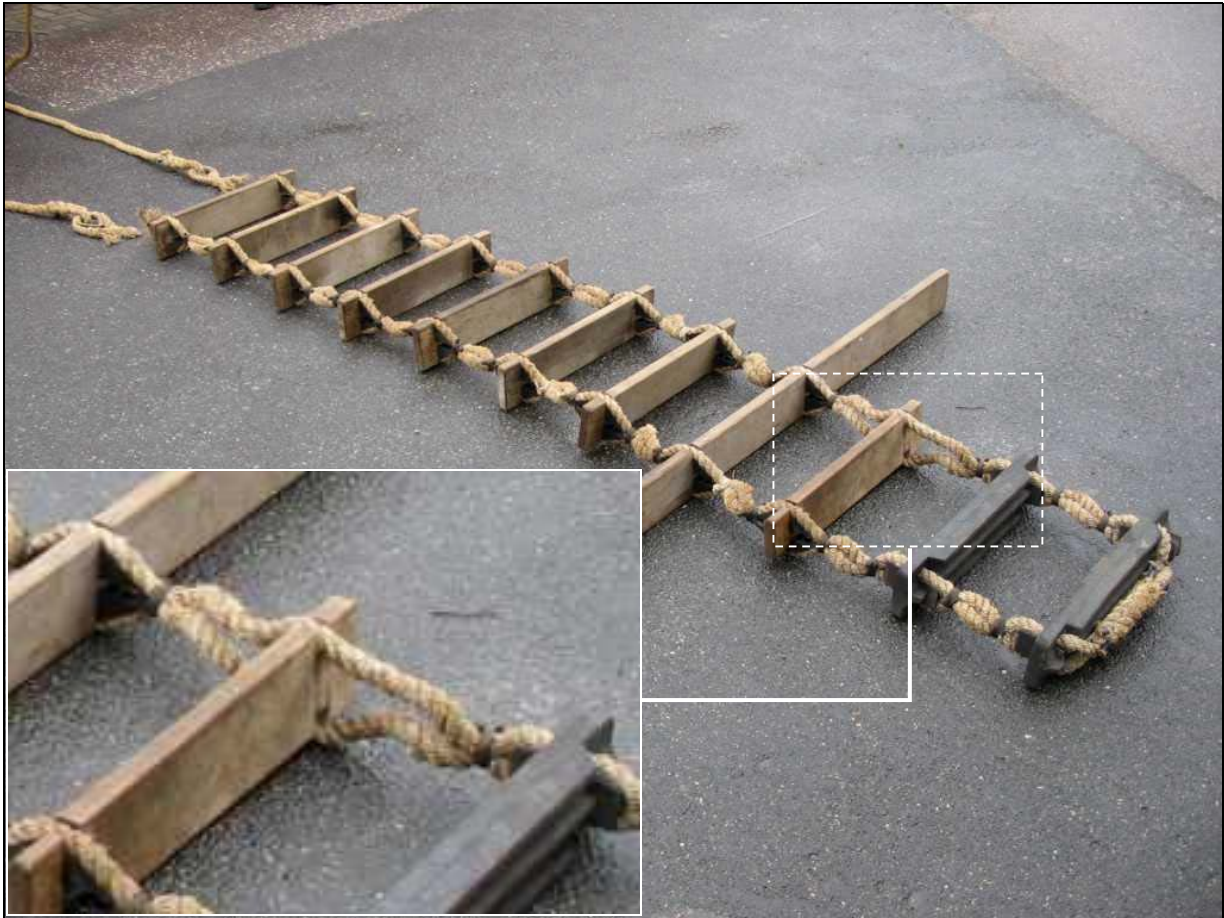
The side ropes consist of non-coated natural fibres. The ropes were hawser-laid (z-lay). The ladder has two ropes on either side, which are separated above and below each step by plastic wedges. Both of these wedges are missing on one side of the step third to last, leaving this step unattached (cf. Fig. 5). Each wedge has a round seizing at the pointed end with threaded endings, which brings the ropes together again.

Figure 5: Damaged ladder step

Both the construction of the ladder and its dimensions meet the requirements for pilot ladders set out in Rule 17 of the International Convention for the Safety of Life at Sea (SOLAS) as well as those of the International Standard for Pilot Ladders pursuant to ISO 799, except for the damaged step.

This marine casualty is due to the use of a damaged pilot ladder. Significant material stress due to a preceding entangling of a pilot launch could with hindsight neither be verified nor ruled out. But apart from any previous damages the ladder was not ready for use on the day of the accident due to the damaged step third to last, as it was in no proper and secure state according to para. 5 of the Pilotage Ordinance<sup>2</sup> in conjunction with SOLAS Chapter V Regulation 23.

KATRINE KROG's command immediately replaced the pilot ladder. As a result of the accident, the entire crew was sensitised to the issues of material stress on pilot ladders.

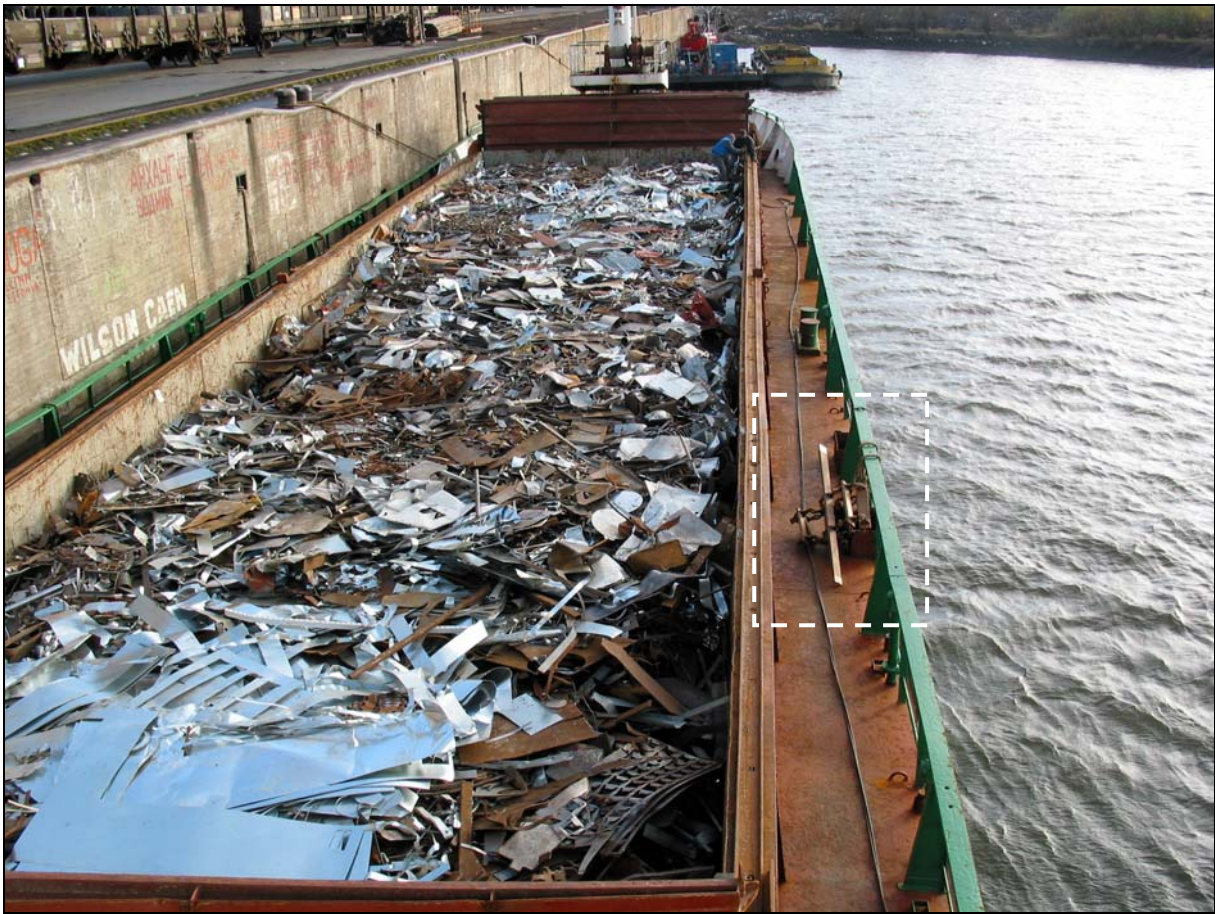
The pilot ladder was deployed amidships on KATRINE KROG's starboard side (cf. Fig. 6).

Figure 6: Accident scene on board, taken on 26 November 2007

Figures 6 and 7 show the new pilot ladder, which is of the same construction as the ladder used on the day of the accident.

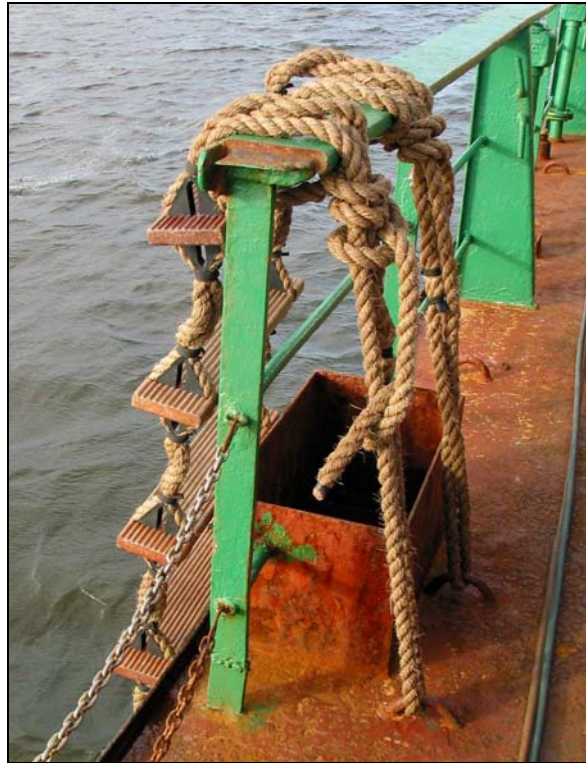
On the day of the accident, the pilot ladder hung entirely outboard. Two eyes, on which a pilot ladder can be secured, are welded onto the deck on the right side of the bulwark opening for pilot transfers on board KATRINE KROG (cf. Fig. 7).

Figure 7: Eyes for securing the pilot ladder

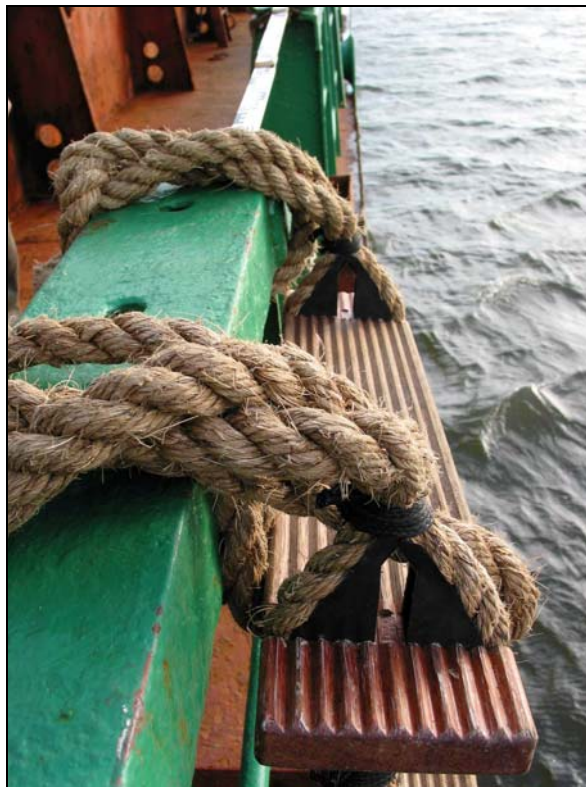
No sharp-edged rail areas, which could have promoted a rupture of the pilot ladder, have been identified at the scene of the accident on board KATRINE KROG during BSU's survey (cf. Fig. 8).

Figure 8: Detail view of the rail
