Investigation Report 455/05

Serious Marine Casualty

**Grounding of CMS DORIA
shortly after leaving
Port Namibe (Republic of Angola)
on 20 October 2005**

15 January 2007

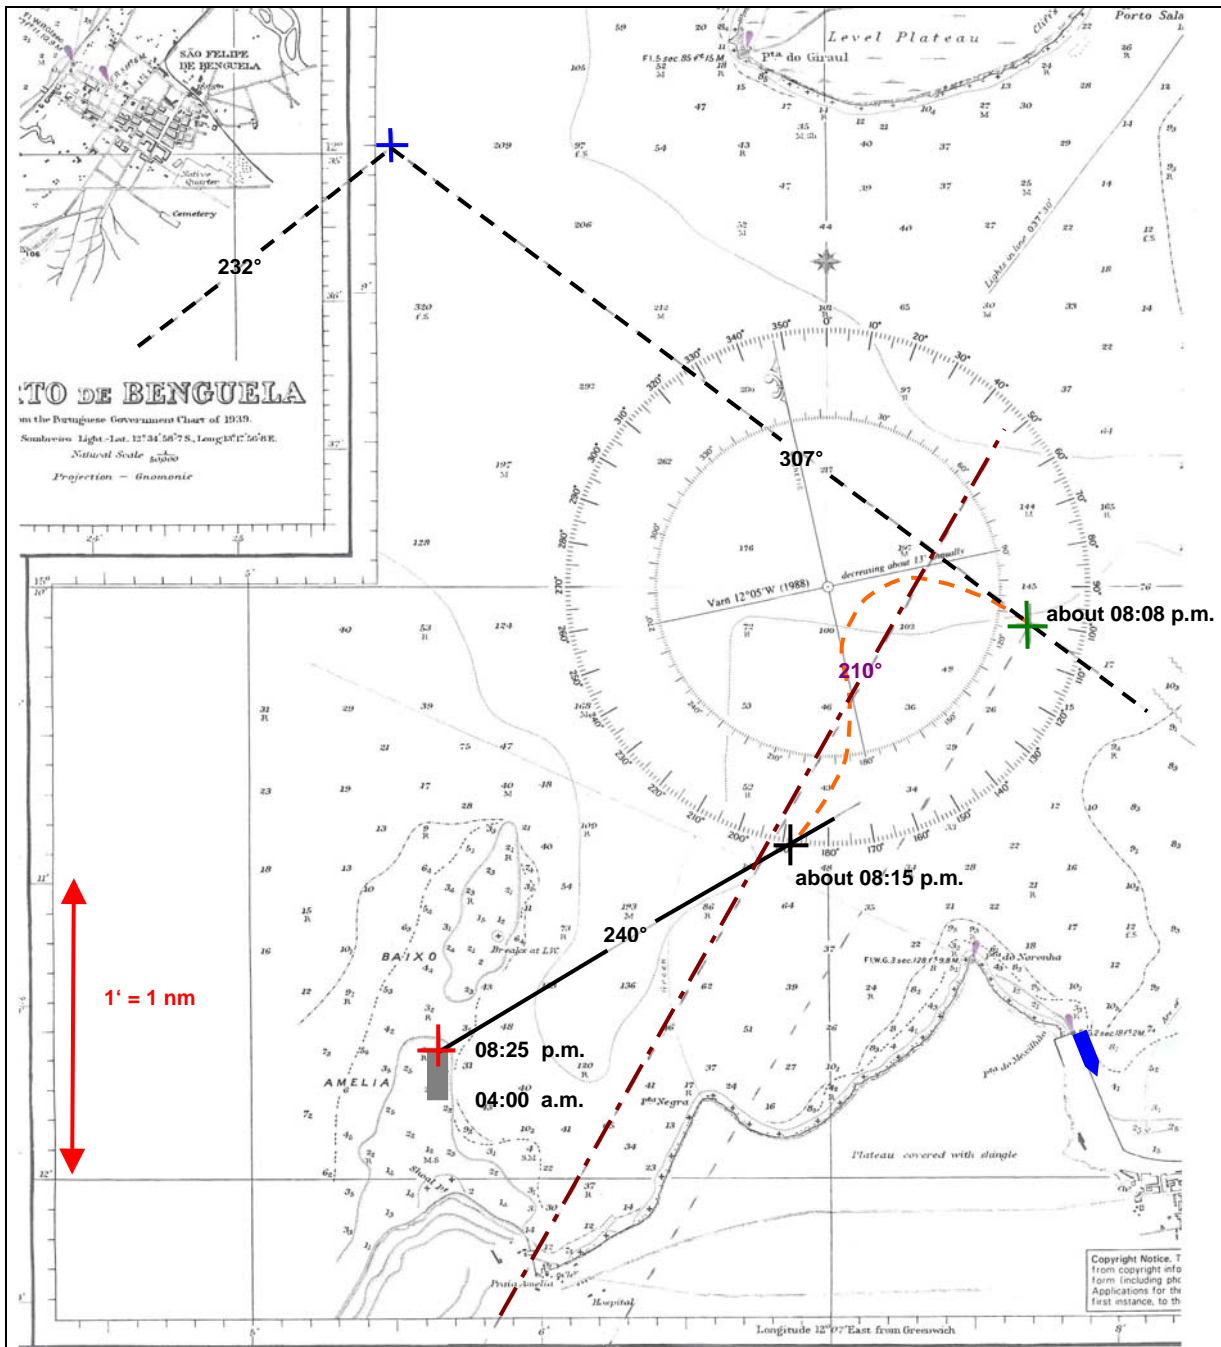
Fig. 3: Course of the voyage until the grounding (Section of BA Chart 1197)

¹² Interpolated indication of the position of the accident following BA Chart No. 1197; fathoms/feet: English linear measures: 1 fathom = 6 feet = 1.8 metres; that is, the depth of the water around the scene of accident was between 4.5 and 7 metres, according to the chart.

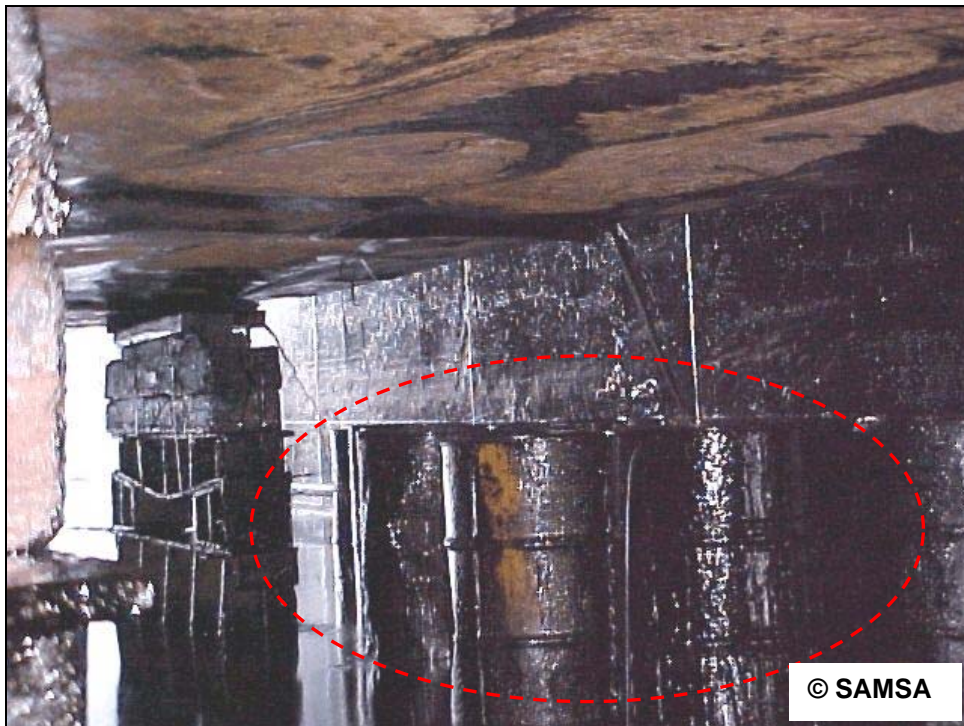
Fig. 4: Oil catch drums beneath the hull

After the discharge of the container cargo, a considerable fuel leakage occurred (about 80 tons) when the water was pumped off around the vessel in the dock, thus removing the external “sealing” of the tanks by the sea water now absent.

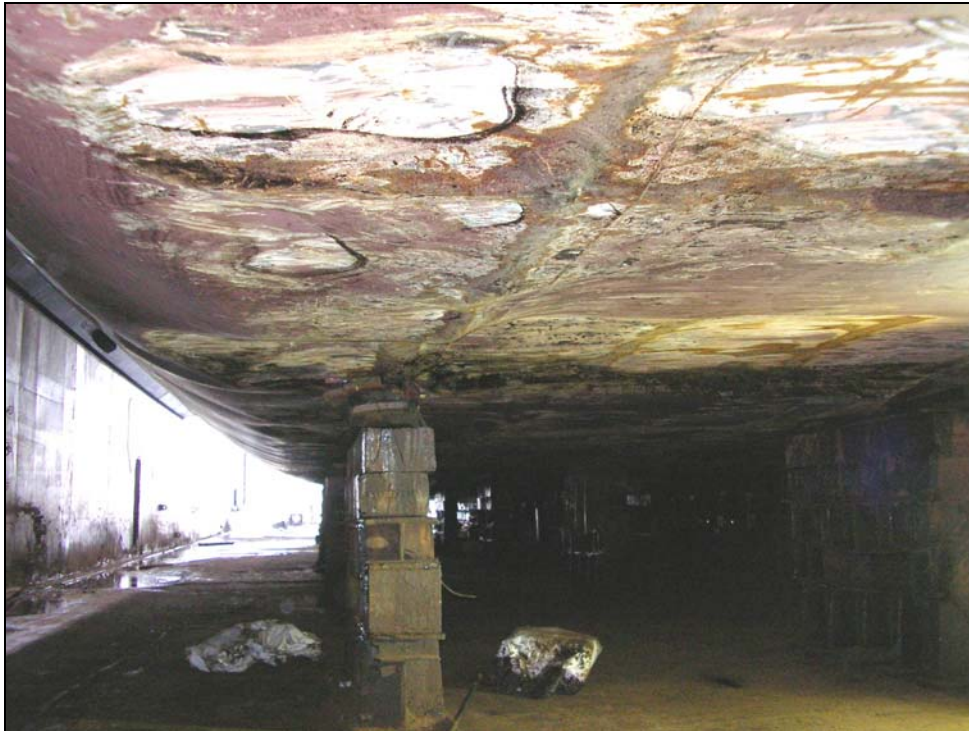
Fig. 5: Damages to the underwater hull²²

The underwater hull of DORIA was exposed to a grounding in the area of the frames 13 to 136. In detail, the following spaces were damaged:

- Ballast Water Tanks No. 3 stb. and port
- Ballast Water Tank No. 3 centre: feeding pipe broken
- Heeling Tanks²¹ No. 2 stb. and side
- Ballast Water Tank No. 4 centre
- Bilge of cargo hold 2 stb.
- HFO Tank No. 5 stb.
- MDO Tank No. 5 centre
- Boiler feed water tank
- Cofferdam

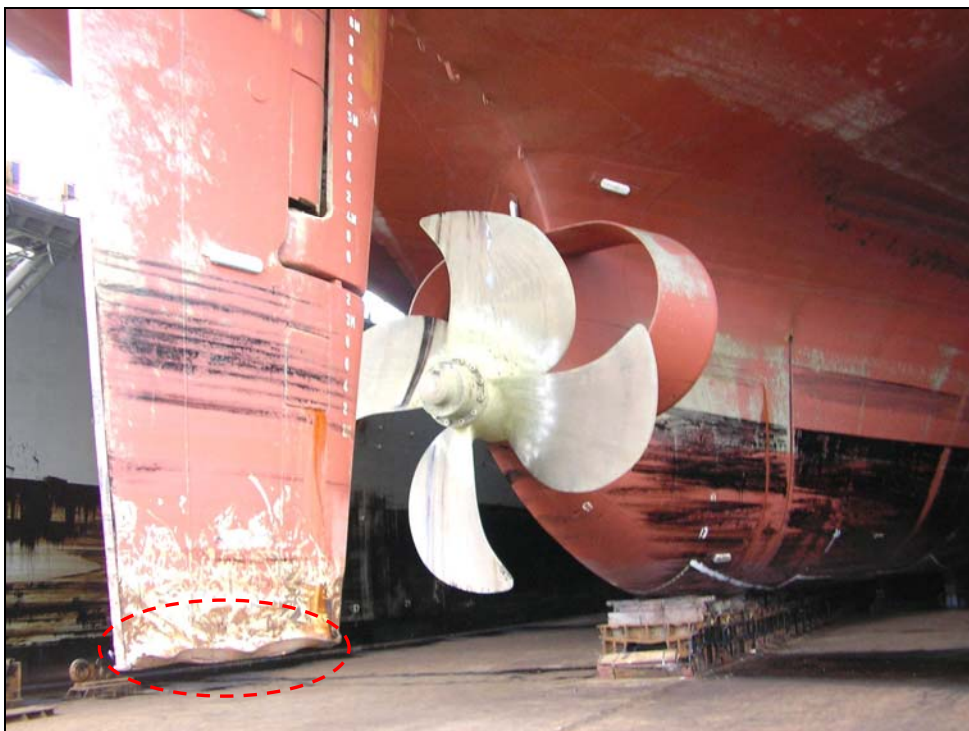
Fig. 6: Deformations on the rudder blade²³

The grounding also affected the rudder blade (cf. Fig. 6), however, without any failure of the steering gear.

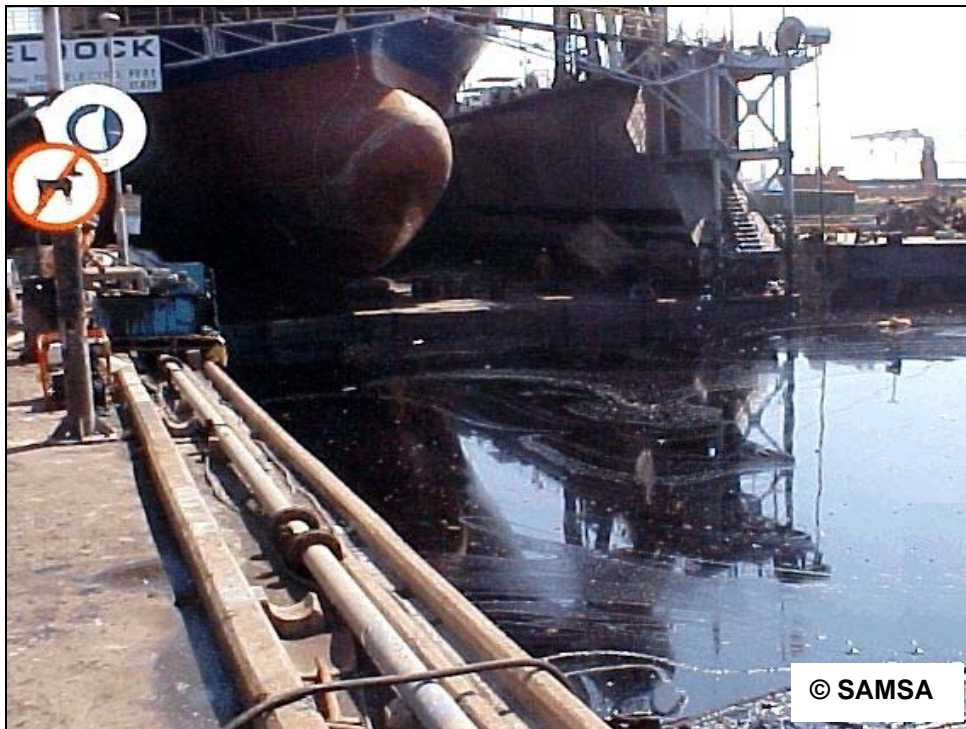
Fig. 7: Pollution by oil in ELDOCK

On the other hand, the pollution by oil that occurred in the ELDOCK floating dock in Durban was not insignificant, with an estimated spilled amount of about 80 tons. Nevertheless, serious and permanent damages to the environment could be prevented.

- Favourable weather
- Use of oil booms that had already been placed around the dock
- Immediate initiation of cleaning measures, with the participation of personnel of the shipyard and with the support of other companies

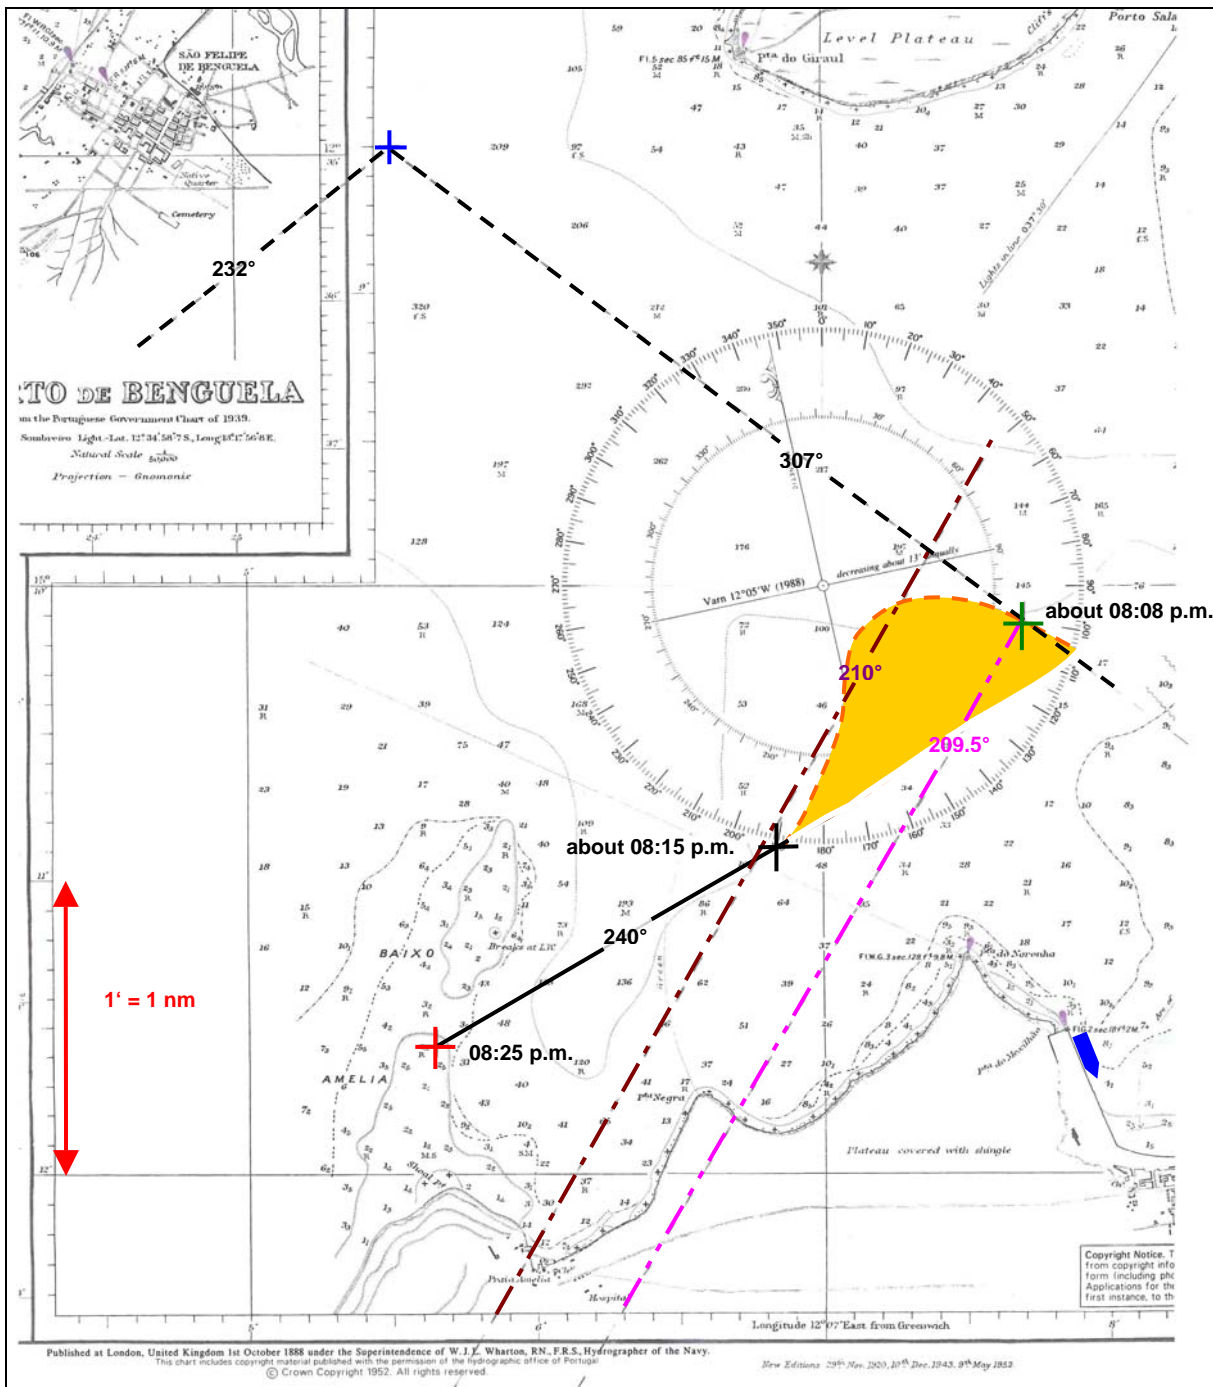
Fig. 8: Reconstruction of the beginning of the accident (Detail BA Chart 1197)

After reaching the new course and increasing the rate of speed to “Half ahead” no determination of the position was carried out. Therefore the bridge team did not realise that the course line was shifted by at least 0.6 nm to the south from the course line that – provided the depth of the water is stated correctly in the BA Chart No. 1197 – would have allowed a safe passage of the shoal of BAIXO AMELIA. Inevitably, DORIA grounded less than 0.5 nm off the coast at 08:25 p.m.

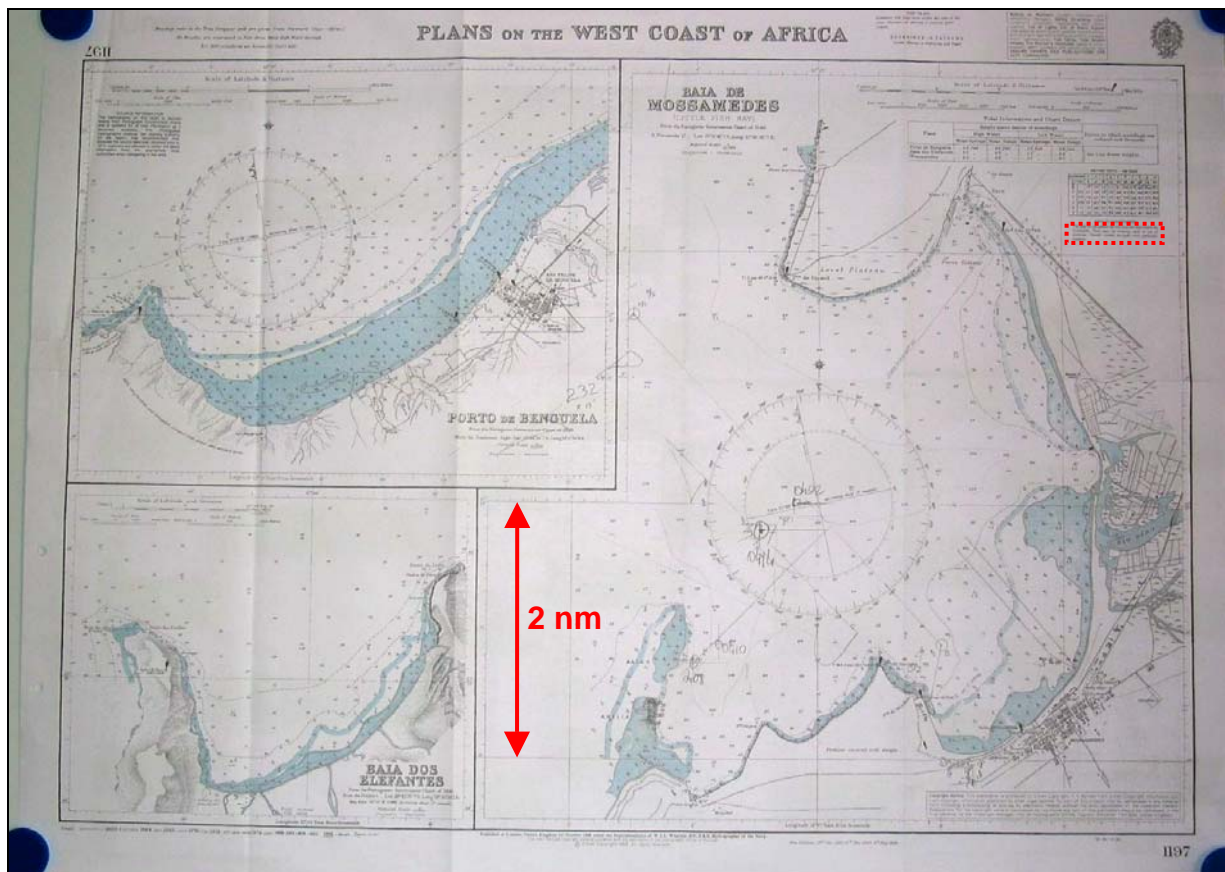
Fig. 9: Photograph of BA Chart No. 1197³²

A comparison of **Fig. 9** and **Fig. 10** illustrates the effects of the different scales of the Harbour and Approach Plan No. 1197 (1:25,000) and of the General Course Map No. 627 (1:1,000,000) on the representation of the navigation zone. It can clearly be seen that Chart No. 627 is completely unsuitable for the navigation close by the shore and in particular for approaching the port. **Fig. 11** below shows the relevant section of the chart in full-scale as an illustration of this fact.

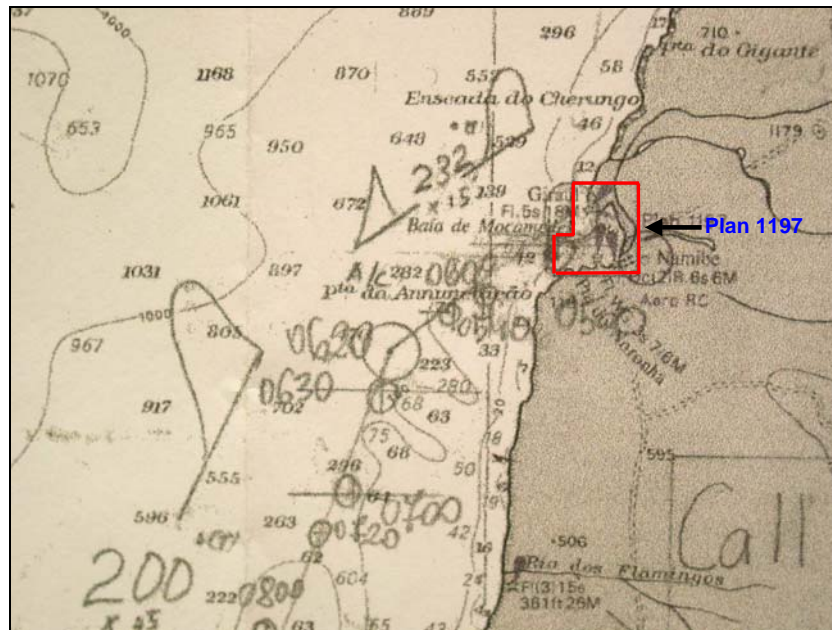
Fig. 11: Section of BA Chart No. 627³⁴

The trigger moment for the insufficient determination of the position of DORIA was most probably the completely insufficient supply of nautical charts in the area of the accident. The lack of a chart of the coasts of medium scale and the understandable intention to visualise the oncoming course of the route lying ahead caused the Master to prematurely change over from the large-scale harbour chart (No. 1197) to the small-scale overview chart (No. 627). Hereby the shoal to be passed got out of sight.

3. The Federal Bureau of Maritime Casualty Investigation recommends the **nautical officer responsible for the planning of the routes** to fix way-points (transfer points) which can be entered on both charts for the transition between adjoining charts. In order to avoid any errors and inaccuracies in the carry-over of way-points and course lines, in particular if the adjoining charts are of different scales, it is recommended to fix transfer points, if possible, at the transit through “even” minutes of longitude and/or latitude, which can easily be localised in the chart depending on its respective scale.
