**Bundesstelle für Seeunfalluntersuchung**  
**Federal Bureau of Maritime Casualty Investigation**  
Federal Higher Authority subordinated to the Ministry of  
Transport, Building and Urban Affairs

Investigation Report 474/06

**Serious Marine Casualty**

**Collision of CMV KLENODEN  
with CMV HANJIN CAIRO  
on 9 September 2006  
in Hamburg**

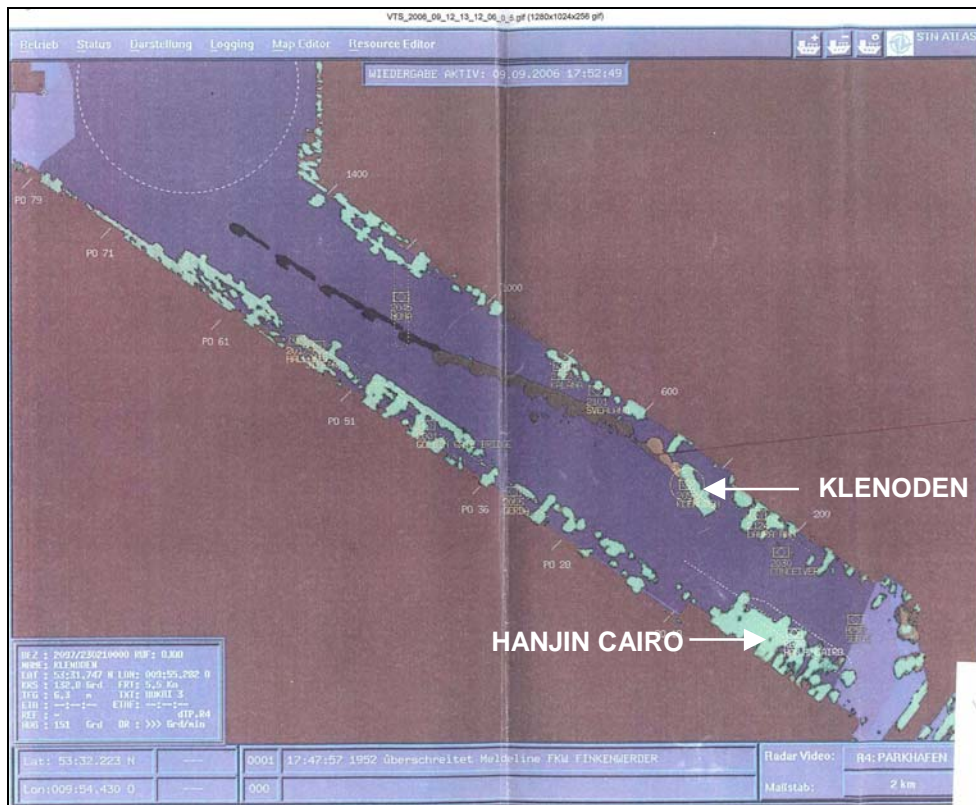
For reasons which cannot be comprehended after the event, due to the lack of details provided by the vessel's command, a deviation to starboard occurred in heading of KLENODEN. This resulted in KLENODEN heading for the opposite pier on which HANJIN CAIRO was firmly moored (see fig. 4).

Figure 4: Radar plot VTS Hamburg, 9 September 2006, 05:52:49 p.m.

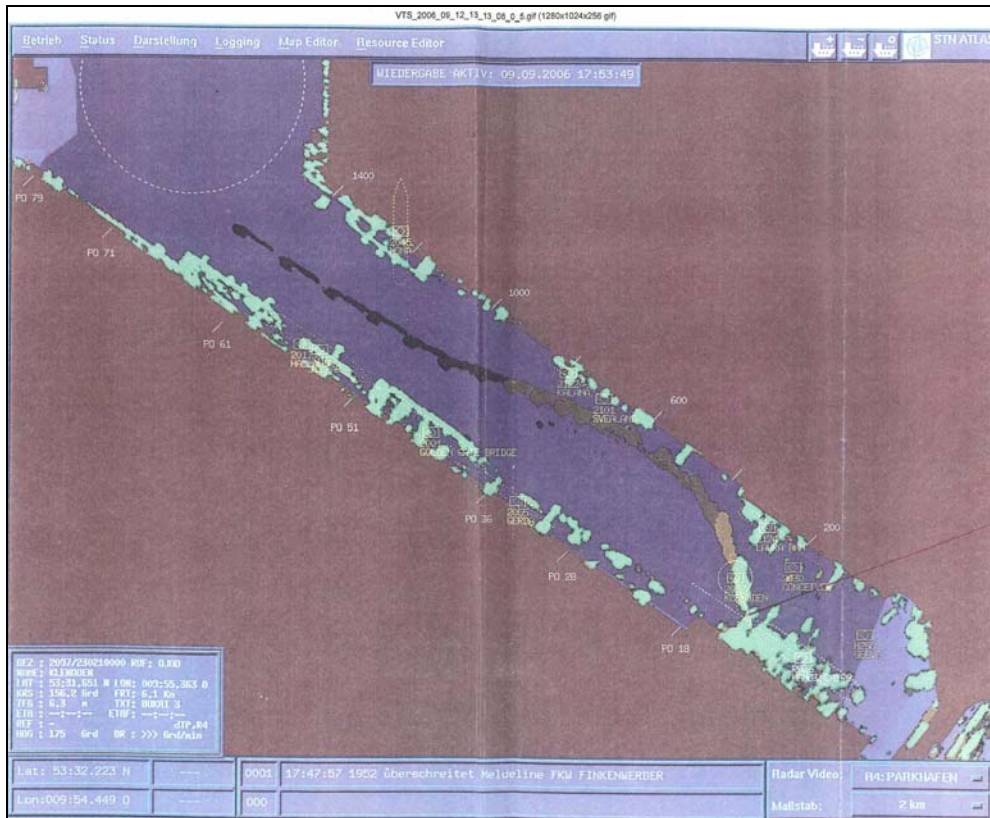
The bow of KLENODEN collided with the bow of HANJIN CAIRO at an angle of about 45° (see fig. 5). After the impact, KLENODEN very slowly drifted backwards, whereupon the port side anchor was let go as well. By this, the crew succeeded in stopping KLENODEN. The main engine, which at this moment was nearly overcharged, was stopped by the 2<sup>nd</sup> Engineer by using the emergency shutdown.

Figure 5: Radar plot VTS Hamburg, 9 September 2006, 05:53:49 p.m.

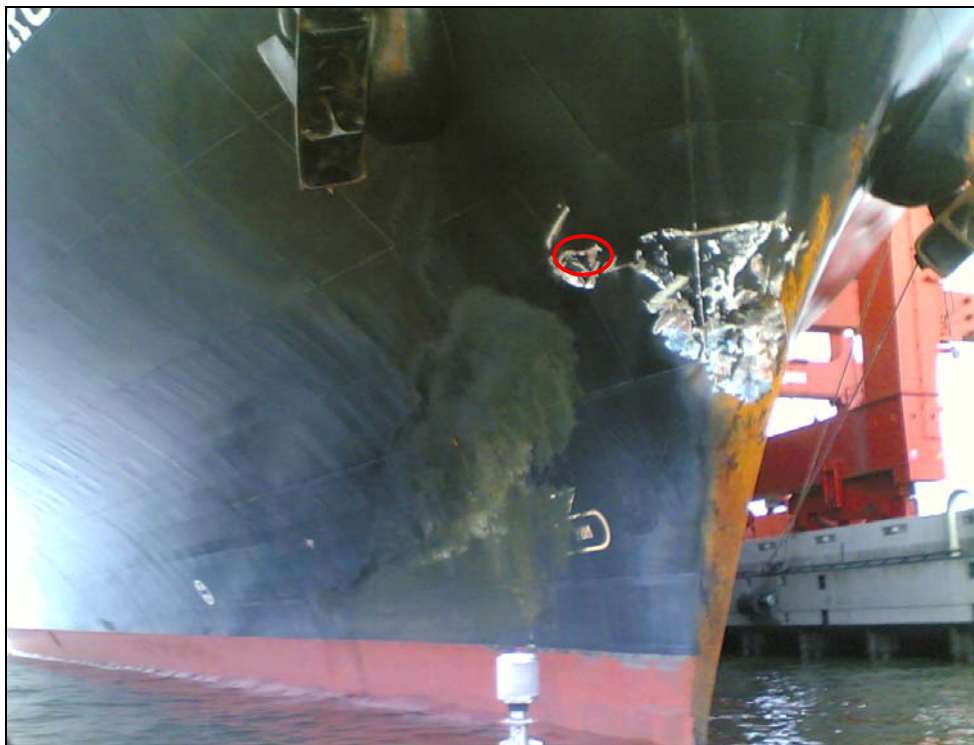
The stem of HANJIN CAIRO was dented by the impact at about 5 m above the waterline, whereby a hole of about 10 x 10 cm was caused in the hull (see fig. 7; hole marked by the red circle).

Figure 7: Damage on the stem of HANJIN CAIRO

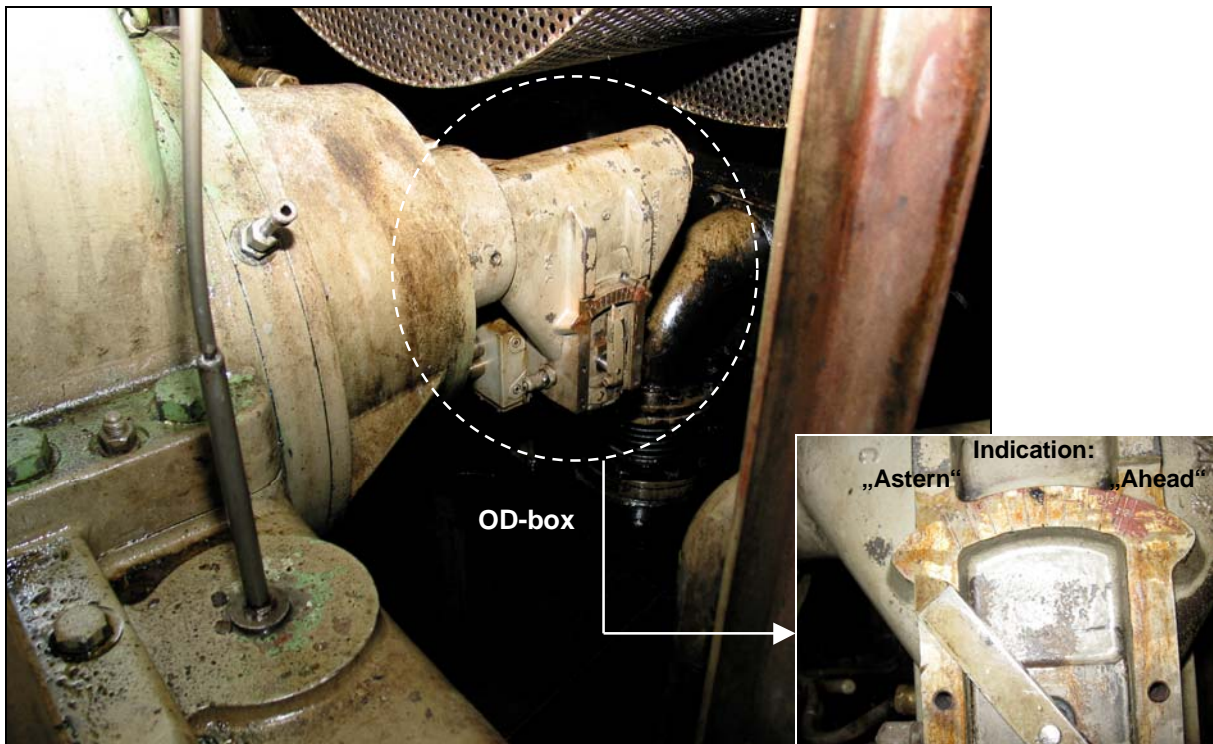
Figure 10: Mechanical pitch indication on the OD box;  
small figure: Indication at time of accident

The mechanical pitch indication on the OD box was beyond the scaling in the “Astern” position, as were the remote indicators (see fig. 10, small figure), the pointer being unusually freely movable.

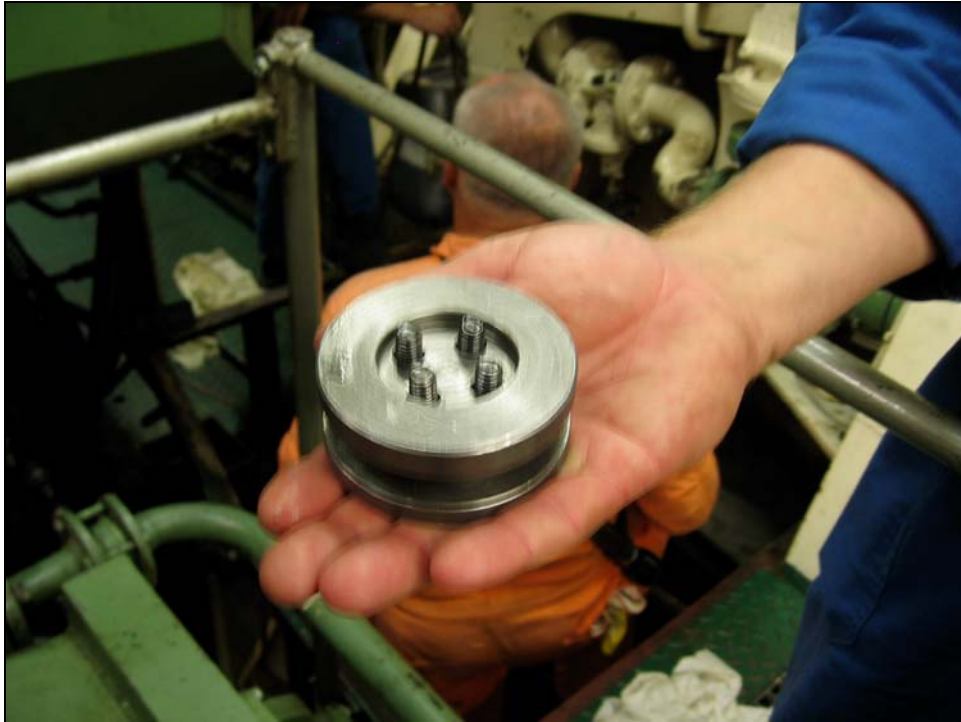
Figure 11: Demounted double sheave from the OD box

This double sheave was demounted and remounted by the service technician during the repair of the leakage on the OD box. The groove of the double sheave serves the link block, which again serves as connection to the mechanical pitch indication on the OD box (see fig. 12).

After the cover was removed it became apparent that the double sheave had completely dropped off, and, as a consequence, the con-rod transmitting the pitch

value to the mechanical indicators was no longer fitting in the groove of the double sheave. Therefore the mechanical connection of the hydraulic pitch control system to the pitch indicator was interrupted, whereby the pointer on the OD box lay outside the scaling. Via the potentiometer, this indication – independent of the actual propeller pitch – was transmitted to all of the remote indicators.

One of the total of four mounting bolts that served as fixation of the double sheave was bent.

The Federal Bureau of Maritime Casualty Investigation recommends **companies and shipyards** that perform maintenance and repair work on OD boxes (oil distribution boxes) on seagoing vessels to assign their service personnel to check for a possible wedging of the double sheave and, if necessary, to perform suitable training measures. In addition, the required safe connection between the double sheave and the mechanical pitch indicator must be ensured by an extensive performance check with the main engine running, in order to minimize the danger of a failure of the pitch indicators as much as possible, in particular during estuary trading.

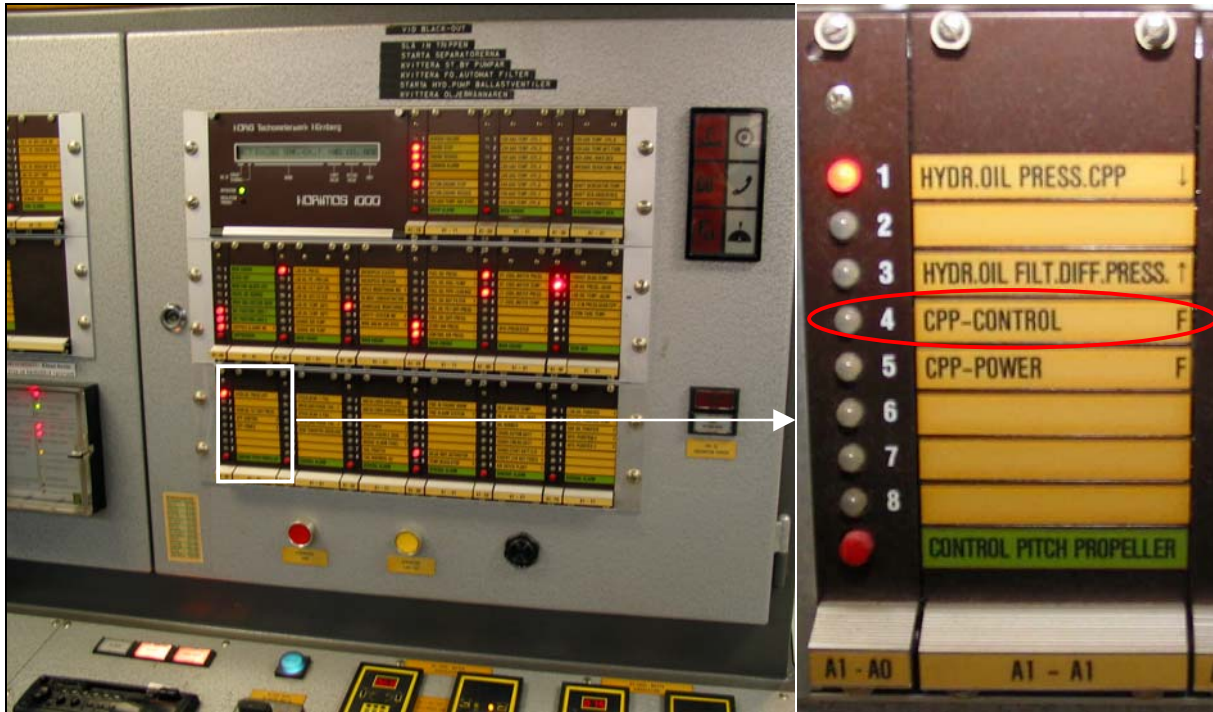
In the engine control room of KLENODEN, the control board is located, from which, among others, the CPP alert (controllable pitch propeller-control) can be read. The “F” in the alert field is for “fault” (see fig. 15).

Figure 15: Alert board in the engine control room

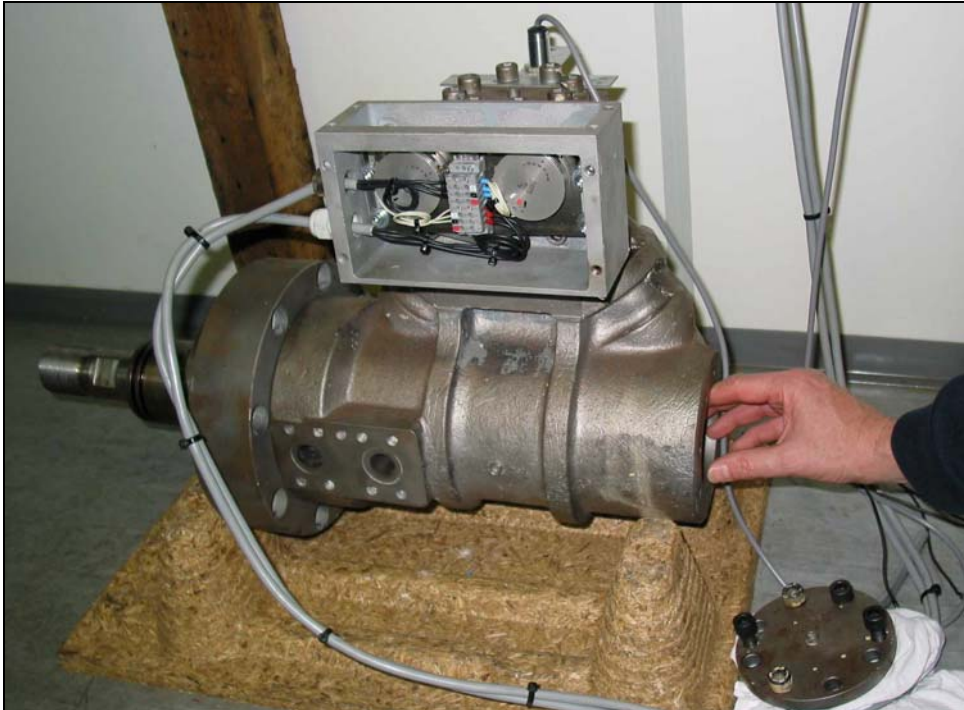
was inevitably performed with only one hand and as “blind” work, i.e. without any possibility of seeing the parts, as the inside of the OD box is only accessible through a comparably small opening with a diameter of 8 cm (see fig. 16).

Figure 16: OD box of identical construction (demounted, upside down)

The design of the OD box as well as its arrangement in the engine room is prone to cause errors during maintenance or repair works of wearing parts. The narrow opening only allows working with one hand. As the OD box cannot be opened in such a manner as to enable an unrestricted view to the components to be mounted or demounted, any work must be performed as "blind" work. The restricted view onto the relevant components inside the OD box through the narrow opening is additionally rendered difficult by the fact that in the engine room there is only a small amount of light is available below the driving shaft in order to finally check whether the components are mounted correctly. Therefore an engineer who performs repair or maintenance work on the OD box must inevitably rely on his professional experience and on his sense of touch.

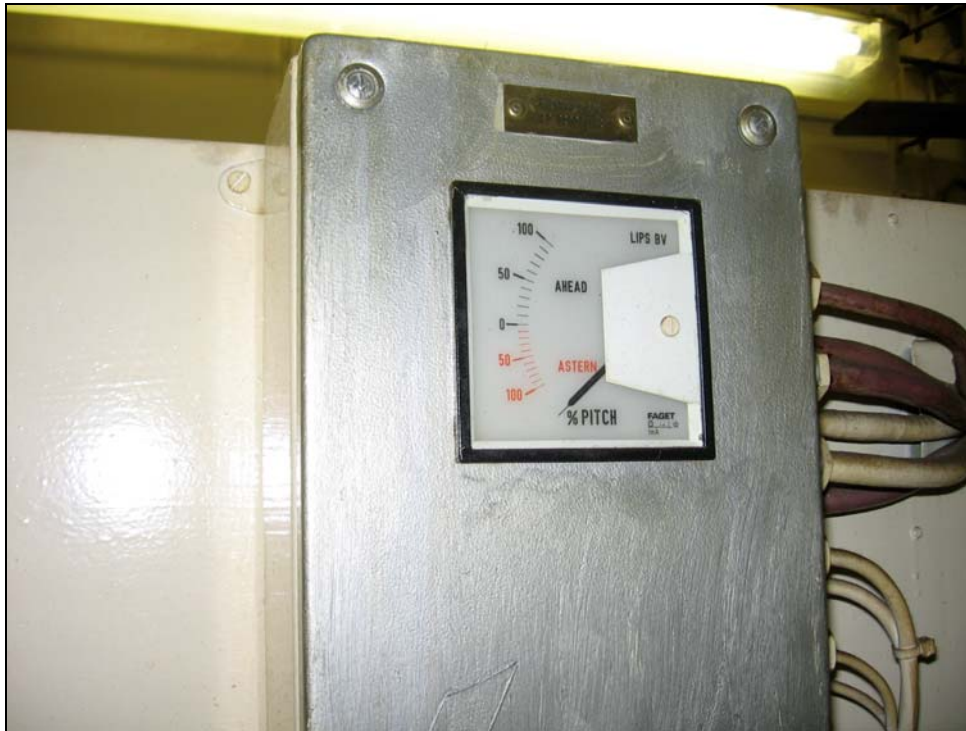
All of the remote indications for the pitch control system showed a pitch to “Astern” outside the scaling (see fig. 17).

Figure 17: Pitch indicator in the engine room after the collision

The Federal Bureau of Maritime Casualty Investigation recommends **vessel's commands** not to make time-consuming attempts to reactivate the pitch indicators of the propeller blades by using the control lever in case the pitch indicators fail during estuary trading. Instead, the pitch push buttons for emergency operation should consistently be operated in one single pitch direction. This is the only chance to manoeuvre the vessel despite the failure of the indication while being unaware of the real pitch. In this regard, a simultaneous observation of the propeller stream can provide information about the real pitch of the propeller blades.
