Bundesstelle für Seeunfalluntersuchung
Federal Bureau of Maritime Casualty Investigation
Federal Higher Authority subordinated to the Ministry of Transport
Building and Urban Affairs

Investigation Report 476/06

Serious marine casualty

**Collision between
MV SVEN
and
MV COMET
on 18 November 2005
in the port of Hamburg**

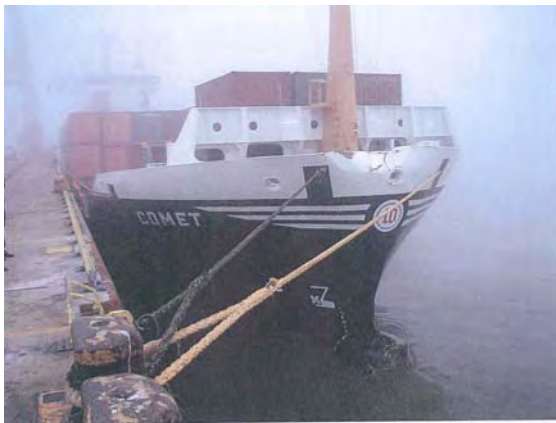
Fig. 4: Bow damage COMET

Seconds later a shadow could be seen from the bridge and subsequently the collision was felt. The collision came as a surprise for COMET. The Second Officer reported from the forecastle that COMET had been hit front on in the bow area and there were no injured persons. Only damage to the bulwark and the bulbous bow had been sustained. Then, after SVEN had passed the bow of COMET, the starboard turn was not continued, but instead the vessel was made fast at CTT with its starboard side using a propeller pitch of 20% to 40% in order to simplify the berthing manoeuvre and not start any new turn. At 11:00 h all mooring lines were fast and the position was reported to the VTS.

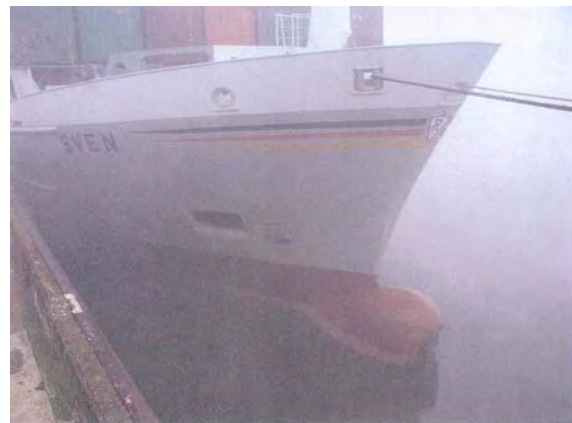
Fig. 5: Bow damage SVEN

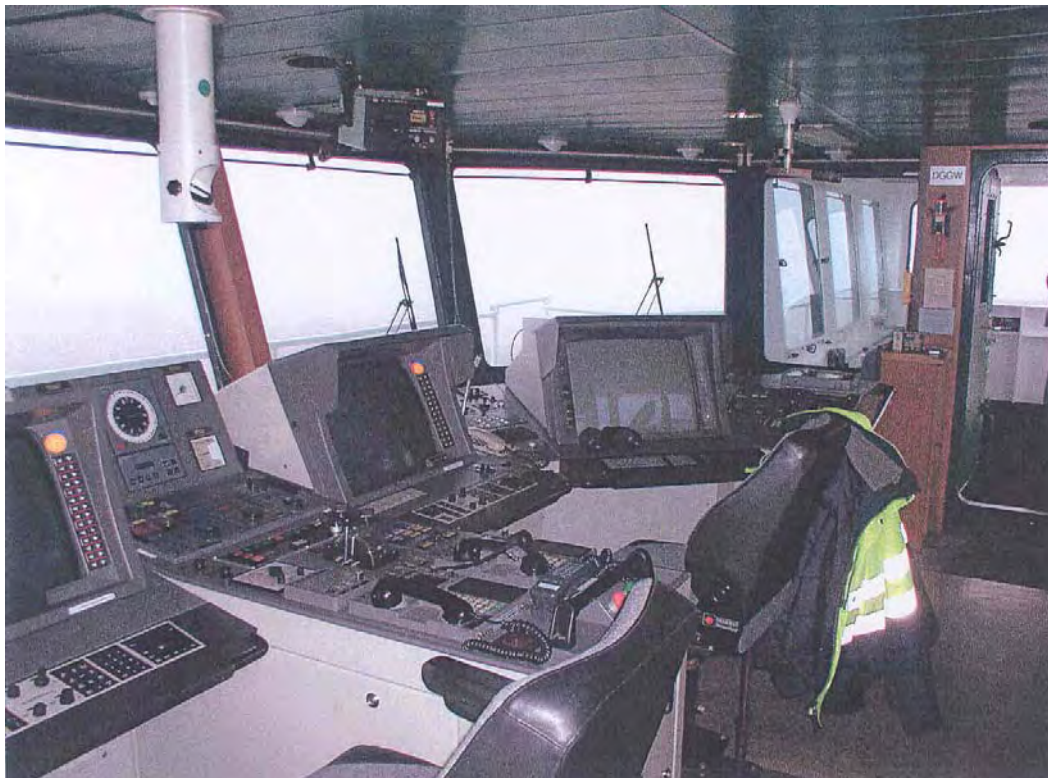
Both vessels were built at the Sietaswerft yard in Hamburg and have a similar bridge design (see Fig. 6), as well as similar manoeuvring characteristics with a left-hand variable pitch propeller, Becker rudder and bowthruster. Both Masters were steering their vessels from the starboard conning position and were able to vary their speed well with the variable pitch propellers.

Fig. 6: Bridge SVEN with conning position (windbreaker jacket)

Considering the technical equipment of the vessels, the dense fog and high rate of traffic in the port of Hamburg as well as the services to be conducted with the Vessel Traffic Center, the allocation and manning of the bridges on both vessels were inadequate and inexpedient. Instead of transferring the tasks of lookout to a deckhand, the Chief Mates were engaged in this task on both vessels and could not support the Master appropriately e.g. by taking over VHF on board COMET or analysing the AIS targets on board SVEN. Furthermore, due to the fact that both vessels should have been navigating with a paper chart, an officer¹⁴ would have been necessary for this task.

Owners, operators and masters in feeder service are recommended to describe the bridge management in detail in the ISM manual of their vessels and to work towards a watch system in which under normal circumstances four hours sea watch and eight hours free are provided for. In the Port of Hamburg the frequent shifting in feeder service (in some cases 6 to 7 times within a period of two days) should be facilitated by additional staff, e.g. board pilots and bridge personnel. The vessel operator must ensure that the master is provided with the necessary means for this.

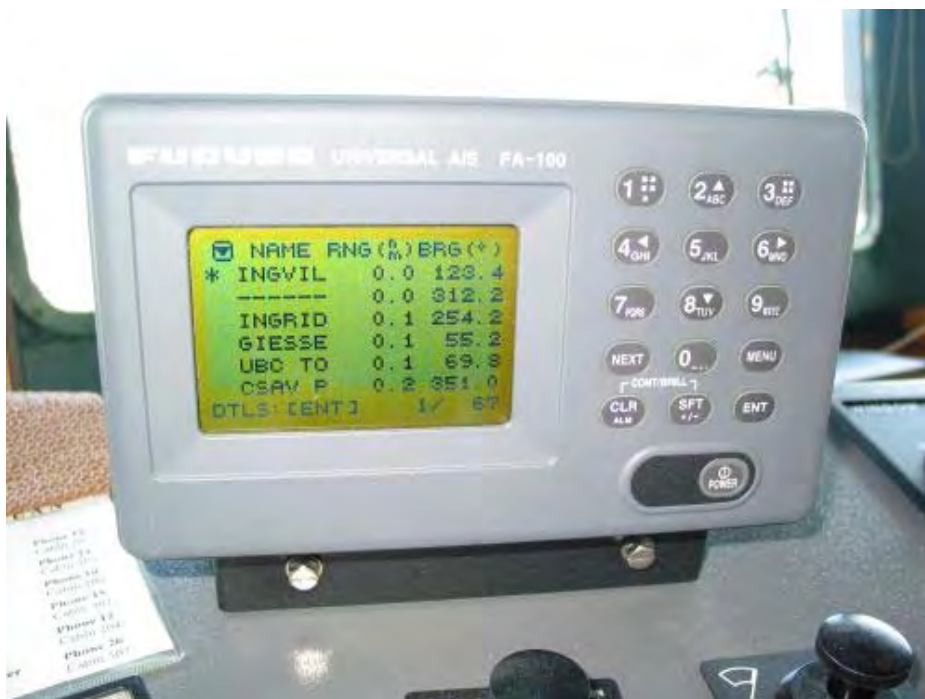
On 18 November 2005 low water at Hamburg St. Pauli had been calculated for 12:57 h. The rudders have a better efficiency with counter current due to the oncoming flow running with the current or without any current. The speed of SVEN was appropriate to the conditions on entering the Vorhafen. On board COMET the turning and berthing manoeuvre was, on the one hand, more difficult because of the adverse visibility conditions, but, on the other hand, was facilitated by the fact that there was no wind. The Master on board COMET other than the Master of SVEN was additionally engaged in radio traffic and turning the vessel. Both Masters were navigating by radar and the electronic chart (ECS). Differing from the situation on board SVEN, on the ECS screen of COMET it was possible to display the targets of the automatic vessel identification system (AIS). SVEN only had a separate display of the AIS target on the so-called minimum keyboard display (see Fig. 7).

Fig. 7: AIS installation SVEN

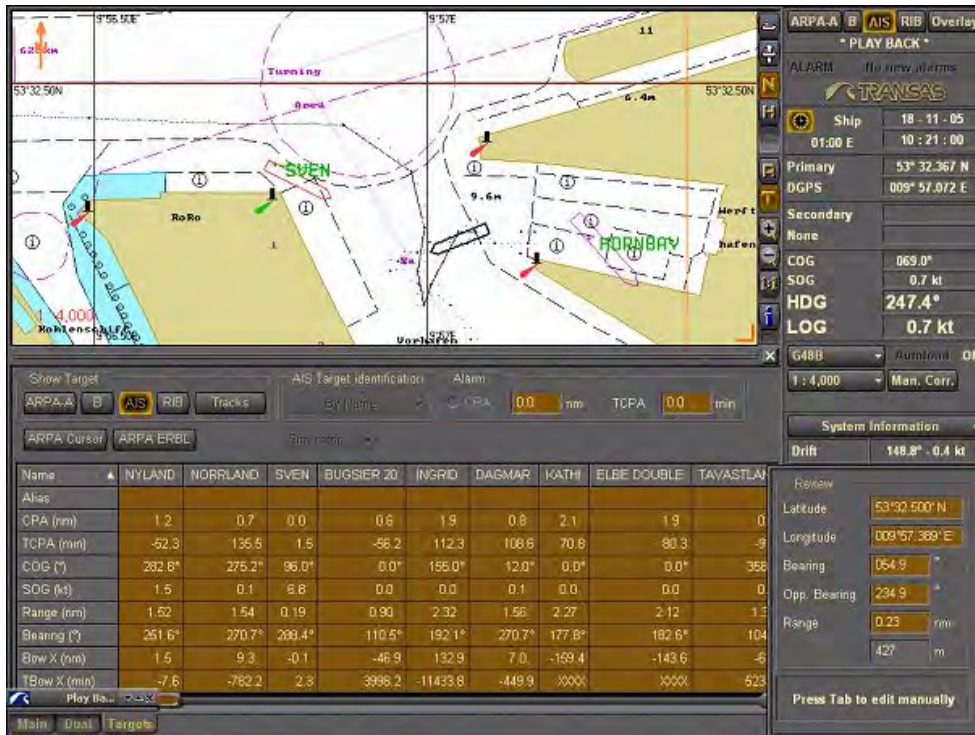
Fig. 10: ECS record COMET with AIS data 10:21:00 h

Thus there were differing displays on the electronic charts of the two vessels. Irrespective of the fact that no official chart data were used and that SVEN did not have a valid permit for operating the system, on board SVEN radar, AIS and chart data had to be evaluated on three different screens, while on board COMET two screens were necessary. The matter was further rendered difficult by the fact that on board SVEN one radar set was defective. Formally, the proprietary chart data of the two ECS should not have been used for navigation. However, this would have meant that the crews would have had to work with official paper charts creating additional analog data sources outside the conning position, and not all the information could have been called up from the conning position.

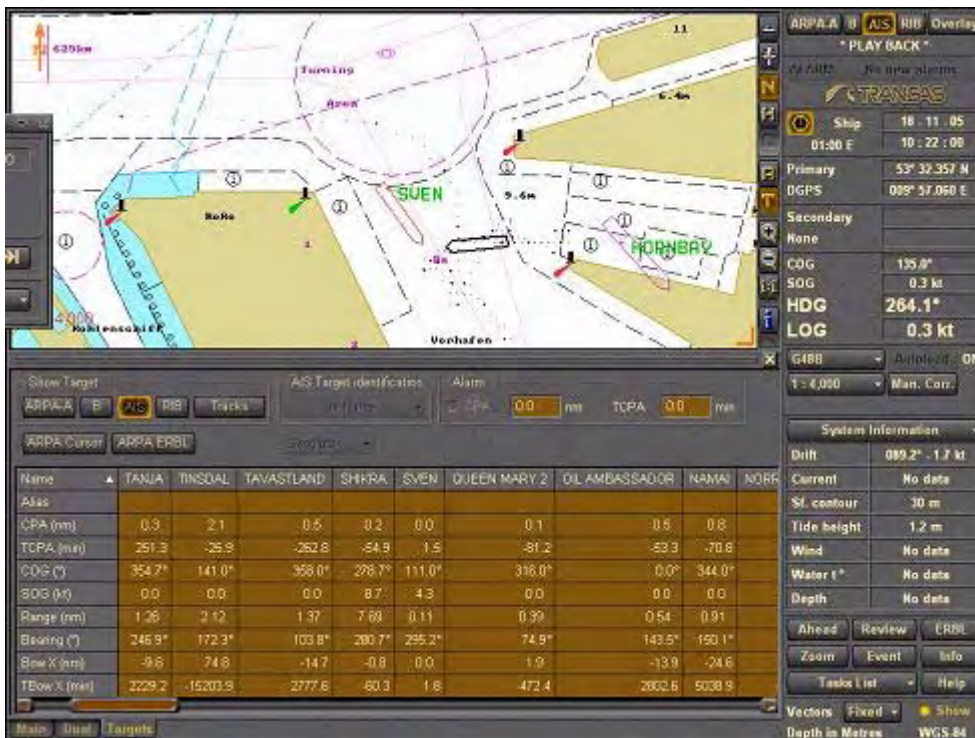
Fig. 11: ECS record COMET with AIS data 10:22:00 h
