Report on the investigation of  
the collision between **Arctic Ocean** and **Maritime Lady**,  
capsize of **Maritime Lady** and contact with wreck of  
**Maritime Lady** by **Sunny Blossom**, and its subsequent grounding  
in the Elbe River  
5 December 2005

**Report No 2/2007**  
**February 2007**

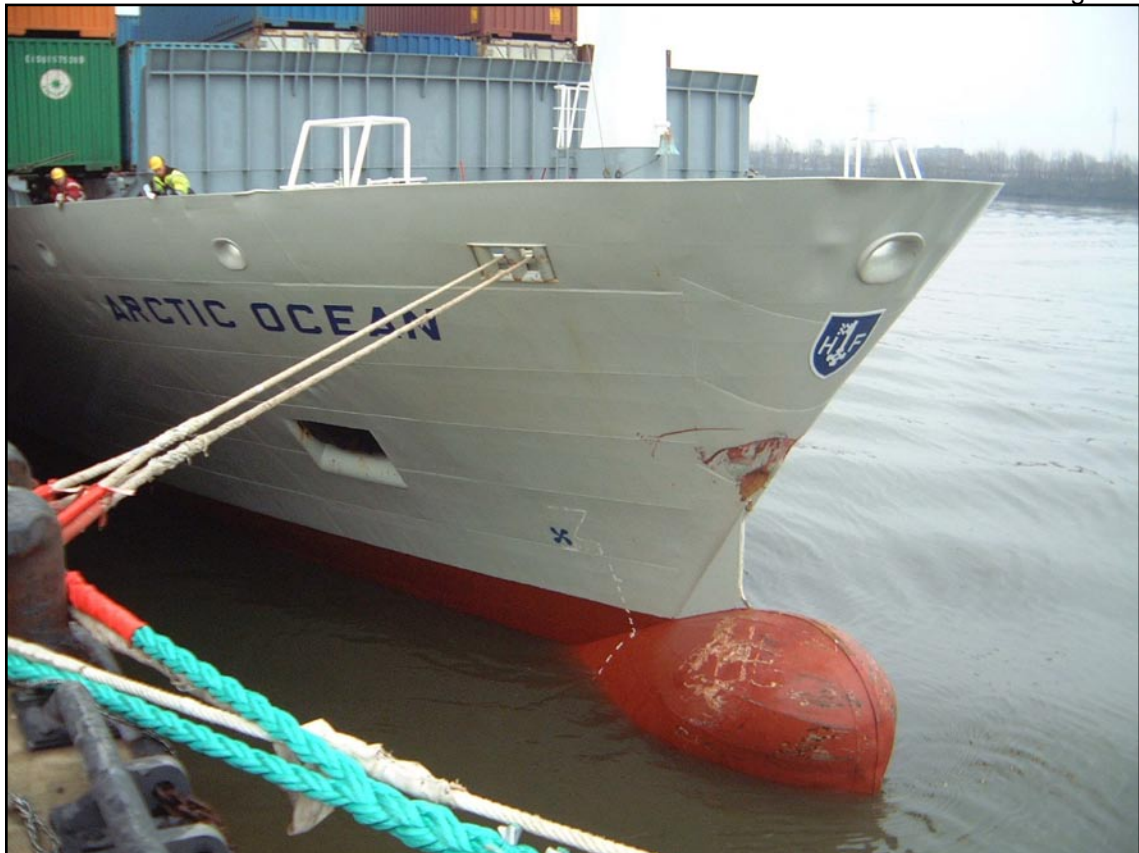
Figure 9

Damage to *Arctic Ocean*, as a result of the collision, was confined to her bulbous bow and stem. The bulbous bow suffered minor paintwork damage but no obvious indentation of the plating. The stem, several metres above the bulb, was slightly indented (**Figure 9**).

Damage to bows of *Arctic Ocean*

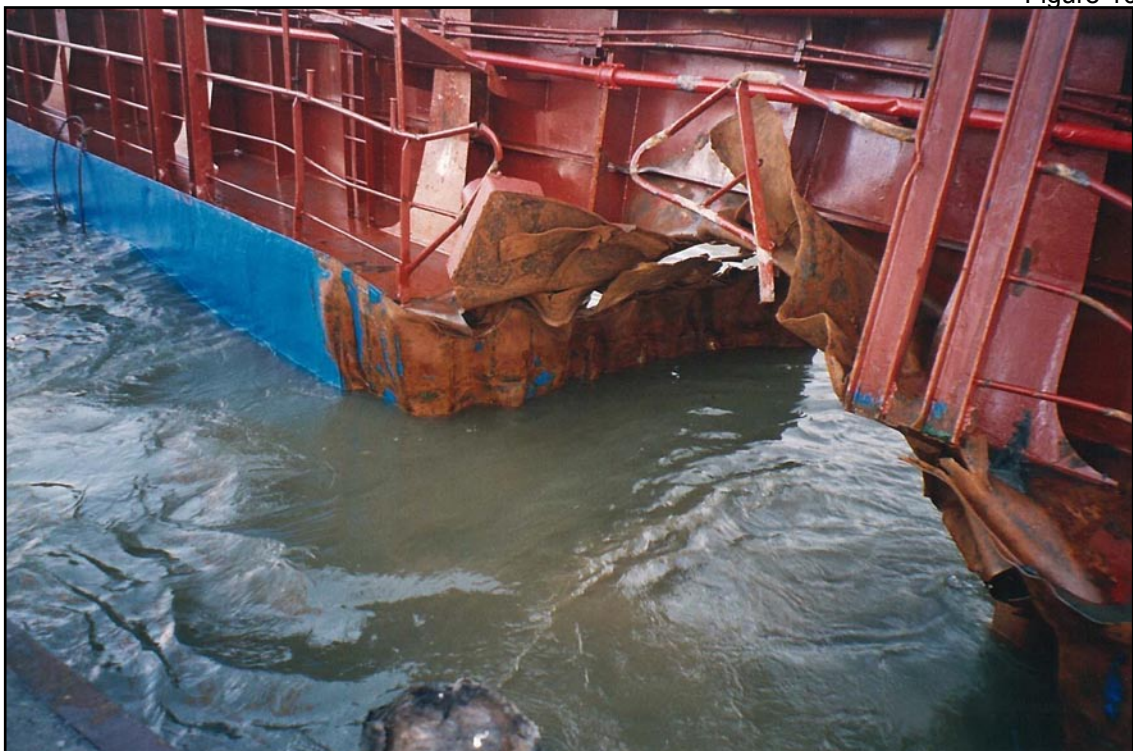
Figure 10

Damage to starboard side of *Maritime Lady*

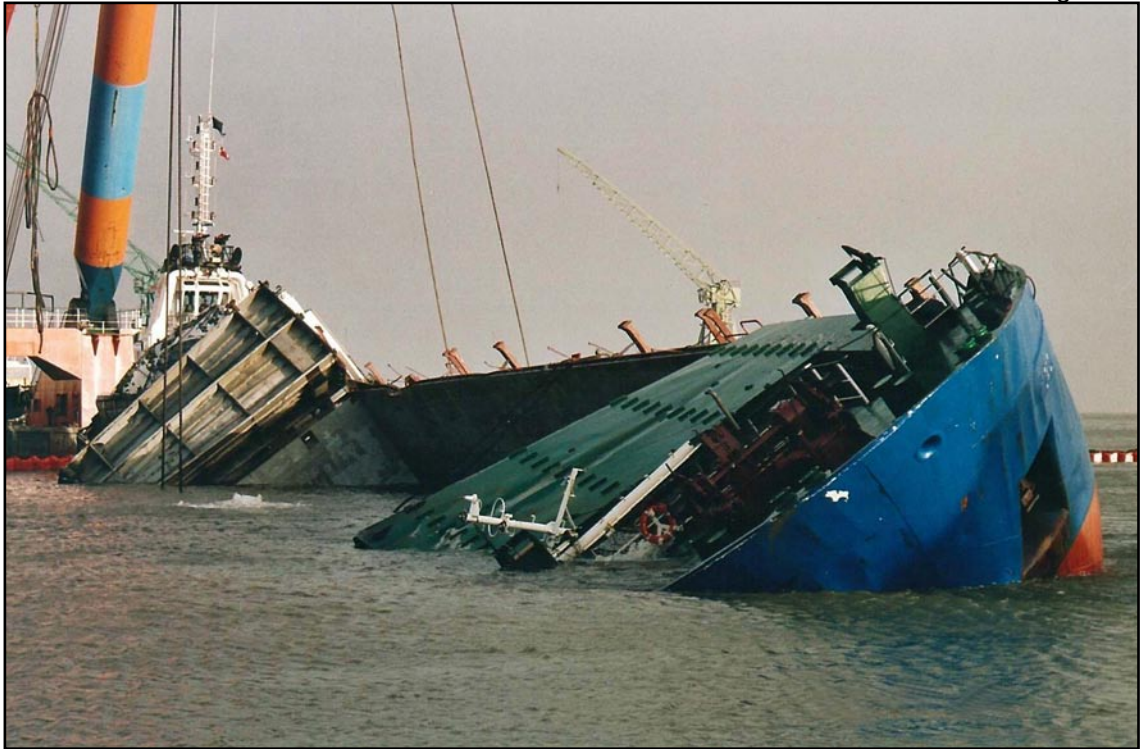
Substantial further damage occurred as a consequence of the vessel's capsize, drift in the river, contact by *Sunny Blossom* and salvage. This included: loss of all hatch covers except two sections, crushing of the wheelhouse; displacement of most equipment in the wheelhouse; loss of funnel; loss of masts; destruction of the starboard lifeboat davit; accommodation linings torn free; total loss of cargo, aft peak tank holed and rudder and stock deflected (**Figure 11**).

*Maritime Lady* during recovery

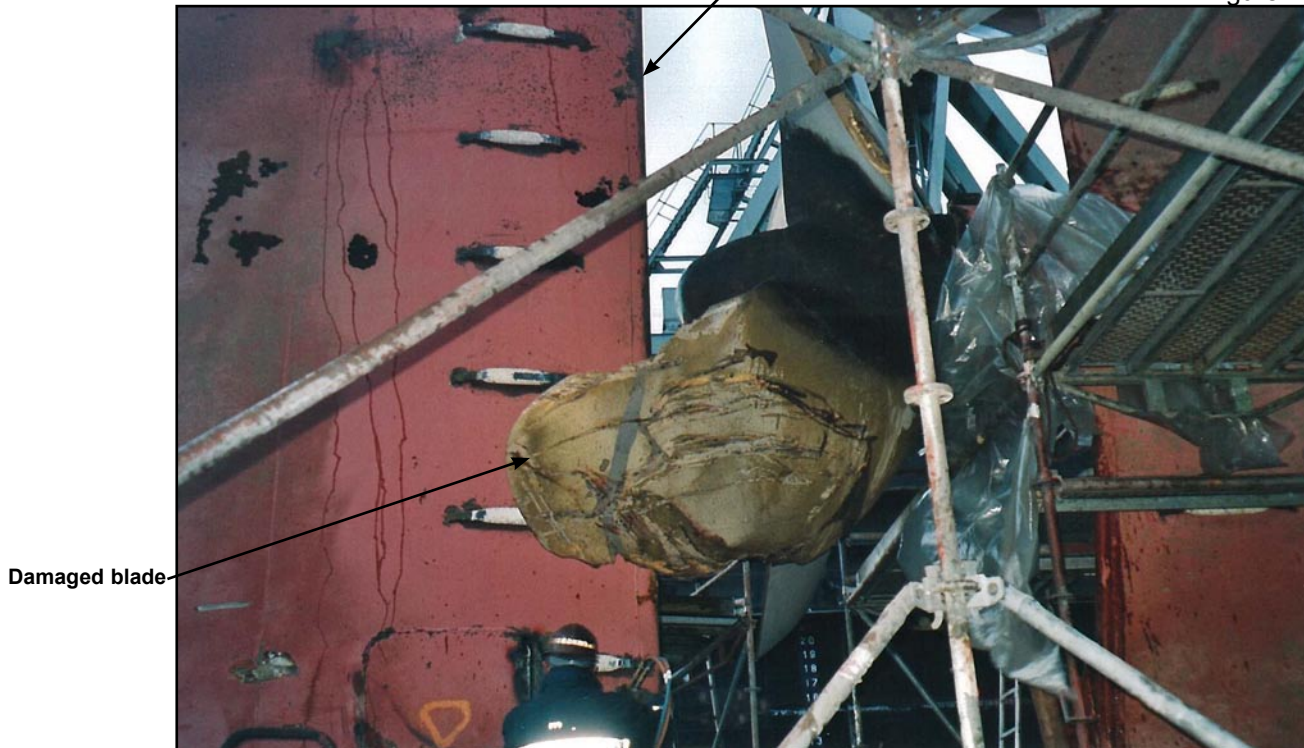
Figure 12

Following her collision with the wreck of *Maritime Lady*, the following damage to *Sunny Blossom* was found: a slight fore and aft crease in the starboard quarter of her hull plating, in way of the engine room; damage to the rudder stock and bearing; one blade of her propeller was deflected aft; and the tail and intermediate shafting were damaged.

Although the damaged propeller blade did not make contact with the rudder, the degree of deflection was such that the blade extended aft of the leading edge of the rudder (**Figure 12**). While recording this damage, it was noted that two further blades had previously been cropped (**Figure 13**).

Damaged blade

Damage to propeller blade of *Sunny Blossom*

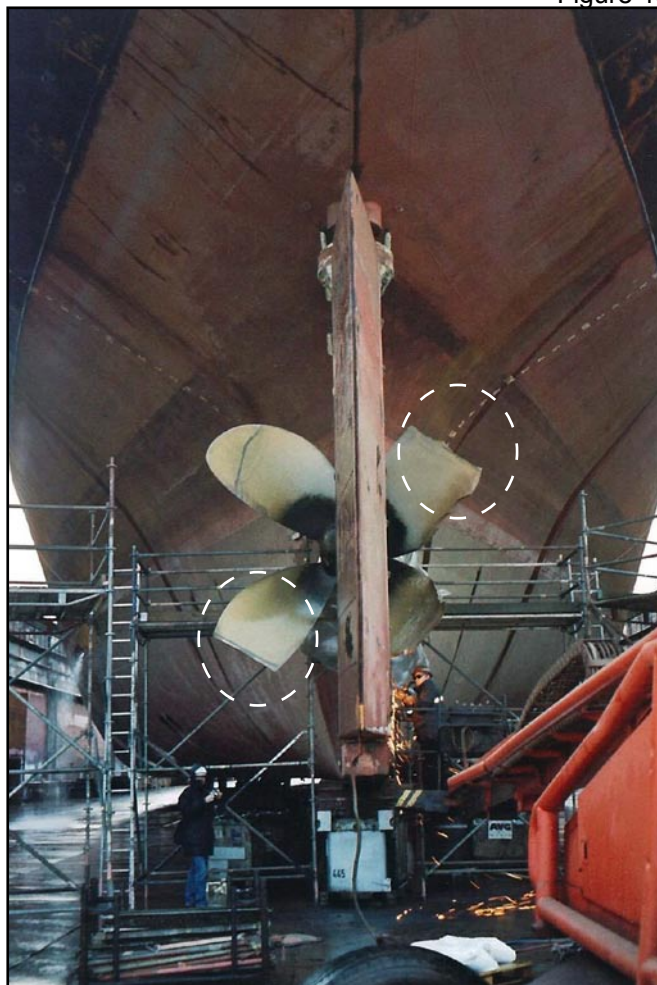
Figure 13

Propeller of *Sunny Blossom* - showing two cropped blades

During survey by the vessel's classification society, Det Norske Veritas (DNV) between 7 and 17 June 2005, the tip of one propeller blade was recorded as damaged over a length of approximately 600mm. The same amount of material was removed from the opposite blade, and the blade edges rounded off and faired in.

Following this survey, a classification society condition was imposed requiring permanent repairs be made to the propeller by 31 March 2006. Ship's staff were advised to adjust engine speed in such a way as to avoid possible excessive vibration. Any abnormality in service was to be reported to DNV.

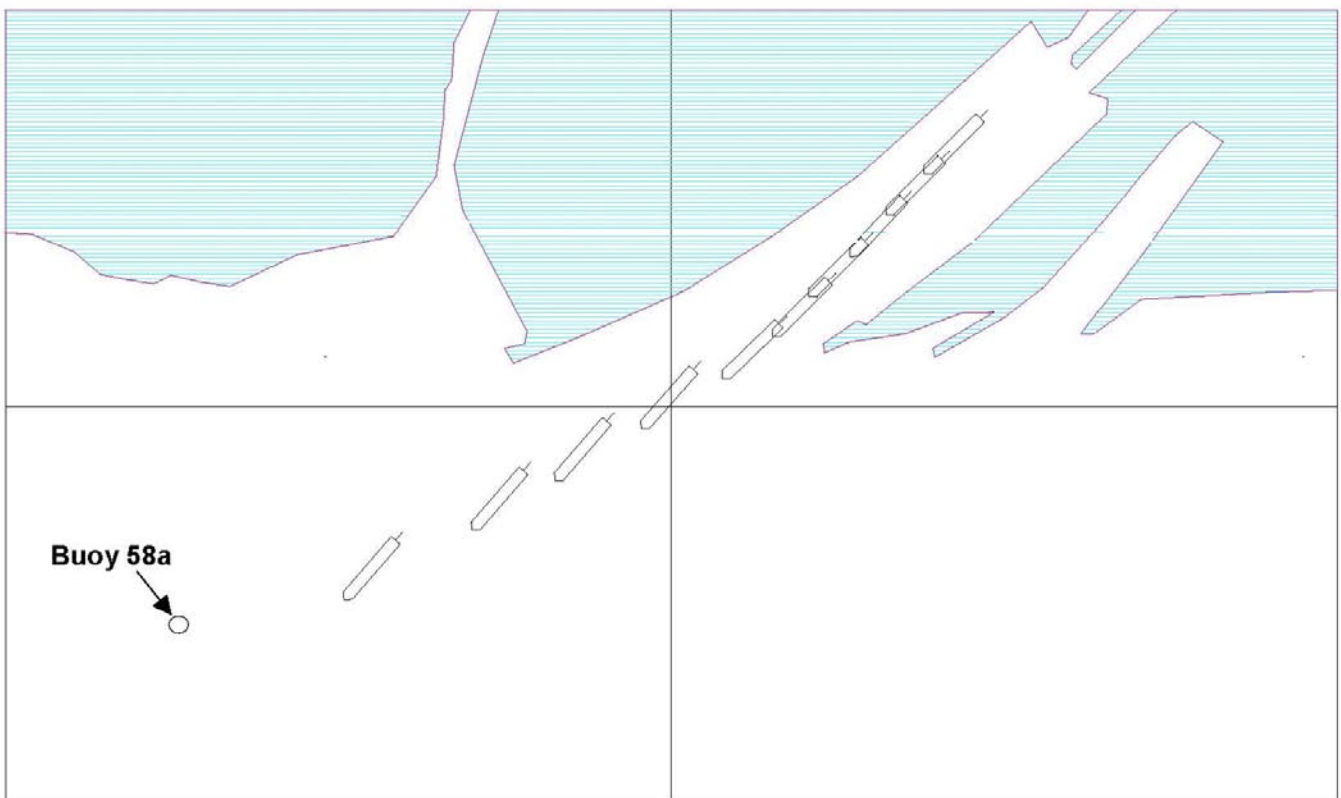
Figure 18

*Sunny Blossom*, therefore, moved at a rather slow speed when she passed through the current shear zone at the exit from the basin, and appears not to have picked up much speed through the water before hitting the wreck of *Maritime Lady*. Because of her slow acceleration, a more easterly heading, before she left the lock basin, would have been necessary to allow full port helm to counter the tidal shear due to the ebb (see **Figure 18**).

*Sunny Blossom* track reconstructed from AIS information
