INVESTIGATION REPORT

SERIOUS MARINE CASUALTY

MV "WILMA"

overhead road bridge construction crossing the Kiel Kanal

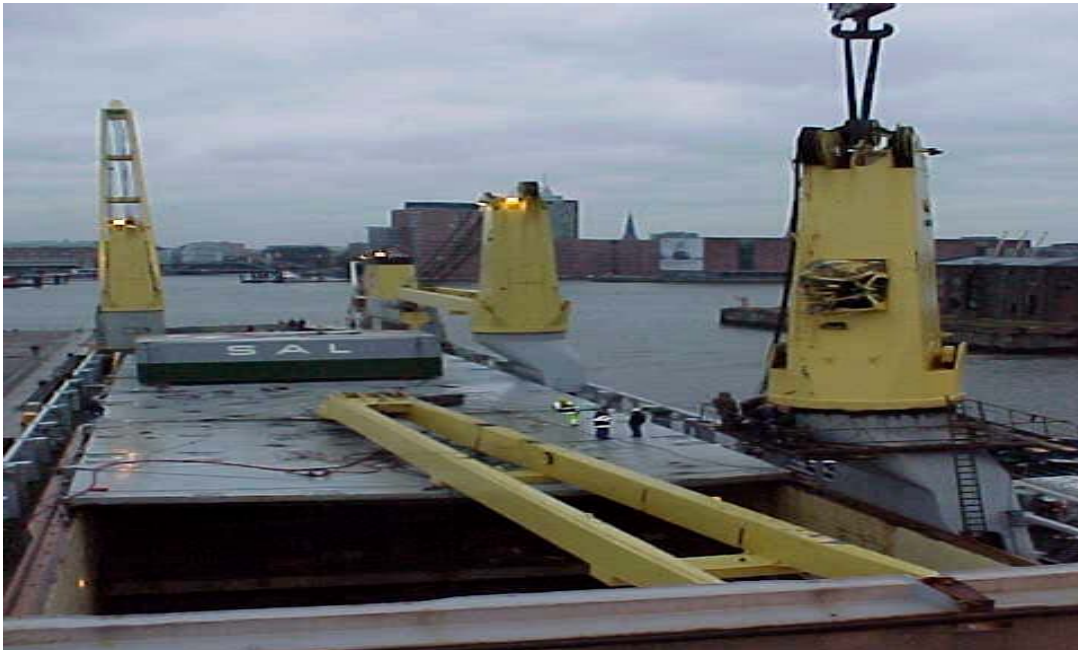
Damage to *Wilma*, as an immediate result of the crane crash with the overhead bridge construction, was confined to the hatch covers and was caused when the topped derrick broke away from the crane pillar and smashed on top of the only partly opened covers.

View from the bridge to the aft: the torn off derrick on the hatch cover

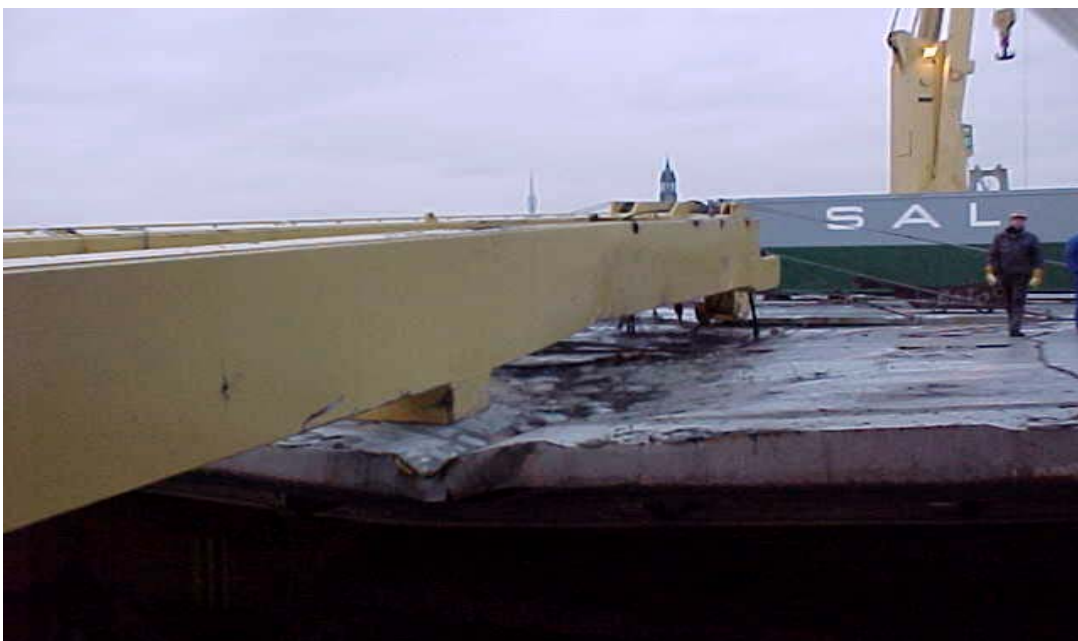
The damage caused to the hatch cover by the fallen crane leg

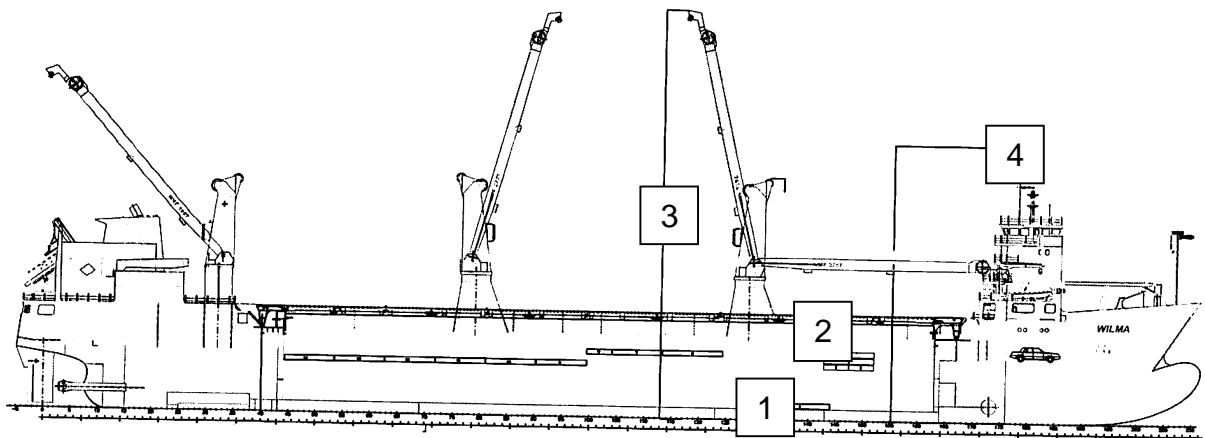
Crane derricks erected: This sketch clearly illustrates the latent risk of a potentially dangerous over height variance to the calculated air draught once the cranes are in operation.

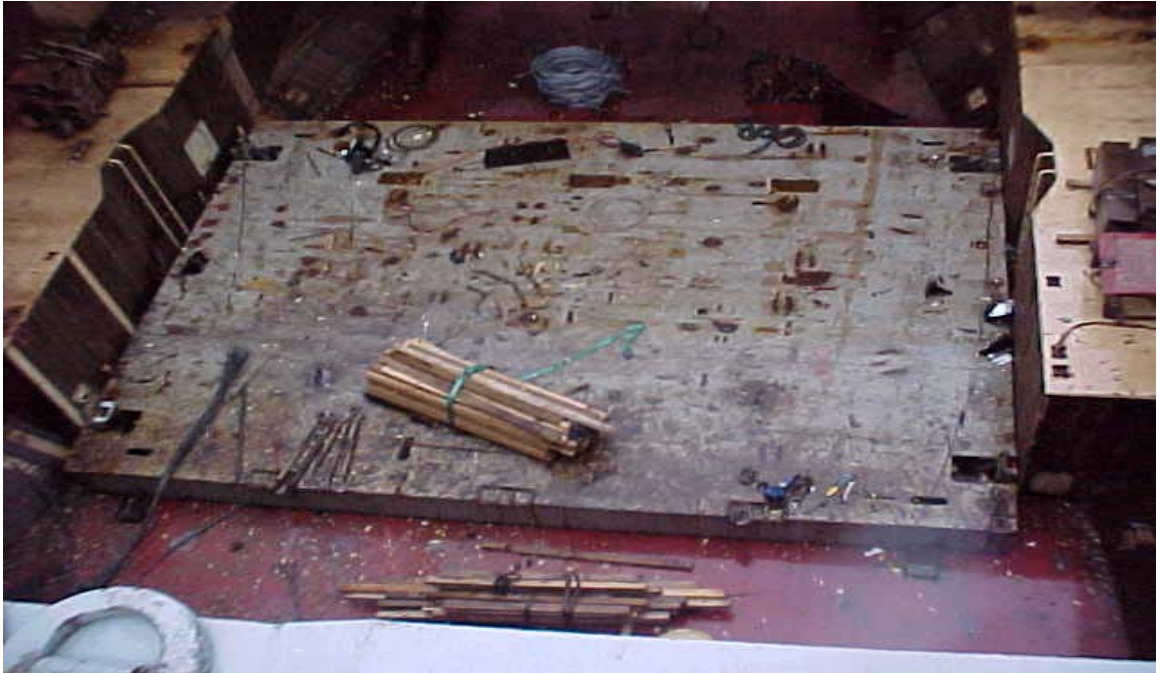
A look into the hold shows the tween deck pontoon, still flooded and subject to be lifted and tilted to get drained. For doing so, it had to be lifted on its front side as the draining openings are on the after end (**see sketch: position 1**)

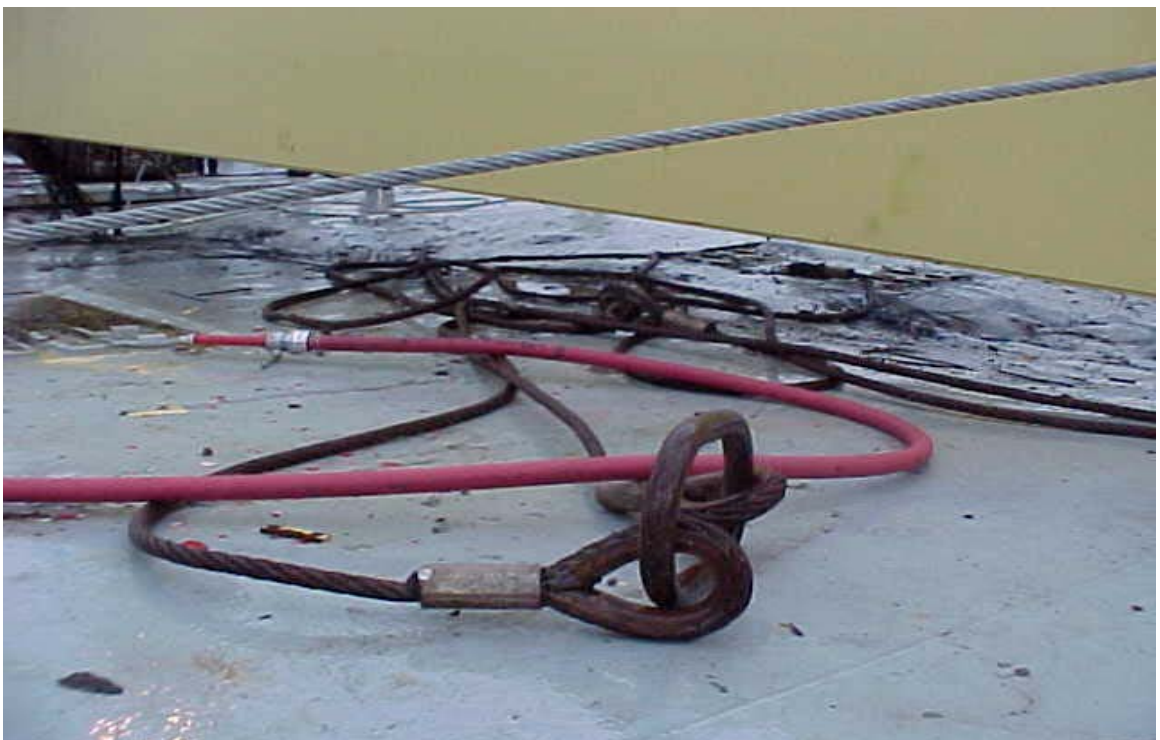
Below: The sling needed to lift the pontoon lid shown on the picture below. (**see sketch: position 2**)

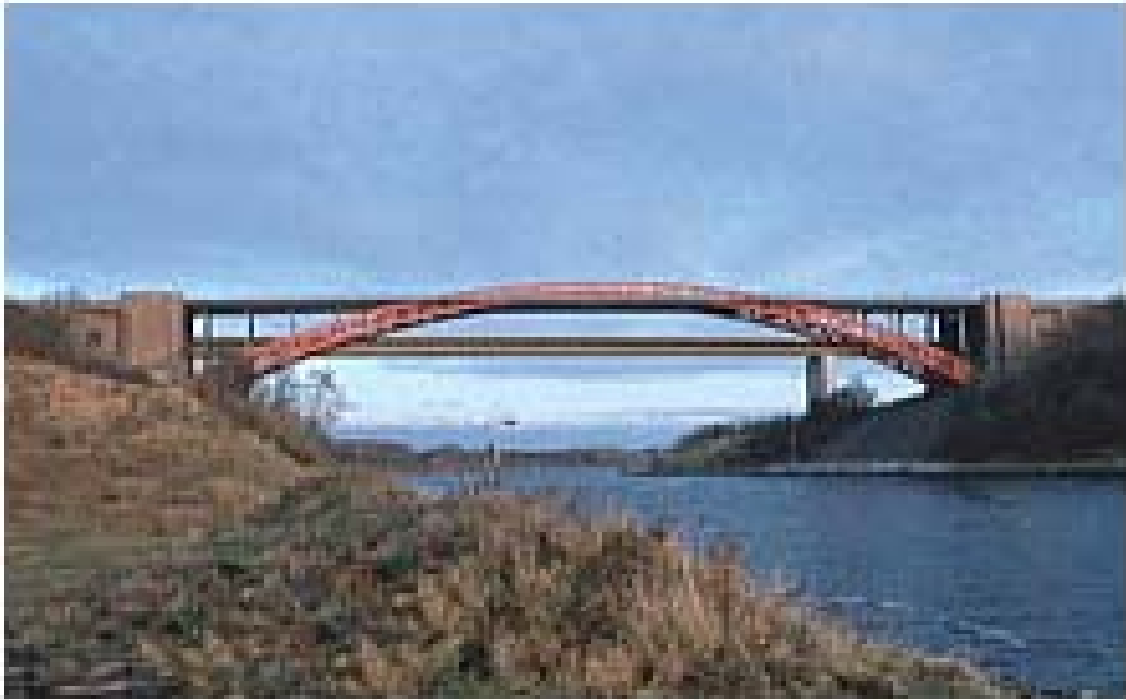
The old and the new Levensauer Bridge. A view from west to east.

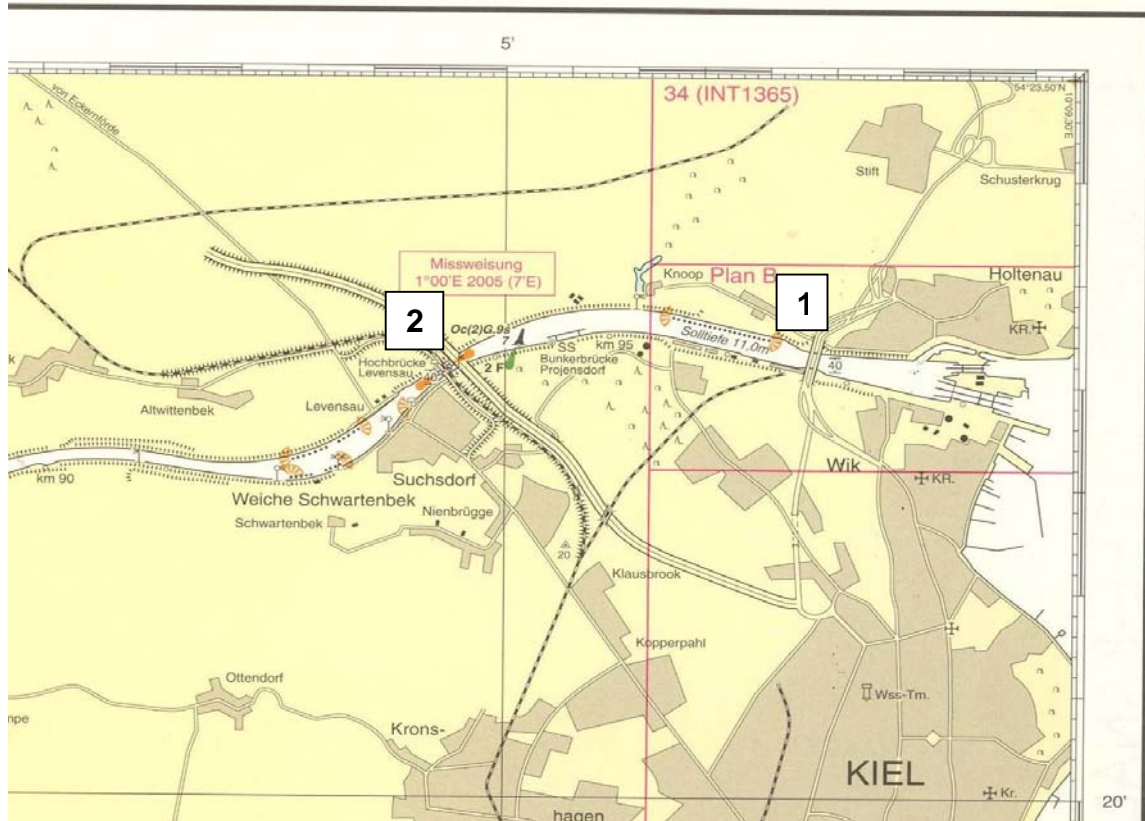
The bridge behind the Kiel-Canal entrance locks (1). The occurrence site (2)

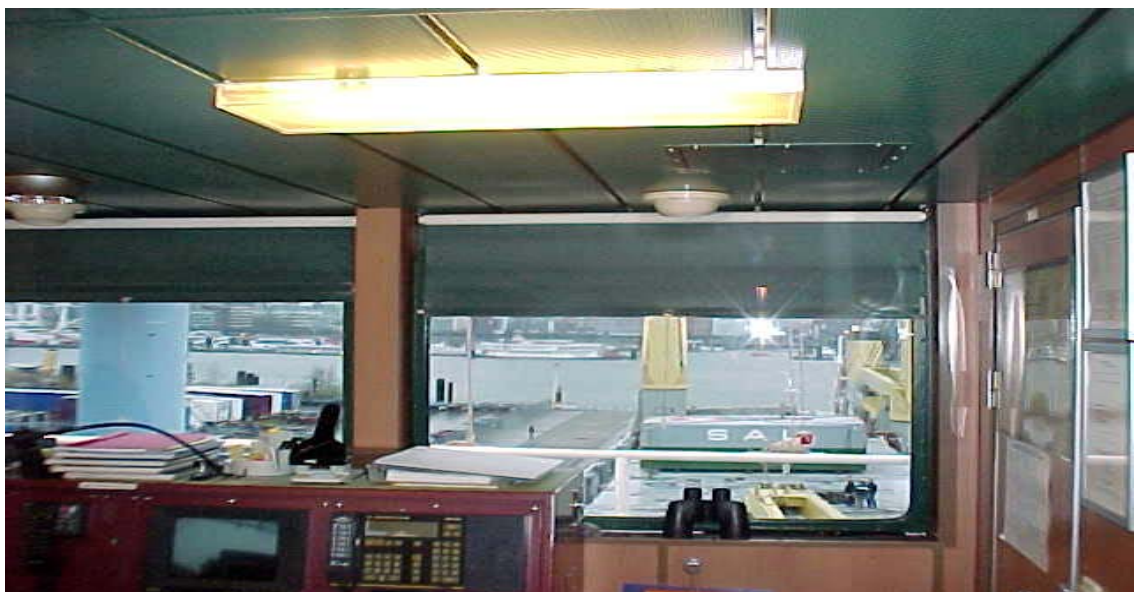
A view from the aft bridge windows back on deck into the working area. At the time of the occurrence they were shaded to not impact the performance in the wheelhouse.
