**Bundesstelle für Seeunfalluntersuchung**  
**Federal Bureau of Maritime Casualty Investigation**  
Federal Higher Authority subordinated to the Ministry of Transport,  
Building and Urban Affairs

Investigation Report 637/06

**Very Serious Marine Casualty**

**Fatal accident involving two crew members  
as well as personal injury to two other  
crew members  
on board the M/V CAP EGMONT  
on 28 December 2006  
off the Japanese coast**

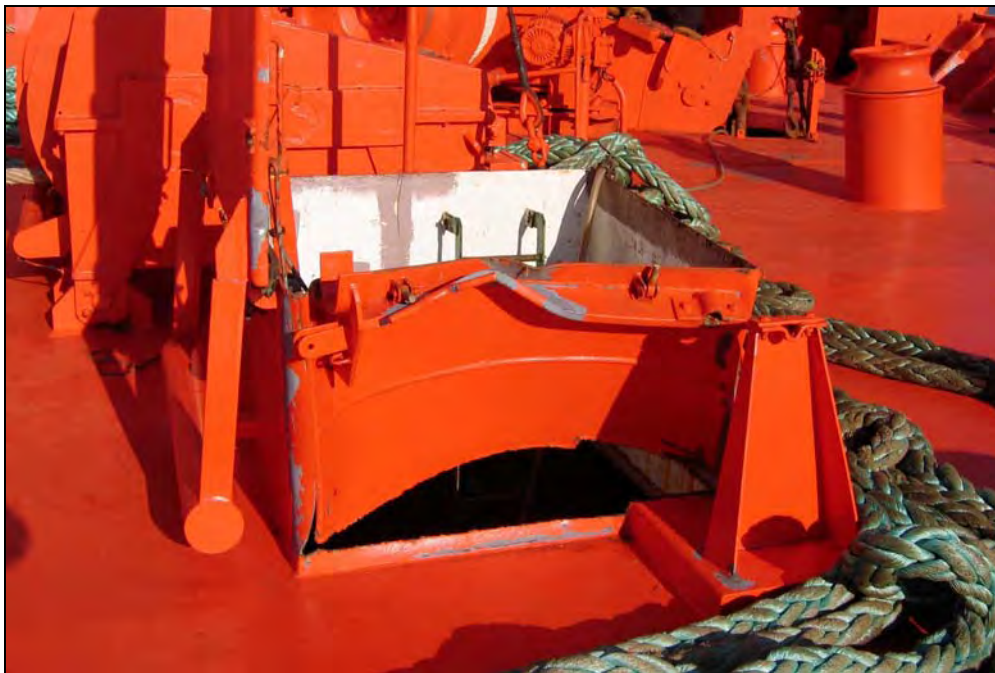
At around 1100 h the C/O and the deck crew went to the forecastle to inspect the anchors. Lashings on both anchors were tightened as instructed by the Master. While doing so the C/O ascertained that a few wing screws were missing from the hatch leading to the bosun store and the rope locker located beneath. The weather conditions did not permit closer examination of the damage.

According to the Master's instructions, at around 1520 h the C/O and the deck crew again went to the forecastle to inspect the anchors. No safety wires had been rigged there. Though it would have been possible to hook in a safety belt in the proximity of the anchor windlasses, as there were said to be lugs close to the anchor. The seamen in the deck crew wore neither hard hats nor inflatable life vests. They were accompanied by the Polish Third Officer, who was responsible for maintenance of the firefighting and safety equipment and who wanted to examine the damaged firefighting equipment cabinets on the forecastle. The C/O inspected the forecastle for further damage. He determined that the entry hatch to the bosun store and the rope locker area had been seriously damaged due to a ripped welding seam on the leading edge of the hatch coaming. A large hole had developed, through which water had entered the area (cf. fig. 4).

Figure 4: Damaged hatch entry on the forecastle

Furthermore, the forecastle hatch that had been damaged before the accident had been repaired in the meantime and reinforced against wave impacts (cf. fig. 16).

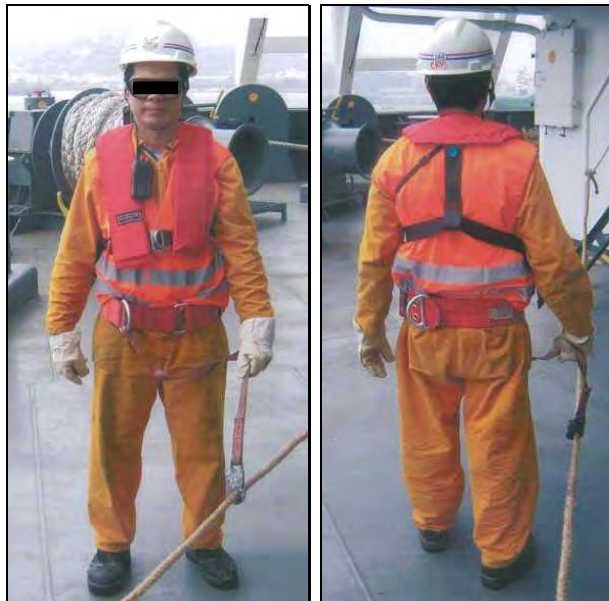
Figure 8: Full personal protection equipment as intended to be worn for work on deck

Although in the morning of 28 December 2006 the Master is said once again to have pointed out the need for wearing personal protective equipment, it is indisputable that in the afternoon and despite the temporary presence of the Master and of the

C/O on the forecandle the crew did not wear the protective gear to the extent required.

Wearing a hard hat would certainly have prevented the head injury that occurred in this case, and more particularly the extensive scalping.

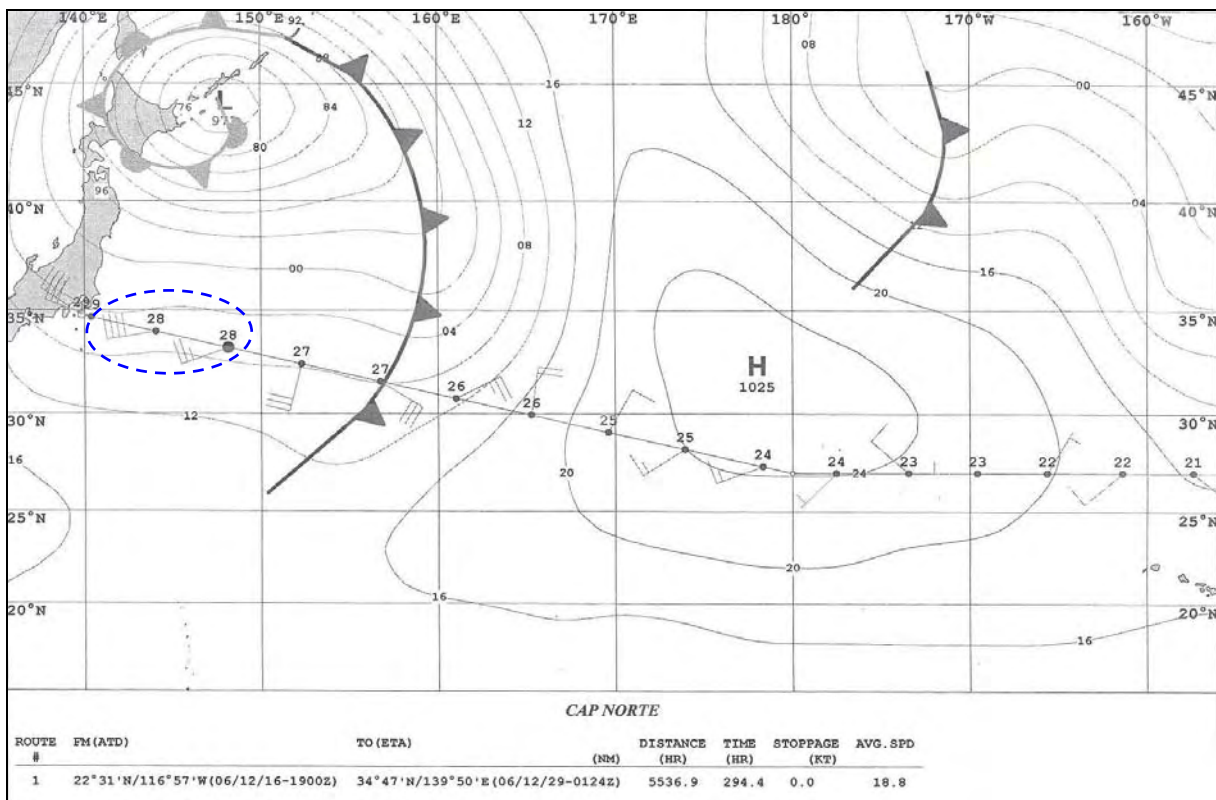
Figure 9: Weather chart produced by the ship owner's weather information service of 23 December 2006 for 24 December 2006

For 28 December 2006 the forecast included a fresh breeze to gale force winds with speeds of between 25 and 40 knots (cf. fig. 9, blue edge). Twenty-five knots correspond to a strong breeze, 40 knots to gale force winds, corresponding in turn to 6 to 8 Bft.

The predictions developed by the ship owner's weather forecast service for the day of the accident (wind speeds of 25 to 40 knots) ultimately match the occurred wind conditions. The charterer's weather information service had not yet specified conditions to be expected on the day of the accident in its telex of 24 December 2006. As the telex did contain the general confirmation whereby similar conditions were to be expected along all routes, CAP EGMONT's route deviation is held arguable given the weather information present at that time. After all the wind forecast provided by the owner's weather information service did not per se constitute a scenario threatening to ship and crew.

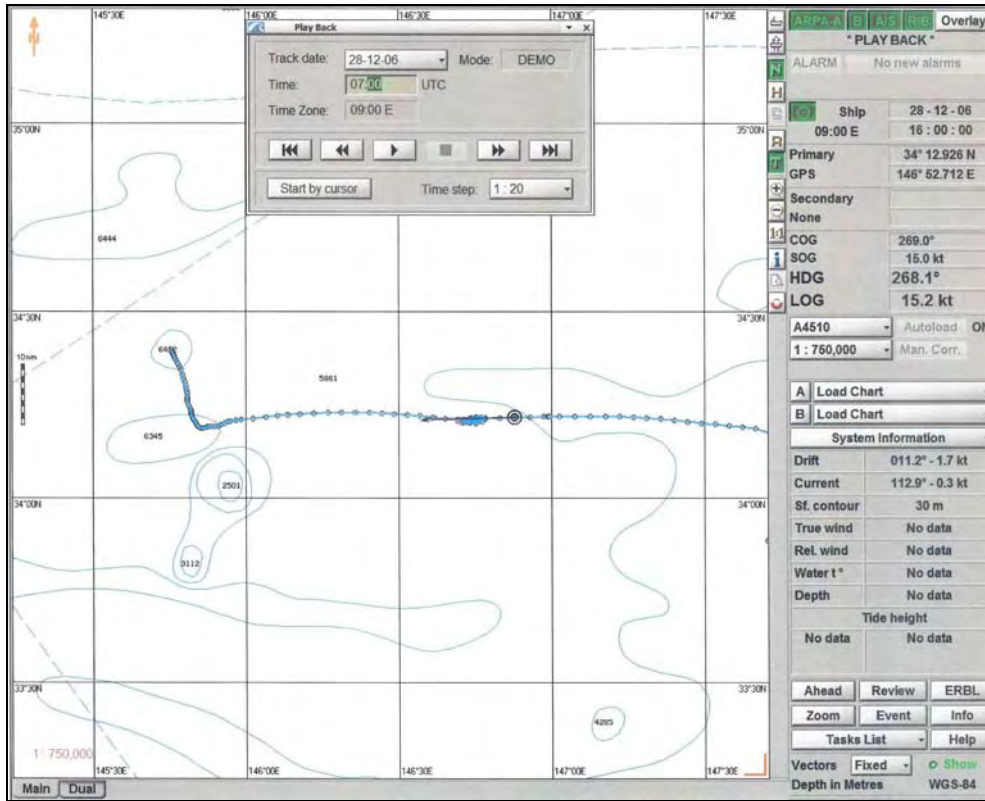
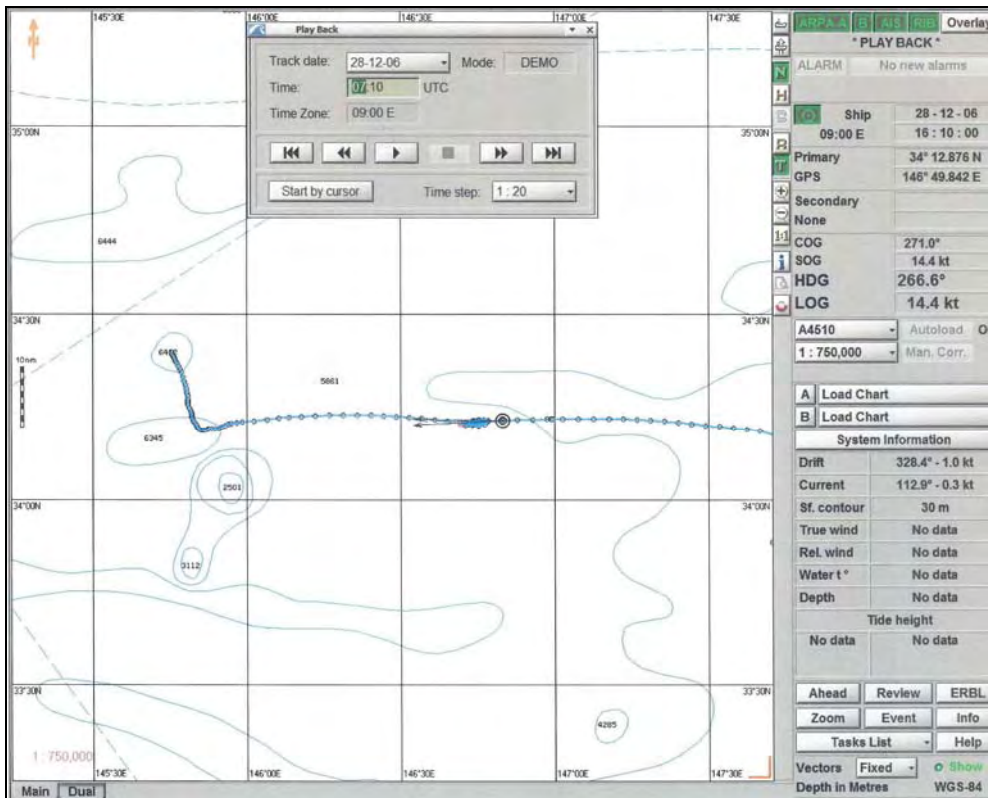
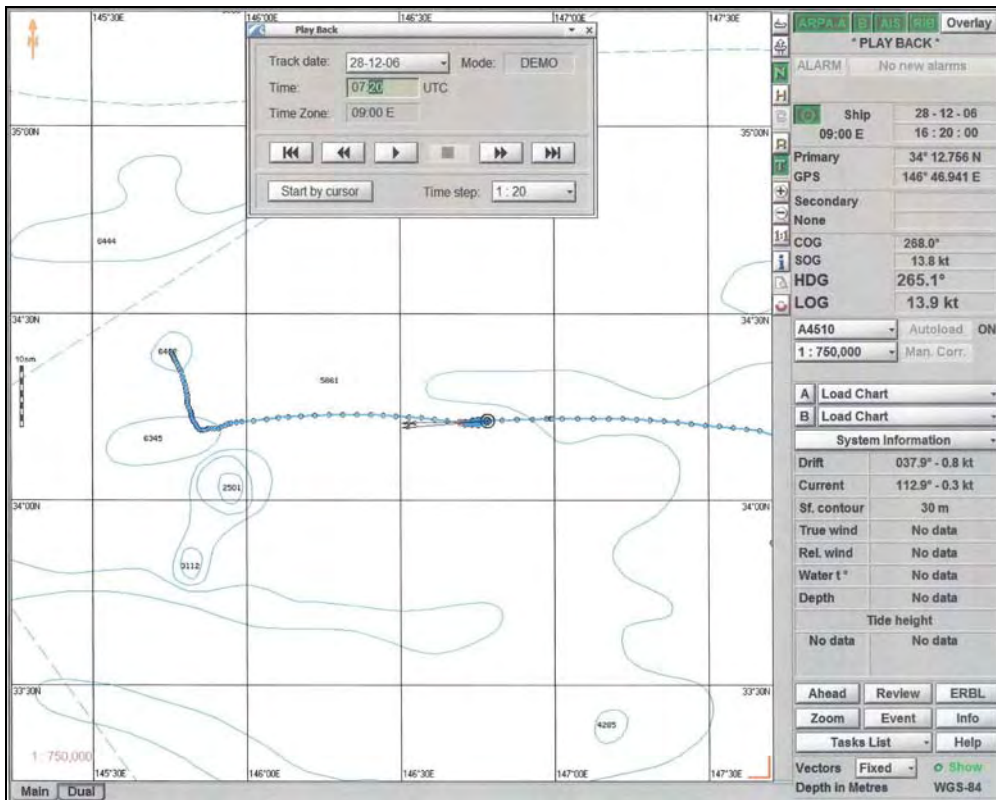
The wind conditions as aforesaid could not be verified with ECDIS-records because no weather data has been retained (cf. fig. 12 to 14).

After the Master had returned from the forecastle to the wheel house at about 1600 h, the revolution speed of the main engine was reduced by order from 101 rpm to 96 rpm. This lead to a decrease of the ship's speed from 15 knots to 13.8 knots until 1620 h (cf. fig. 12 to 14).

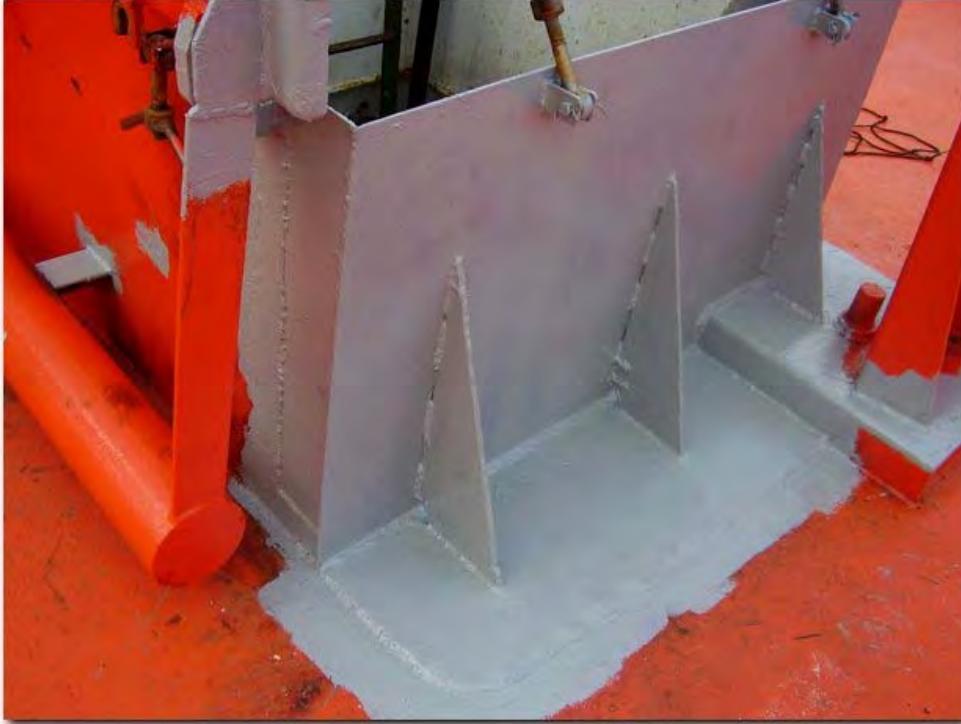
Figure 16: Repaired and reinforced hatch coaming on the forecastle of the CAP EGMONT
