Investigation Report 638/06

Serious Marine Casualty

**Serious Personal Injury
on board MV MAIKE
on 30 December 2006
off the Dutch Coast**

15 August 2007

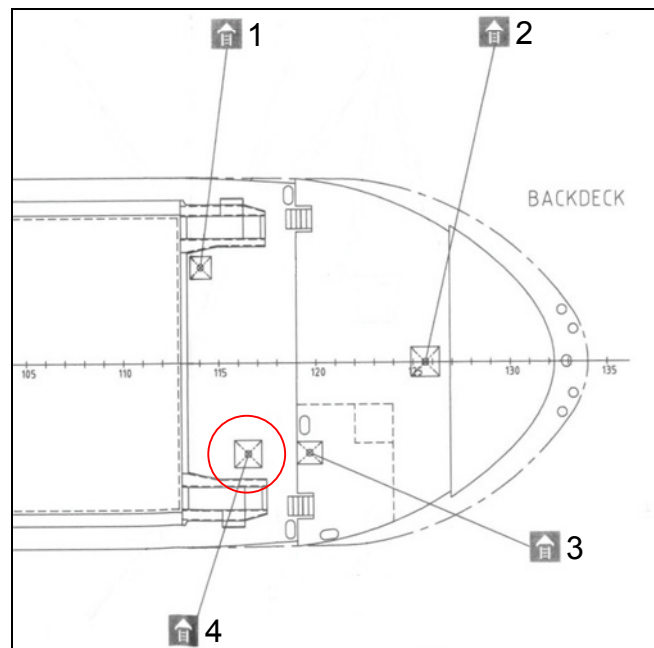
Figure 3: Plan of the forecastle with the four hatches

On the forecastle of MAIKE, there are a total of four hatches (cf. fig. 3, scene of the accident is marked in red).

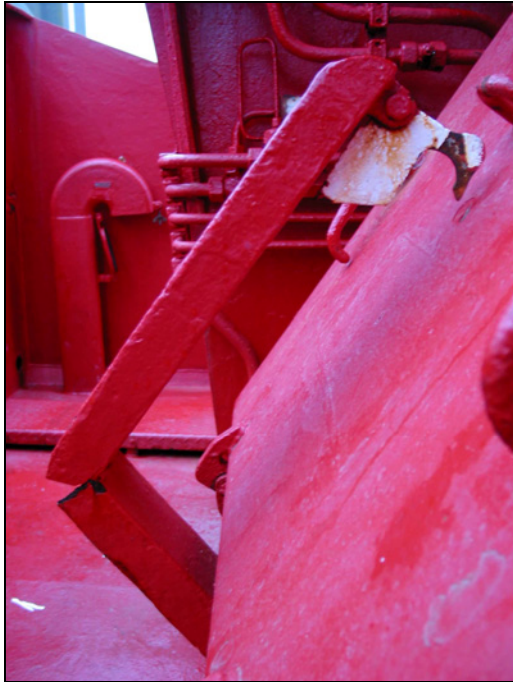
Figure 4: Broken device (No 4)

For each hatch cover, there is one retaining device intended to secure the cover from the outside. The retaining device broken on the day of the accident (No. 4) is identical in construction with the intact device No. 2 (cf. figs. 4 and 5).

The edge length of the broken U-profile is 80 x 50 mm with a material thickness of about 8 mm. The total of four retaining devices on the hatch coamings on the forecandle differ in that the retainers of the hatch covers No. 2 and No. 4 are fixed by means of U-profiles mounted on the outside of the hatch coaming, whereas the retainers of the other two hatch covers are fixed by means of round profiles mounted above the hatches (cf. fig. 6).

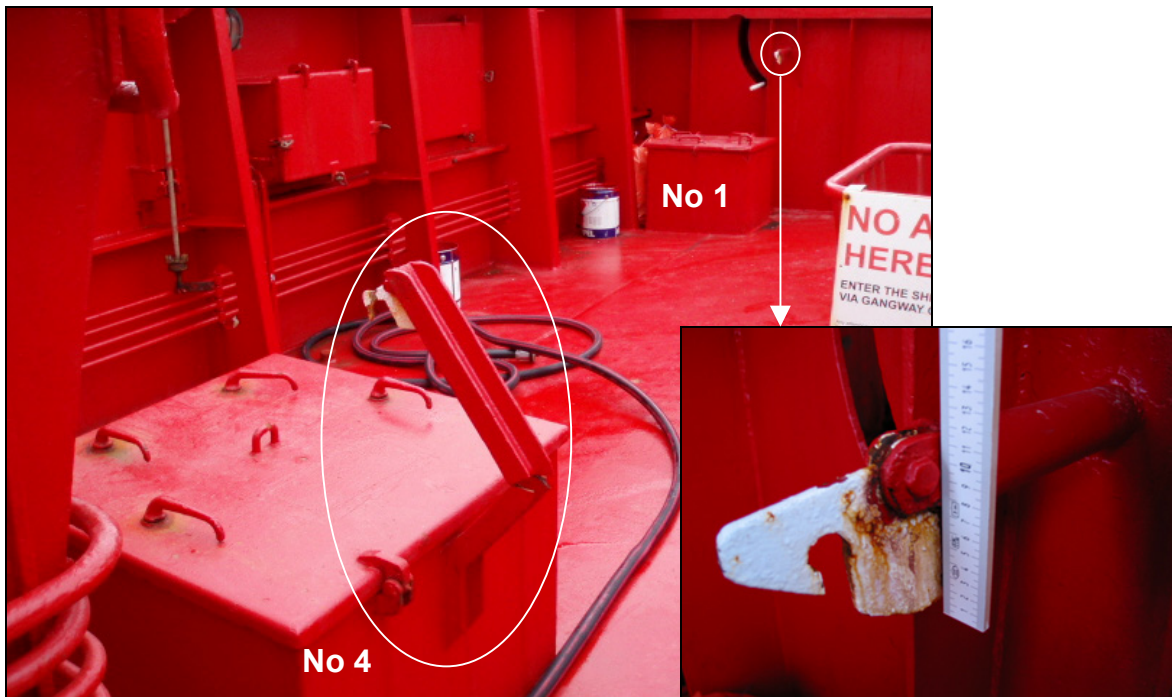
Figure 6: Different retaining devices on the forecandle of MV MAIKE

According to the present standards, the retaining devices of the hatches No 1 and No 3 on the forecastle of MAIKE do no longer correspond to the technical standards established in DIN 83405 as well. The retainers are similar to the retaining device form D (cf. fig. 15) determined in DIN 83405 since 2001, a not self-locking retaining device also to be mounted above the hatches.

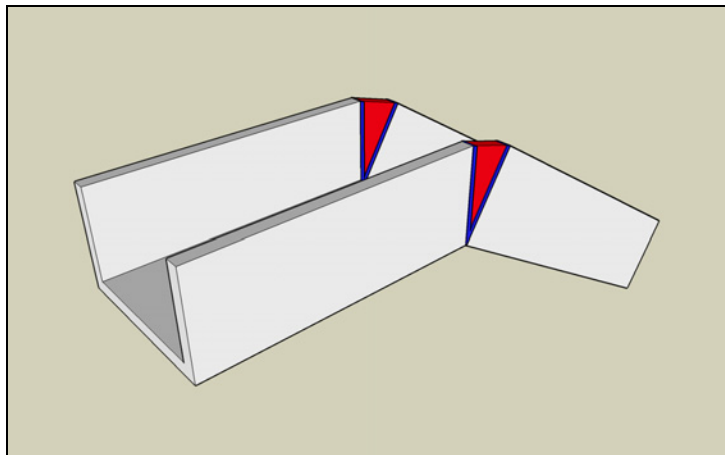
Figure 7: Illustration of the wedges inserted into the U-profile

Due to its design, the retaining device showed a kink. In order to achieve this, the shipyard inserted two wedge-shaped pieces into the U-profile, that had been delivered by the factory in a straight condition, and connected them to the profile by welding seams (cf. fig. 7; wedges marked in red, welding seams in blue).

Therefore, the retaining device mounted on the forecastle of MAIKE consisting of a hook picking from outside the hatch, fixed onto a rigid U-profile with multiple kinks, must be considered as non-conforming to DIN-standards. On the contrary, the design's resistance was already weakened by the inserted wedges, regardless of the execution of the welding seams.

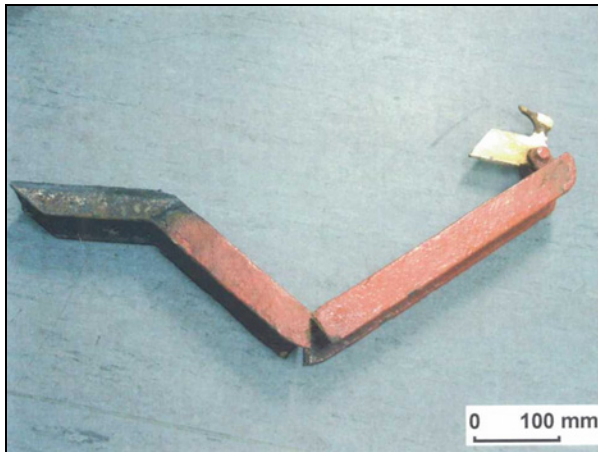
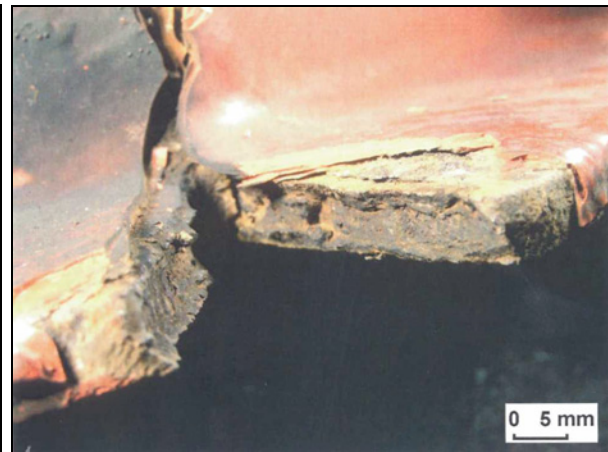
Both, the U-profile as well as the inserted wedges, were made out of weldable steel S235. On the surfaces of the tear of the U-profile, despite the brisk corrosion that occurred after the accident, separation fractures could be identified on the outer and inner edges. In the centre of the surfaces, traces of a flame cut were present instead of fragmentation (cf. figs. 8 and 9).

As only the area of the edges showed crack structures, the experts reached the conclusion that the material in the centre had not been previously connected by welding seams.

Thus, the welding filler used (cf. red edges; heat affected zones marked in blue) did not completely fill the material. The supporting cross section of the welding seam cracked during the accident had a thickness of about 2.5 mm only. The remaining 5.5 mm of the material were not connected, which is why the structures of the flame cut could still be identified (cf. fig. 9).

Therefore, the material testing came to the conclusion that the hatch cover securing device had cracked due to overload. The expert opinion recommends, for safety reasons, to check the welding seams on comparable safety retainers or to replace them with safety devices welded with full root penetration.

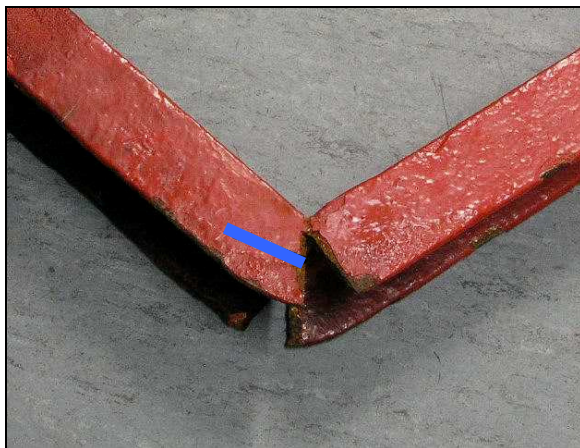
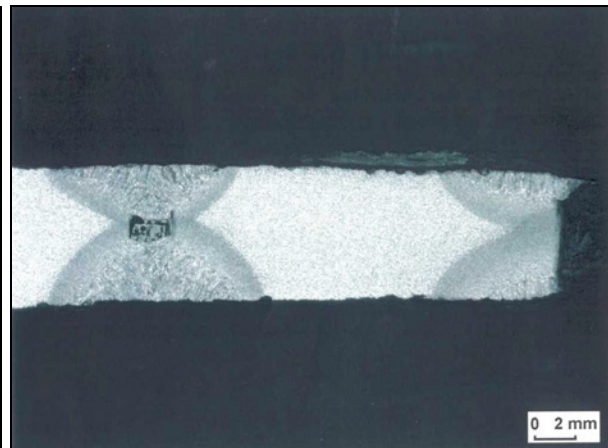
In order to verify that assumption, a material sample was extracted from the crack surface, and a macroscopic section was made (cf. figs. 10 and 11).

The macroscopic section shows two of the welding seams for one of the inserted wedges, the right seam of which is cracked. The welding seams consist of two layers each, that were welded transverse to the direction of the strain as so-called butt joints. The raised part of the seam was abraded after welding, so that the welding seams could no longer be identified from the outside.

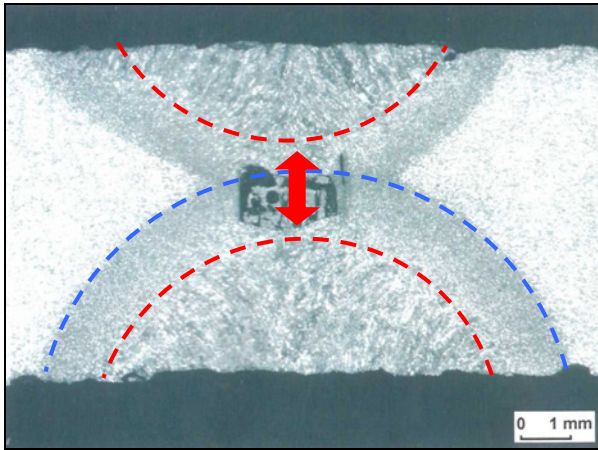
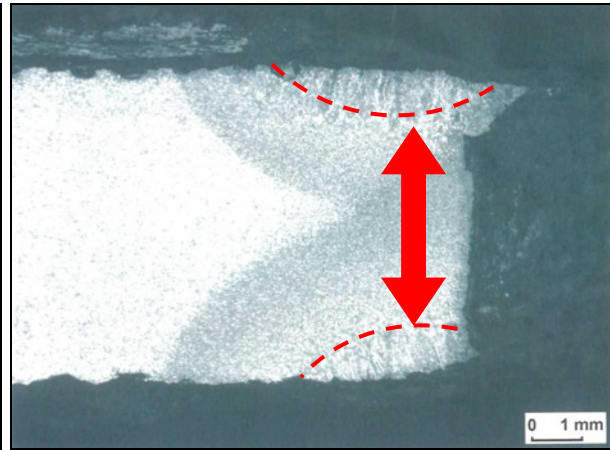
In the centre of the material, there are two non-welded bars (cf. figs. 12 and 13; non-welded bars marked by red arrows). The one located near the intact seam lacks penetration for a depth of about 2 mm and the one near the torn seam for about 5.5 mm.

The technical workmanship of the welding performed on the hatch cover's retaining device which broke on the day of accident were inappropriate and not state of the art. As can be learned from the expert opinion, the welding seams connecting the inserted wedges with the U-profile were not carried out with full penetration. The steel partly showed significant non-welded bars (5.5 mm compared to a material thickness of only 8 mm).

The Federal Bureau of Maritime Casualty Investigation recommends **owners and operators of seagoing vessels as well as shipyards** to ensure and periodically inspect, that metallic components that serve safety aspects on board seagoing vessels are sufficiently connected by joint welding, in order to withstand overloads and to prevent incipient cracks due to dynamic operational strains. Workmanship is to be performed in an appropriate manner, meeting the design requirements in vessel operation.
