Bundesstelle für Seeunfalluntersuchung
Federal Bureau of Maritime Casualty Investigation
Federal Higher Authority subordinated to the Ministry of Transport,
Building and Urban Affairs

Summary
Investigation Report 68/06

Person over board
from fishing vessel BELEN
on 23 January 2006 at approx. 20:00 h
at position 57°41'N and 014°07'W
north-west of Rockall

1 June 2007

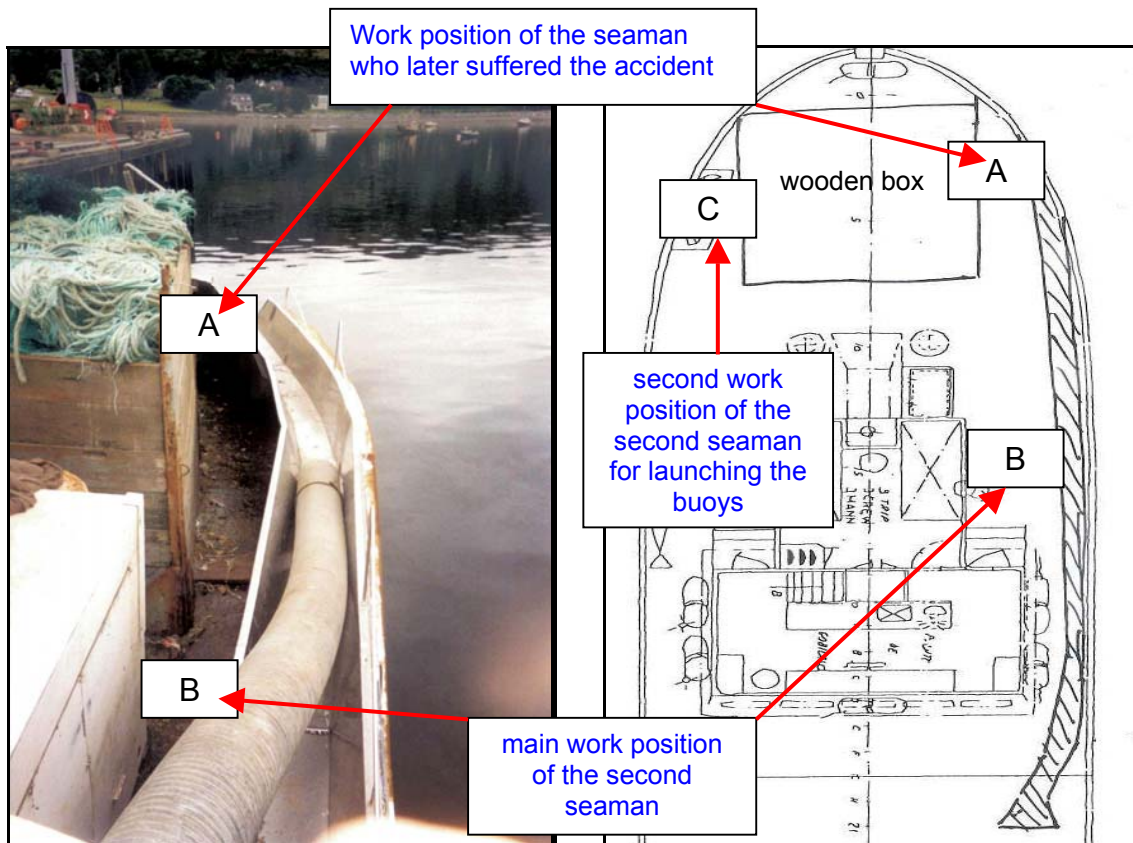
Figure 3: Channel for launching the net

At this point in time the crew was engaged in launching the fishing gear into the sea. This consisted of two parallel guided ropes that were connected by fishing net made from monofiles. The ropes were guided into the sea via a stainless steel channel that is to be found on the bulwark on the port side (see fig. 3).

Two seamen would normally be positioned at this channel (see fig. 3 and 4: position A and B). The speed is generally between three and four knots and it is attempted to take the wind from ahead when launching the net. The seaman had to ensure that the fishing gear runs out smoothly and can be launched into the water without interference.

At the time of the accident the Master, the 1 Nautical Officer and the fishing officer were on the bridge. As regards the cause of the fall it is assumed that the seaman might have climbed on the channel for laying the net in order to do something with the ropes. He could have slipped and fallen into the sea. Luckily he did not become entangled in the fishing gear, as he would then have been dragged under water.

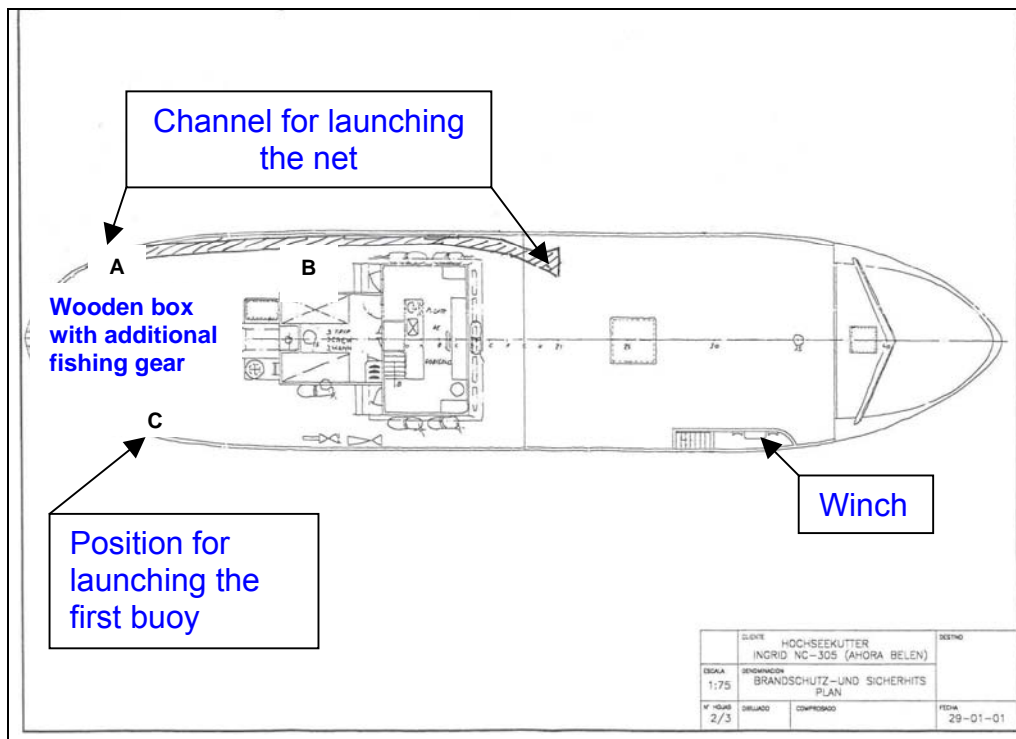
Figure 5: FV BELEN – General plan

A buoy is laid starboard astern by a seaman (see fig. 4 and 5: position C). He then proceeds to his actual work position (see fig. 3, 4 and 5: position B), in order to ensure together with the other seaman that the net is let go smoothly (see fig. 3, 4 and 5: positions A and B). The buoy is weighted with chain links to ensure that it can only drift to a minimum. A rope's end, attached to the buoy connects this with the net. This rope's end runs from the buoy in the water to the portside astern up to the channel that serves to cast the net. The net is launched through this U-shaped channel whilst the vessel continues its way at approx. 3 to 4 knots. In this way the net can unfold in the water. This is supported by the various longitudinal lines of the net. Whilst the lower longitudinal line is so heavy due to a lead interior that it pulls the net downward, the upper longitudinal line of the net is lighter and floats so that it pulls the net upward.

When the net has been completely launched, a second buoy is laid to mark the end of the net. For this the seaman proceeds once more to his second work position (see fig. 4 and 5: position C). Afterwards, the ship no longer has a connection to the net.

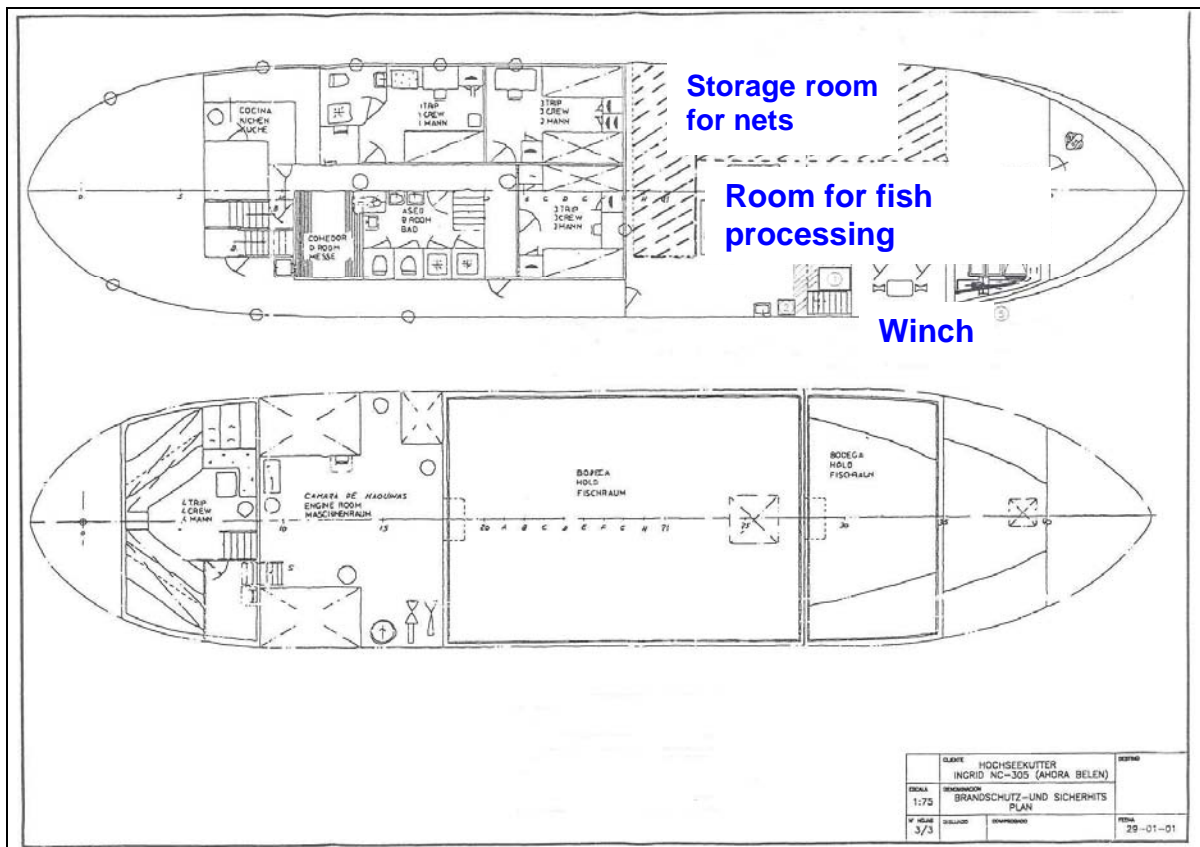
Figure 6: FV BELEN – Detailed plan

There is a recess in the bulwark on the fishing deck in the front third of the starboard side in order to pull the fishing gear back on board by means of a winch. If the net is to be hauled in, the vessel moves towards one of the buoys and drifts alongside with its starboard side. The buoy is pulled onto deck followed by the entire net. The catch is removed from the net into the processing room behind the winch and stored in the cold storage rooms. Whilst there is only just room for two fishers around the winch, there are up to 6 people in the processing room to handle the fish. Finally, the second buoy is also hauled out of the water.

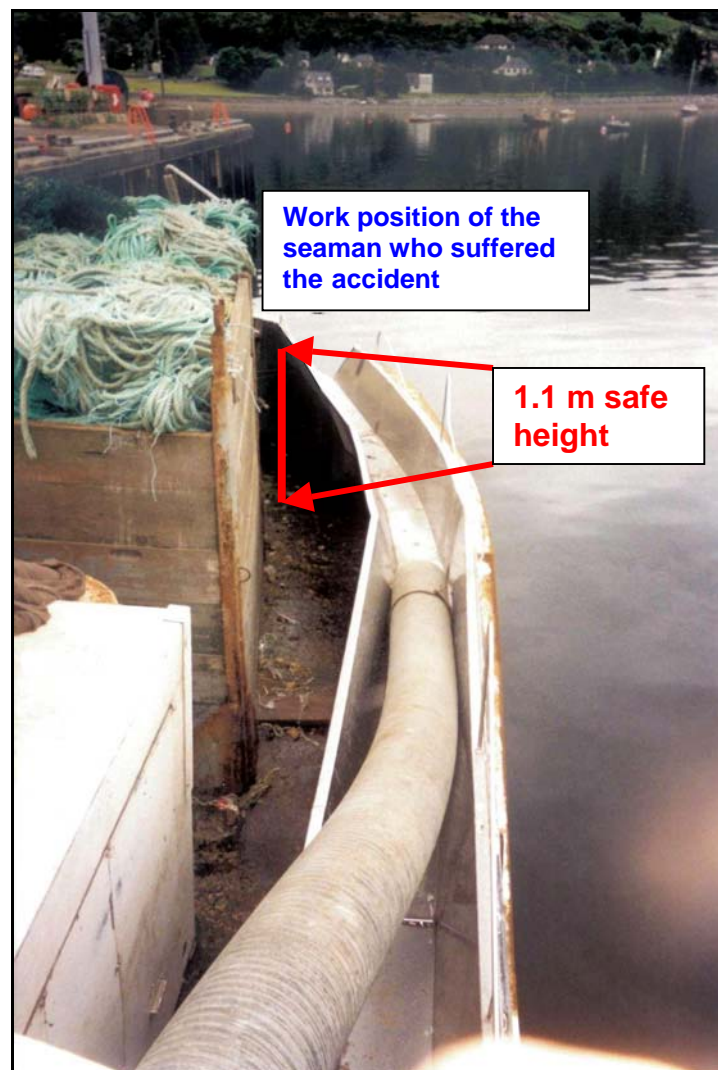
Figure 7: FV BELEN – Channel for launching the net

As described in 5.3.1.1, in order to launch the net the seaman who later suffered the accident took up position at the end of the channel on portside in order to supervise the launching of the net. The second seaman proceeded to starboard in order to lay the first buoy into the water. At the accident position the bulwark is approx. 1.1 metres high, so that the seaman, approx. 1.60 metres tall, was in a safe position. It was a dark, clear evening. The searchlights of the vessel, however, illuminated the working deck and the immediate vicinity adequately. The first buoy was streamed and the net began to run out.

The investigations indicated that the seaman falling overboard was a misfortune. The exact cause cannot be established. The measurement on board showed that the accident position astern is adequately secured by the height of the closed bulwark. The seaman could not have fallen over board as long as he stood on deck. It is most likely that, for unknown reasons, he climbed onto the channel for launching the net and then lost his balance. However, as nobody actually observed the circumstances of the accident, only presumptions remain as to why the seaman fell into the water.

When working on deck, the crew members wear weatherproof clothing, so-called oilskins, that do not provide any significant buoyancy, but do offer the best possible detection effect due to their orange signal colour. Wearing the usual foam life jackets, as available on board, would comprehensibly appear not to be practicable, as they not only restrict the arm movements of the wearer, they rather more restrict the mobility within the narrow corridor next to the channel for launching the net. It would be worth considering wearing modern automatic life jackets and/or securing the working alleyways with a rope stretched in longitudinal direction that the seaman could hook onto with a safety belt.

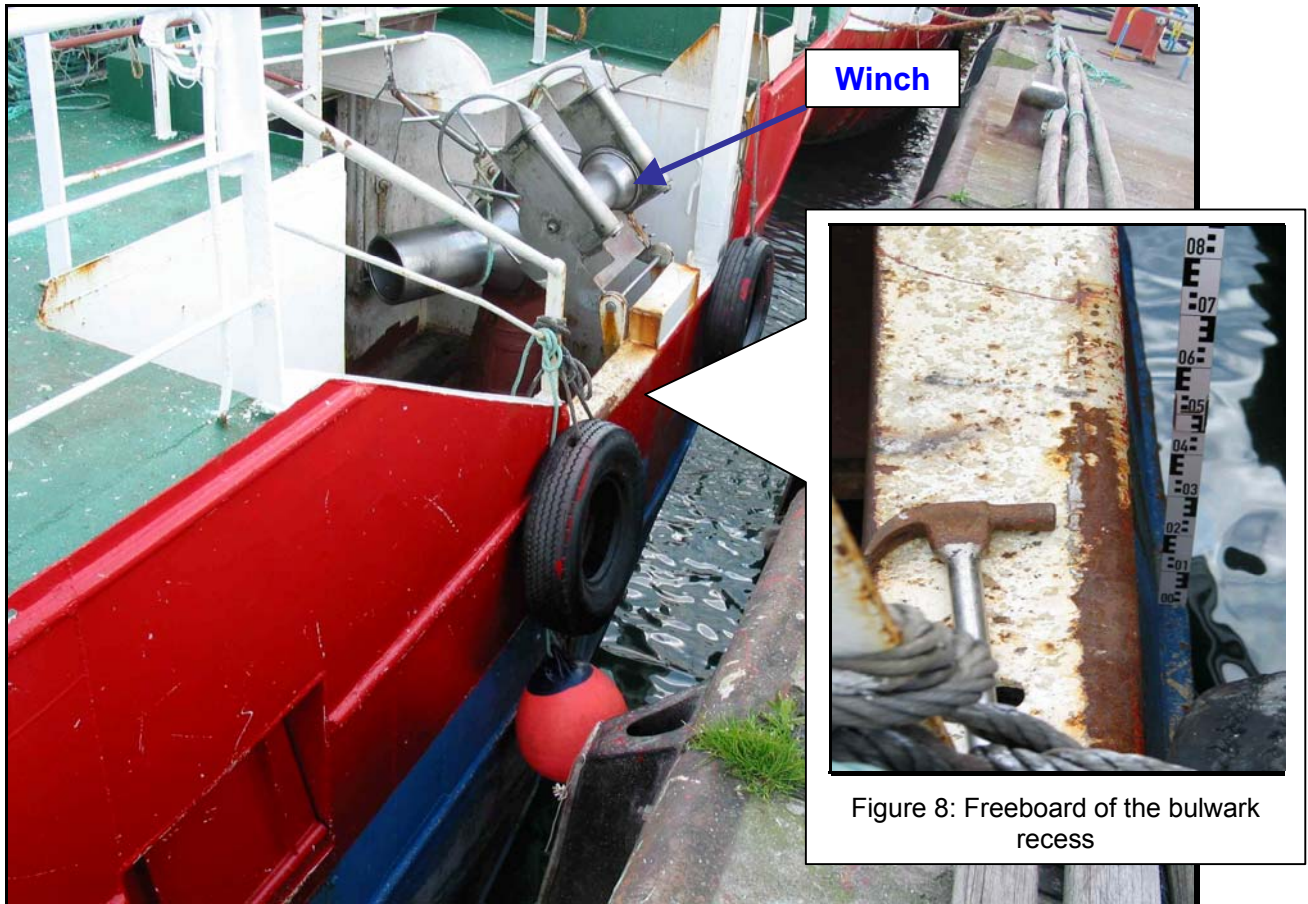
Figure 9: Bulwark recess for hauling in the fishing gear

Nobody saw how the man fell overboard. The second seaman raised the alarm when he saw his colleague in the water, because he was calling for help. The crew on the bridge heard this immediately as the bridge doors were open, as is usual practice when launching the fishing gear. The first nautical officer, who supervised the launching of the net from the bridge, informed the crew. “Hard Starboard” and “full speed ahead” was ordered. The net was cut and visual contact maintained with the aid of a mobile spotlight on the bridge. After the ship, by conducting a return manoeuvre, had been positioned near to the seaman who had suffered the accident, a life buoy with a signal light was thrown to him. In spite of initial reactions by the seaman who had suffered the accident, he no longer, however, took hold of the life buoy. A few minutes later the vessel’s engine was stopped, so that its starboard side could drift toward the seaman. Using a boat hook it was possible to pull him over by his clothes. Two crew members pulled the seaman who had suffered the accident onto the deck where there is the recess for hauling in the fishing gear. The freeboard reduces here to approx. 0.8 metres. Making use of the rolling of the vessel, it was possible to pull the man out of the water.
