## Investigation report

C1/2006M

# MS ESTRADEN and MT WOLGASTERN, collision in the Kiel-Canal on 2.2.2006

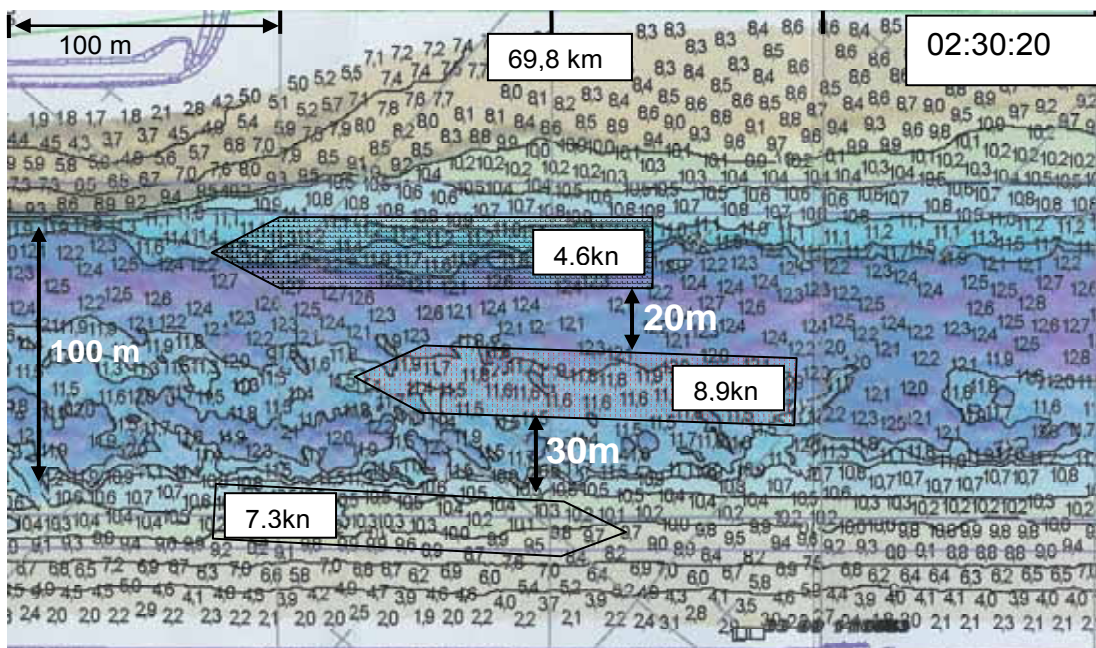
Figure 6. The LENA is encountering the ESTRADEN and the WOLGASTERN. The vessels were positioned by the investigators so that their sides were as far as possible from each other (exact positions were not known). The widths of the vessels are: the WOLGASTERN 27m, the ESTRADEN 27.7m and the LENA 20.6m.

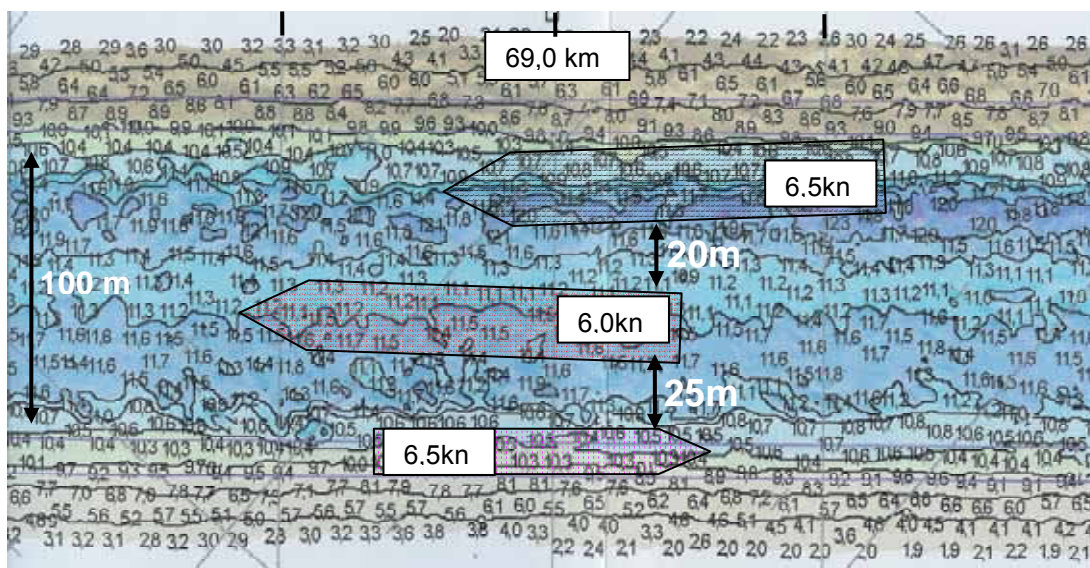
At the moment preceding the accident there were three vessels side by side in a part of the Canal with a nominal width of 100 m, Figure 9. Onboard the RIROIL 5 it was noticed that at the time of the overtaking, the bow of the RIROIL 5 was alongside the sterns of the ESTRADEN and the WOLGASTERN and the overtaking distance between these vessels was smaller than the distance between the ESTRADEN and the RIROIL 5.

Figure 9. Investigators' view on the positions of the vessels in the Canal at 02.33.20.

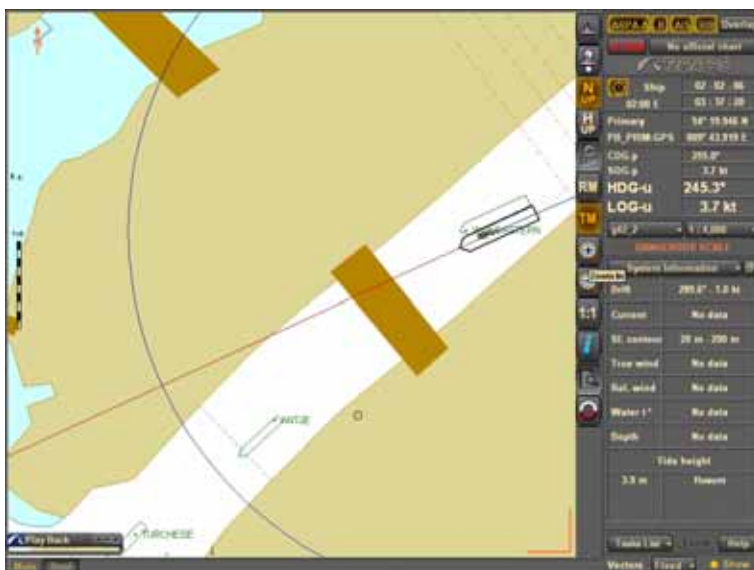
After that the stern of the WOLGASTERN turned portside and the ship hit the aft part of the ESTRADEN. Due to the strength of the impact, the ESTRADEN started to turn to starboard and her aft part approached the portside bank. The Master of the ESTRADEN immediately took control of the steering. The Master took the steering to the portside wing and set the engines to go crosswise so that the portside engine was astern at 60–70 % and the starboard engine was ahead at 40 % while the right rudder was to portside. By this measure it was avoided the stern from drifting to the bank. This measure dropped the speed of the ESTRADEN so that the WOLGASTERN started to slide along the starboard side of the ESTRADEN, Figure 12a.

Figure 12a. The WOLGASTERN is sliding along the side of the ESTRADEN on the electronic chart display. (Time on the chart is Finnish time).

The fact that the ESTRADEN dropped her speed after the first collision resulted in the WOLGASTERN sliding along the side of the ESTRADEN, and this caused further damage to both vessels. On the other hand, this was how the drifting of the ESTRADEN to the channel wall was prevented, which could have resulted in damage to the rudders and propellers.

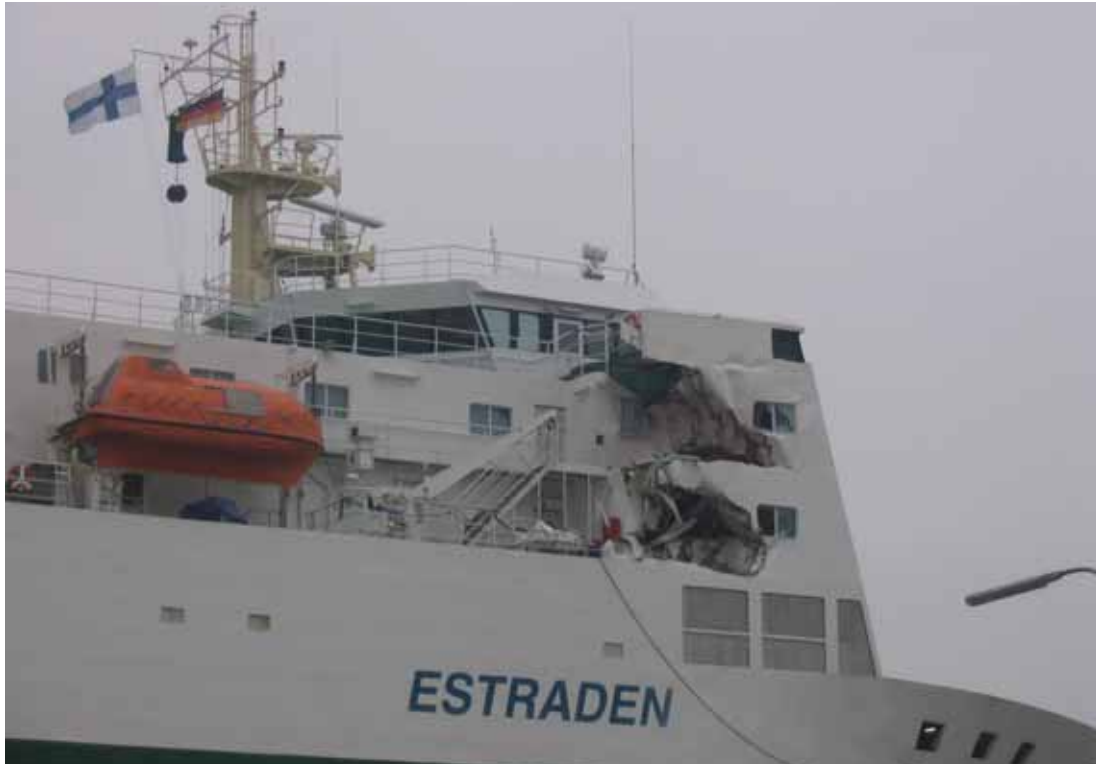
The vessel received numerous dents as well as 4 minor cracks in the upper starboard bulkhead of the main deck. Starboard from the living quarters, the wall of the mess and the master's cabin was ripped open and the interior was damaged. The starboard wing of the bridge was partly bent and its lid was bent open.

Figure 13. Damages of the ESTRADEN's SB-side.  
(the picture on behalf of BSU)

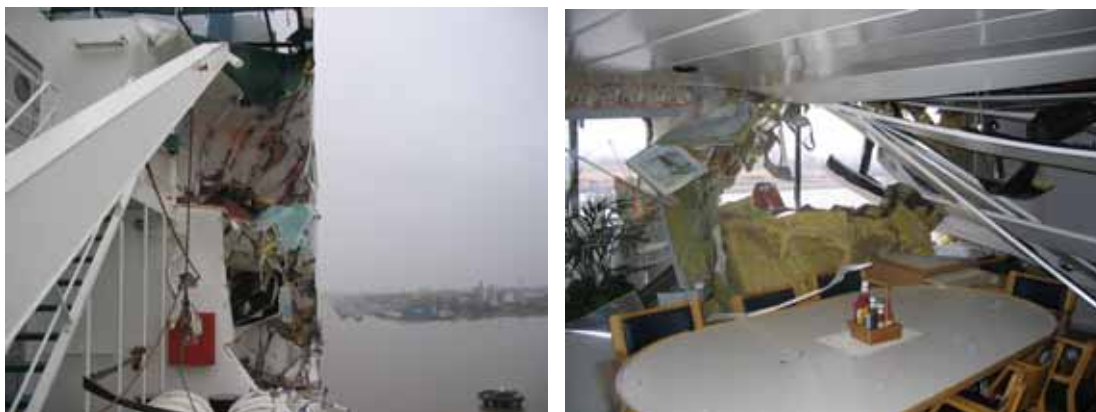
The portside wing of the bridge of the WOLGASTERN hit the starboard deckhouse, mess and master's cabin of the ESTRADEN, Figure 12b. There were no people in either of these premises so personal damage was avoided.

Figures 14 and 15. The outer bulkhead of the master's cabin and the mess (Figure 14, left). The mess from the inside (Figure 15, right).  
(the pictures on behalf of BSU)

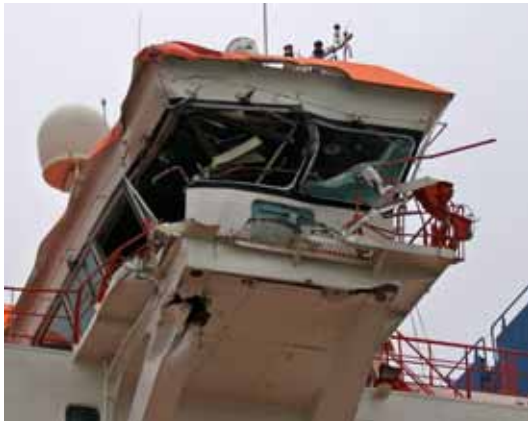
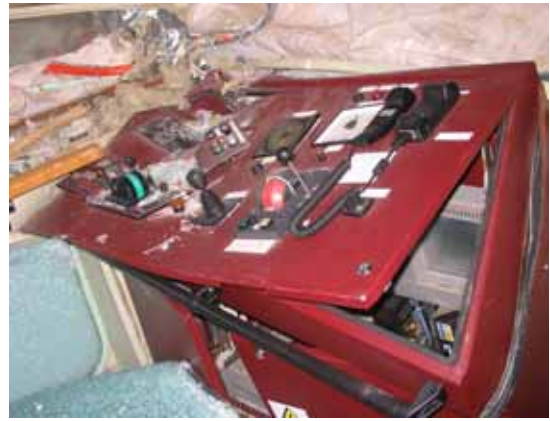
The portside bulkhead of the forecastle of the vessel was bent and the portside planking got several dents. The portside wing of the bridge and the steering console there were badly damaged.

Figures 16 and 17. The portside wing of the vessel (Figure 16, left). The portside steering equipment console (Figure 17, right). (the pictures on behalf of BSU)

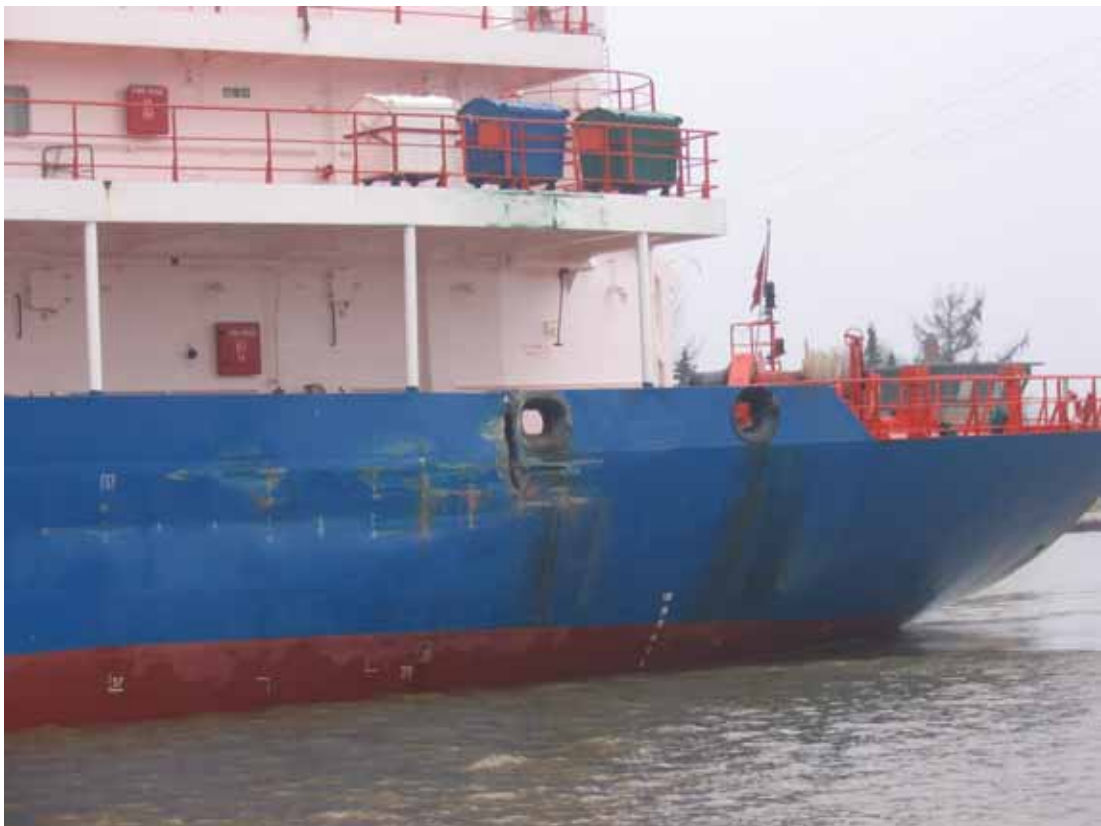
Figure 18. Damages on the side of the WOLGASTERN. (the picture on behalf of BSU)

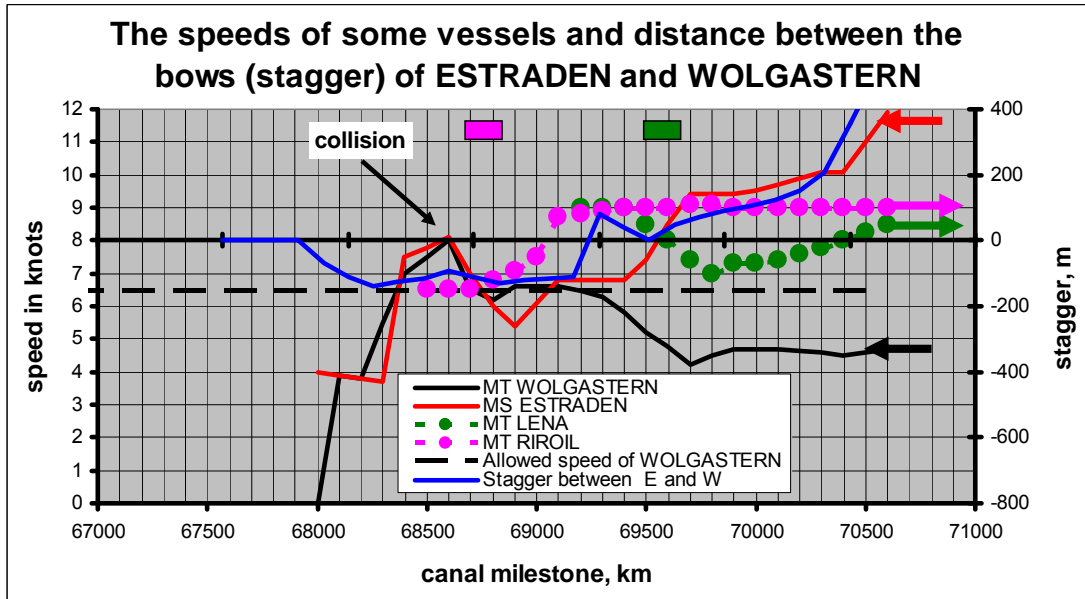
**Speeds and positions.** Figures 19 and 20 present the view of the investigators on the speeds and mutual longitudinal positions of the vessels before and during the accident. The mutual longitudinal positions of the vessels are indicated as the distances between their bows. When three vessels met each other, the encountering vessel had reduced its speed. The ESTRADEN and the WOLGASTERN had about the same speed about 4 minutes before the collision and both were increasing their speed. The allowed speeds were at times exceeded.

Figure 19. The speeds of the vessels and the longitudinal distance between the ESTRADEN and the WOLGASTER. The encountering situations are indicated with small rectangulars.

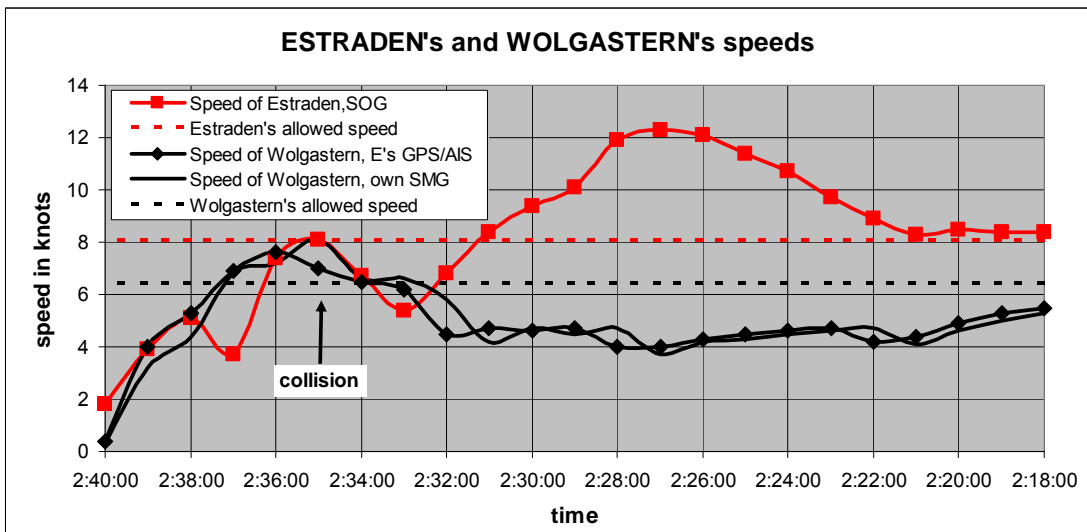
Figure 20. The speeds of the ESTRADEN and the WOLGASTER.

**The speed.** The investigation revealed that the speed limits of the Kiel Canal were broken. The ESTRADEN had sailed at times at least at 22.8 km/h (12.3 kn) against the maximum allowed 15 km/h (8.1 kn). The WOLGASTERN had exceeded her maximum allowed speed of 12 km/h (6.5 kn) by increasing her speed just before collision up to 14.8 km/h (8 kn). The investigators do not know if there are any consequences to the ship Masters or ship owners concerning over speed or how the canal traffic control is observing and regulating the speeds of the vessels.

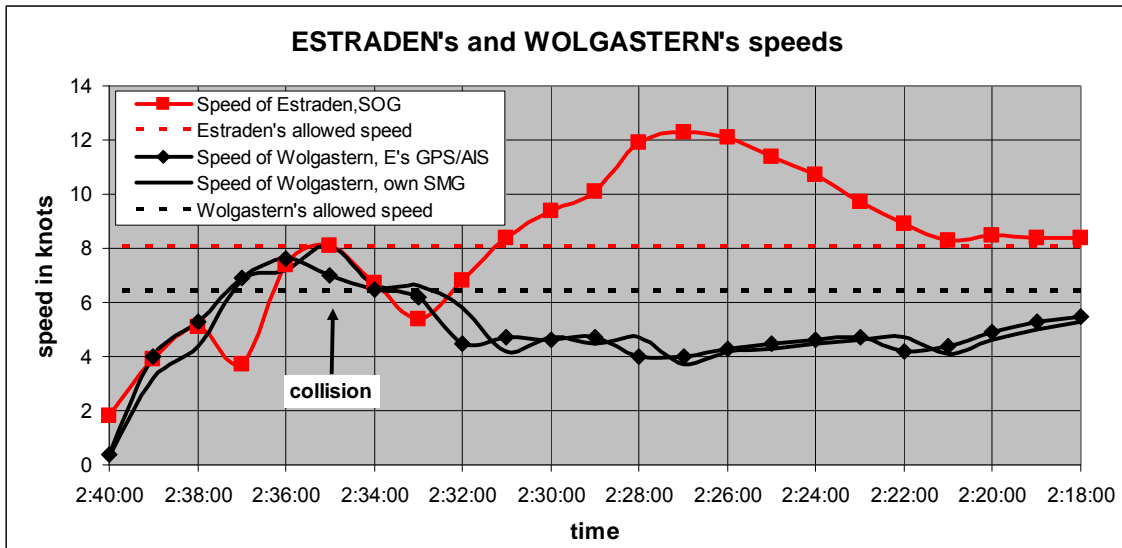
6,5 knots. When she accelerated the speed before the collision, her highest speed was about 8 knots. Also LENA and RIROIL 5 exceeded the speed limit at some instants. It may be concluded that the increase of speeds increased also the risk of collision.

Figure 4. Speeds of ESTRADEN and WOLGASTERN and allowed speeds. Collision's first stage happened at about 02:35.

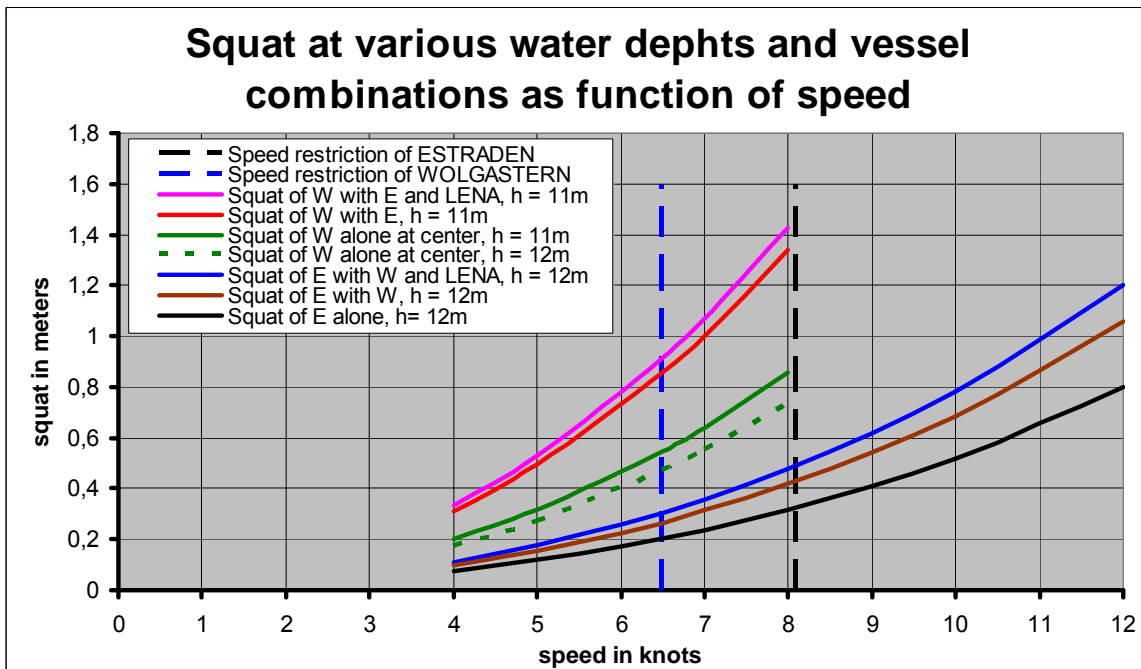
Water depth varied both lengthwise and across the channel resulting in variable squat, forces and moments depending on the vessel position. Squat is evaluated according to the principles of reference 10, figure 5. Squat at encounters with LENA and RIROIL 5 might be overestimated, because the meetings lasted only about one minute. Squat of WOLGASTERN increased considerably with the speed increase; from about 0,4 m possibly to nearly one meter. This fact has been one reason for the worsening maneuvering observed.

Figure 5. Estimated squat of various ship meetings.

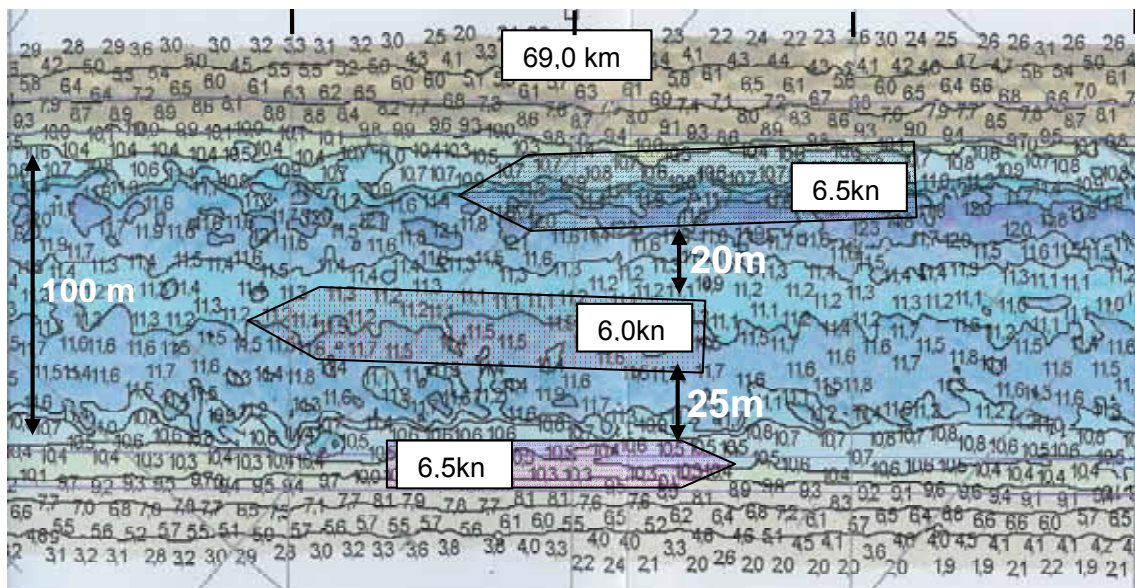
ESTRADEN and WOLGASTER had two encounterings with other ships. Therefore the separation between their sides was at maximum about only 20 meters. During the meetings of three vessels they reserved 50–55 per cent from the useful bottom breadth of about 130 m. The opinion of the investigators is that the separations shown in figures 2 and 6 were all too small. According to the reference 9, the forces and moments acting on WOLGASTER (4.5 kn) and ESTRADEN (7.5 kn) will be doubled if the separation between sides decreases from 33 m to 9 m. The reported distance between sides was 10–20 m. After the RIROIL 5 encounter this distance could have been increased to about 50 m, and the forces and moments had decreased at least by 50 per cent, if ESTRADEN had moved towards the left bank. Then WOLGASTER had probably not increased her speed and ESTRADEN had succeeded in her overtaking operation.

Figure 6. Second encounter of three vessels. RIROIL 5 is encountering ESTRADEN and WOLGASTER.
