Investigation Report 329/03

Very Serious Marine Casualty

**Fatal casualty in the scavenge air receiver of
the main engine of the CMS LONDON
EXPRESS
in the night of 24 to 25 October 2003 on the
voyage from Savannah/USA to Norfolk/USA**

15 October 2007

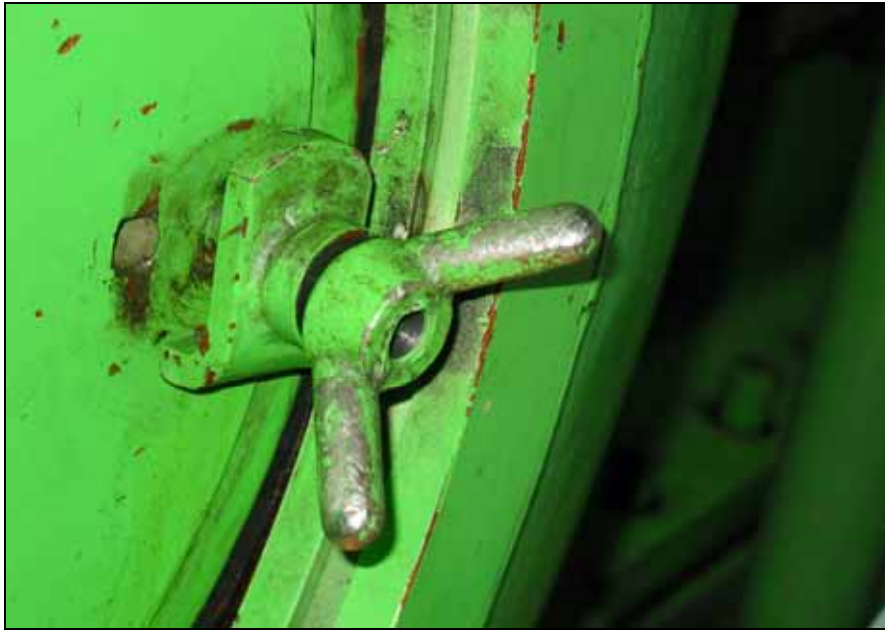
Figure 29: Tangential opening position⁶⁹

In order to open the hatch, the reverse procedure is followed, i.e. after loosening the toggle nuts, the bolts are swung out of the circular groove and brought into a release position in which they have no further contact points with the hatch frame. Because of the relatively short distance between the turning point of the bolt and the hatch frame the opening position can only be a tangential-type position of the bolt that allows for only very little variability (cf. **Figure 29**).

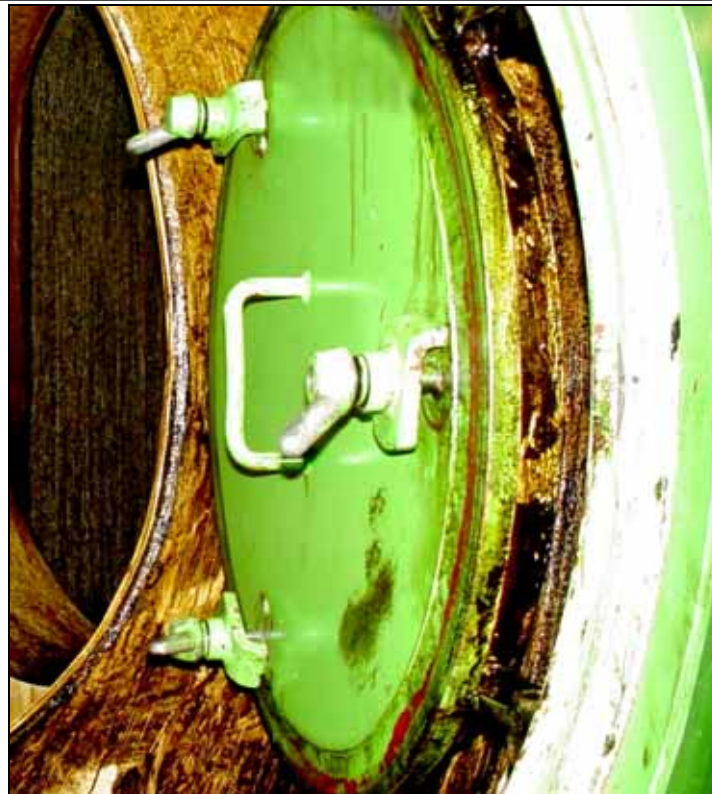
Figure 30: Bolts remain in the tangential opening position

The fact that the dogs [tend to] remain in the opening position is of decisive importance for the accident, because automatic swinging out of the tangential position due to gravity would cause the two dogs in the 11 o'clock and in the 7 o'clock position to jut out beyond the edge of the hatch cover after it had swung open. Thereafter, only intentional return to the tangential position would enable the hatch cover to be drawn onto the frame and bolted without the hindrance of the displaced dogs (cf. **Figure 31**).

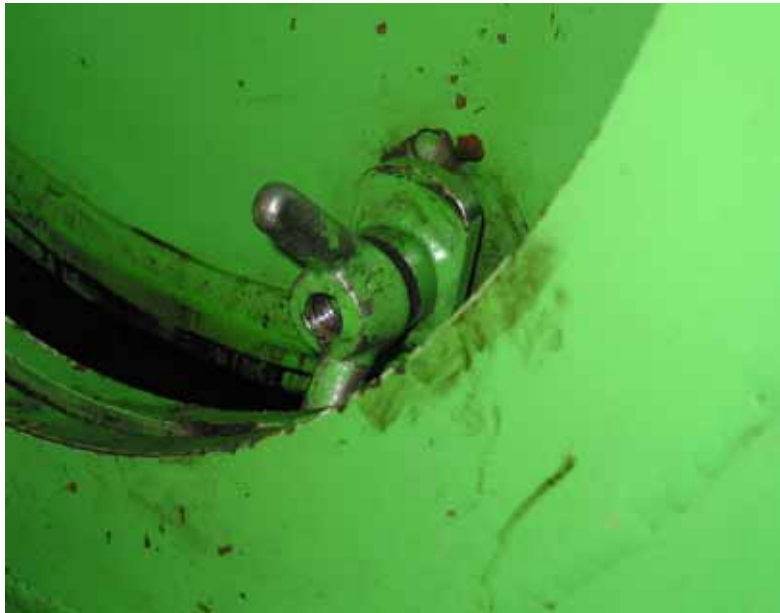
Figure 32: Double wing toggle nut as a blocking obstacle

intentionally or unintentionally – turned by hand out of its tangential position after the hatch had been opened (cf. **Figure 32**).

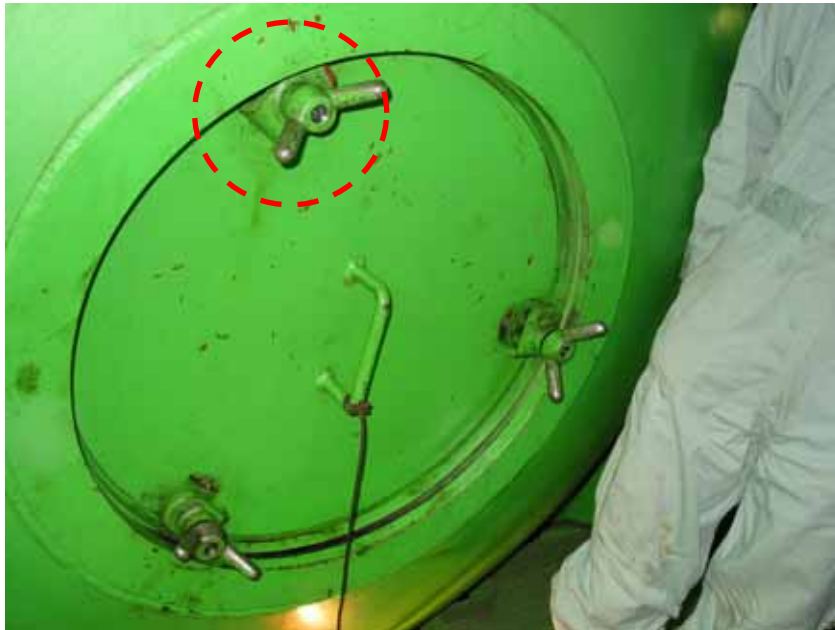
Figure 33: Partial locking condition – overall view

cause the bolt to continue to move towards an approximately vertical position, thus ultimately more or less entirely catching in the circular groove (cf. **Figures 33** and **34**).

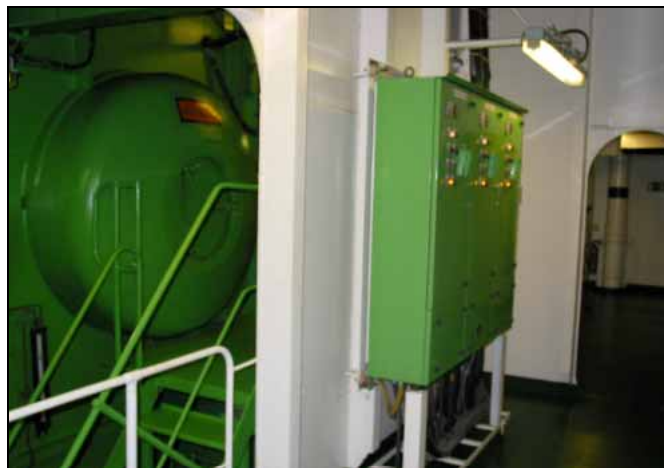
Figure 35: Main auxiliary fan panels 1 to 3

The local inspections showed that this safety precaution was not complied with on board the vessels visited. The selector switches had not been switched over from REMOTE to LOCAL after stopping the main engine, so that the auxiliary fans could have been turned on from the bridge at any time.

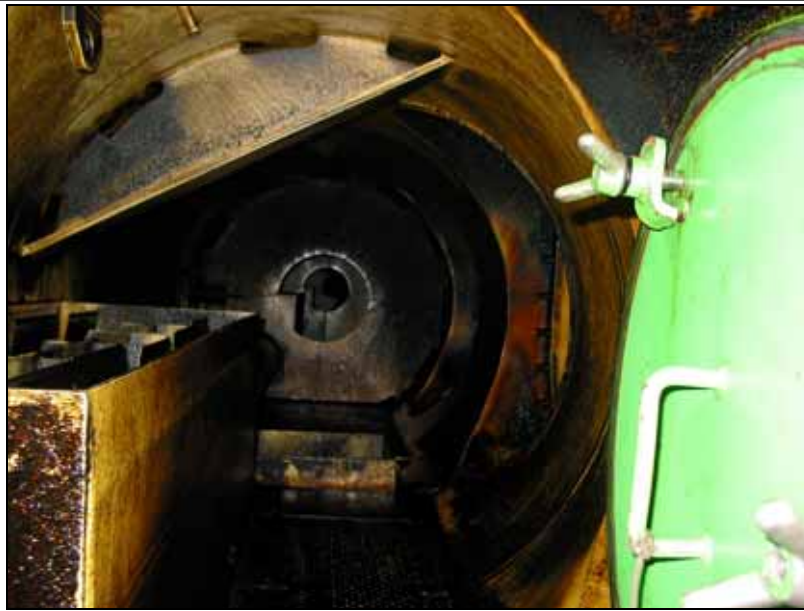
Figure 45: View from the forward end into the scavenge air receiver, with aft hatch closed

In contrast, **Figures 45** and **46** show that with the opposite hatch closed visibility is insufficient in the only weakly lit scavenge air receiver, as the entering light is strongly absorbed by the dark oily inner surfaces of the tubular receiver. Accordingly, the person who was positioned inside at the opposite, closed access hatch when **Figure 45** was taken cannot be discerned on the photograph, and the passage of this person through the throttles in **Figure 46** is only schematically visible despite the relative brightness created by the flash.
