Investigation Report 101/06

Very serious marine casualty

Fatal accident on board the
MFV JAN MARIA
on 13 March 2006
approx. 150 nm west of Ireland

1 September 2008

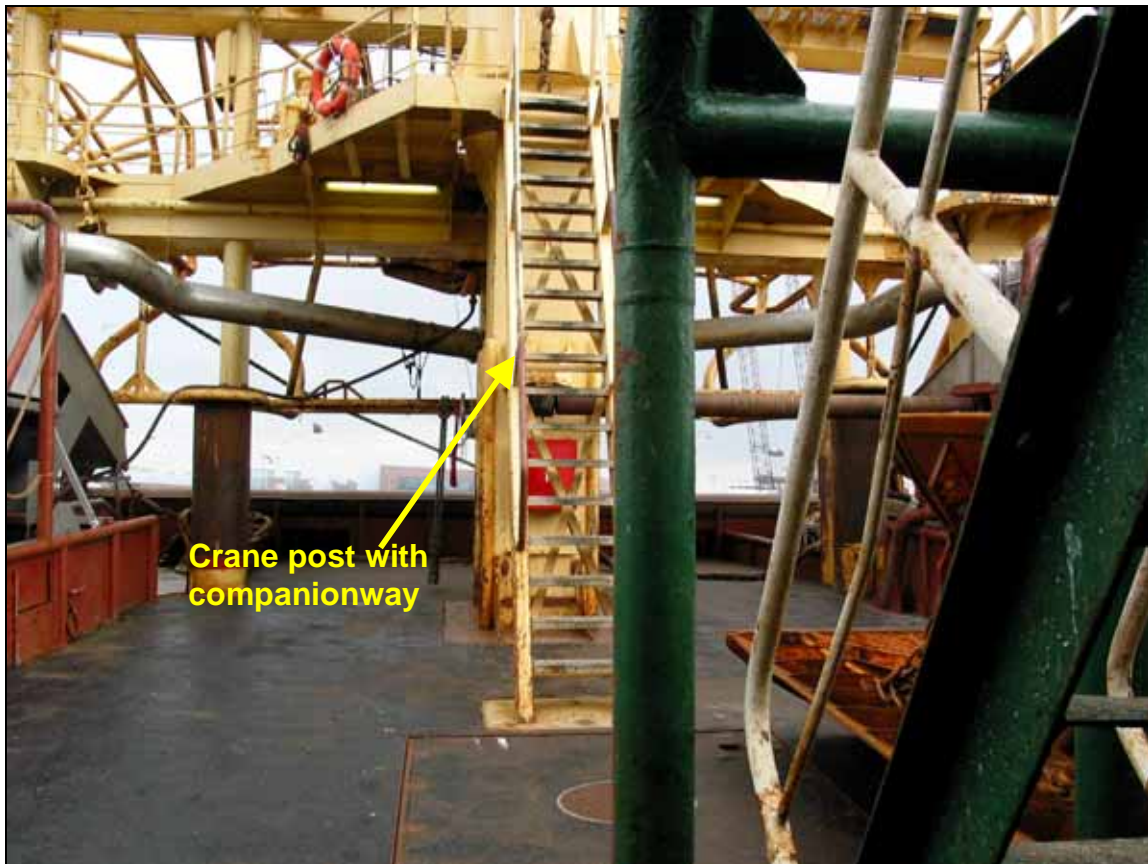
Figure 6: View from the forward edge of the fishing deck aft⁸

⁸ N.B.: The accident relevant guide roller is in the blind spot behind the crane column.

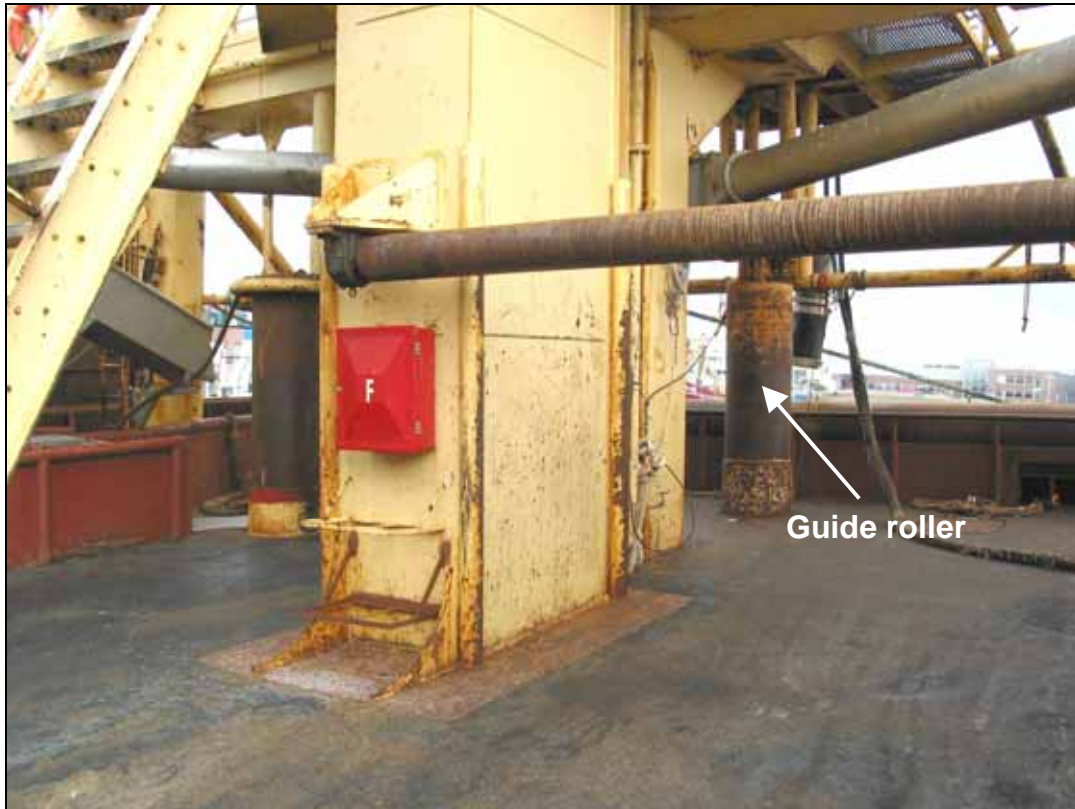
Figure 7: View onto the guide roller

Midships and directly before the vessel's after edge, is the vertical guide roller involved in the accident; its diameter is 0.6 m (Figs. 7 and 8). The distance between the aft bulwark and the guide roller is also 0.6 m. Figures 5, 6 and 10 make clear the fact that the dimensions of the crane column create a relatively large blind spot, so that the area immediately around the guide roller cannot be seen from either the winch operating control position on the bridge or from the platform companionway.

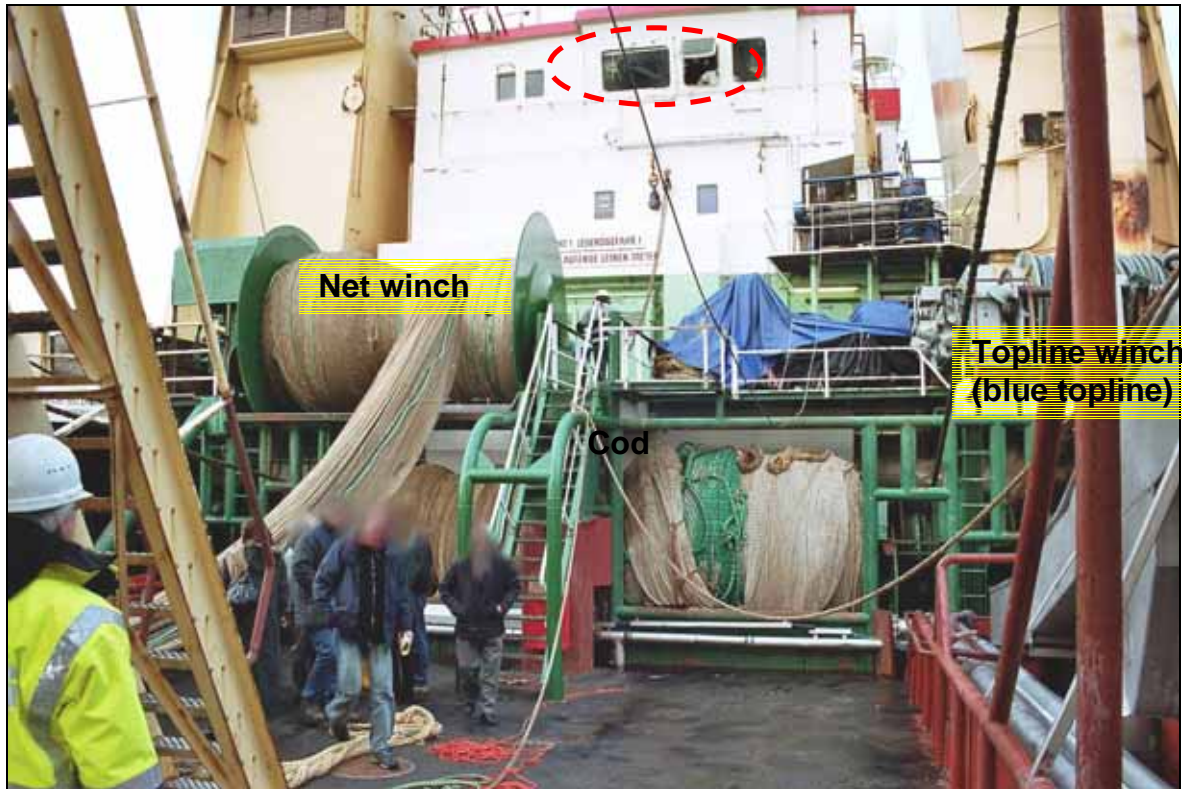
Figure 9: View from the fishing deck towards the after edge of the bridge⁹

⁹ N.B.: The platform companionway is in the foreground left, and part of the coaming that limits the working area is visible in the foreground on the right. The windows of the winch operating station on the bridge are marked in red.

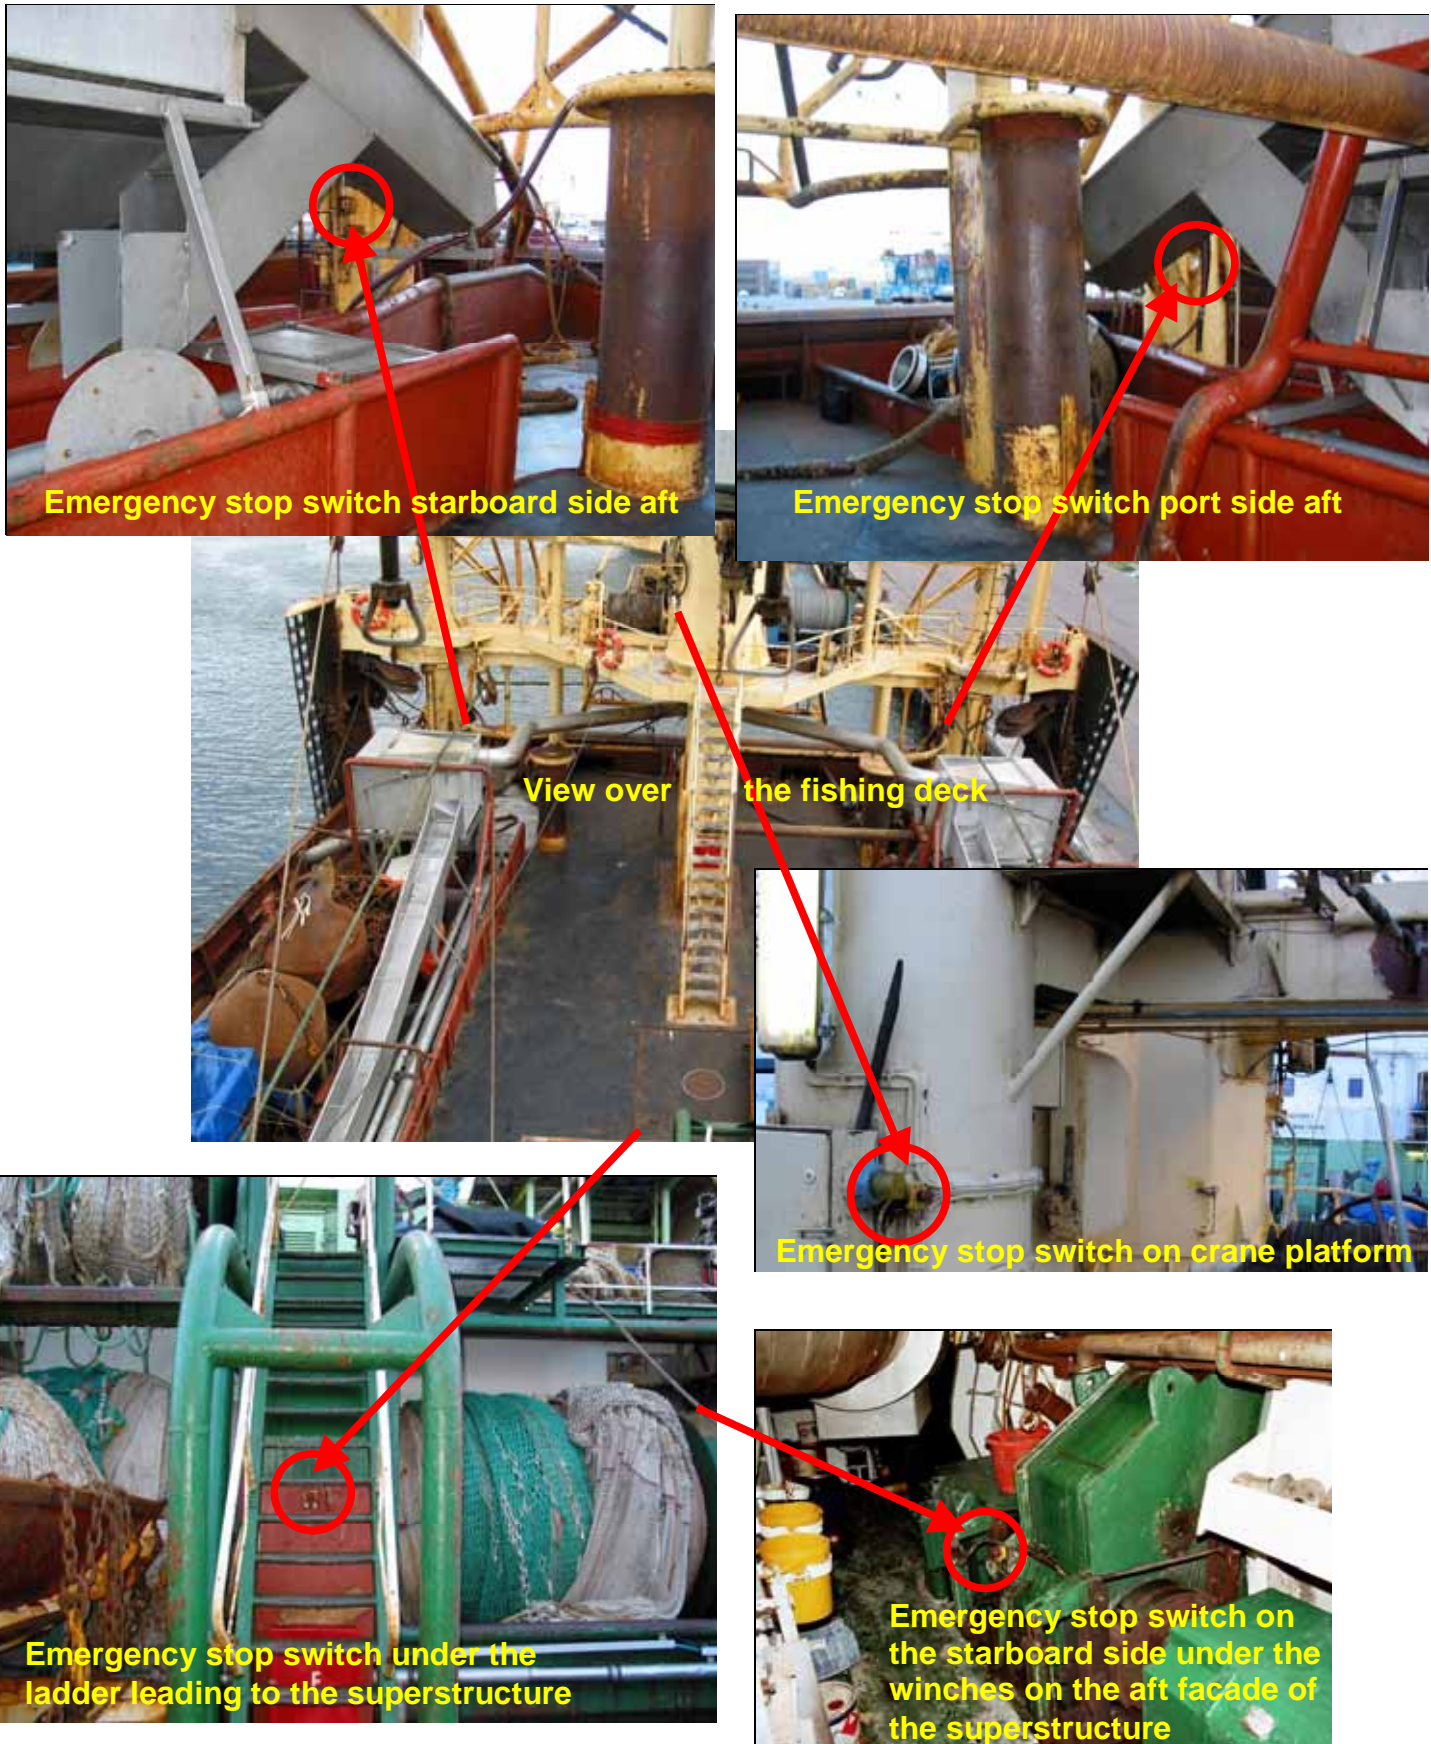
Figure 19 : Illustration of emergency stop switches on the fishing deck

The following illustration of the emergency stop switches shows how difficult it is to find them.

- 3) The mandatory emergency stop switches must be easily accessible. Their position and function should be publicised on board by means of regular training sessions; if possible, indicator signs should be installed.
- 8.5 The Federal Bureau of Maritime Casualty Investigation recommends that **operators of seagoing fishing vessels and their management teams** to implement a uniform working language on board among their crews and to enforce a standardised sign language for all vessels operated by the shipping company. At the same time it must be ensured that emergency signal systems are not used for regular work communications.

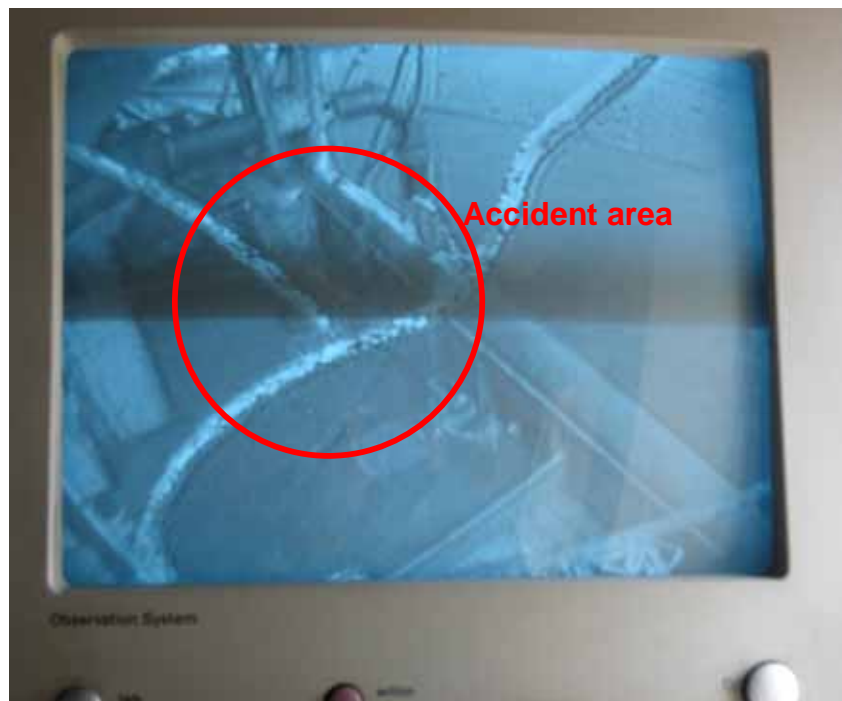
Figure 20 : Additional B/W monitor on the bridge
to show the blind spot on the fishing deck

This image was in black and white. Transmission was disrupted by interference at irregular but relatively frequent successive intervals (probably due to the natural vibrations of the camera). In all other respects it essentially appeared unclear and fuzzy. The transmission of the second installed camera could not be represented. Accurate and especially longer observation of the monitor is required in order to e.g. recognise a person in the monitored area, in particular at night visibility conditions. In contrast, the cameras directed on the winches worked perfectly and generated clear, interference-free pictures.

When a BSU team carried out an on-site inspection in the port of IJmuiden on 22 May 2006 it could be determined that this requirement had already been implemented. According to the See-BG requirement, one camera had been installed on each of the girders of the crane platform on port and starboard, respectively. Both cameras appeared to be active, as a red light diode could be seen. The cameras pointed to the area not visible from the bridge and located between the midships guide roller and the stern (=scene of the accident).

On the bridge were two monitors on shelves, positioned left and right above the winch operating station oriented towards the fishing deck. When pressing a button, the right hand monitor shows three different camera images, all of which are trained onto winches; the left hand monitor showed an unchanging camera image, namely that of the camera mounted on the aft port side.
