Investigation Report 116/07

Serious Marine Casualty

**Grounding of the MV VOLGO-BALT 209
on 22 March 2007 on the Lower Elbe River
south of Buoys “3” and “5”**

15 February 2008

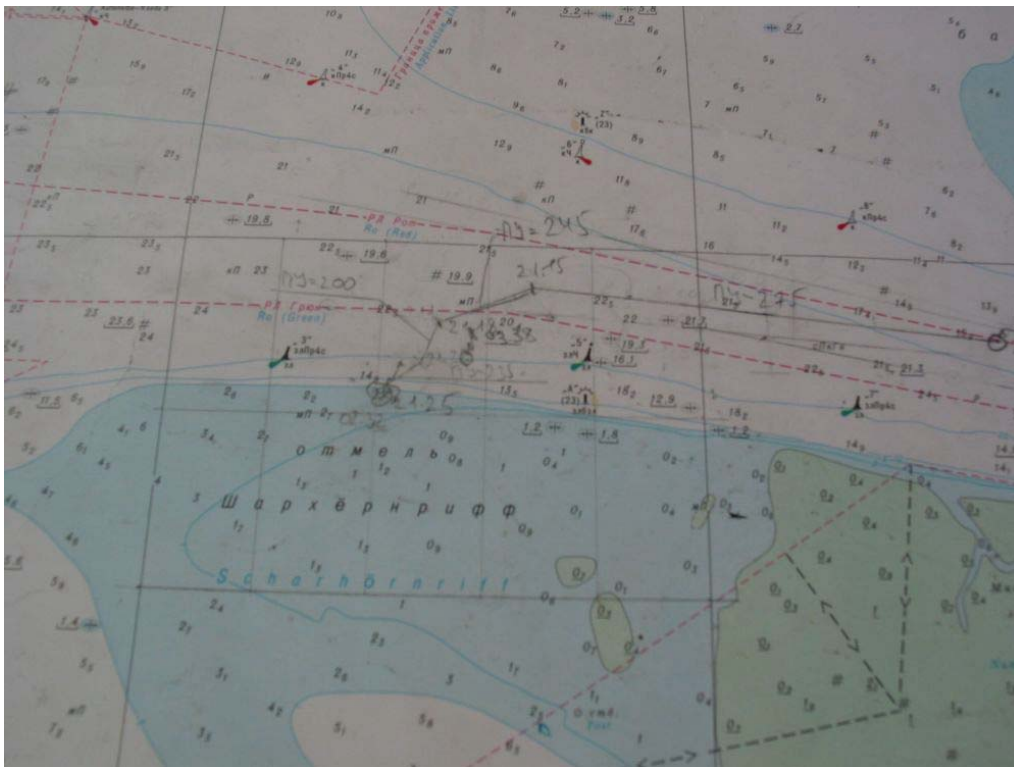
Figure 3: Section of Chart, VOLGO-BALT 209

The Pilot on board spoke in German to the Radar Pilot and then translated the recommendations and directions into English for the Russian Watch Officer. The Pilot was at first not fully able to identify the Master as compared to the Watch Officer. After passing Buoy "10" the radar advisor informed the ship that a vessel proceeding in the same direction wished to overtake, and that thereafter the VOLGO-BALT 209 would meet with no further traffic between Buoys "6" and "Elbe", either travelling in the same or in the oncoming direction. However, after passing the "Elbe" Buoy large amounts of incoming traffic should be expected. It was therefore a matter for consideration whether to cross the fairway immediately after passing Buoy "6", following the line between Buoys "3" and "1" (leaving both buoys to port) to the "Scharhörner N" Shoal Buoy in order then, once south of this buoy, to head for the "Alte Weser" lighthouse. The Pilot explained the course to be followed on the charts. Using these charts and the GPS receiver handing above the chart table the Third Mate reviewed the position on an ongoing basis and made annotations on the chart (cf. Fig. 3).

Up to the overtaking by the vessel proceeding in the same direction, the VOLGO-BALT 209 ran distinctly on the right hand of the fairway with a gyrocompass course of 285°. After passing Buoy “6” the pilot recommended a course change to 220° so as to take Buoy “3” dead ahead in order to cross the fairway. This recommendation was relayed in English to the Master, who translated it and then issued orders to the helmsman in Russian.

After the course had been changed and steering stabilised, the Pilot realised that Buoy “3” was quickly passing to starboard. He checked the compass course and saw that it was 200° instead of 220°. He then recommended a course of 250°. This course recommendation was not implemented. Shortly before passing the southern radar line Buoy “3” could still be seen clearly to starboard, and the Pilot recommended 270° and “Hard to Starboard”. Thereupon the Helmsman put the helm 20° to starboard. The ship turned but could not get beyond a course of 262°. Both engines were running “full ahead”, so that it was not possible to increase engine revolutions to enhance the rudder effect.

At approximately the same time the Third Mate determined that the VOLGO-BALT 209 was in shallow waters and informed the Master. Thereafter the VOLGO-BALT 209 drifted outside of the buoy line and ran aground at approx. 20:25 h west of the Beacon "BCN A".

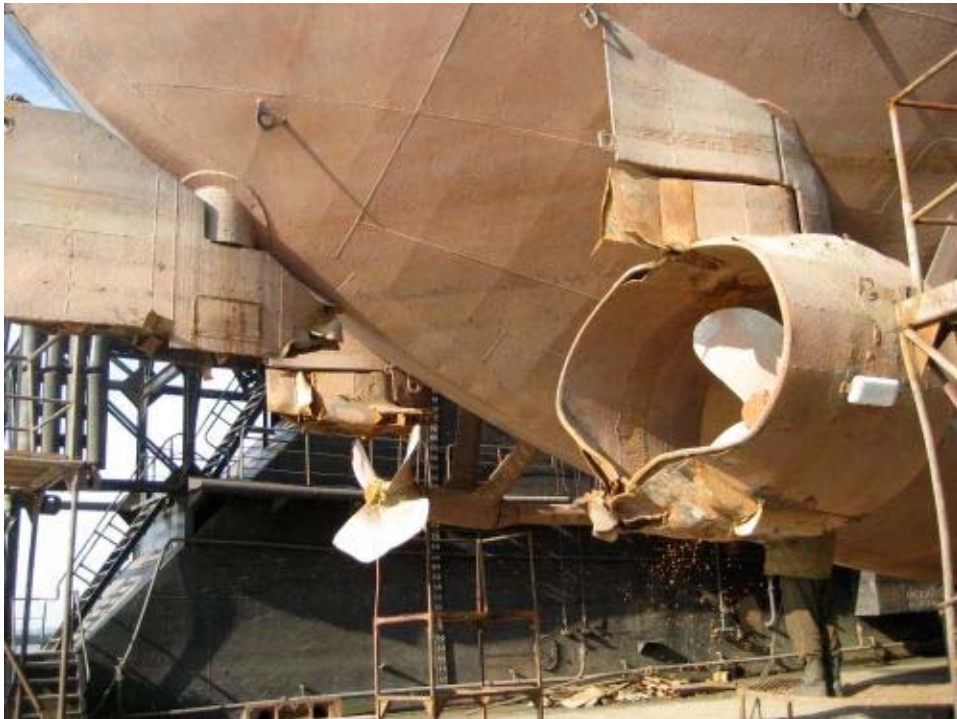
Figure 4: Damage to aft section

In the RMRS inspection report it was determined that the hull was dented and cracked in the area of ballast tanks 1 and 3 on the port side. Both the rudder and propeller were damaged (cf. Fig. 4). The bulwark and the deck planking were deformed in the area of frames 64 to 84, probably due to green water slamming. There was no visible damage inside the cargo spaces in the areas of planking, frames or bulkheads. The superstructure, hatches and entry holds were in satisfactory condition, and the cargo spaces were dry.

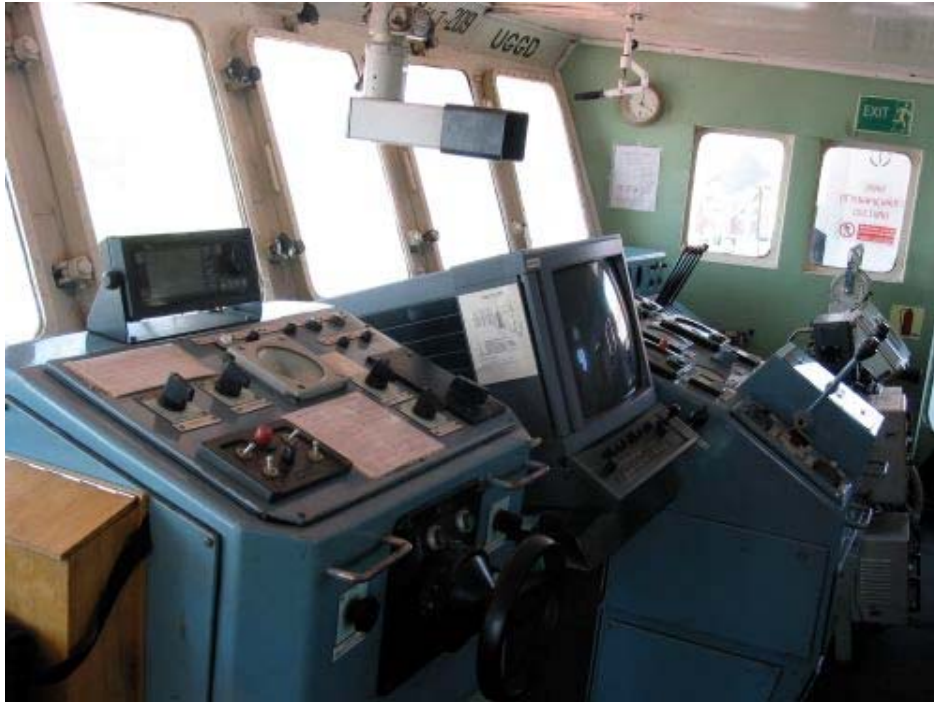
Figure 5: Bridge of the VOLGO-BALT 209

The navigation equipment consisted of two Decca Bridgemaster radar's, a Sperry gyrocompass, a standard magnetic compass, two GPS (Philips and Sperry), a Sperry ES 5000 echo sounder, an Anthea log, a AP 1500 Sperry autopilot and a C. Plath course and rudder position recorder. One of the radar's was damaged. There were up-to-date Russian charts and Sailing Directories as well as a 2006 deviation table

for the magnetic compass as well as maintenance records on board. The chart that was used, No. 25212 (INT 1452) had been kept up to date and included correction No. 5306 of 30 November 2006 as the last change. The next inspection would take place at the wharf.

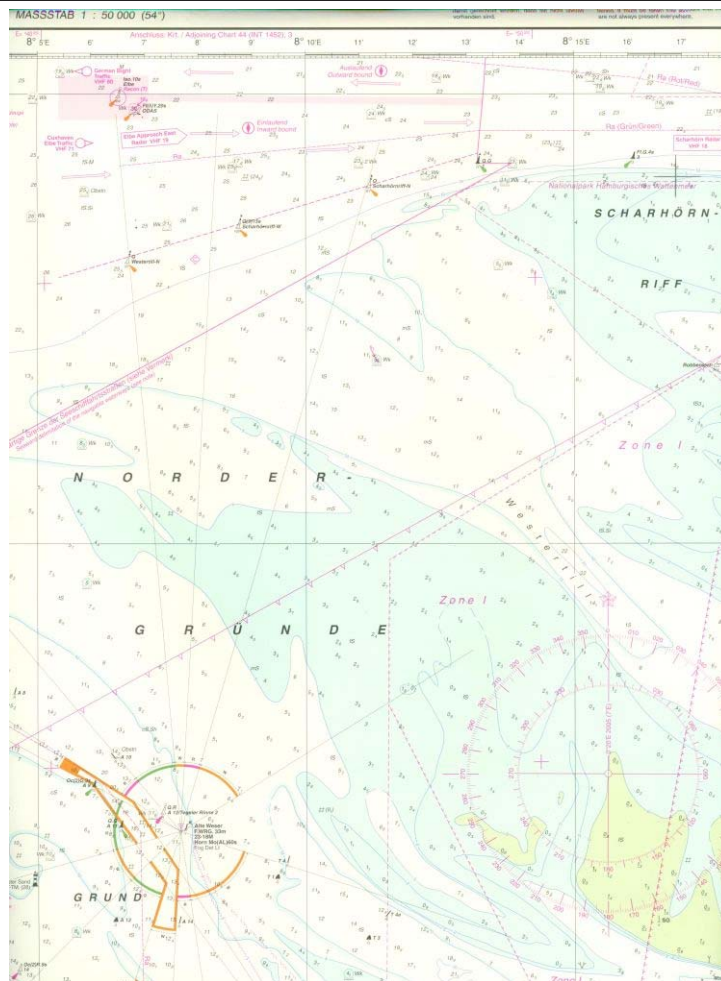
Figure 6: Section of Chart 2 (INT 1456) BSH

The BSU reviewed the planned and actual courses of the VOLGO-BALT 209 by means of the Russian paper charts corresponding to German Charts 44 (INT 1452) “Elbe Estuary” and 2 (INT 1456) “Jade and Weser Estuaries” at a scale of 1:50.000, in the presence of the Master and of the Third Mate. Chart 87 (INT 1413) “Borkum to Neuwerk and Helgoland” at a scale of 1:150.000 was also on board. However, Chart 49 (INT 1463) for the “Jade, Weser and Elbe Estuaries” at a scale of 1:100.000 was missing. This would have shown the approaches between the Elbe and the Jade/Weser on one page, although at a smaller (less easily readable) scale. The map of the Cuxhaven harbour is printed in the bottom left corner of Chart 44, so that the way to the “Alte Weser” lighthouse to attain the “Alte Weser” fairway is not shown in one stretch. Therefore, charts could have been changed only on the meridian of the Elbe Approach Buoy or immediately beforehand. On the current German Chart 2 only the southern portion of the fairway around the Elbe Approach Buoy is shown. If the chart section had been increased by one minute further northwards (cf. historical Chart 2 before the last conversion to the IALA Buoyage system²), the chart image would have been significantly better, enabling a better transition to Chart 44. This is particularly striking if intending to leave the Elbe on the northern fairway. The current map sheet division can be irritating when transferring a position (cf. Fig. 1 and 6).

A change-over between Charts 44 and 2 would already have been possible between Buoys "5" and "3" of the Elbe Fairway.

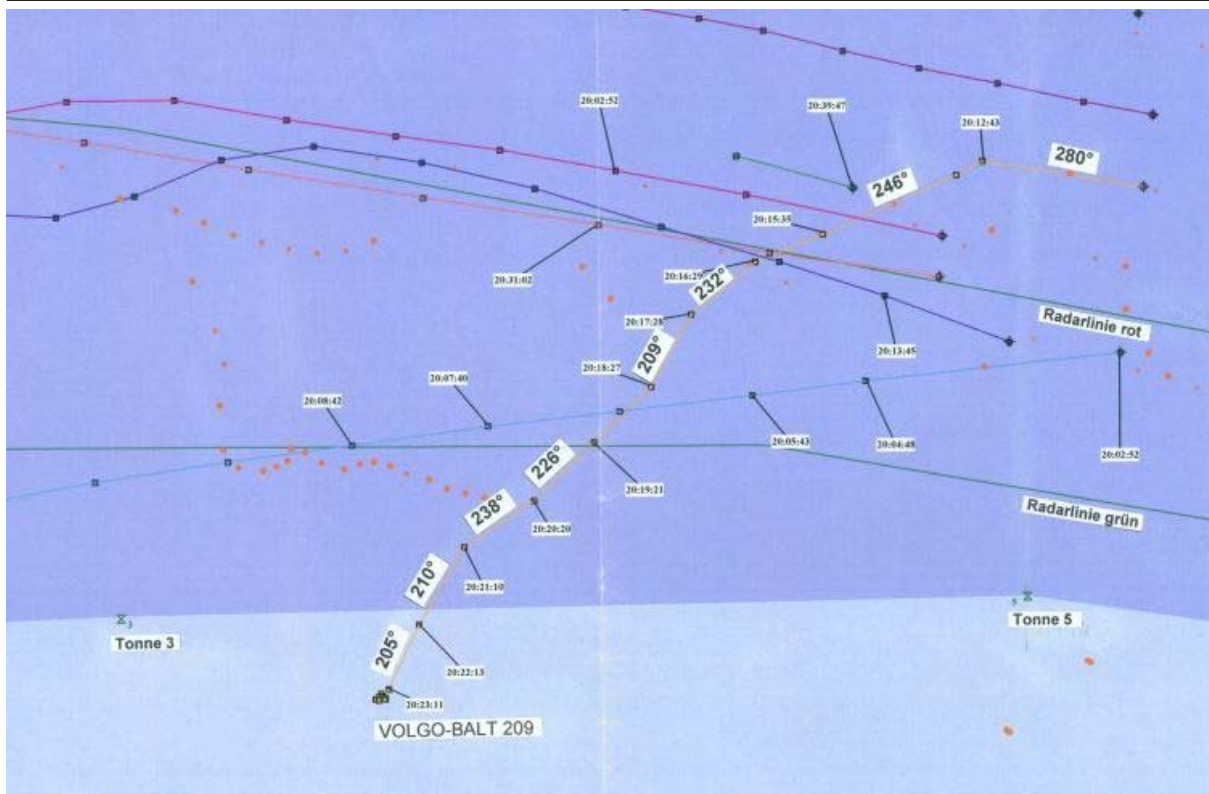
Figure 11: Track of the VOLGO-BALT 209

The track records of the Cuxhaven Vessel Traffic Service (cf. Fig. 11) show that the VOLGO-BALT 209 started crossing the fairway after passing Buoy “6” at 20:12 h. Until 20:23 h, shortly before running aground, it travelled courses over the ground (COG) varying between 280° and 205°.⁵

After evaluation of the currents and wind effects, within the Elbe fairway northerly winds of force 8 Bft would generate a current setting westward (272°) at 2.3 kn. The average course through the water (CTW) would then be 212° at an average speed through the water (STW) of 8 kn.

The high standard deviation of 16° (cf. footnote) is due to the unstable course characteristics of the VOLGO-BALT 209. An aggravating factor were the crossing wind seas with 2 m wave heights at 5 s intervals. The exact reason for the unstable course could not be definitively determined. The Helmsman did not carry out the helm commands directly following the Pilot’s instructions, but only after the Master had translated them from English into Russian. This could potentially also have led to communication difficulties between the Pilot, the Master, the Watch Officer and the Helmsman. Out of the bridge personnel, only the Master was able to communicate with the Pilot. The Watch Officer verified the course made good by means of GPS position entries on the sea chart, and warned of the proximity of shallow waters. After crossing the southern buoy line it was however no longer possible to alter the average COG from 224° to 270°.

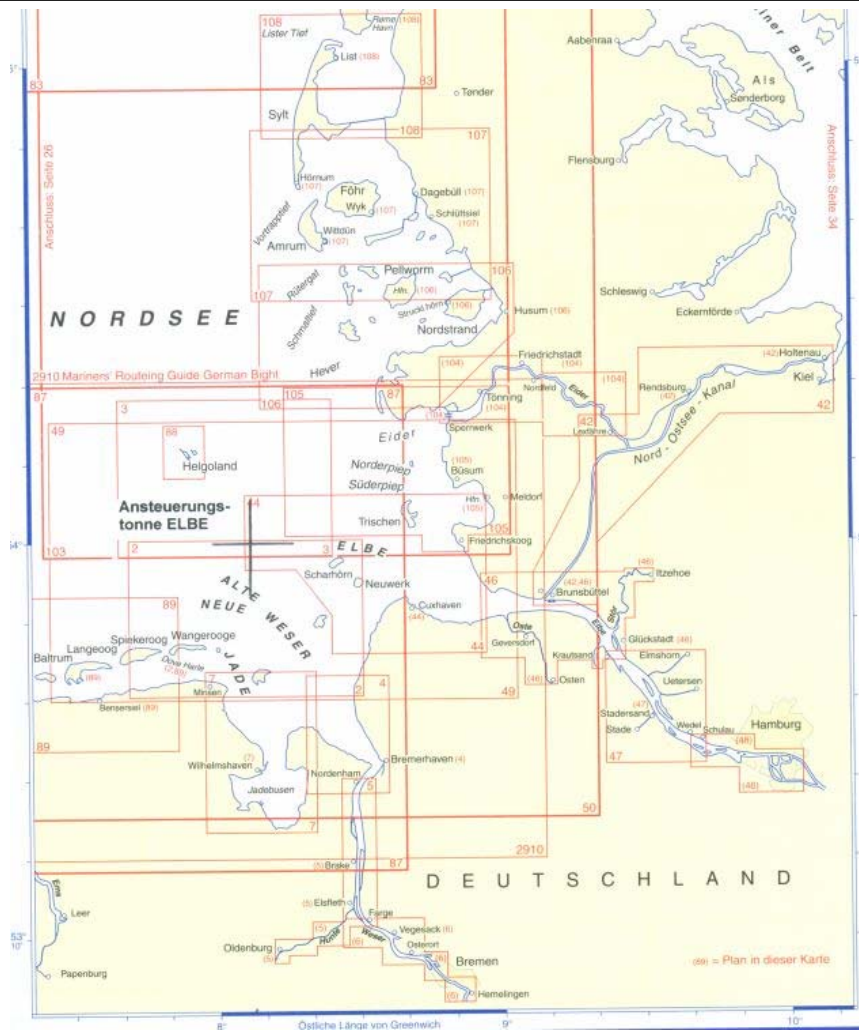
Figure 12: BSH Catalogue Charts and Books

When looking at the BSH Chart catalogue, on the charts at the largest scale the Elbe Pilots’ transfer position is shown on the edges of Charts 2, 3 and 44 (cf. Fig. 12). Only on Chart 49 is the Elbe Pilot Transfer position shown centrally, providing a connected overview between Elbe and Weser and vice versa. Use of the largest chart scales available can therefore easily lead to irritation when planning the voyage and to errors when transferring the vessel’s position onto the new chart.

A carry-over of the position of chart 44 to chart 2 would also have been possible without chart 49 between the buoys “5” and “3” of the Elbe fairway. An extension of the map sheet division of chart 2 in a northward direction would result in an improved chart image for this area. This would for technical reasons lead to a reduction of the map sheet division in a southward direction. An alteration of only 1 minute would

The BSU recommends that the Federal Maritime and Hydrographic Agency [*Bundesamt für Seeschifffahrt und Hydrographie (BSH)*] as the original publisher of the international charts for the German sea areas pursuant to SOLAS Chapter V Rule 9, revise the sheet divisions of the charts in the area of the Elbe Approach Buoy from the perspective of safe ship handling requirements. On the charts with the largest published scales the pilot transfer positions, which are the central approach point for ship commands, are usually shown on the edge of the charts. This can lead to irritation when carrying over the vessel's position from one chart to the next, as well as to confusion in voyage planning. According to the Watch Standards (STCW 95 Chapter VIII), the largest scale chart on board must be used. It must be appropriate for the area and contain the latest available information.
