**Bundesstelle für Seeunfalluntersuchung**  
**Federal Bureau of Maritime Casualty Investigation**  
Federal Higher Authority subordinated to the Ministry of Transport,  
Building and Urban Affairs

Investigation Report 172/07

**Very Serious Marine Casualty**

**Fatal personal accident  
on board TMS SEACOD  
on 27 April 2007  
North West of the Azores**

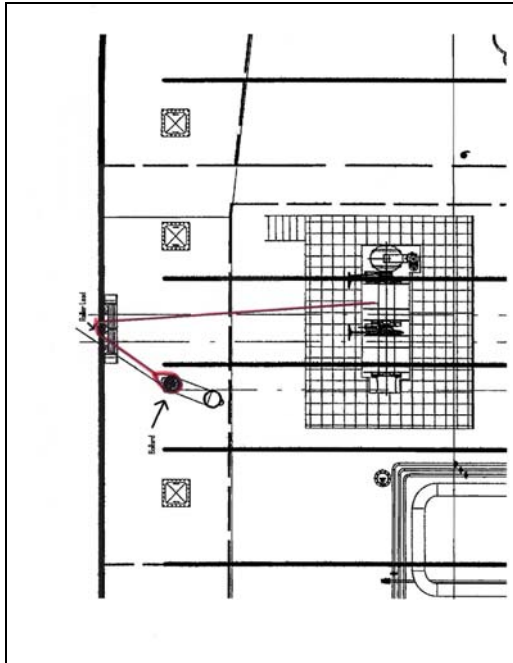
Figure 3: Planned implementation

Both crew members began with the preparation of the line. The normal procedure would have been taking the spring from the winch through the Panama fairlead and then back to the bollard, throwing over the eye and holding the line tightly (see Fig. 3). At approx. 10:50 h they were exposed to rain and spray washing over on the port side of the spring winch when carrying out the work.

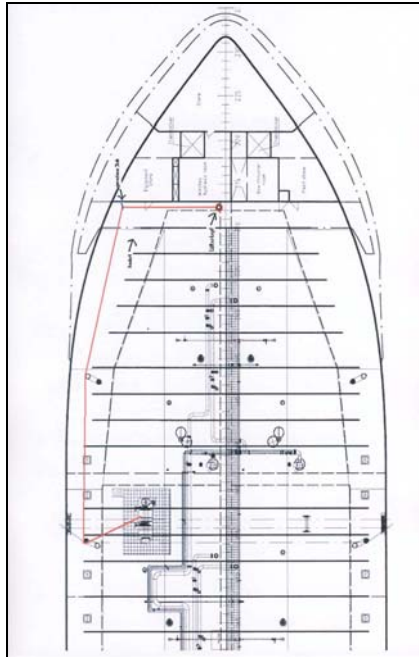
Figure 4: Structure of the auxiliary construction

When they were about to discontinuing work due to the adverse conditions, the able-bodied seaman suggested completing the work at another location. For this purpose the spring eye would have to be placed around a ventilation head in a protected area amidships behind the fore-castle (see Fig. 4). The ordinary seaman objected to this procedure but the able-bodied seaman began to implement the plan. In order to tighten the spring as much as possible, he placed it around a centre roller and took it around another bollard with attached centre roller on port side to the fore stairs. Then he passed the spring through a strop which was fastened to a ladder rung at the aft end of the fore-castle and deflected it with this auxiliary construction at a right angle to the ventilation head (see Fig. 6-9). At approx. 11:00 h the line was tightened by the ordinary seaman on the instructions of the able-bodied seaman. When the ordinary seaman had secured the brake of the mooring winch, he unshipped the winch and then heard a bang. Initially he was not able to recognise anything in particular and proceeded forward. There he discovered the able-bodied seaman lying on deck (see Fig. 5). The bosun also heard the bang and began to rush to the spot immediately. He was not able to witness the accident from his place in the workshop.

The cause of the accident was the improper auxiliary construction for rigging a splice to the forward spring. A great friction loss resulted due to deflecting the spring by approx. 90° with the aid of a strop which distributed the power in a ratio 15:1 in front and behind the strop. This led to the ladder rung being broken and perhaps the strop as well. In the process the casualty was struck by the rebounding tightened Atlas line and hurtled onto the main deck or deckstringer and fatally injured.

In order to henceforth avoid such accidents the shipping company has decided to prohibit the use of mooring winches for purposes of maintaining “Atlas ropes”. Tightening of mooring ropes with objects other than mooring devices is strictly prohibited.

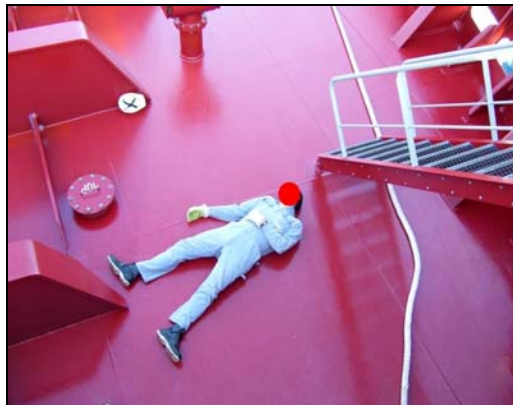
Figure 5: Place where the casualty was found

It was ascertained that the ladder rung was broken. This probably resulted in the rope rebounding and striking the able-bodied seaman on his left arm and left side of his head. In view of the position in which he was found, it may be concluded that he could have been standing beside the stop at the stairs at the aft end of the forecastle at the time the rung broke.

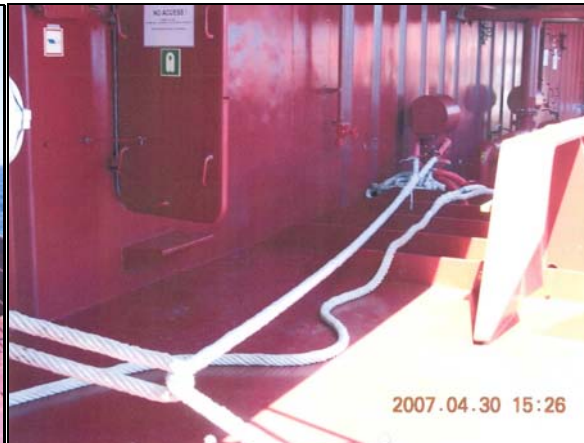
Figure 7: Deflection with stop of 90° angle

During the accident the ladder rung broke because of the kinetic energy that was stored in the tightened spring. At this position the spring was deflected by 90°. According to crew member statements, the broken ladder rung was pointing upwards and was bent outwards. However, it is still not known, why the casualty was in the vicinity of the forward life raft at that time.

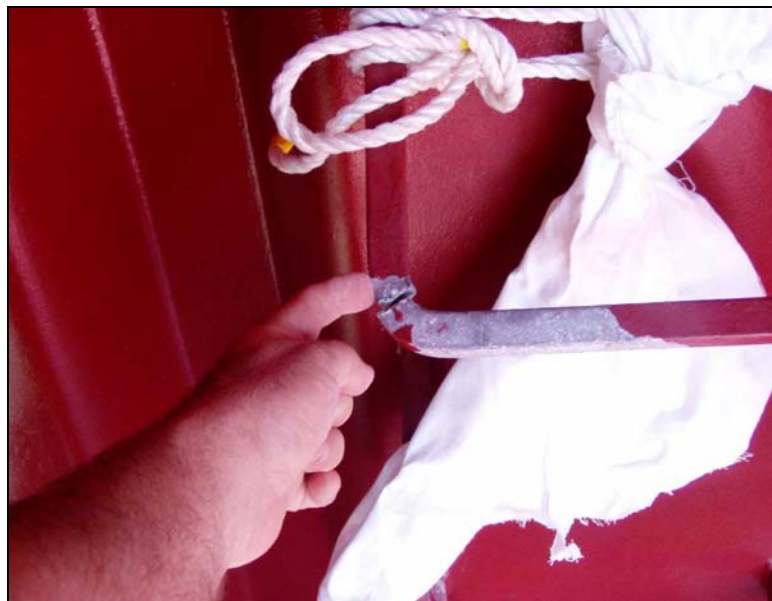
Figure 9: Broken ladder rung

Although nobody witnessed how the able-bodied seaman got injured, it appears probable that the ladder rung gave way and the kinetic energy stored in the spring was released. At this place the spring was deflected by 90°. It is assumed that either the strop which was fastened to the ladder rung or the spring struck the able-bodied seaman's body and hurtled his body on deck or, rather, on a deck stringer.

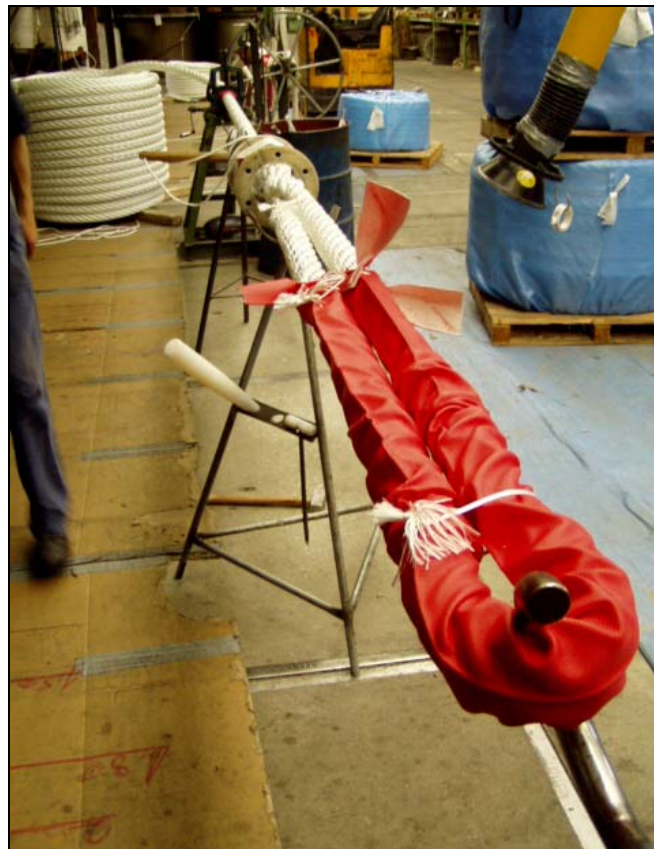
Figure 10: Manufacturer's rigging

The Atlas rope was manufactured by Drahtseilwerke Bremerhaven (rope factory Bremerhaven) and delivered by Walter Hering Hanf- und Drahtseile, Hamburg (Walter Hering hemp and wire ropes, Hamburg). The splices of the eye ends are covered with a rigging produced at the manufacturer. The rope is tightened for this purpose (see Fig. 10). Rigging only serves to improve handling and is useful when heaving in in order to prevent possible catching at the edges. There is no maintenance manual for this work. When replacing the rigging on board, conventional seamanship is relied upon. A serving mallet must be used and the Atlas rope forced through a short way.

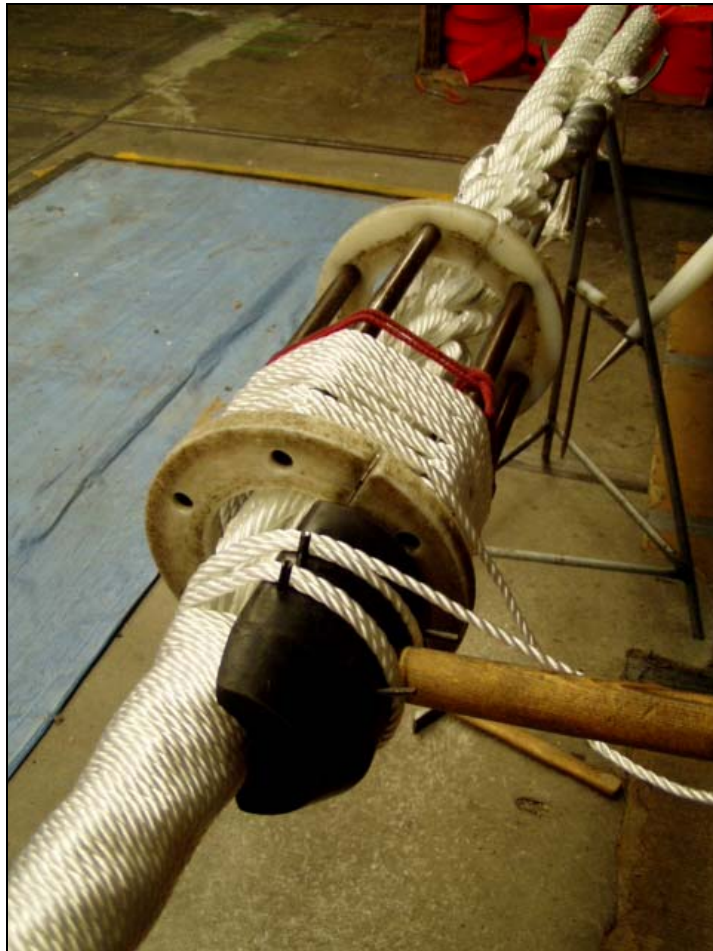
Figure 11: Manufacturer's rigging device

Whereas the manufacturer carries out this work with a rigging device (see Fig. 11), a serving mallet is only provided on board. In this respect, basic reservation did not exist with regard to safety precautions, e.g. in the form of taking particular additional supervision. However, such auxiliary construction used here could not be foreseen by the superintendents (bosun, officers). The superintendent placed his trust in the persons assigned the task of carrying out the rigging on own responsibility. This required tightening of the forward spring with a winch in order for the rigging to hold. The able-bodied seaman who was fatally injured was considered experienced and received a satisfactory rating in all concerns in his last letter of reference.
