Investigation report 215/07

Very Serious Marine Casualty

**Death of two crew members
due to crash of the lifeboat
of the MV FOREST-1
during a lifeboat drill in Emden on
16 May 2007**

16 June 2008

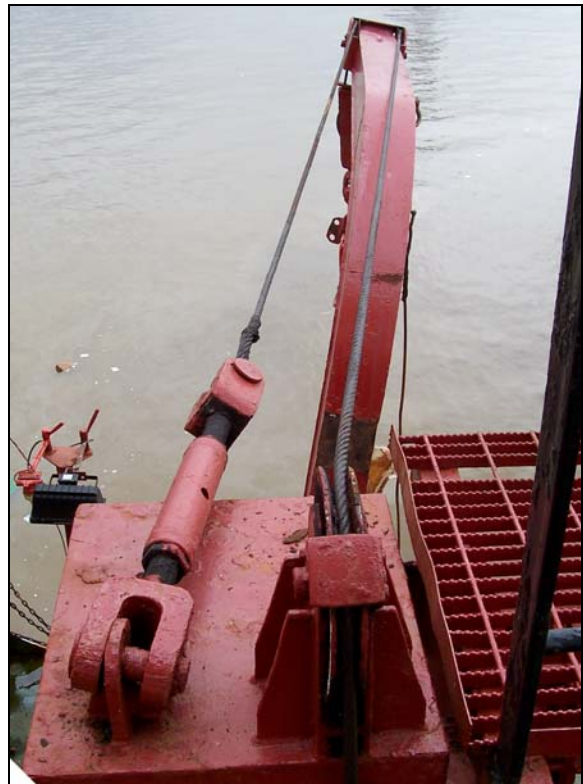
The crash of the boat severely damaged the forward davit arm. The entire arm was bent aft. The plunger of the hydraulic shock absorber was bent (Figures 4 and 5).

Figure 5: Forward davit arm starboard side

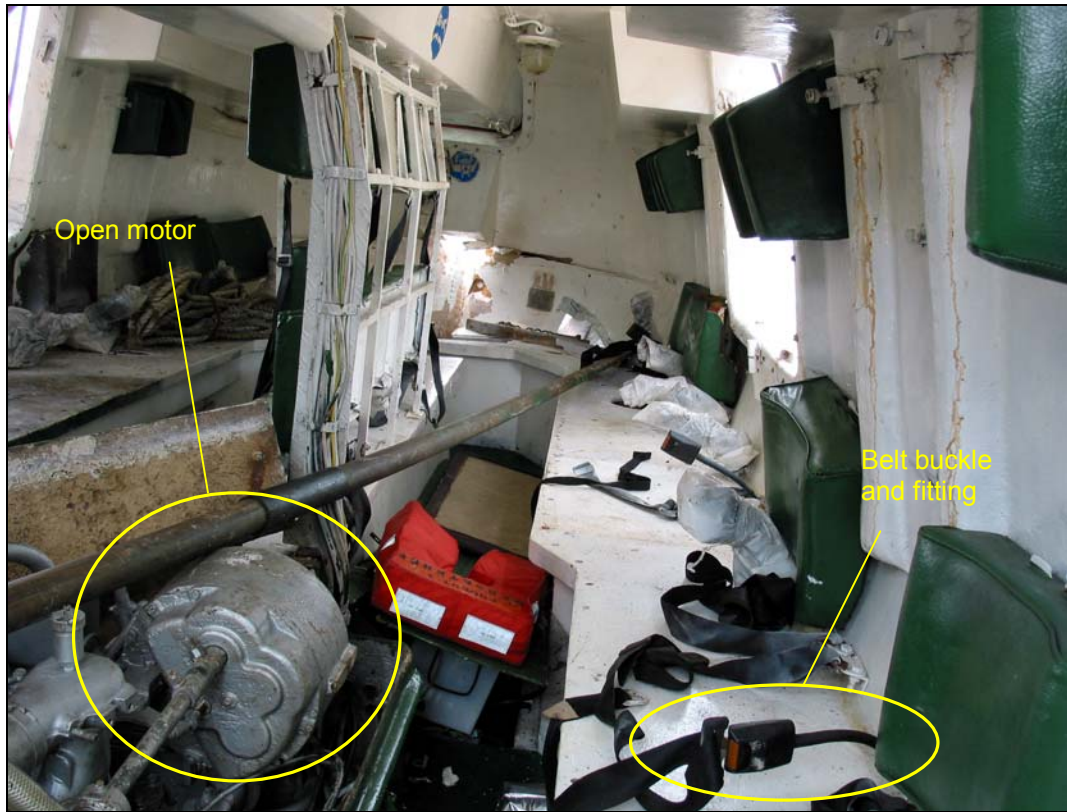
For the crew the boat was fitted with a bench running around. The seats were fitted with a loose cover, insertable pelvic cushions and headrests. Each seat was fitted with a lap belt similar to a car seat belt. A metal plate at the end of the belt strap locked into a buckle fixed onto a flexible fitting (Figure 7).

During the investigation it was determined that most of the belts and buckles were packed in plastic foil and therefore not immediately available for use. Despite the packaging, most of the belt buckles inspected were found to be either difficult to operate or inoperable due to corrosion.

Figure 7: FOREST-1 lifeboat, starboard side, view towards the bow

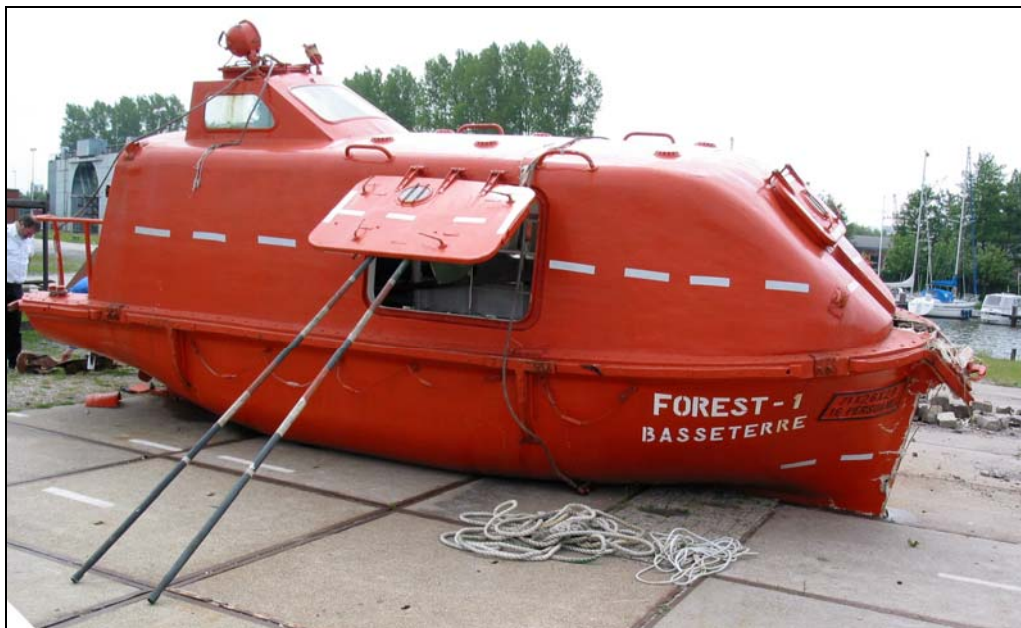
- the forward releasing hook had broken out of the bow in a forward direction together with the hull fitting (Figures 9 and 11),
- this caused the wire ropes of the forward hook remote control to tear (Figure 12),
- stern window of the helmsman dome destroyed,
- cover of the port side access hatch bent,
- stern platform railing bent,
- hull broken open on the aft port side (Figure 10).

Figure 9: FOREST-1 lifeboat

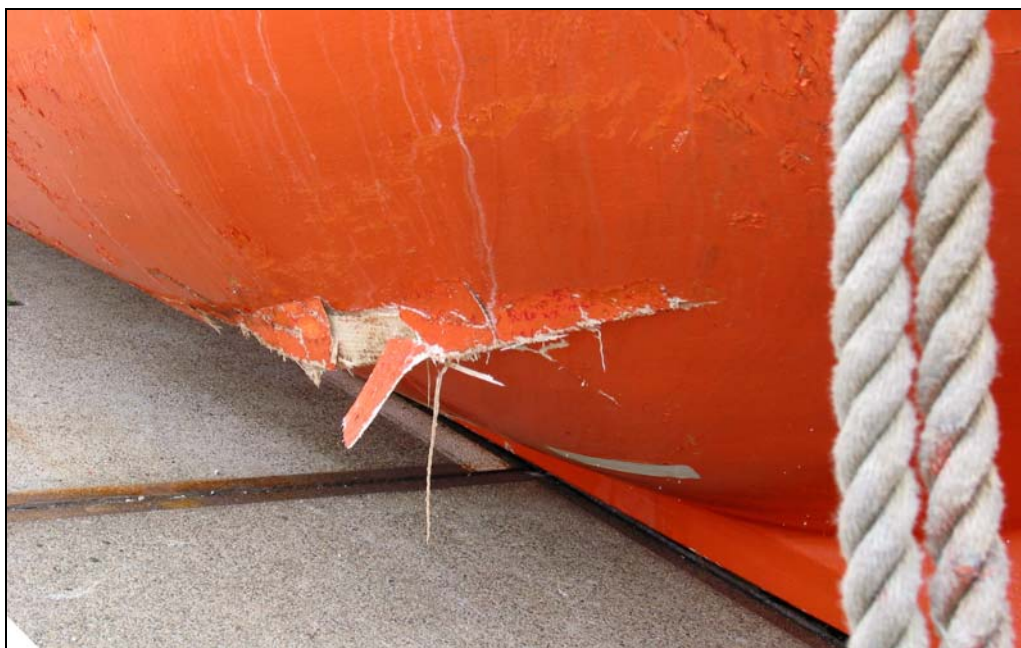
Figure 10: Hull broken open on the port side aft

The peak load led to the release of the aft releasing hook of the FOREST-1. The stern fell and in doing so struck the outboard edge of the boat deck with its port side. This damaged the hull of the boat (Figure 10). The boat then hung for a few seconds from the forward releasing hook, stern downwards. The suspension system was unable to resist the forces acting on it and broke out of the bow of the lifeboat (Figure 11). The boat crashed onto the water’s surface from a height of approx. 7 m.

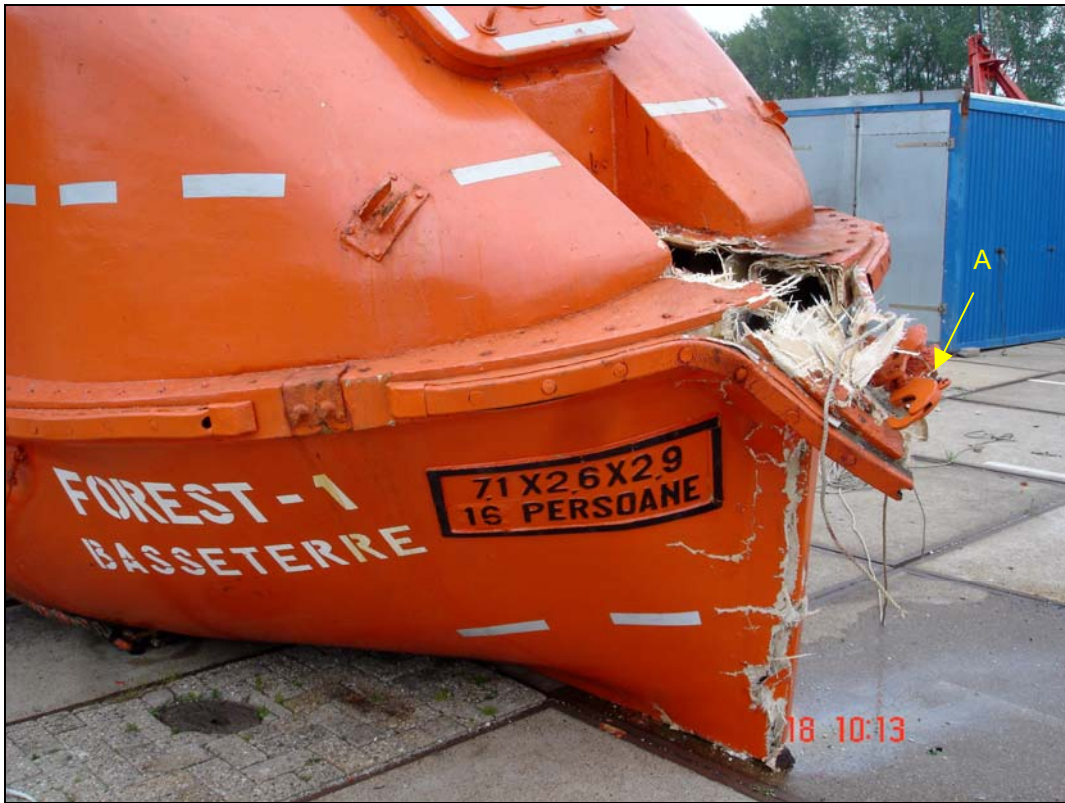
Figure 11: Damage to the bow due to releasing hook having been torn out; A = hook for forward painter

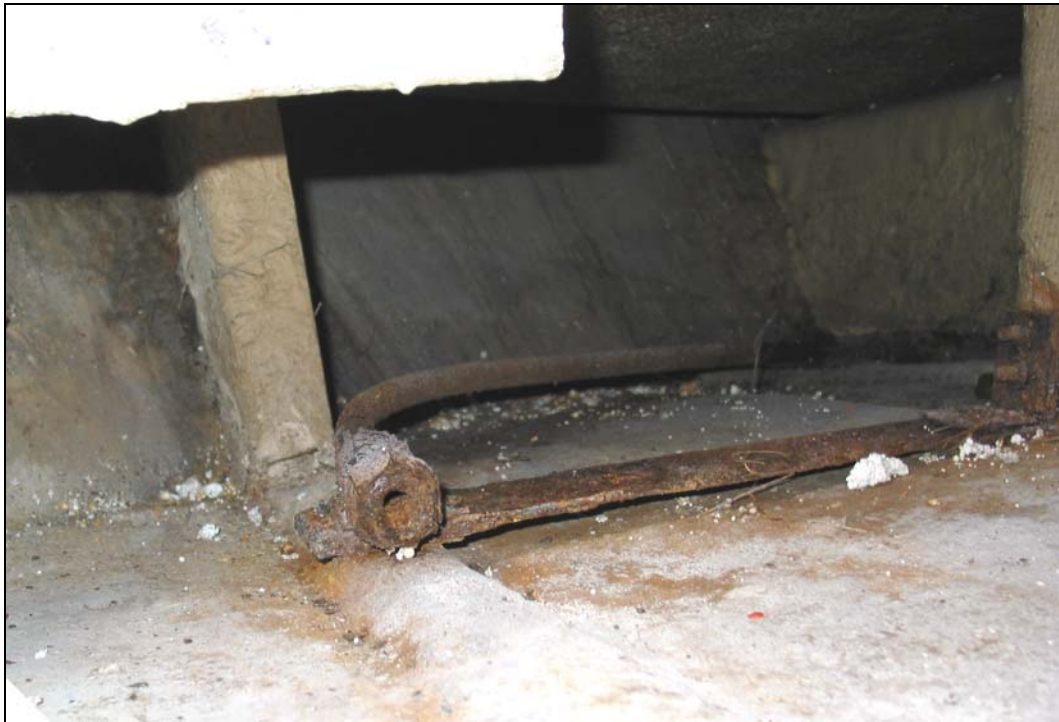
The transfer of the motion of the release lever to the forward releasing hook could not be verified as the forward releasing hook operating wire ropes had been torn off by the crash of the boat. It could however be determined that the guide tubes were heavily corroded (Figure 19) and that in the forward port side area there was no connection with the inner skin of the boat, which resulted in play in the system.

Figure 19: Guide tube for the starboard operating wire rope at the forward exit point

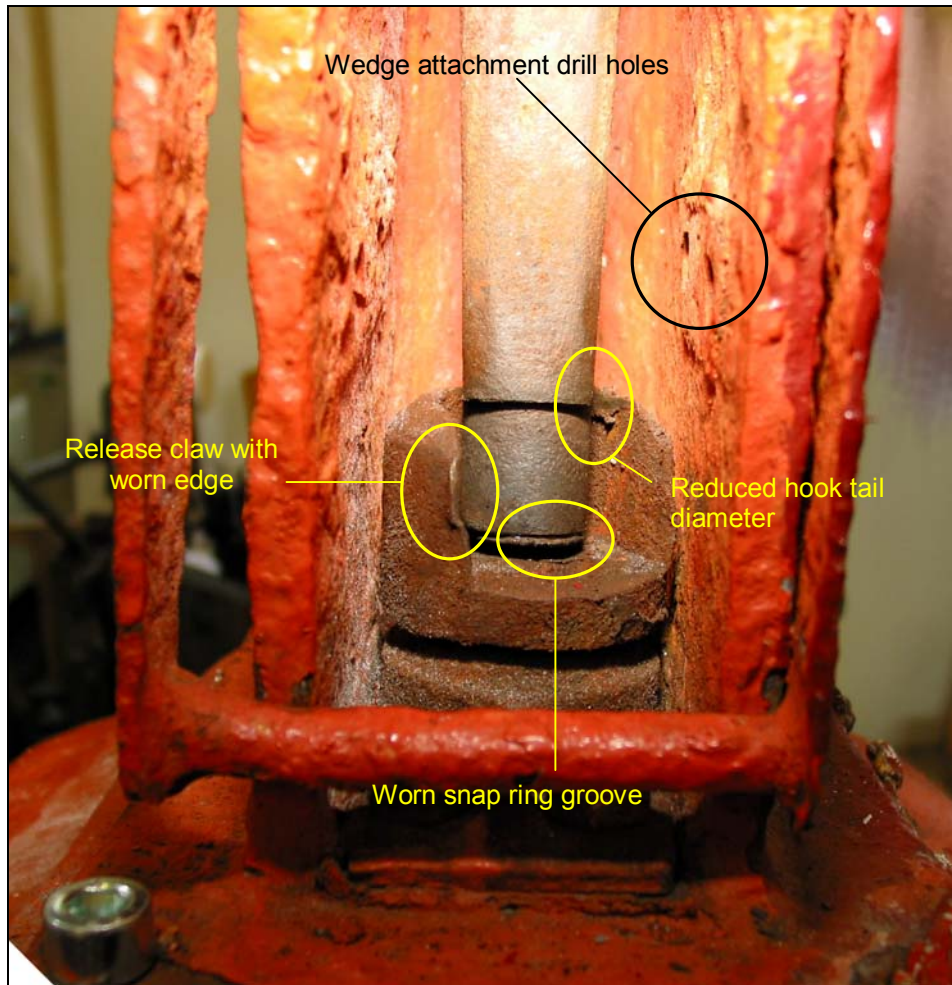
Figure 22: Aft releasing hook

- **Missing steel bushing** at the hook tail (Figure 22). This bushing had been missing for some time, as the groove designed to accept the snap ring was already severely damaged. Under load, the snap ring could no longer hold the bushing on the hook tail. The missing bushing caused a strong mechanical wear on the release claw and thus a decrease in the area intended to hold the hook tail.

In addition, the absence of the bushing reduced the diameter of the hook tail. This also led to a reduced effective area.

- **Missing wedge** on the inside of the port support plate of the releasing hook (Figures 22 and 23). This wedge had also been missing for some time. Both the attachment area and the drill holes were thickly covered in old paint. With load on the hook, the missing wedge causes the hook tail to move to port (Figure 24). This in turn reduced the holding performance of the release claw.

The expert’s inspection of the aft releasing hook revealed that as a result of the missing components bushing and wedge the releasing hook was no longer safe for operation. Although under static loads the system was able to attain adequate values, the simulated dynamic load was closer to reality and thus more meaningful. When re-enacting the situation found after the crash, i.e. aft releasing hook without bushing and wedge, release occurred at 56 kN. This was equivalent to twice the boat weight plus six people. The aft releasing hook therefore released at a load that fell within the normal range for a lowering manoeuvre. The release situation becomes clearer when compared with the fully manned boat. At a weight of 6,660 kg (4,260 kg according to the certificate + 32 people) the releasing hook would have released at 1.7 times the load (1.7 x SWL).

The tests performed show that the missing wedge was the determining cause for the failure of the releasing hook. The absence of this component allowed the releasing hook tail to deflect to port. The now eccentric force caused severe torsion of the release rod assembly in itself, i.e. causing it to twist open, subsequently enabling release.

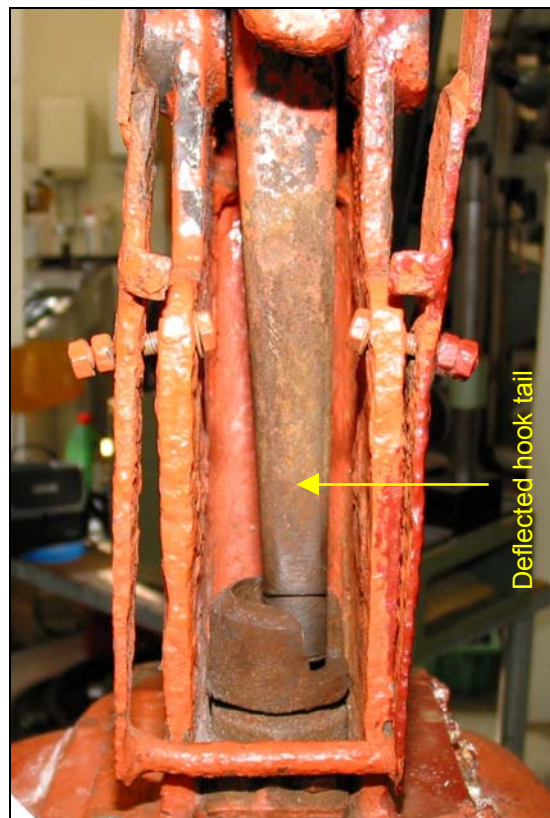
Figure 24: Aft hook tail without bushing

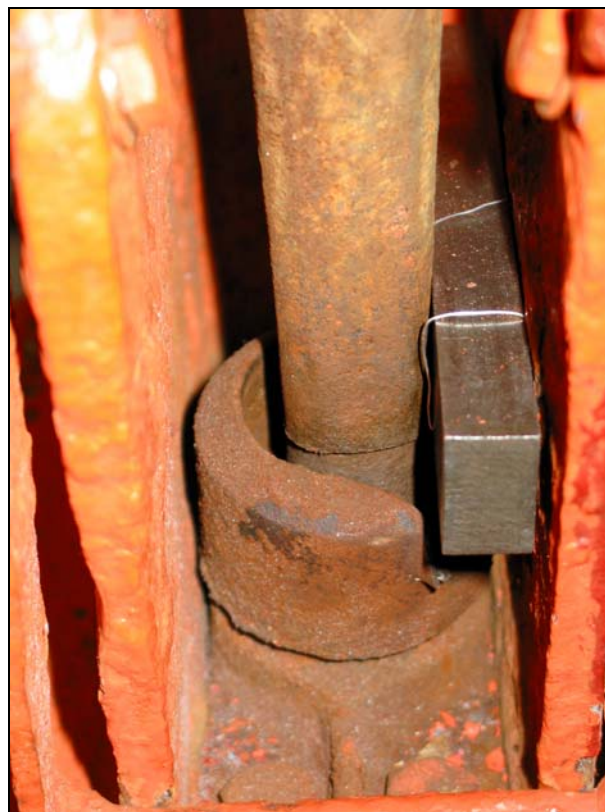
The absence of the wedge was compensated by adding a 15 mm thick flattened steel bar (Figure 25). With and without the bushing fitted, a force of 70 kN could be sustained. With the bushing fitted, a rotation of 2° could be determined in the rod assembly.

Figure 25: Aft releasing hook with wedge added
