**Bundesstelle für Seeunfalluntersuchung**  
**Federal Bureau of Maritime Casualty Investigation**  
Federal Higher Authority subordinated to the Ministry  
of Transport, Building and Urban Affairs

### **Investigation Report 23/07**

**Very serious marine casualty**

**Person overboard**  
**on the MV LENA**  
**at the Elbe**  
**on 19 January 2007**  
**at 08:53**  
**resulting in death**

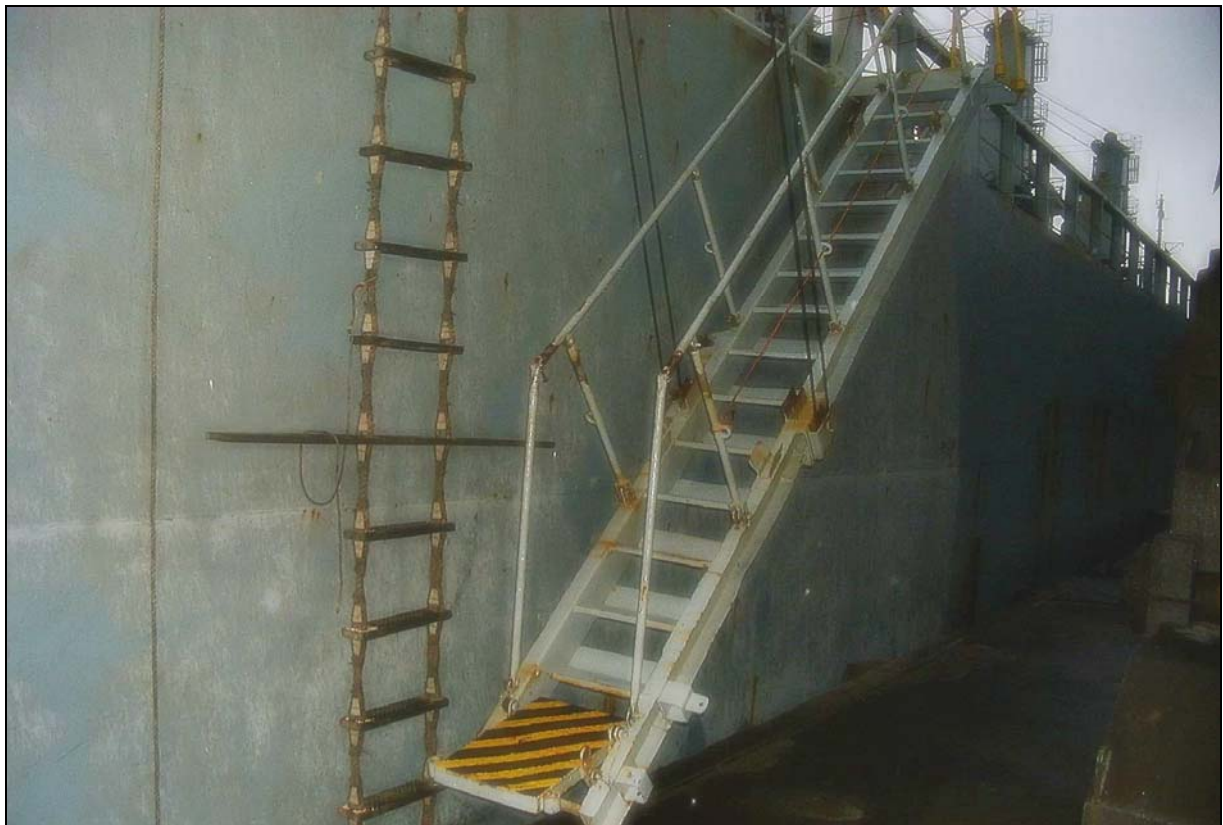
Figure 4: Subsequent demonstration of the mixed pilot ladder

On 21 January 2007, the WSP asked both AB-men to demonstrate how they had rigged the combined accommodation / pilot ladder. The rope ladder and gangway were in working order and no defects were apparent.

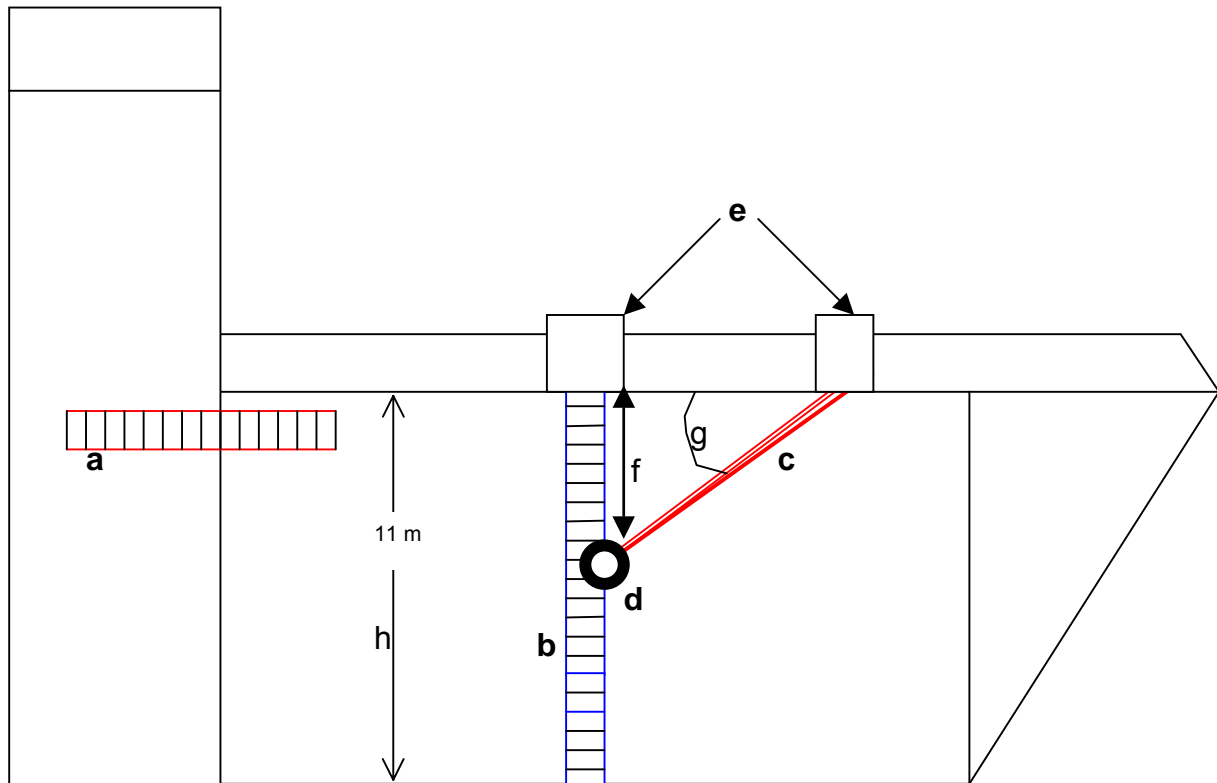
Outline sketch (extremely schematic, not to scale)

- (a) Lowerable gangway for regular onboard operations (permanently installed port and starboard)
- (b) Pilot ladder (is stored rolled up on deck) brought out for each use and attached to the appropriate deck eyes on port or starboard side depending on requirements
- (c) Lowerable gangway exclusively for pilot transfer (permanently installed port and starboard)
- (d) Transfer point between ladder and gangway
- (e) Pilot's door in bulwark
- (f) Distance from connecting point to main deck approx. 3 to 4 m
- (g) Pivot angle of gangway approx. 30 to 40°
- (h) Freeboard at time of accident (according to master's statement)

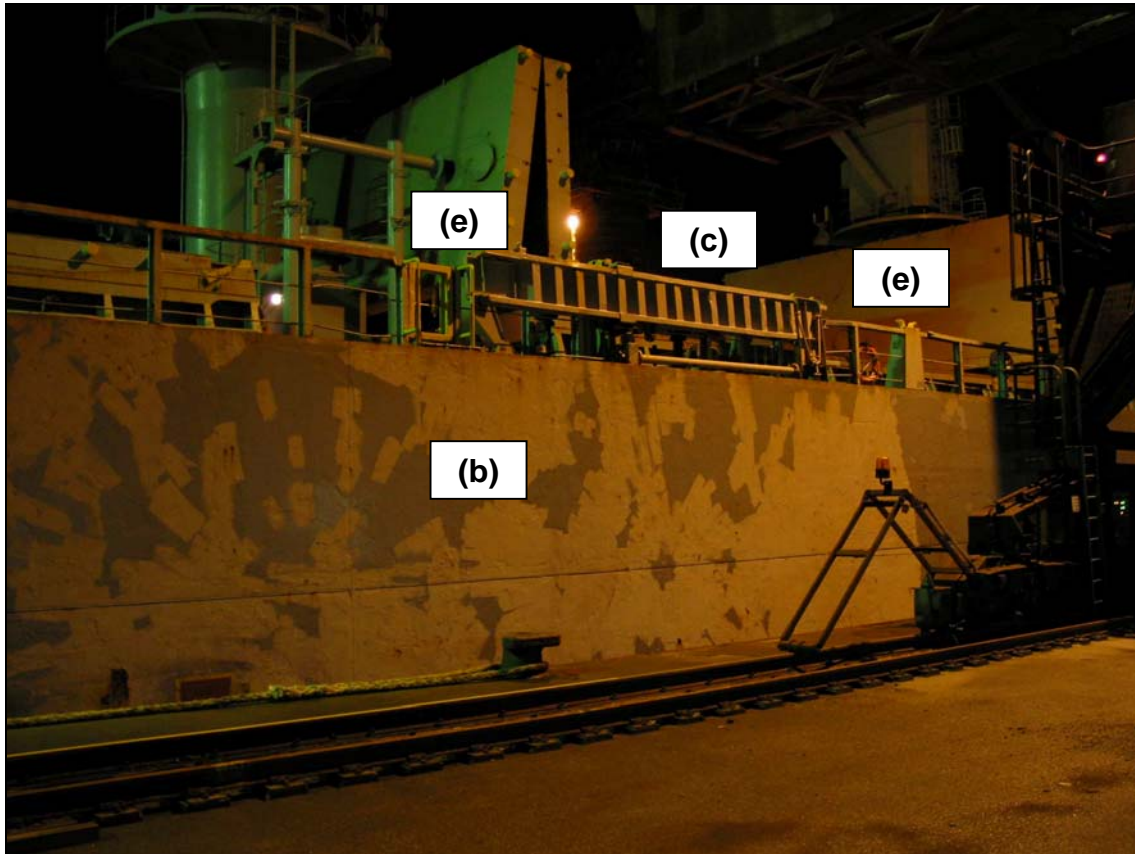
Figure 5: Pilot ladder station

In spite of the rough weather and the consequent movements of the ship, the bosun and both O/S had neither life jackets on nor were they secured by safety lines during their work on deck. The bosun should have secured himself at the latest when he decided to climb down onto the gangway. In addition, at least one of the two ordinary seaman should have supported him.

there was no officer on deck to supervise the rigging of the mixed pilot ladder.

However, the bosun should have fitted himself out with a life jacket and a safety line in order to be secured against falling over board during this work. Furthermore, an ordinary seaman should have secured him and an officer should have supervised the entire procedure for rigging the pilot ladder.
