Investigation Report 305/06

**Serious Marine Casualty**

**Collision between M/V LASS URANUS  
and M/V XIN FU ZHOU  
on 12 July 2006  
on the Elbe River**

2 May 2008

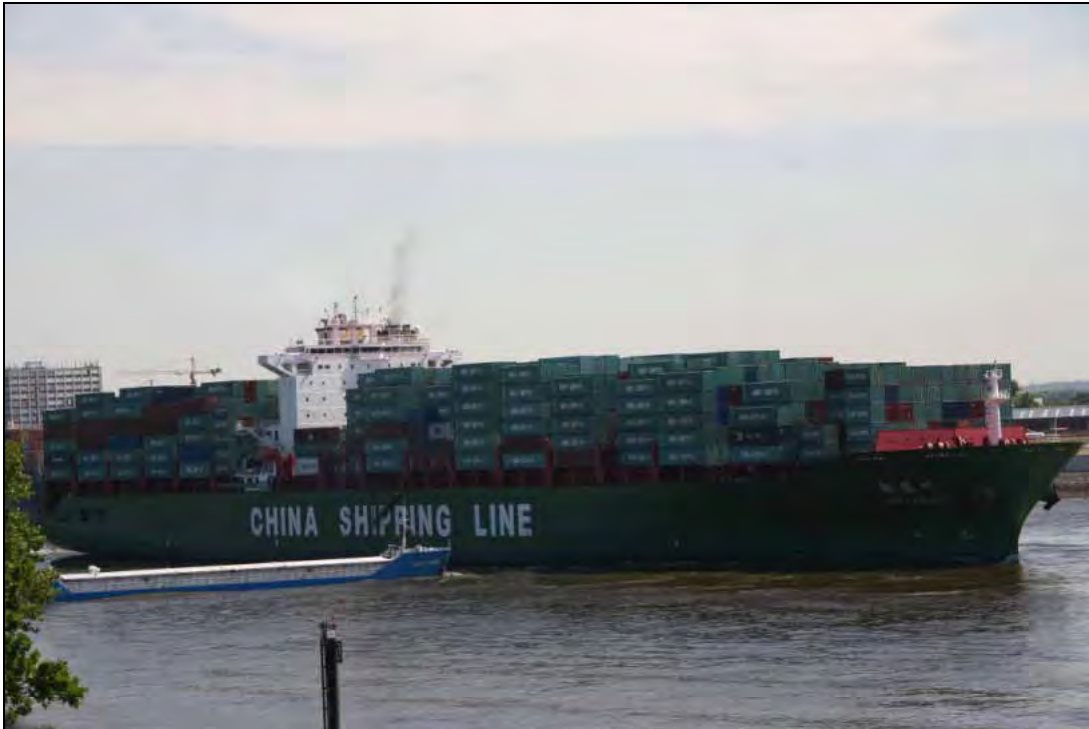
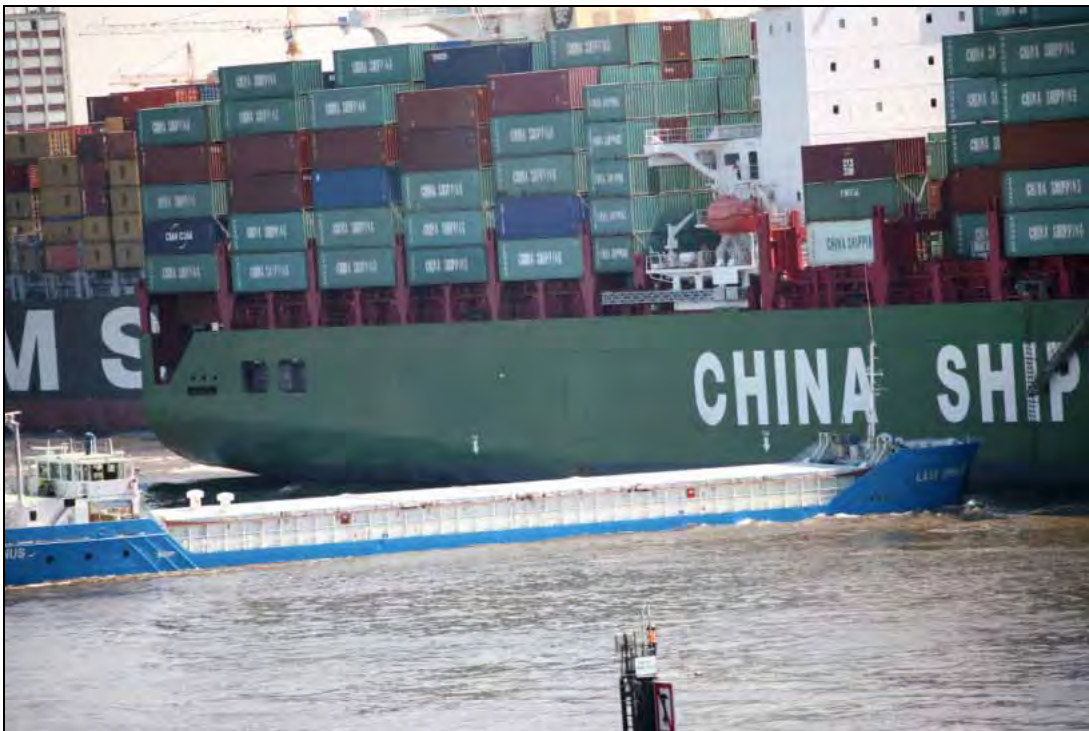
Two more photographs show the position of the LASS URANUS immediately before the collision with the starboard side of the XIN FU ZHOU (figs. 10 and 11).

Figure 10: Photo of the vessels involved in the accident immediately before the collision

Figure 11: Close-up immediately before the collision

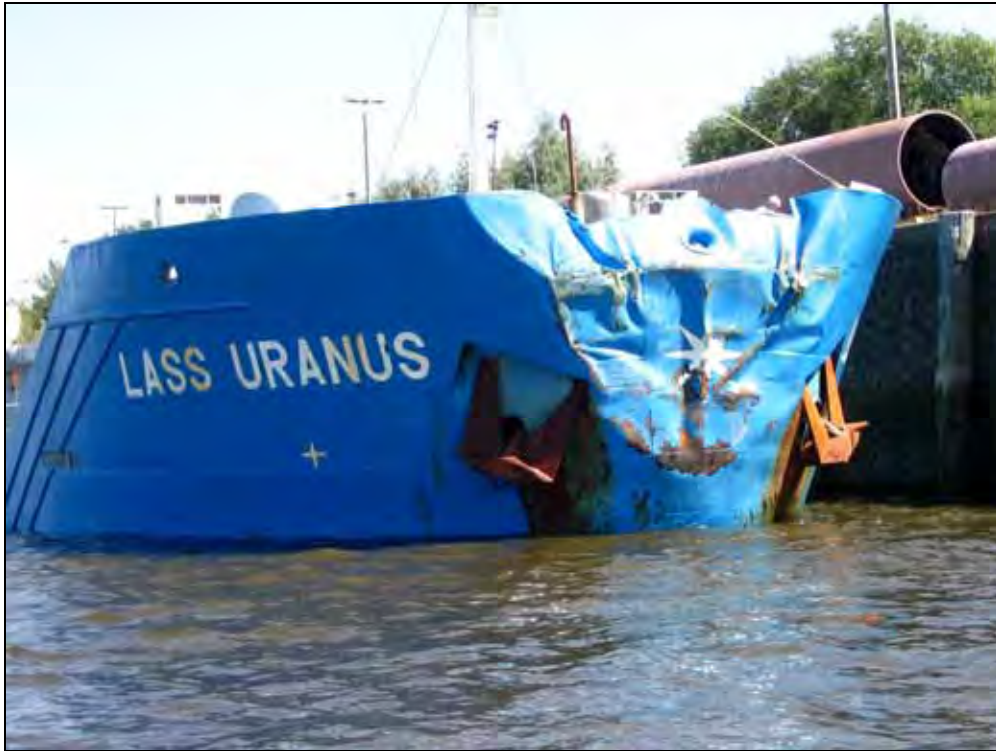
The collision caused an approx. 4.8 m deep dent in the LASS URANUS' stem above the waterline (figs. 12 and 13).

Figure 12: Damage to the LASS URANUS' stem

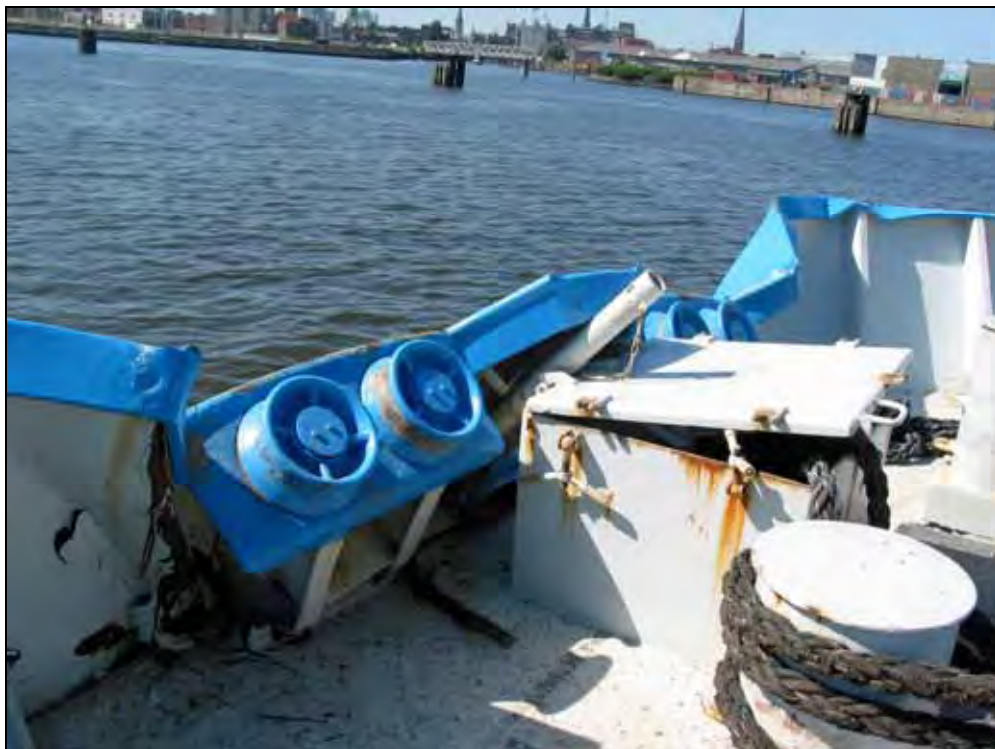
Figure 13: Damage to the forecabin of the LASS URANUS

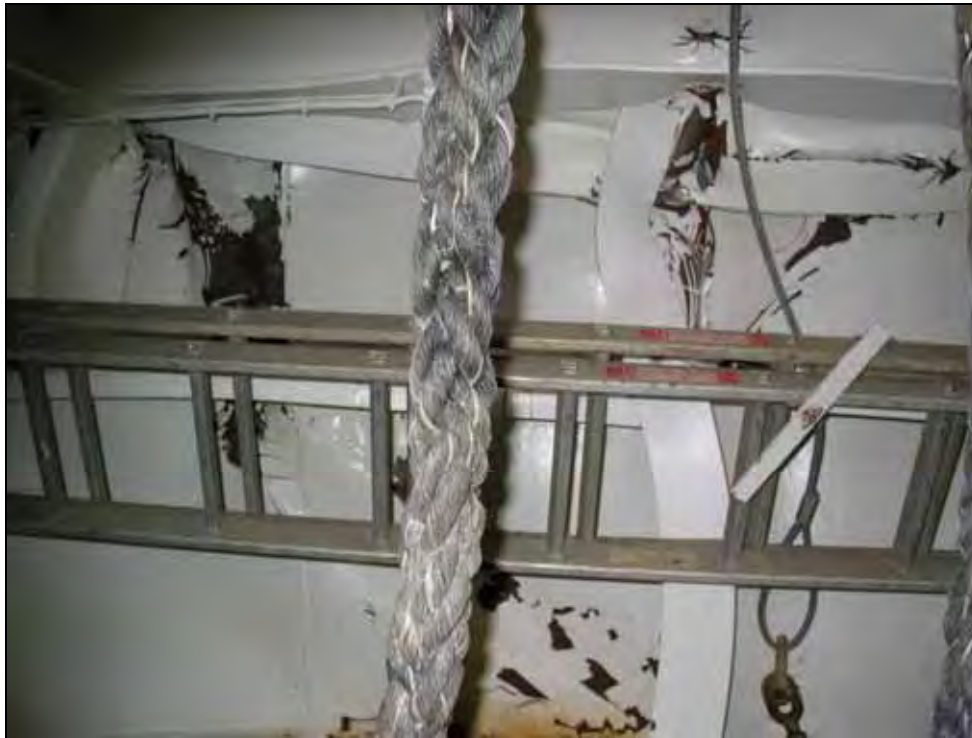
Damage in the vessel's interior ranged from the lower bosun store below the first deck all the way up to the forecabin (fig. 14).

Figure 14: Damage to the interior of the LASS URANUS

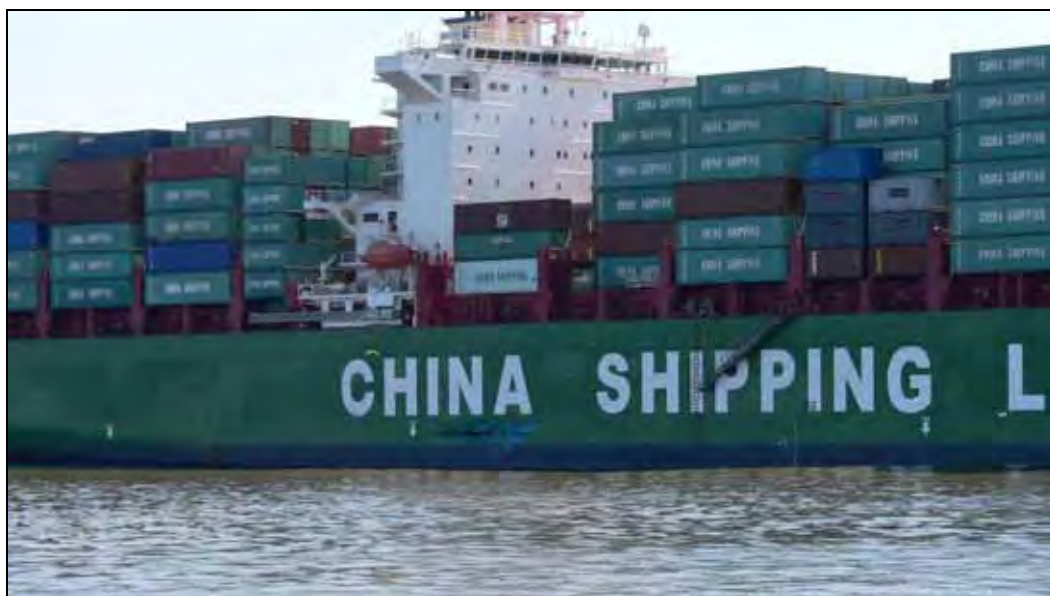
The hull of the XIN FU ZHOU sustained a tear above the waterline of approx. 0.5 m over a length of 8 m (figs. 15, 16 and 17).

Figure 15: Damage to the starboard side of the XIN FU ZHOU

Due to the collision two frames were dented. The XIN FU ZHOU's shipping company did not provide any information concerning the amount of the damage.

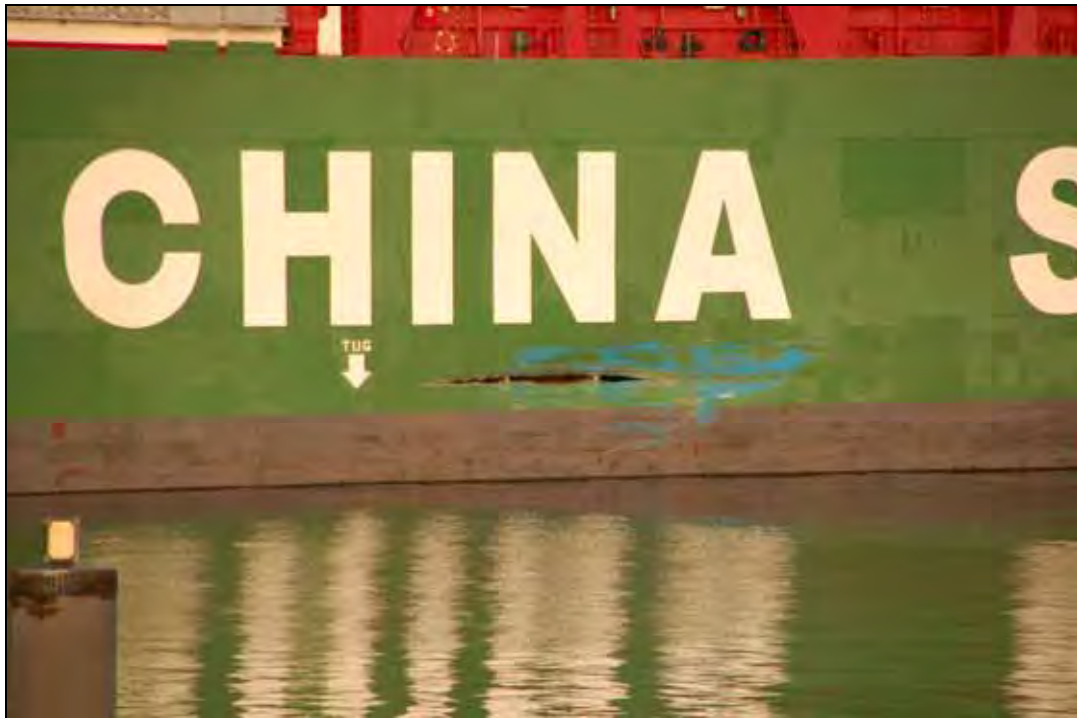
Figure 16: Close-up of the tear on the starboard side of the XIN FU ZHOU

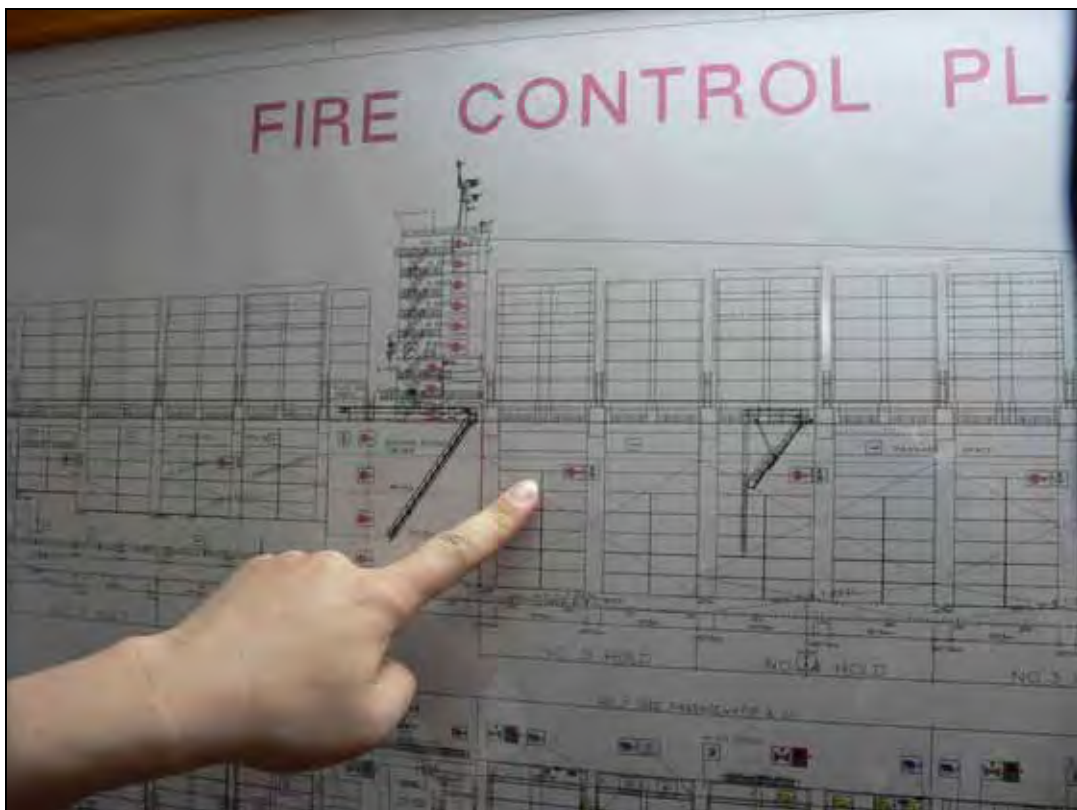
Figure 17: Location of the tear showed on the fire control plan of the XIN FU ZHOU

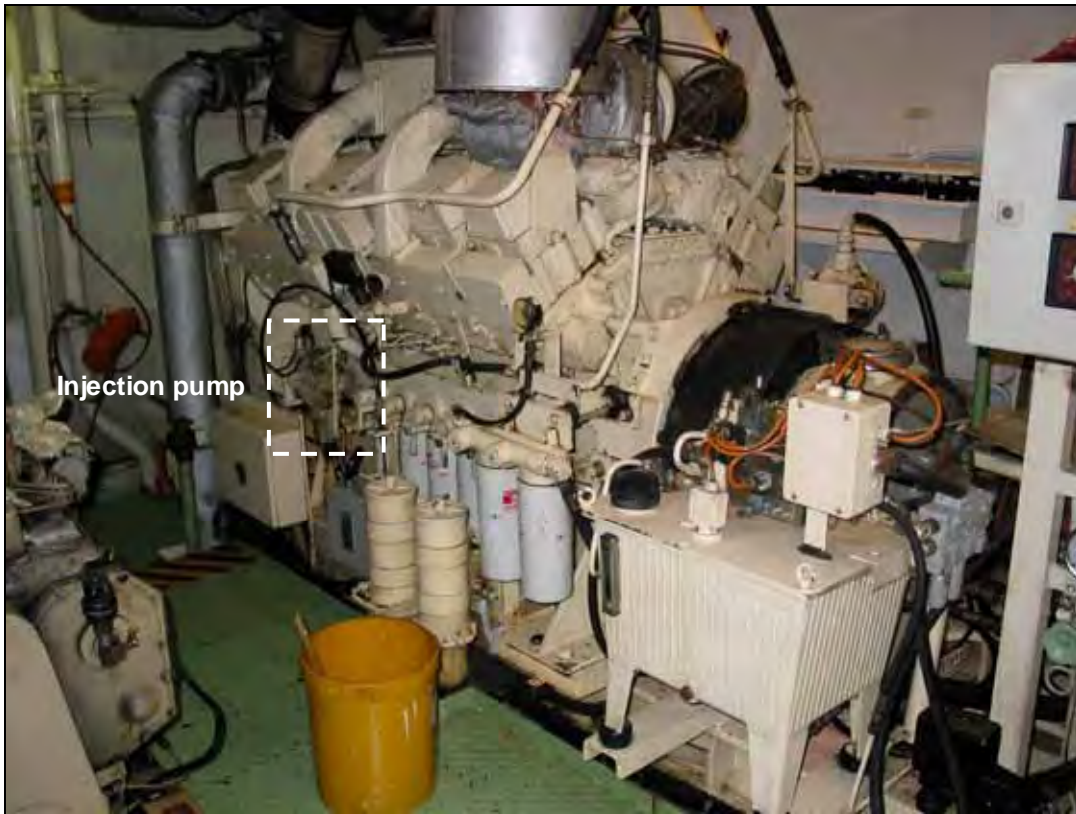
The seals on both the port and the starboard engines were intact.

Figure 18: Port main engine of LASS URANUS

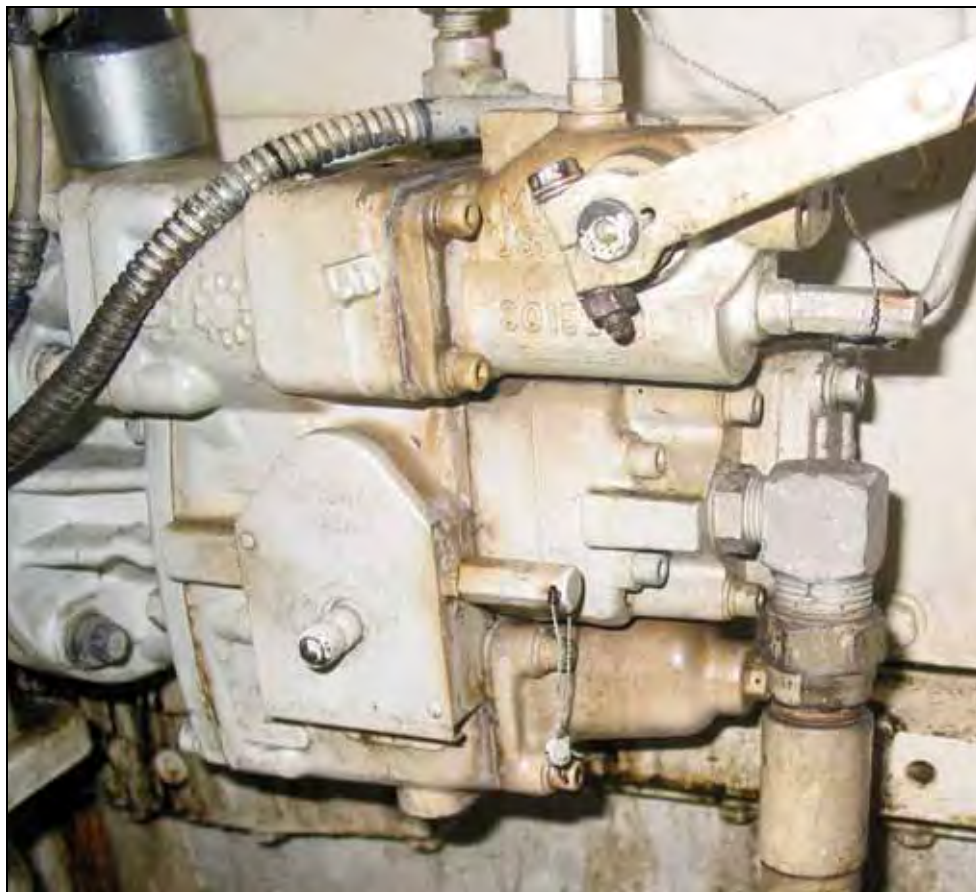
Figure 19: Leaded injection pump of the port main engine of LASS URANUS

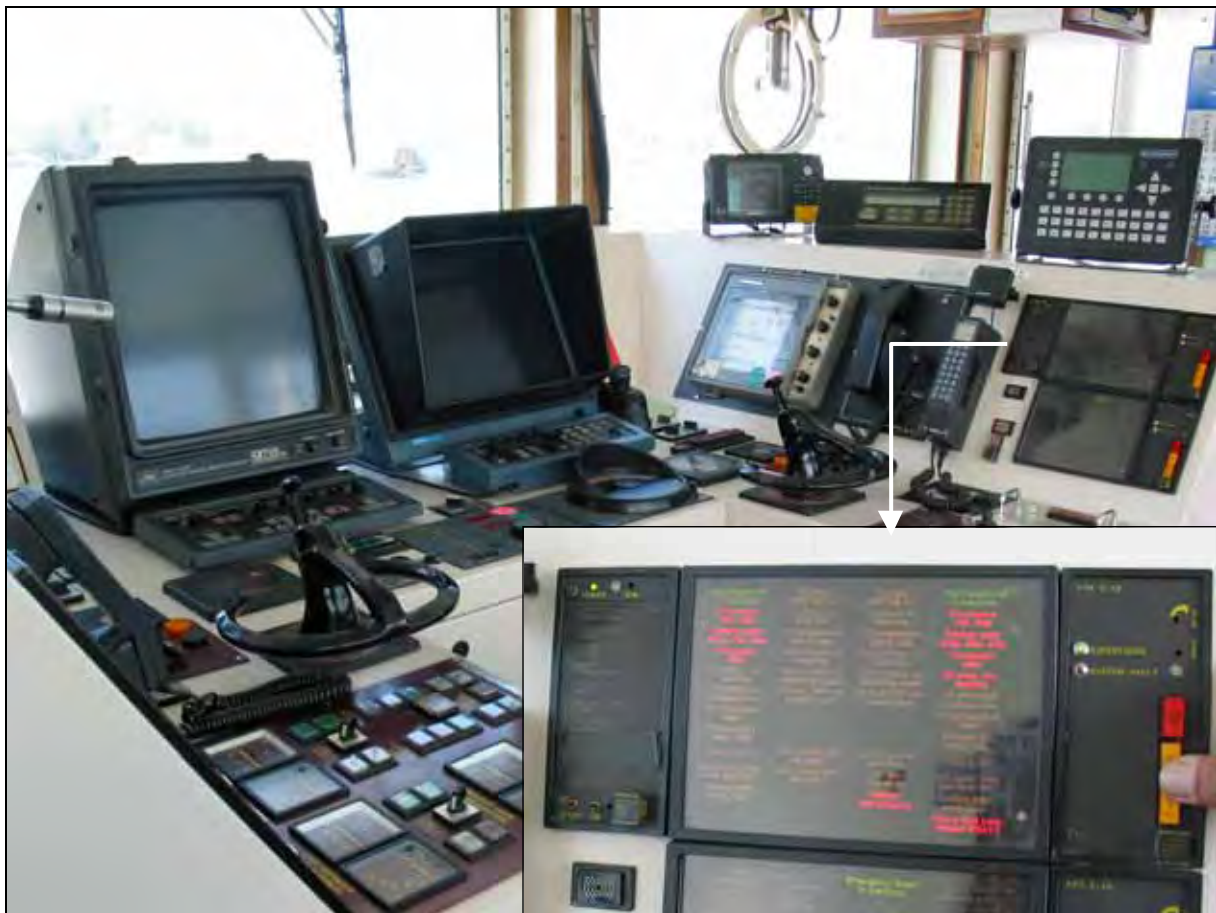
In addition, the alarm panel at the control position on the bridge of the LASS URANUS was also more closely inspected (cf. fig. 20). It indicates potential faults and overload situations in the two main engines.

Figure 20: Alarm panel on the LASS URANUS' conning position

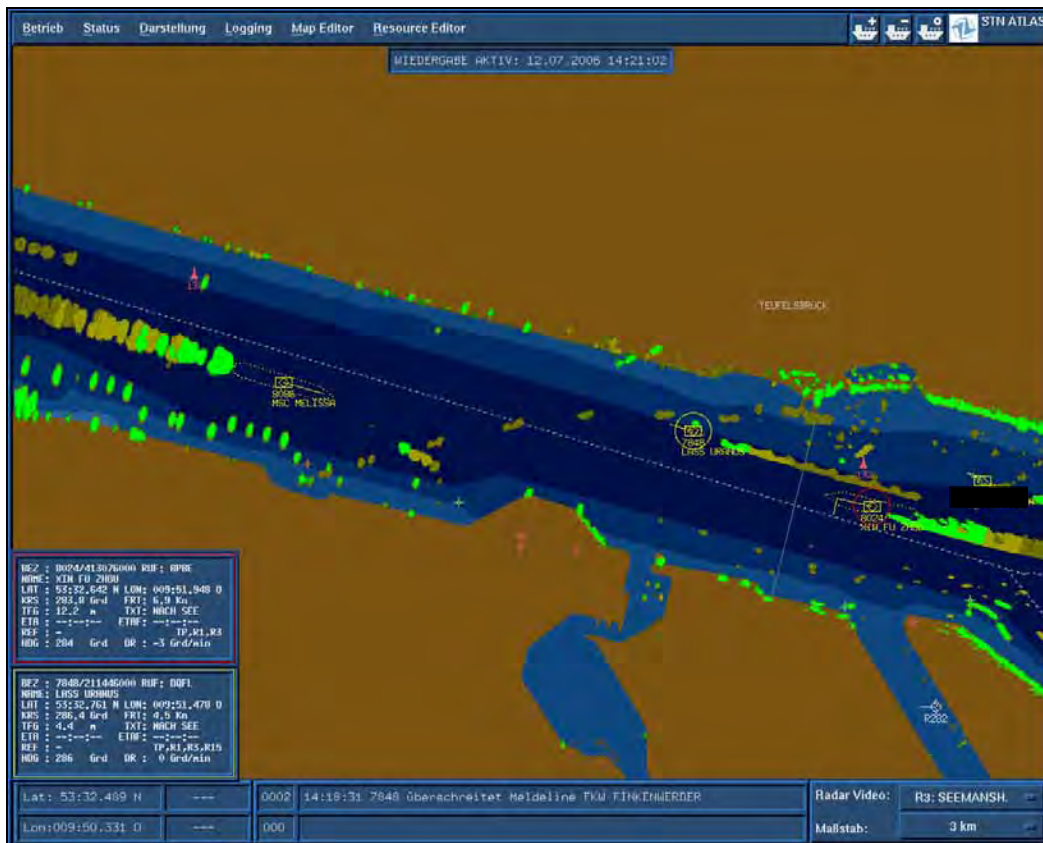
The tracking signs for the craft shown on the radar plots significantly differed from the actual vessel positions, as can be seen on figure 23 below. According to information received from HPA, this problem has in the meantime been substantially remedied by means of an optimisation of the software used in the VTC.

Figure 23: Shore based radar image at 14:21:02

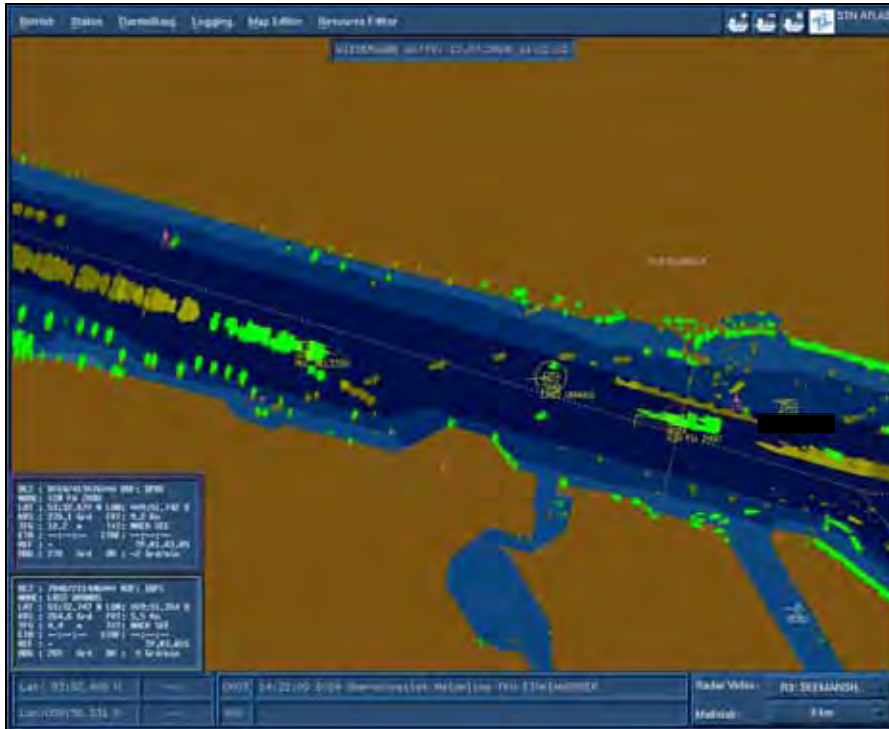
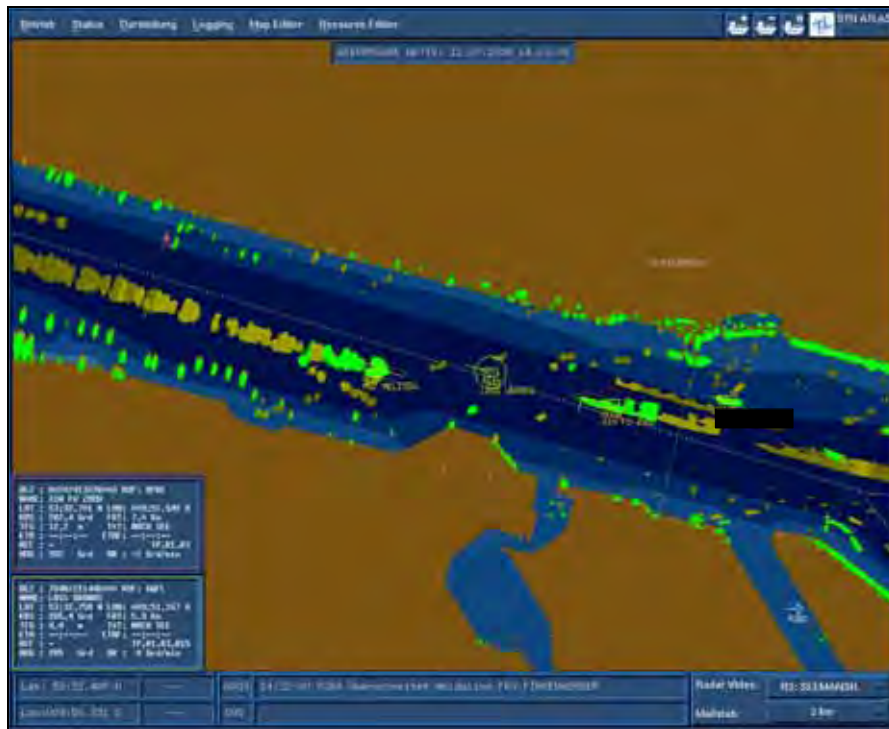
The tracking sign of the LASS URANUS continues to be shown, but does not represent the vessel's actual position (cf. fig. 24, 25).

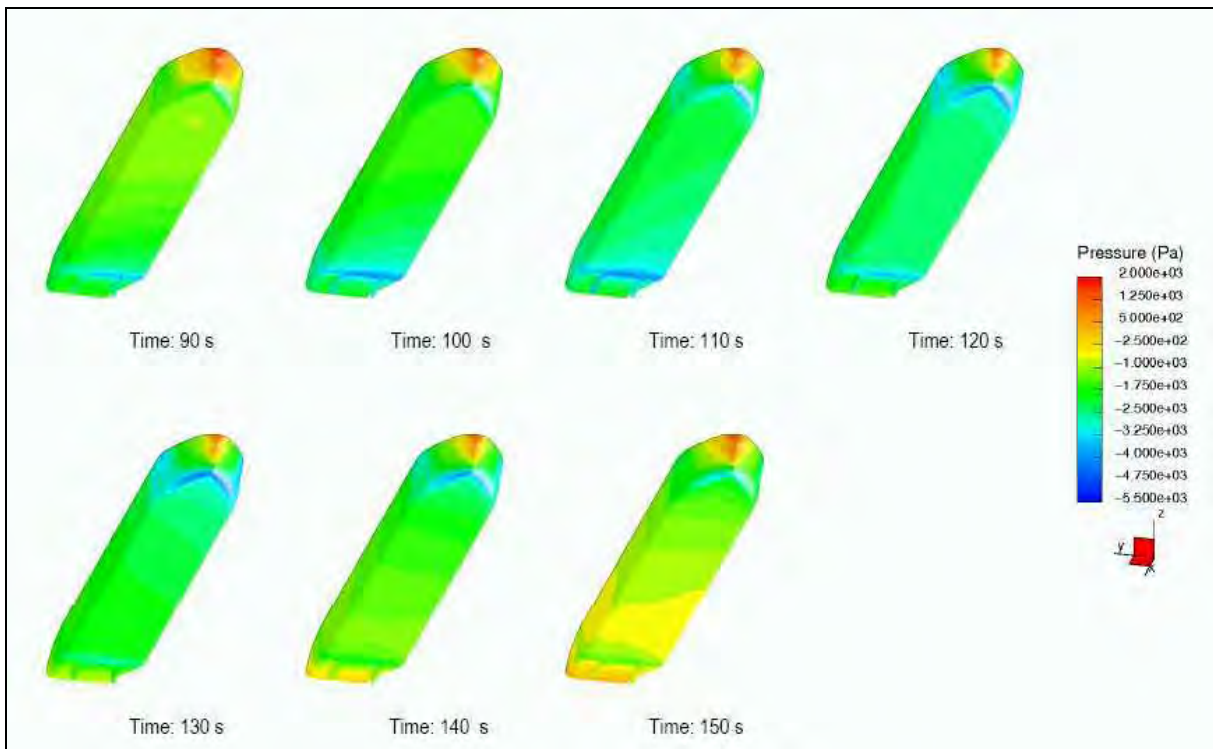
The pressure distribution on the underwater hull plating of the LASS URANUS calculated in the simulation constituted the foundation for the determination of the transverse forces and yaw-moments. The following figures show the pressure distribution from the underwater perspective. While just two minutes before the collision the pressure distribution is still even (cf. fig. 46), in the temporal approximation to the collision (approx. "Time: 120 s") the formation of a low-pressure area (marked in blue) at first at the stern (Time: 110 s) and later at the bow (Time: 130 s) can be clearly recognised (cf. fig. 47).

Figure 47: Pressure distribution on the shell plating of the LASS URANUS immediately before, during and after the collision
