Investigation Report 450/07

**Very Serious Marine Casualty**

**Collision between  
M/V HANJIN GOTHENBURG  
and M/V CHANG TONG  
on 15 September 2007  
in the Bohai Strait/PR of China**

15 September 2008

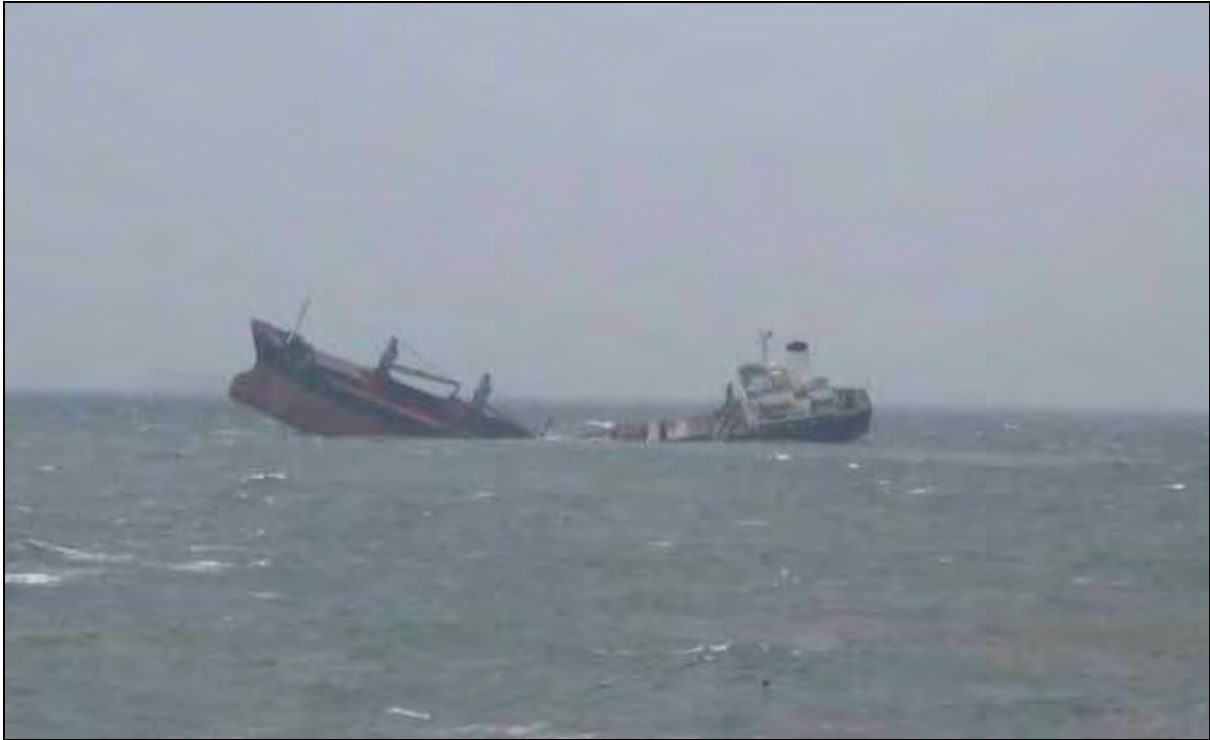
Figure 10: Breaking of the CHANG TONG shortly after the typhoon had passed through

At midday on 20 September 2007 the typhoon “Wipha” with strong gale forces of 9 Bft separated both vehicles. The CHANG TONG was torn apart upon separation (cf. figure 10).

The forecastle bent in direction of the aft ship, tore and came to rest at an angle of about 90° to the aft ship below the surface of the water. The aft ship stuck in the seabed at a water depth of 18 m whereas the superstructure and the engine room remained above the waterline (cf. figure 11).

After the typhoon had passed and separated both vehicles, the CHANG TONG broke amidships (cf. figure 10) and sank (cf. figures 11 and 12).

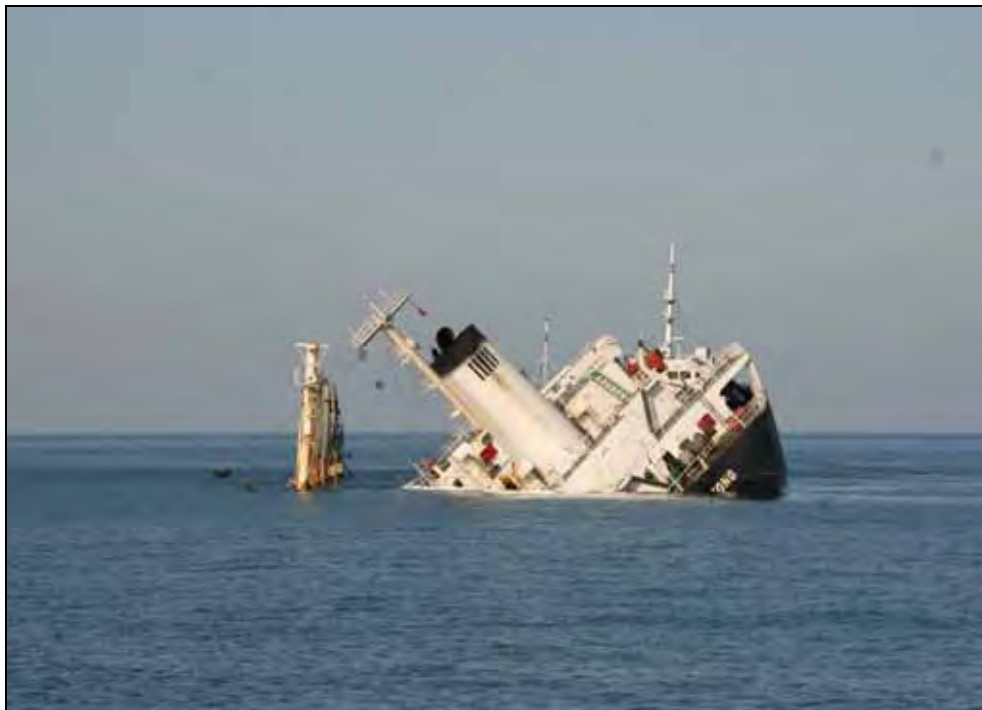
Figure 12: Wreck of the CHANG TONG on 8 January 2008

After the weather had improved, it was possible to pump out heavy fuel oil from the wreck of the CHANG TONG in not quantified quantities. During the winter, the forecastle sank down to the seabed. The aft ship also sank further with an increased list to port (cf. figure 12).

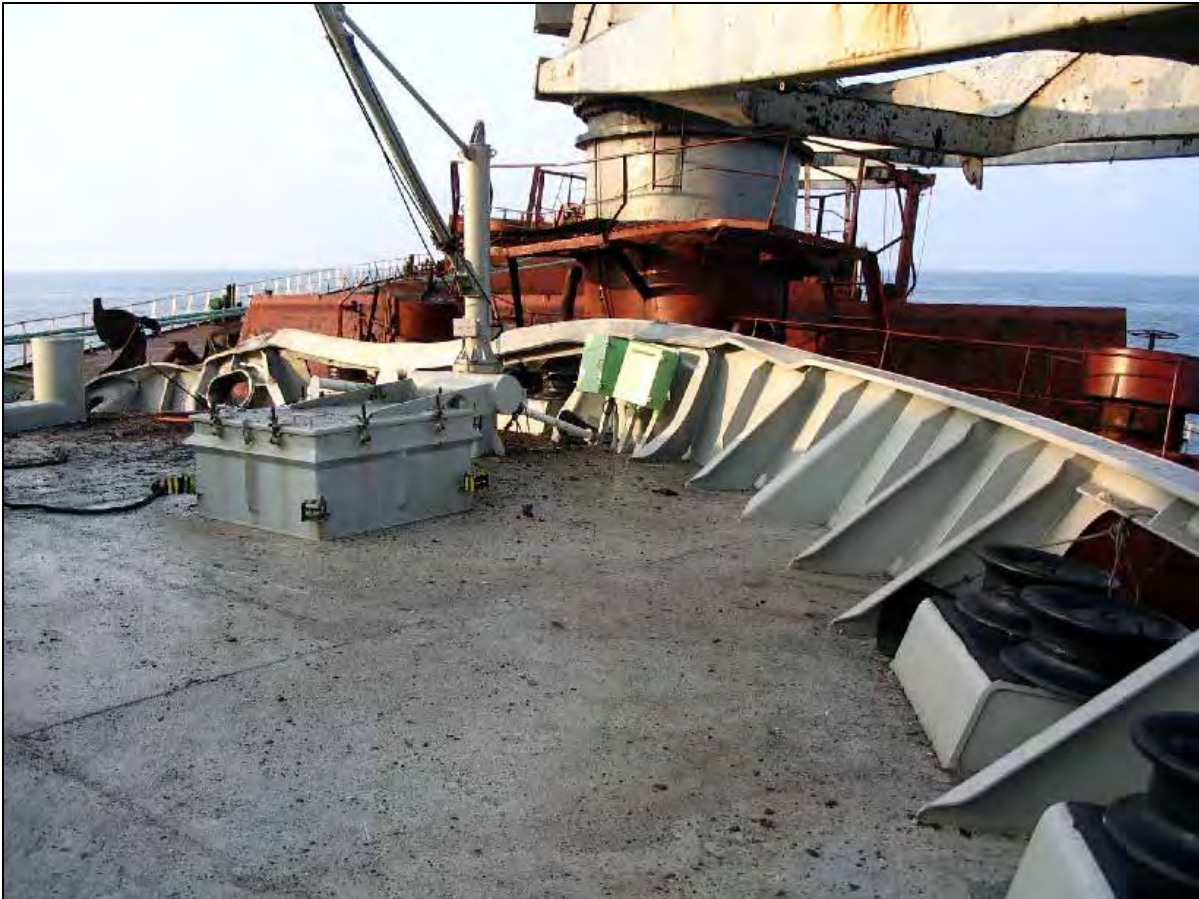
Figure 13: Forecastle of the HANJIN GOTHENBURG on 17 September 2007

The bow of the HANJIN GOTHENBURG was deformed by the collision (cf. figure 13) and the ground tackle of the starboard anchor was damaged.

The bulbous bow was severely notched when it slid under the hull of the CHANG TONG due to the impact of the HANJIN GOTHENBURG.

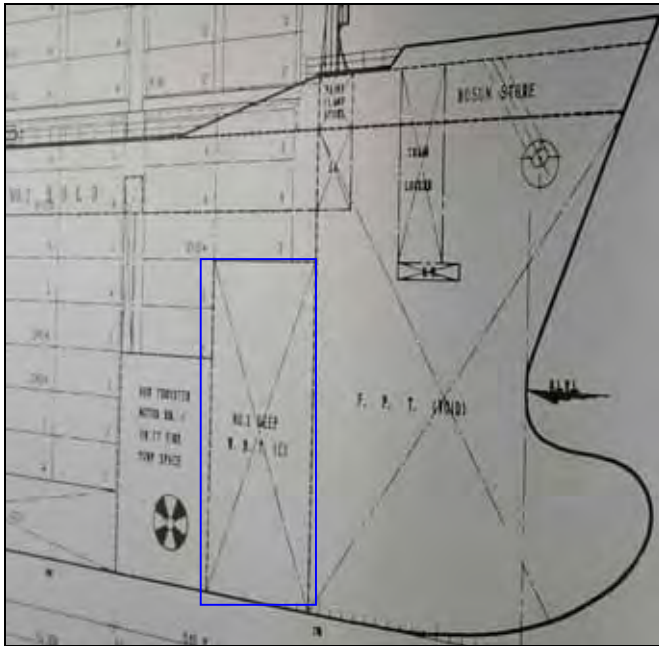
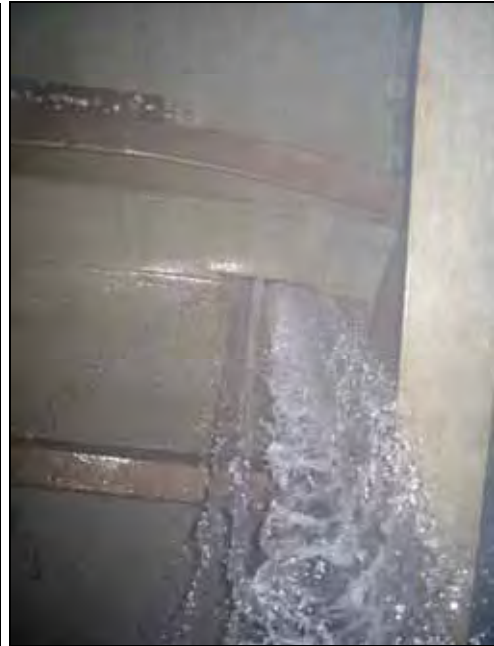
Figure 15: Tear in deep tank no. 1

Ballast water tank no. 1 was penetrated by water due to a tear, about 20 cm wide, in the hull (cf. figure 14 with designated position of the deep tank and figure 15).

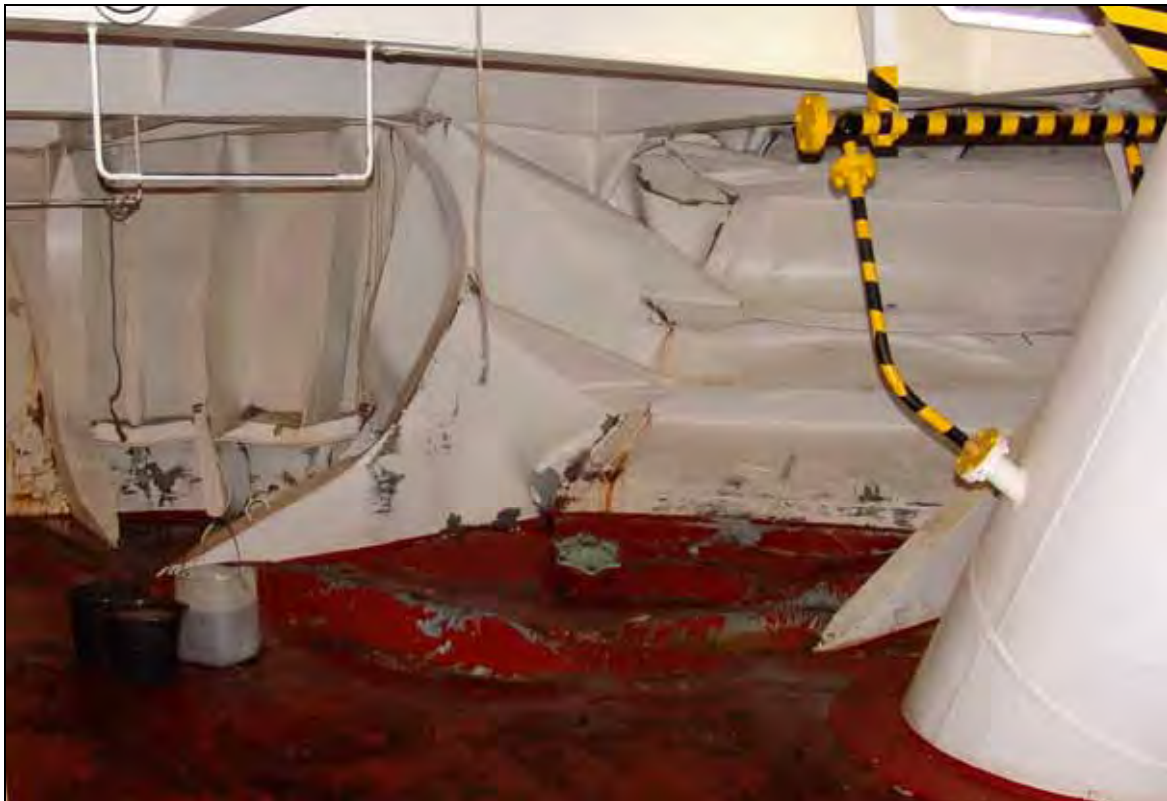
Figure 16: Bosun store of the HANJIN GOTHENBURG

The frames in the forecastle area suffered considerable deformation (cf. figure 16).

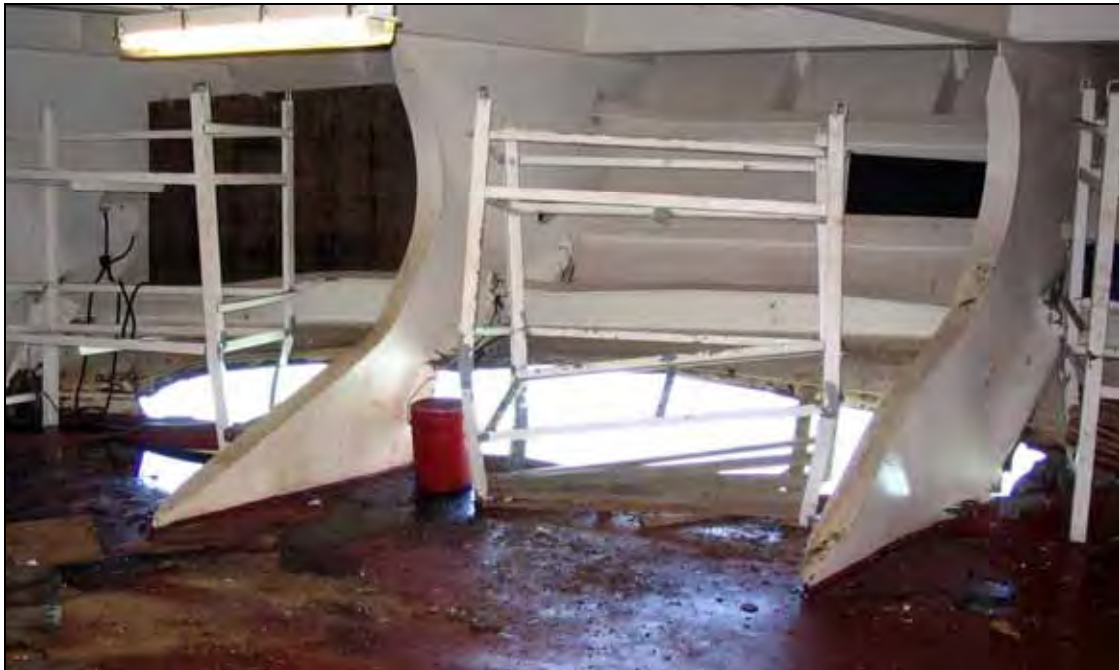
Figure 17: Tear in the hull of the HANJIN GOTHENBURG on 21 September 2007

A tear measuring approximately 5 m in length and 0.5 m in height above the water line occurred on the starboard side of the bosun store (cf. figure 17).

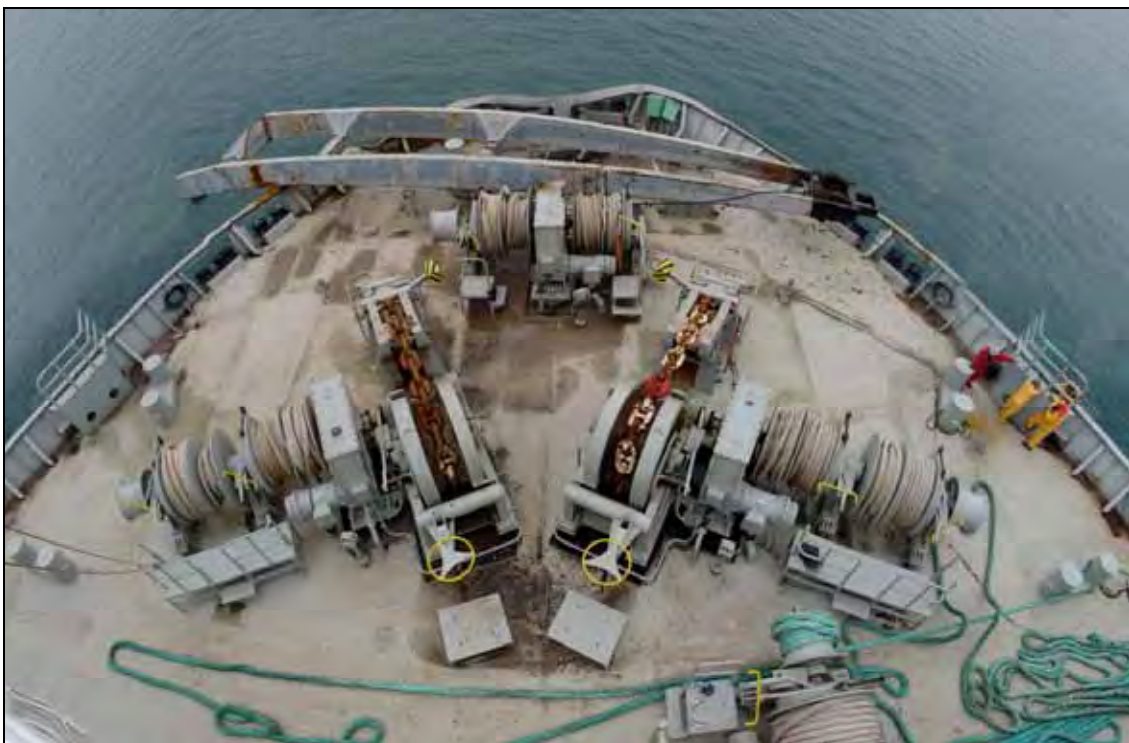
Figure 18: Forecastle of the HANJIN GOTHENBURG on 25 September 2007

When both vehicles were separated by the typhoon, the jib of the third deck crane of the CHANG TONG broke off and remained stuck athwart the forecastle of the HANJIN GOTHENBURG (cf. figure 18).

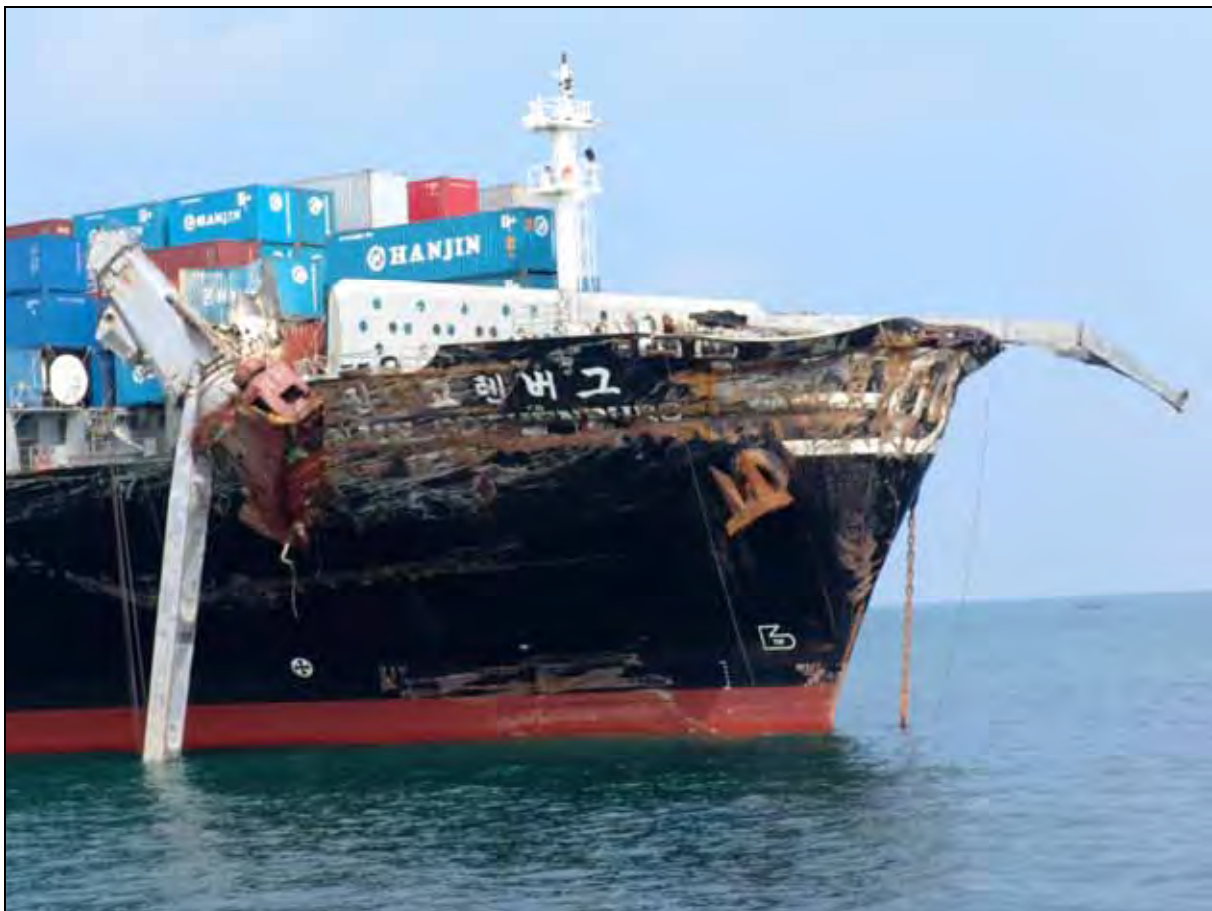
Figure 19: Bow of the HANJIN GOTHENBURG on 25 September 2007

The CHANG TONG's fourth deck crane was completely torn off during separation of the wedged vehicles and clung to the starboard side of the forecastle area of the HANJIN GOTHENBURG (see figure 19). Thereby the containers which were stowed in the first bay on deck were torn up, which led to chemicals being discharged which fall under the classification of the German Ordinance on the Transport of Dangerous Goods by Marine Vessels (Gefahrgutverordnung See) and the International Maritime Dangerous Goods (IMDG) Code (cf. figure 20).

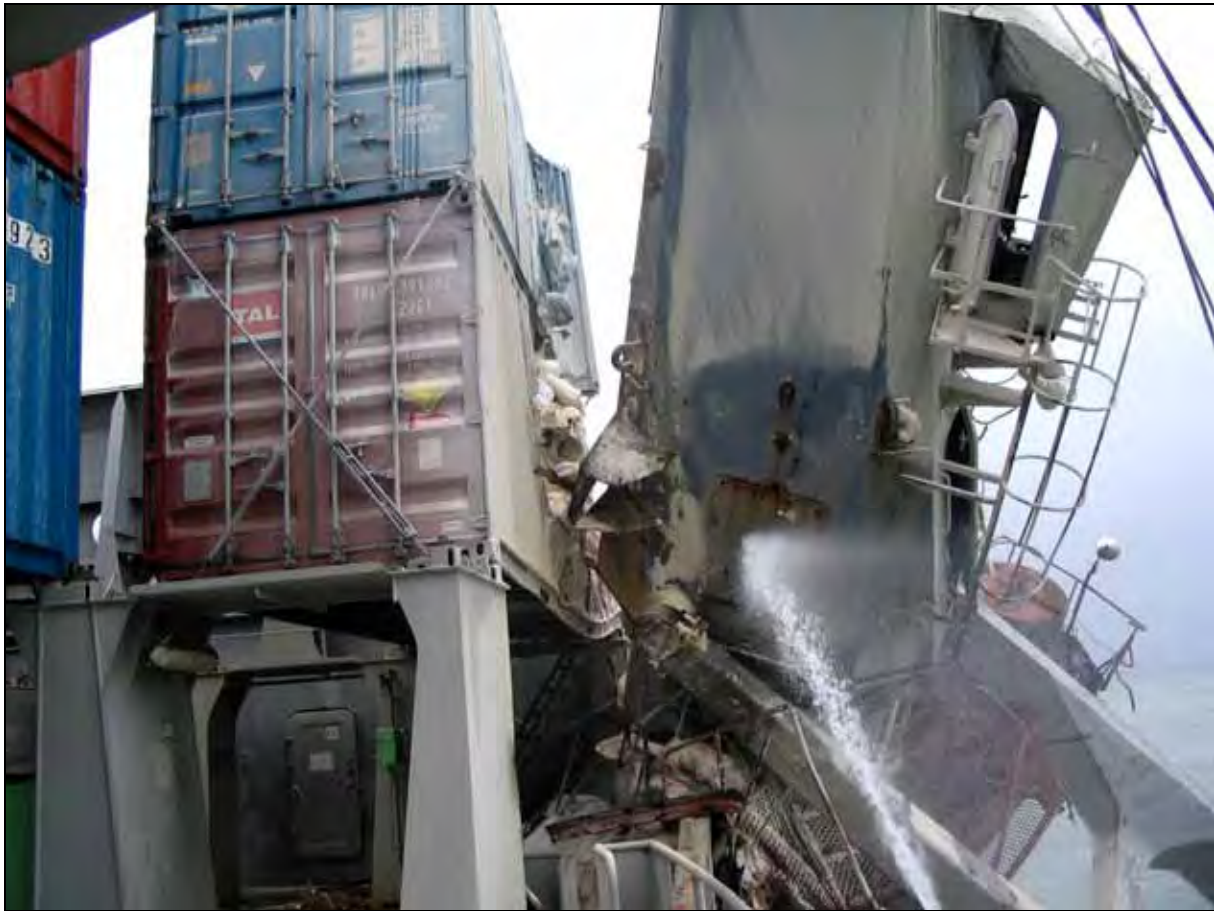
Figure 20: Damaged containers on the HANJIN GOTHENBURG on 20 September 2007

The bosun of the HANJIN GOTHENBURG, who came into contact with these chemicals during the clear-up and safeguarding measures on the forecastle, suffered temporary irritation of the eyes.

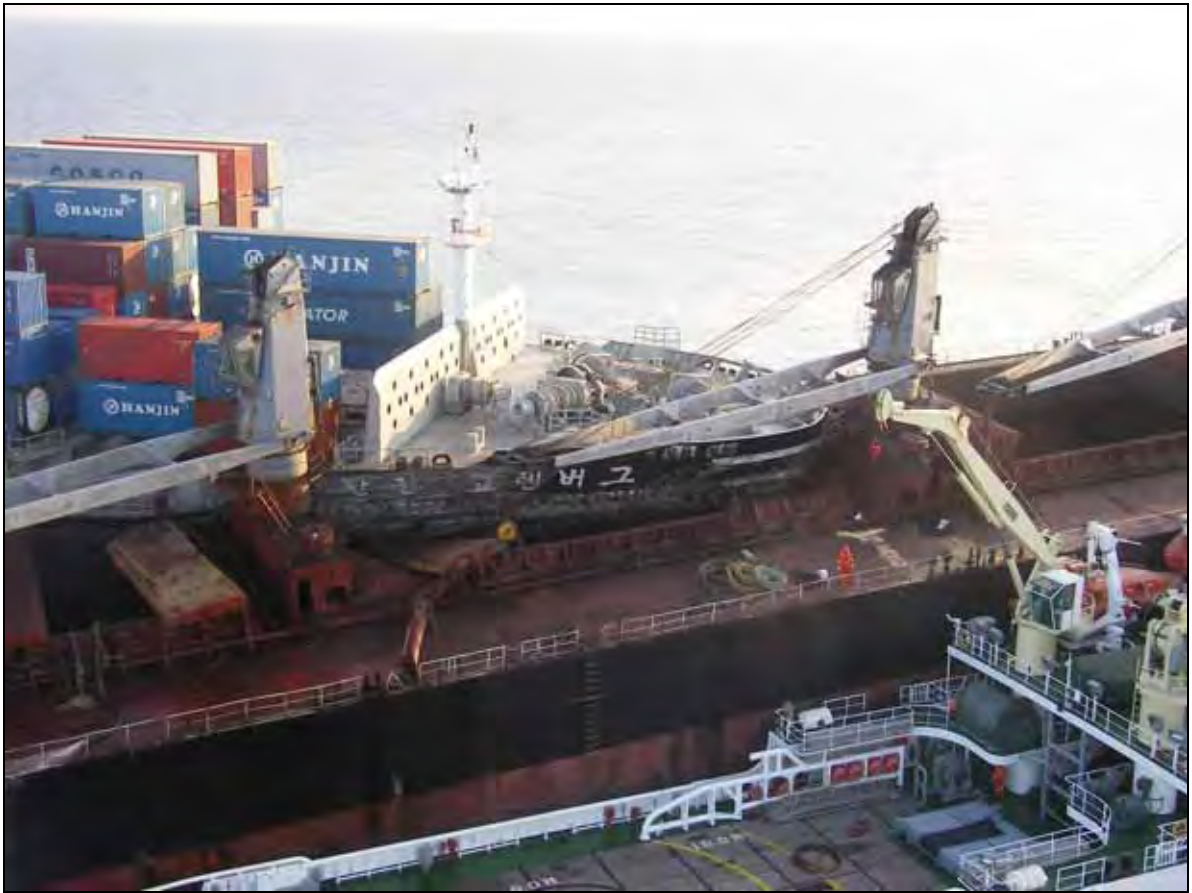
Figure 21: Close-up of the vehicles wedged into each other

The bow tore apart the bulkhead between cargo holds 3 and 4 which caused substantial deformation and breaking of the bulkhead and the frames. The upper and lower side tanks in these areas were destroyed. Water penetrated cargo holds 2 to 5.

Deck cranes 3 and 4 were damaged.

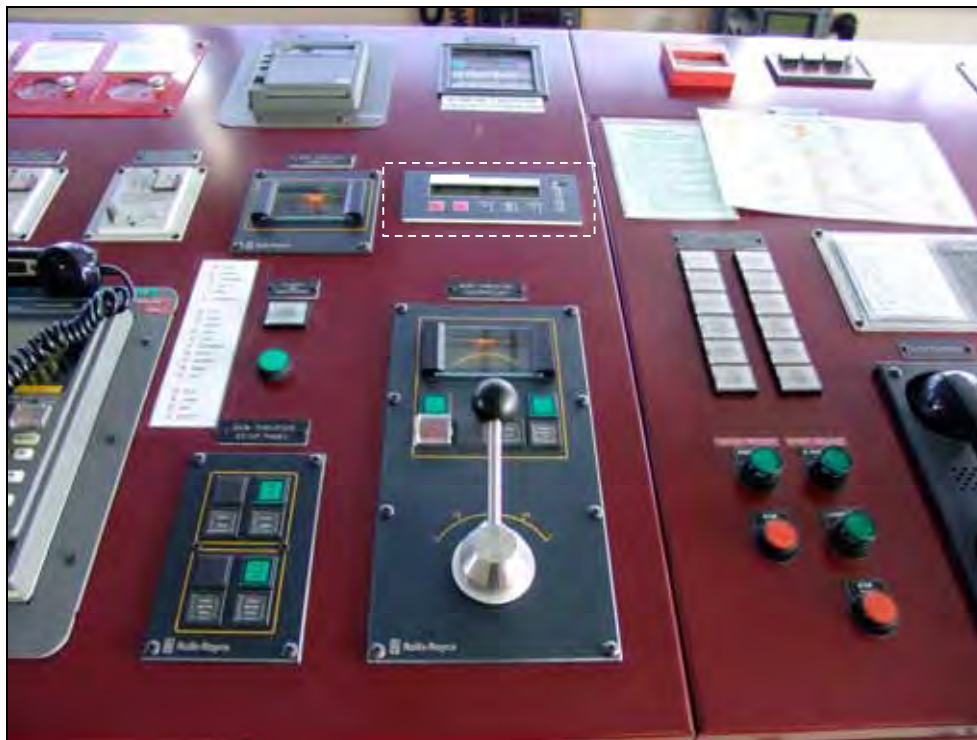
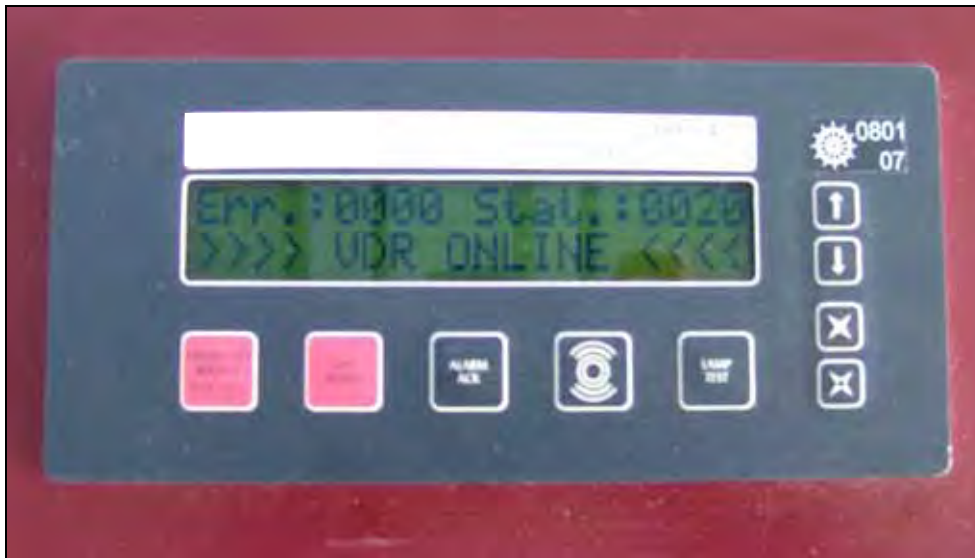
The operating console of the S-VDR displayed an error message when the BSU first performed a survey (cf. figures 42 and 43).

not operating securely in all operating modes, irrespective of operating actions being performed or not. A back-up was recorded or not, depending on at which position within the programme cycle the internal programme actually was. The reaction (back-up performed or not) could not be foreseen by the vessel's crew, regardless of whether the back-up was initiated on the control unit or on the S-VDR main unit. Apart from this malfunction, which was rectified on the 22 October 2007, a fuse had burned through leading to the operating device's display not functioning properly. The system's functionality was restored after the fuse had been exchanged.
