Bundesstelle für Seeunfalluntersuchung
Federal Bureau of Maritime Casualty Investigation
Federal Higher Authority subordinated to the Ministry of Transport,
Building and Urban Affairs

Investigation Report 537/06

Person overboard
from MS BELUGA STIMULATION
on 27 October 2006 at 08:20
in the German Bight

1 June 2008

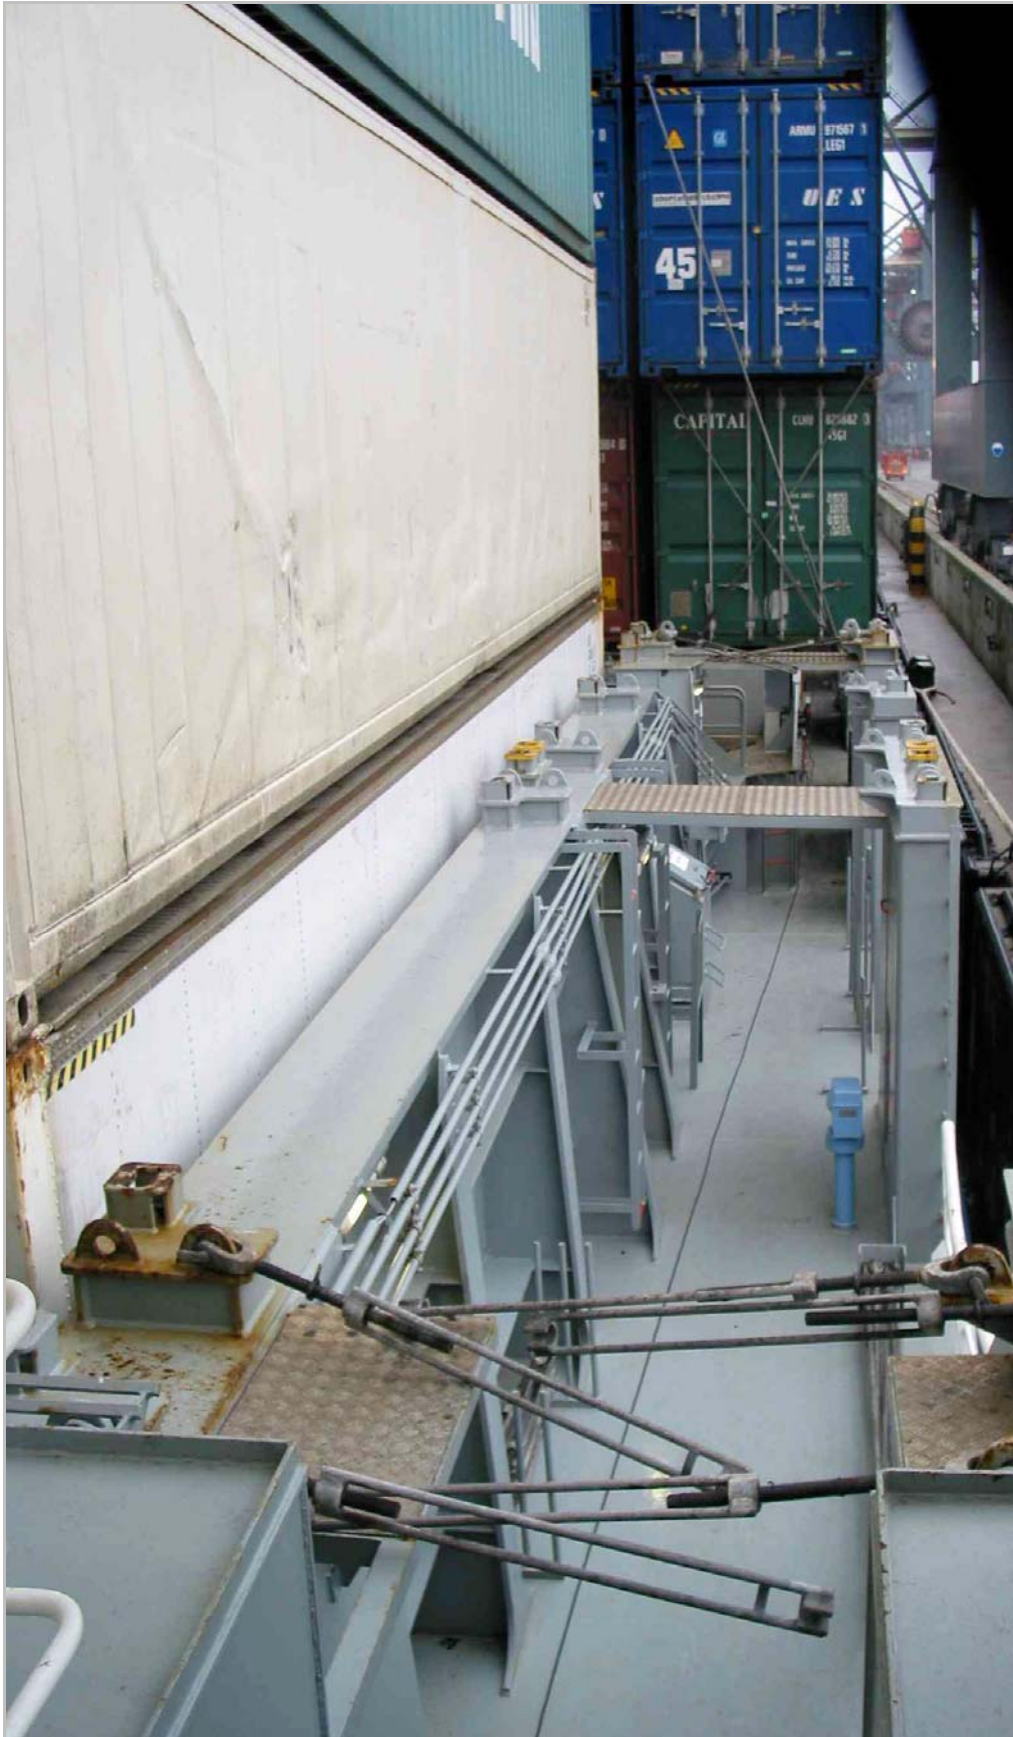
Figure 4: Passageway on starboard

The path to and from the scene of the accident lead via the starboard passageway which is separated (see fig.4) on the outside by a 1.05 m high railing and on the inside by partitioned areas – amongst others for stowing lashing material (twistlocks).

The passageways on the starboard and portside were regularly flooded by green water . Notwithstanding, the Captain saw a greater danger from loose lashing material. Hence he gave instructions not to go forward between the containers but via the lee passageway. However, this assessment of the risk did not take into account whether there was a need to enter the main deck.

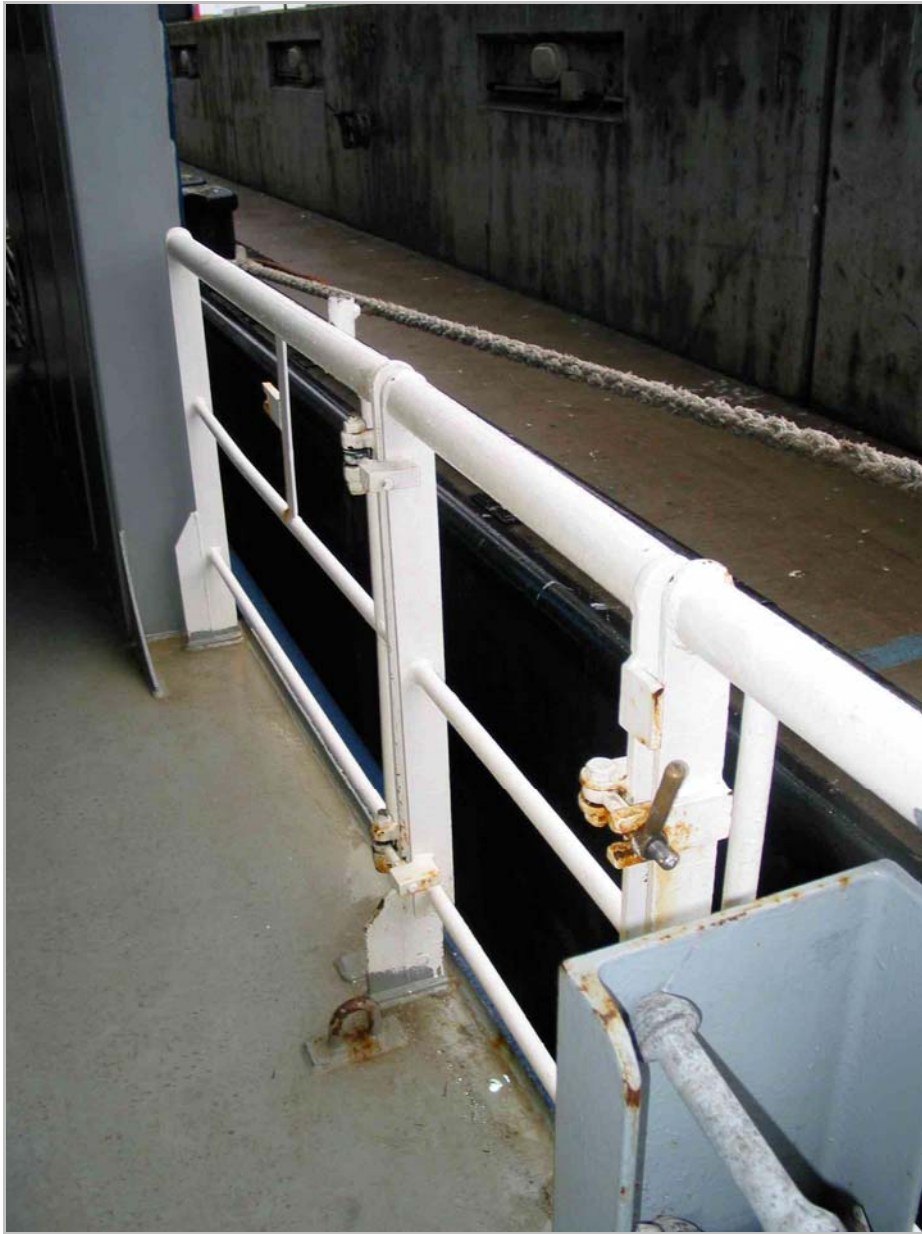
Figure 5:pilot shipside door on starboard

A pilot shipside door is located in the railing a few metres away from the superstructures (see fig. 5).

Both engineers firstly closed the cover of the hatch cover controller. This is located at Bay 25 in immediate proximity to the pilot shipside door. They then gripped the railing when the next big wave washed over deck. The pilot shipside door is only differs slightly from the actual railing. A rope fender is always located directly beside the pilot shipside door underneath the pilot ladder to hold a pilot boot. The casualty had such a rope fender (see fig. 7) on his person when he was rescued by the lifeboat. Admittedly, it is very difficult to throw a rescue object to somebody who has fallen overboard so that it gets to him. Thus, in this specific case the Second Engineer was

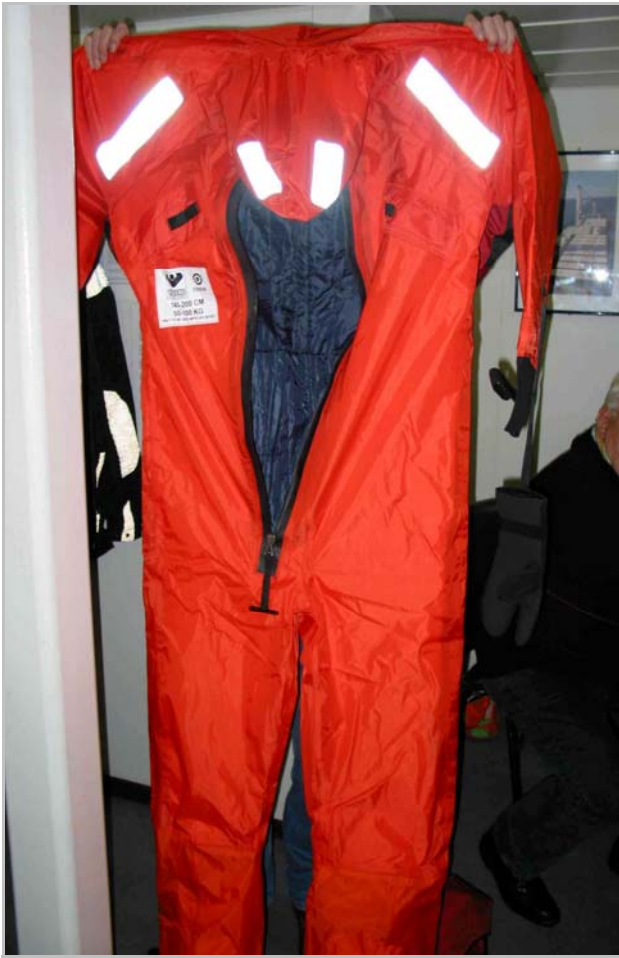
Figure 6: Immersion suit – similar to the used suit

The Second Engineer was wearing a immersion suit without a life jacket when he fell overboard (see fig.6).

He was able to draw the attention of the rescuers with the aid of a torch that he had on his person.

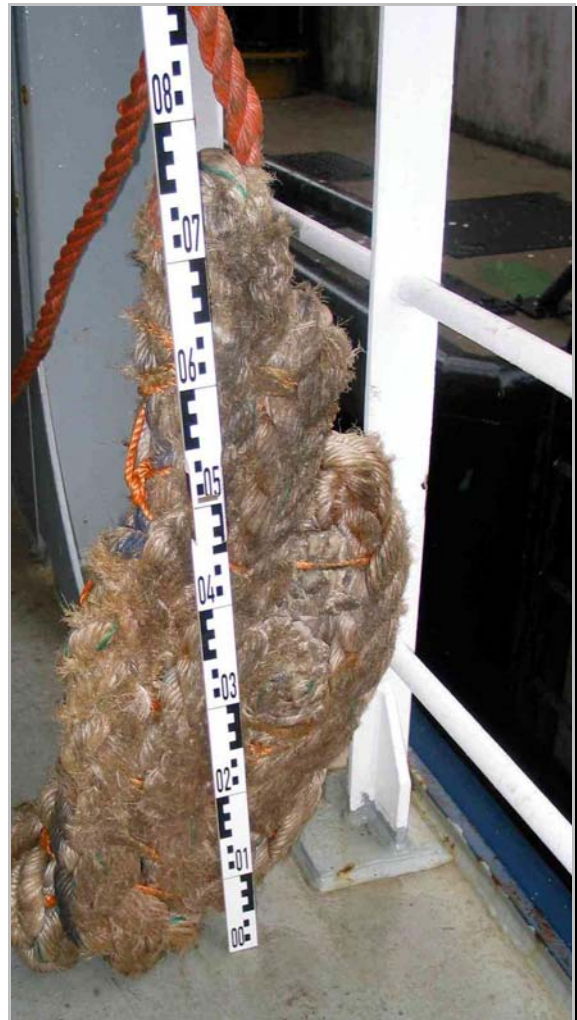
Figure 7: Fender – similar to the fender that was carried away

A fender is attached to the railing beside this pilot shipside door with the purpose of cushioning the pilot boat (see fig. 7).

not able to use the life buoy that had been thrown to him. For this reason it can be assumed that he grabbed the fender when he was suspended from the outside railing – or even most probably from the pilot shipside door. The BSU assumes that the Second Engineer wanted to cling to the railing but, in fact, gripped the pilot shipside door unintentionally. His body resisted the onslaught of the body of water with the result that the pilot shipside door pressed his body inwards. The pilot shipside door lock enables this as it opens towards the inside (see fig. 17). At this moment the vessel lay on its portside. Then the BELUGA STIMULATION rolled starboard and the pilot shipside door struck the railing's limit stop with increased force. This jerking movement made the Second Engineer fall over the pilot shipside door and thus overboard. He was able to hold on for a brief moment and attempted to hoist himself up by grabbing the fender. This did not help secure him and he fell into the water with the fender.

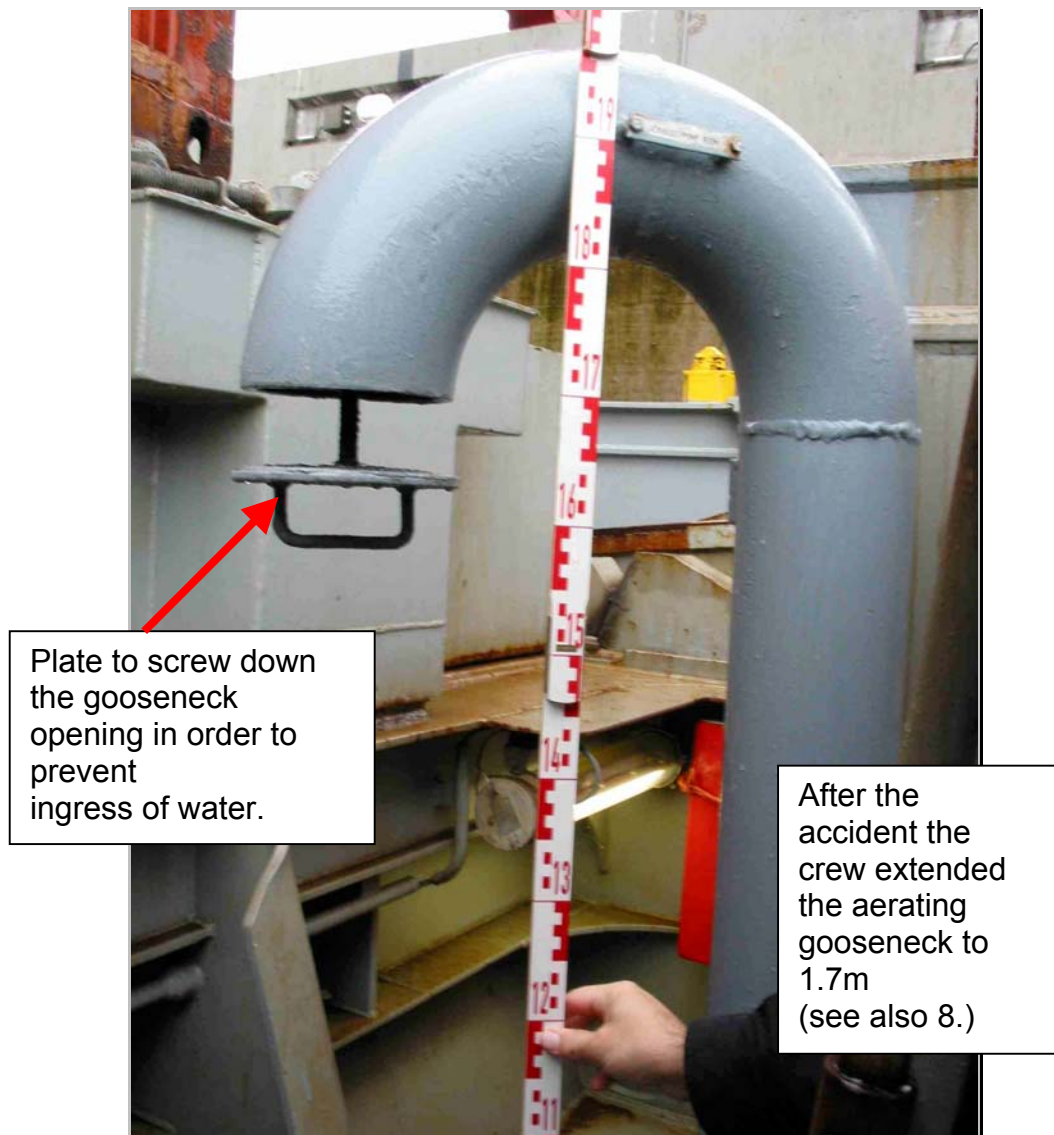
Figure 8: Aerating gooseneck – after extension

There are two goosenecks in the cross passageway between the holds 2 and 3 where entry to the bunker room is located: one for aerating and the other for de-aerating the bunker room. They are used for active ventilation. The gooseneck for de-aerating is installed at such a height that water could not have penetrated. The gooseneck for aerating was so short at the time of the accident that it was located about 70 cm above the deck. If the level of water had increased to over 70 cm, augmented by the movements of the vessel, then water may have penetrated at this location.

- 2) **The Federal Bureau of Maritime Casualty Investigation recommends the operators of seagoing vessels and vessel command** (in accordance with Accident Prevention Regulation for Shipping Enterprises § 80):
Ventilators and air pipes must be closed in sufficient time when the danger arises that water can thereby penetrate the vessel in large quantities.
