# **Summary Investigation Report 558/07**

**Serious Marine Casualty**

Grounding of the Motor Vessel
LADOGA-3
off the Darss peninsula, Baltic Sea on
16 November 2007

Ref.: 558/07

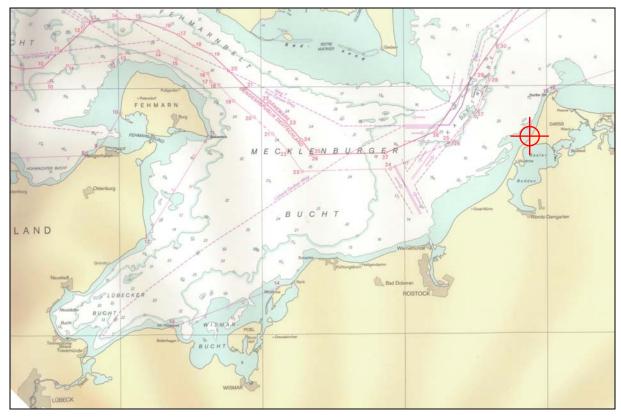
Figure 1: Chart showing the grounding position

Latitude/Longitude:  $\phi$  54°24,31'N  $\lambda$  012°26,82'E

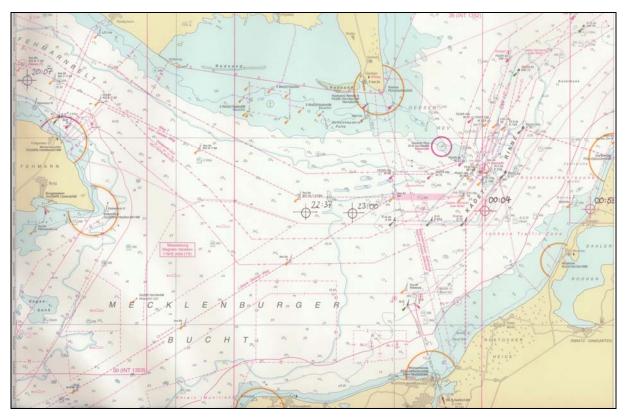
The ship's log showed three position entries after the time when the Master had taken over the watch at 19:00. The first entry was made 67 min after the start of the watch. At this time the vessel was at the course change point near buoy KO 6 - T 63, north of Fehmarn. The Master made another entry 2.5 hours later. This was again done at a course change point, close by buoy KO 10 - T 67/68. The last entry was made at midnight, 23 min after the previous position fix. All positions were determined by GPS.

Figure 3: Course of the voyage of the LADOGA-3; black positions – position fixing by the Master; red positions – further course of the voyage; Detail of chart 64 BSH

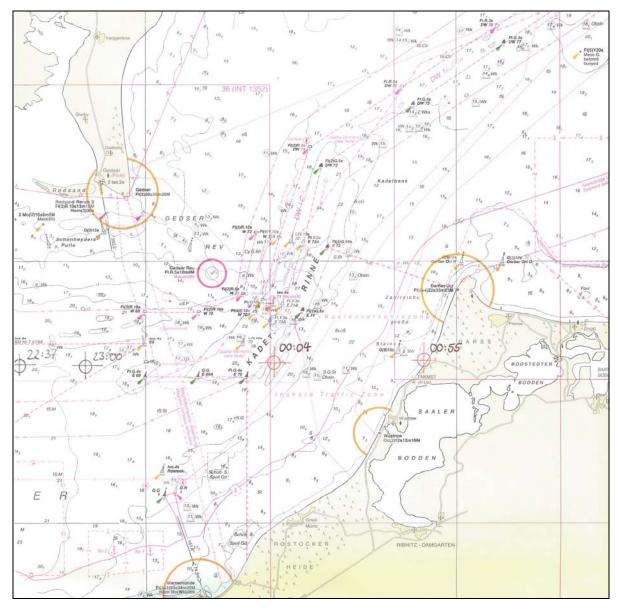
Figure 4: Course of the voyage of the LADOGA-3, position at the time of the accident and Kadetrenden; black positions – position fixing by the Master; red positions – further course of the voyage; Detail of chart 64 BSH
