Investigation Report 564/06

Very serious marine casualty

**Foundering of the Fishing Vessel HOHEWEG
on 8 November 2006
in the Alte Weser area, western Nordergründe**

15 March 2008

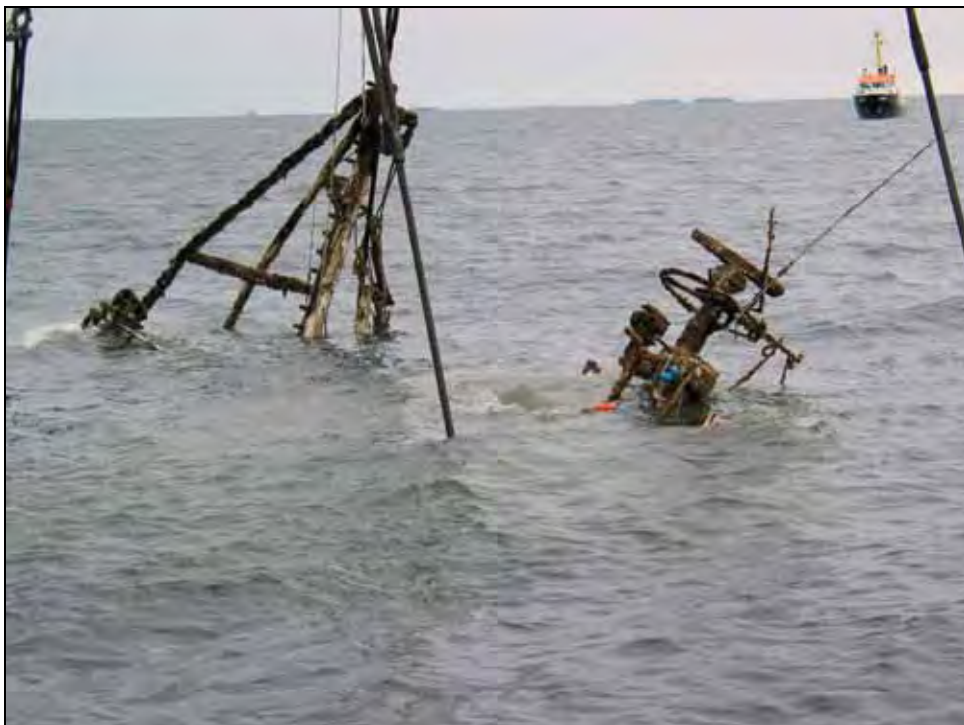
Figure 14: Wreck on the surface

On the surface of the water the vessel was turned into the horizontal floating position. In doing this the fore mast with the derrick broke out of its foundation.

First of all it could be seen that the vessel hull and superstructures showed no visible signs of any damage that occurred before or during the casualty. The damage to the bulwark and the wheelhouse and the forward trawl board galleys evidently occurred during foundering, when the bottom was touched, and during the long time in which the boat was lying under water.

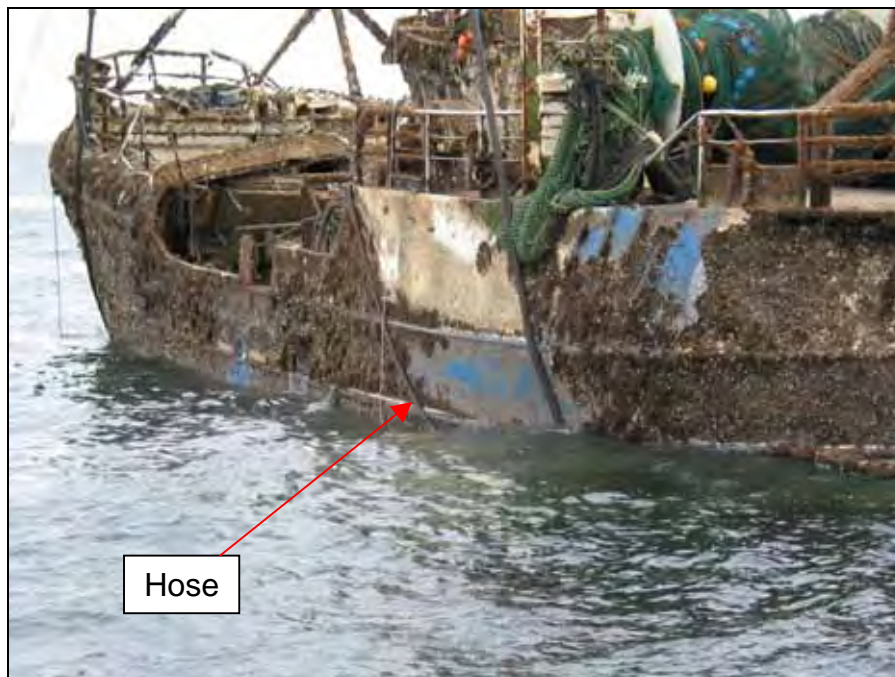
Figure 15: Wreck turned in the floating crane

The significance of the black tube hanging tight over board on the port side was only noticed after the subsequent docking.

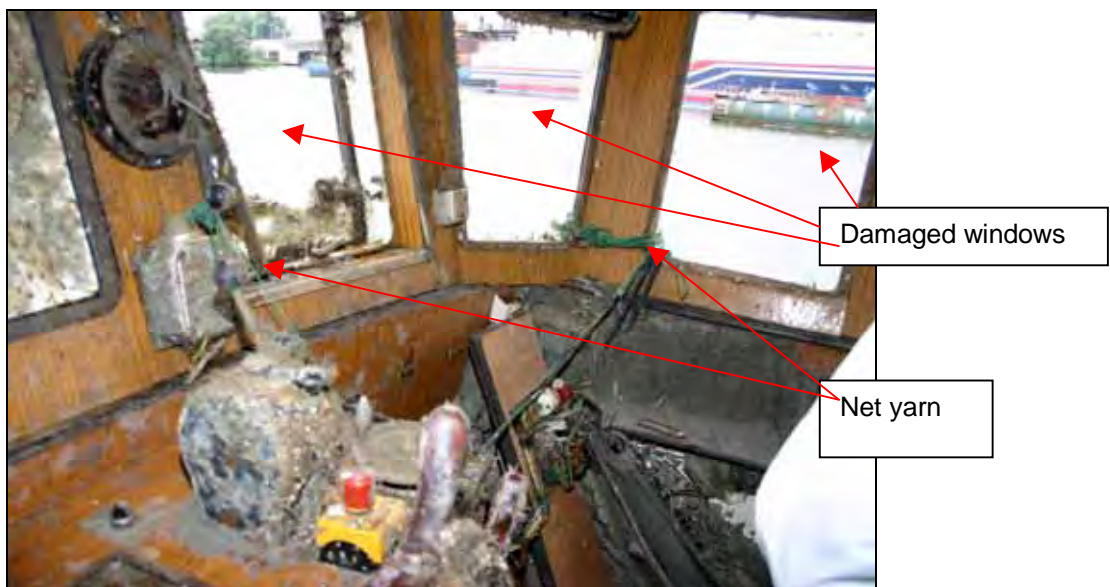
Figure 17: Bridge starboard side

A fourth defective window was the half-broken hinged window on the starboard side that was only firmly closed by the toggle bolts at the bottom.

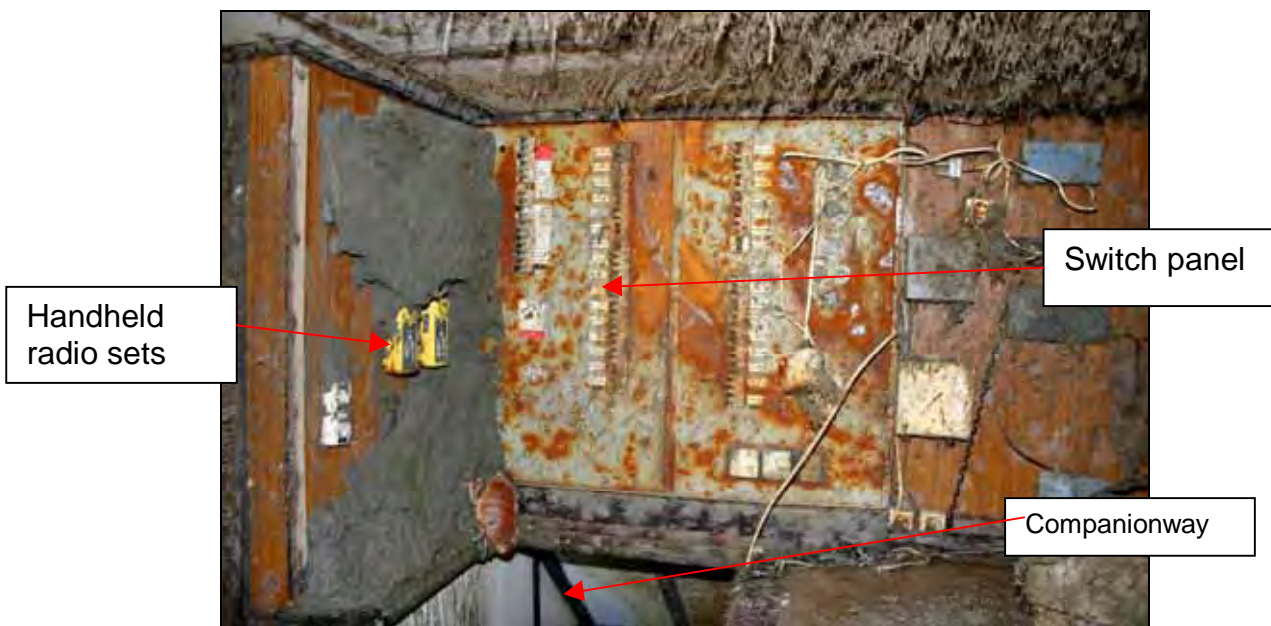
Figure 19: Companion-way and distress radio equipment

Two GMDSS²³ distress handheld radio sets were hanging unused on the starboard side above the companionway without the operable batteries having been activated. On the compaß bridge the bearings/holder for the inflatable boat and the holder for the automatically triggered EPIRB were found. The radar mast with radar devices and antenna was undamaged. Net yarn and a signal light not belonging to the vessel were hanging on the mast.

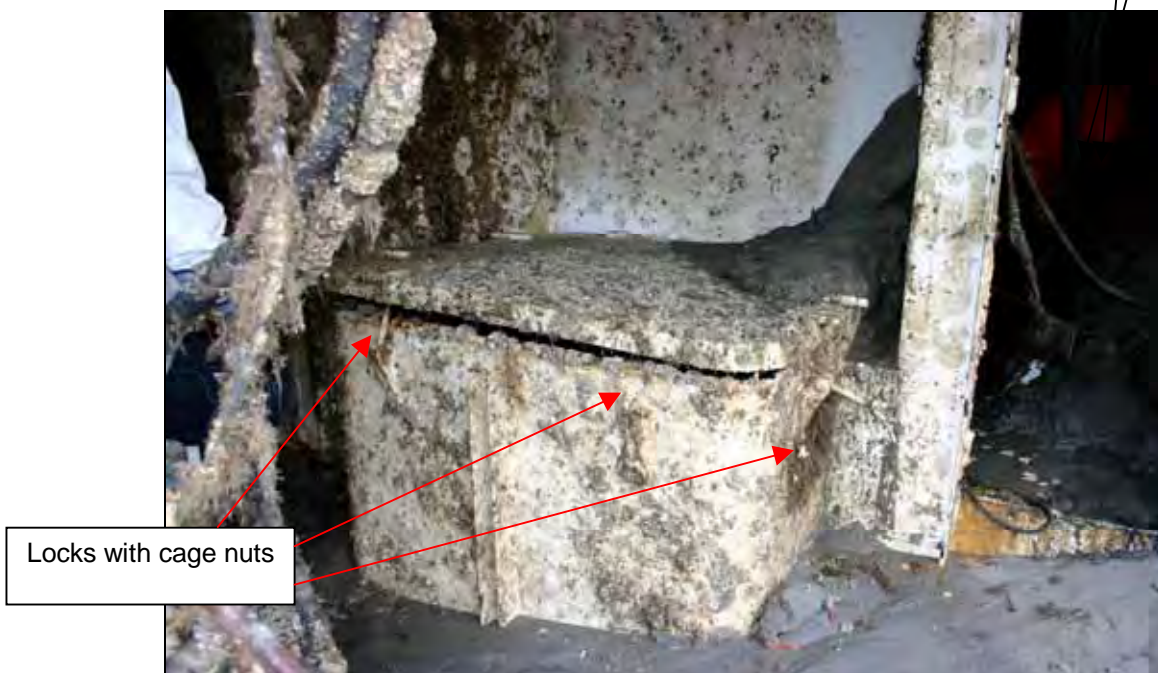
Figure 20: Hatch 1, net hold

The weather guard above main deck including the railing and liferaft holder that could still be seen during the diving operations was no longer present after the recovery. The fish-processing machines had been ripped out of their holders and were partly lying on the fish hold hatches 2 and 3. The lid of hatch 1 (net hold) was lying in open position on the cage nuts of the lock bolt turned open up to the end of the thread.

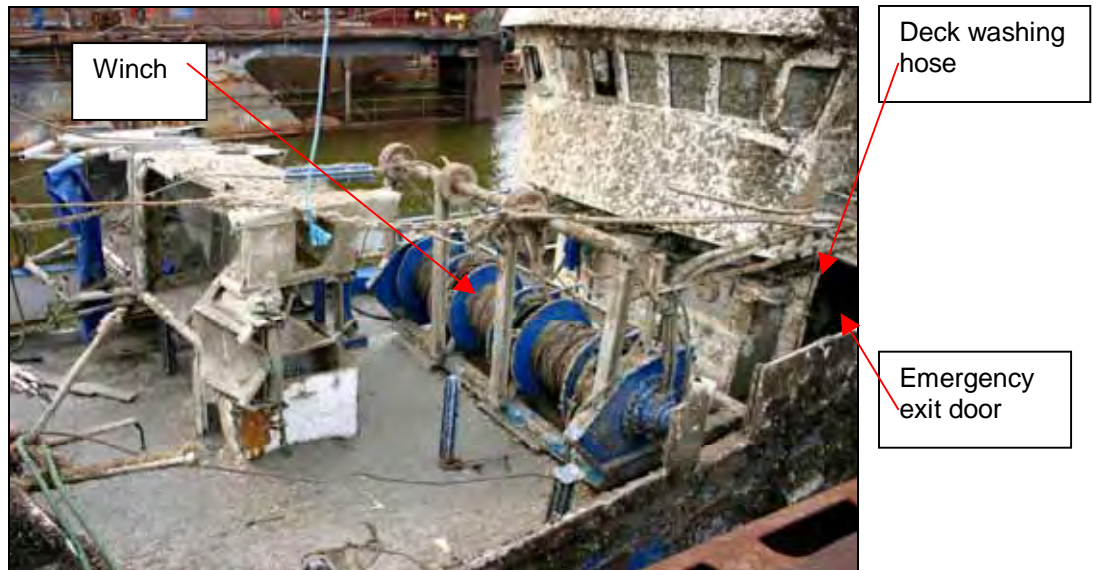
Figure 21: Winch forward edge bridge

2006 and recoiled prior to leaving port. The port side drum was the only one that was shifted out²⁴ and as the belt brake was not tightened, it could easily be turned. The wire on the port side winch was uncoiled and measured. The length of the 18 mm thick wire rope found was in line with the new trawl warp coiled up on board at the beginning of November.

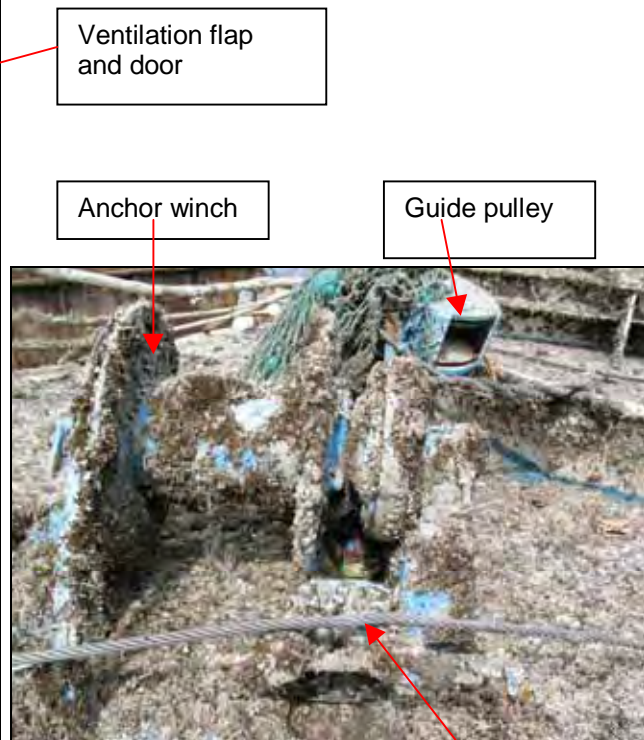
Figure 23: Anchor winch

On the forecastle was the "idler anchor windlass" with opened band brake and opened chain stopper. Traces of use indicating that there was an anchor could not be found clearly in the hawse pipe. An additional guide pulley had been mounted in front of the anchor windlass and T-beams with three large guide pulleys for the trawl warps were installed at the aft edge of the forecastle. The anchor with chain outboard shot was not discovered and had not been found at the time of the first diving investigations either.

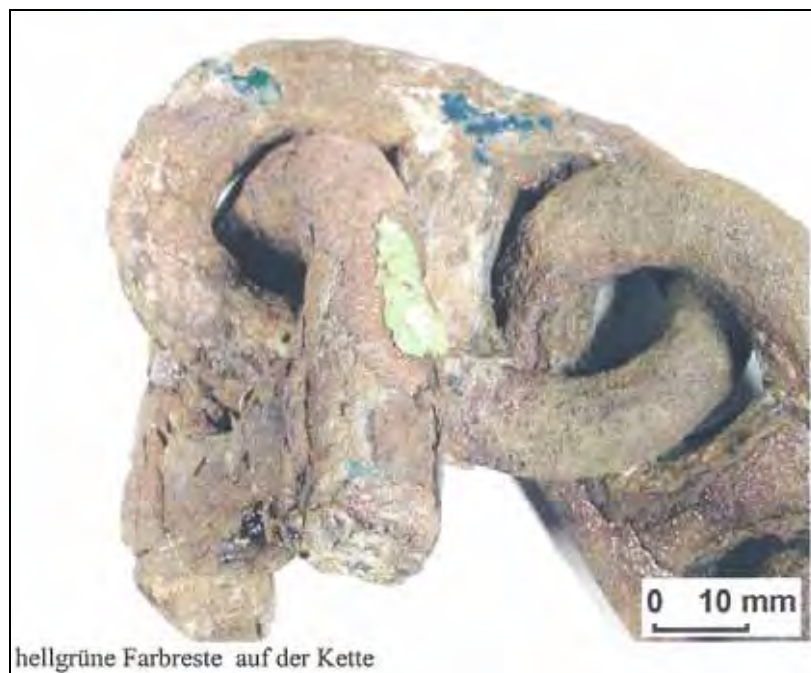
Figure 24: Anchor chain

Of the anchor chain found, a part of the chain secured in the chain hawse pipe with construction foam against water ingress into the chain locker was handed over to the Institut für Werkstoffkunde und Schweißtechnik (Institute for Material Science and Welding Technology) - HAW Hamburg for inspection.

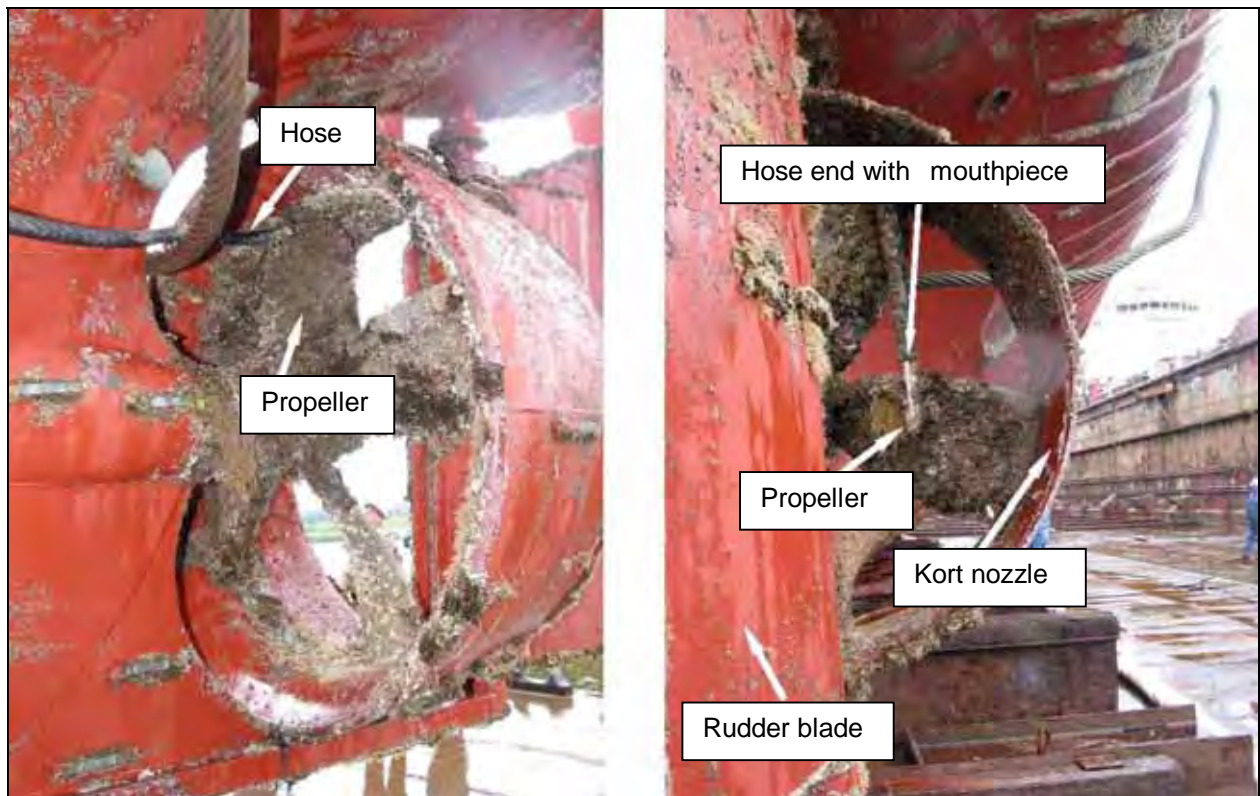
Figure 25: Jammed hose

When the wreck was salvaged it was ascertained that a deck washing hose was jammed between the propeller and the Kort nozzle. In order to ascertain whether this jammed hose could have been the cause of the failure of the propelling unit and whether the engine was still in operation at the time of the casualty, the investigation representative of the BSU, Prof. Dipl.-Ing Diederichs, was commissioned as expert. After the engine room had been largely freed of sand and sludge, a survey was conducted on 31 July and 8 August.

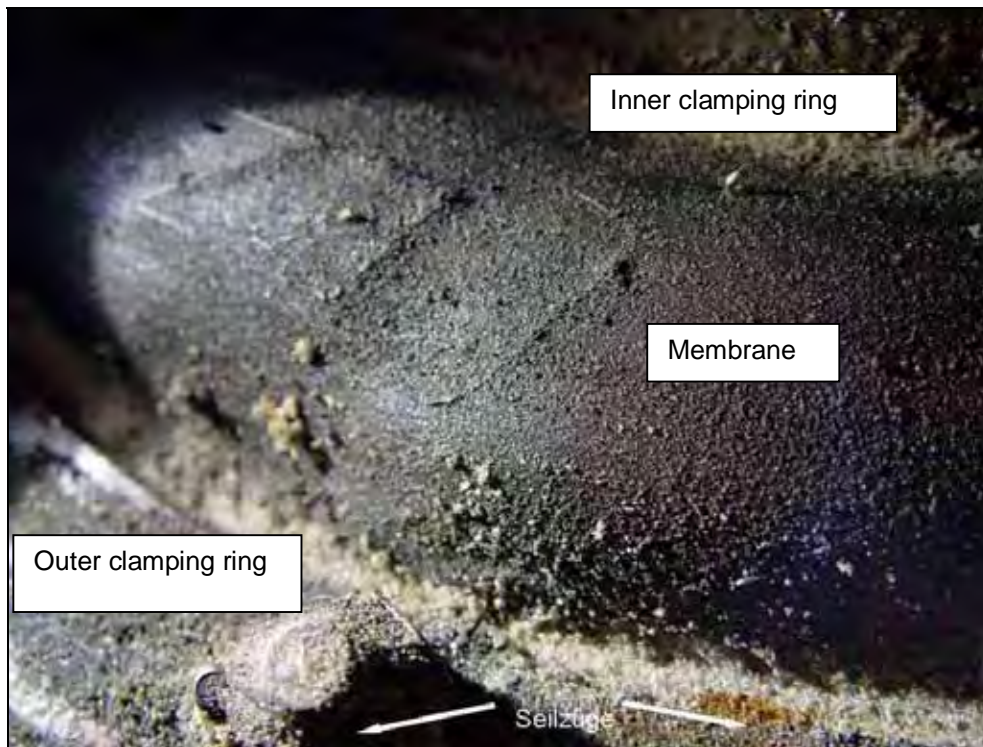
Figure 31: Surface of the membrane on the transmission side

The membrane of the elastic coupling on the transmission side shows a slightly wavy surface represented in the following figure. No cracks were ascertained on the surface of the membrane.

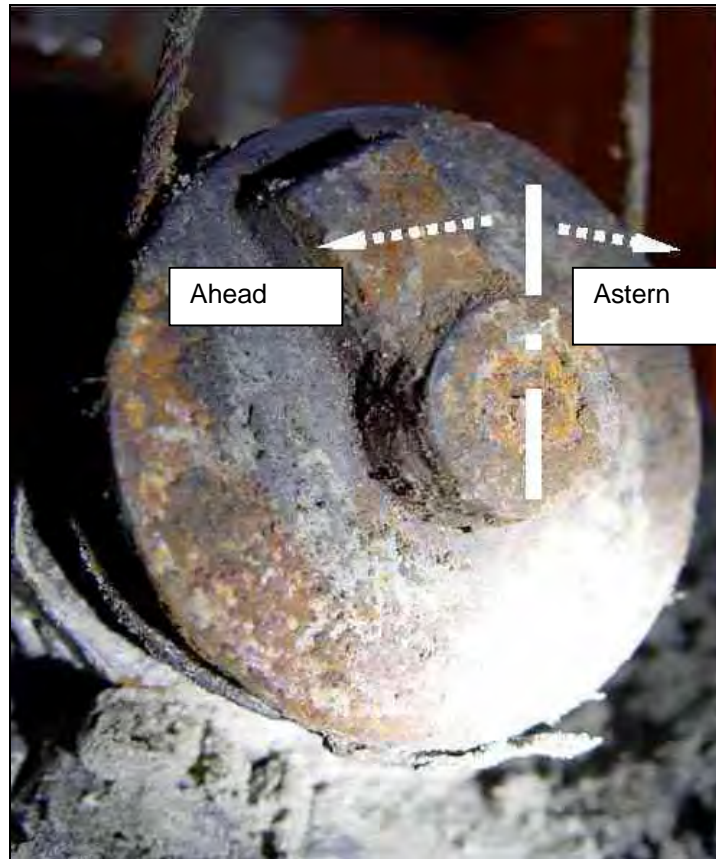
Figure 32: Display position of the transmission shift valve

The display of the pilot valve at the transmission showed the switch position for “ahead” – see figure – and could easily be turned by hand after removal of the rope pull.

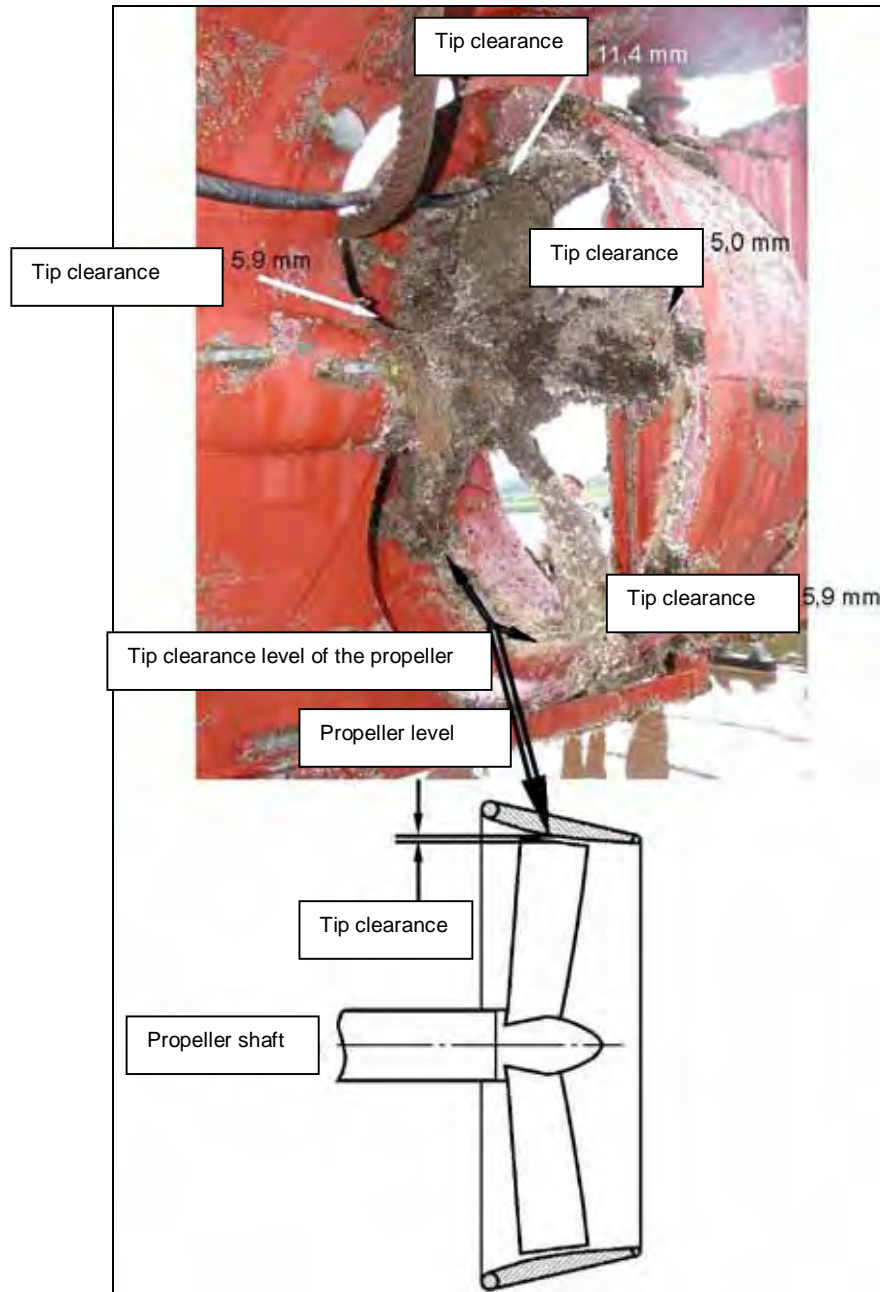
Figure 33: Kort nozzle with hose and propeller tip clearances

In the way of the tip clearance of the propeller, the inner face of the Kort nozzle was heavily covered with mussels.

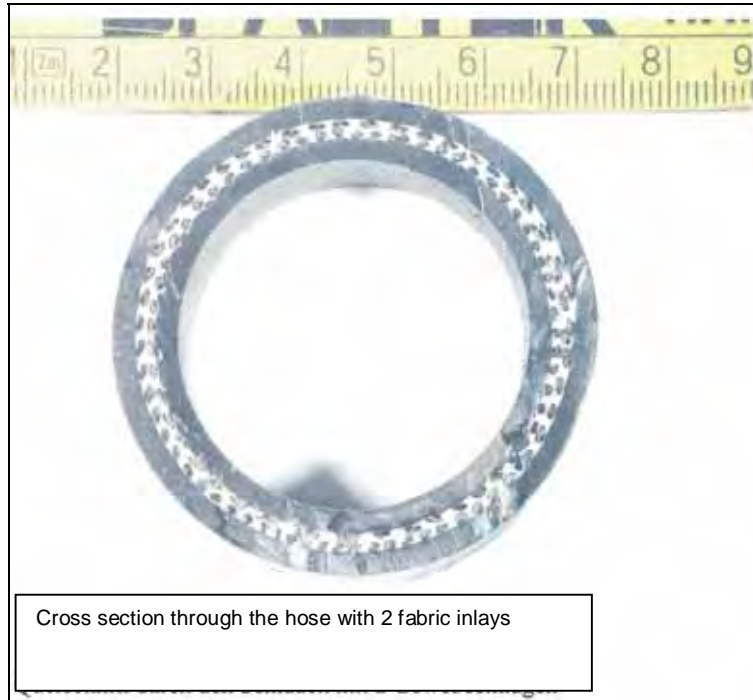
Figure 34: Cross section of hose

The jammed hose was a wound hose in accordance with DIN 7715 with a rubber core, double fabric inlay and a hose jacket of rubber. The hose had an outer diameter of 50 mm, a wall thickness of 6.3 mm, and was designed for an operating pressure of 15 bar.

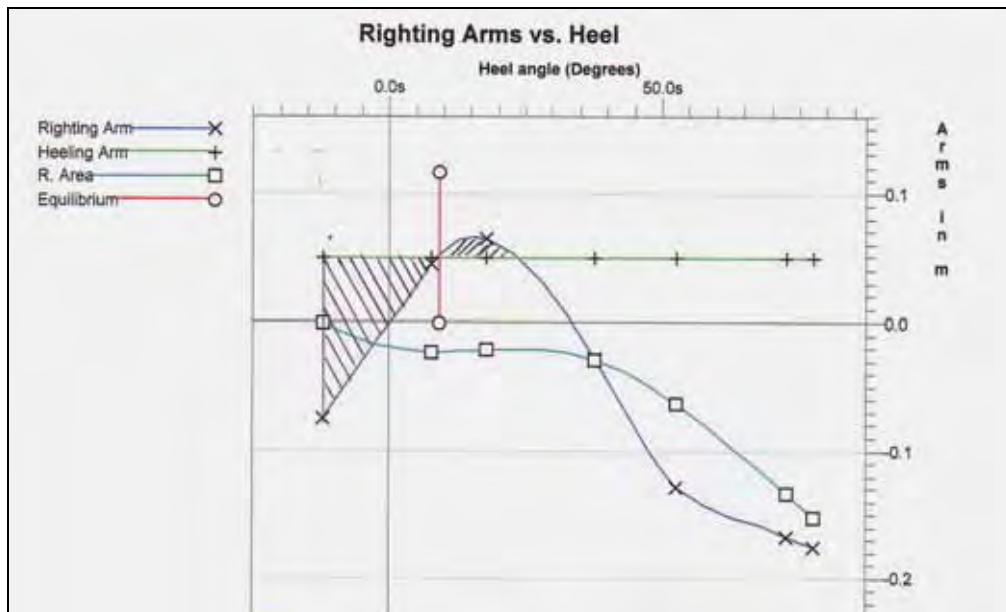
The weather criterion for resisting the joint influence of side wind and rolling is **not** satisfied. The area "B" is considerably smaller than the area "A", as can be seen easily on the above righting arm.

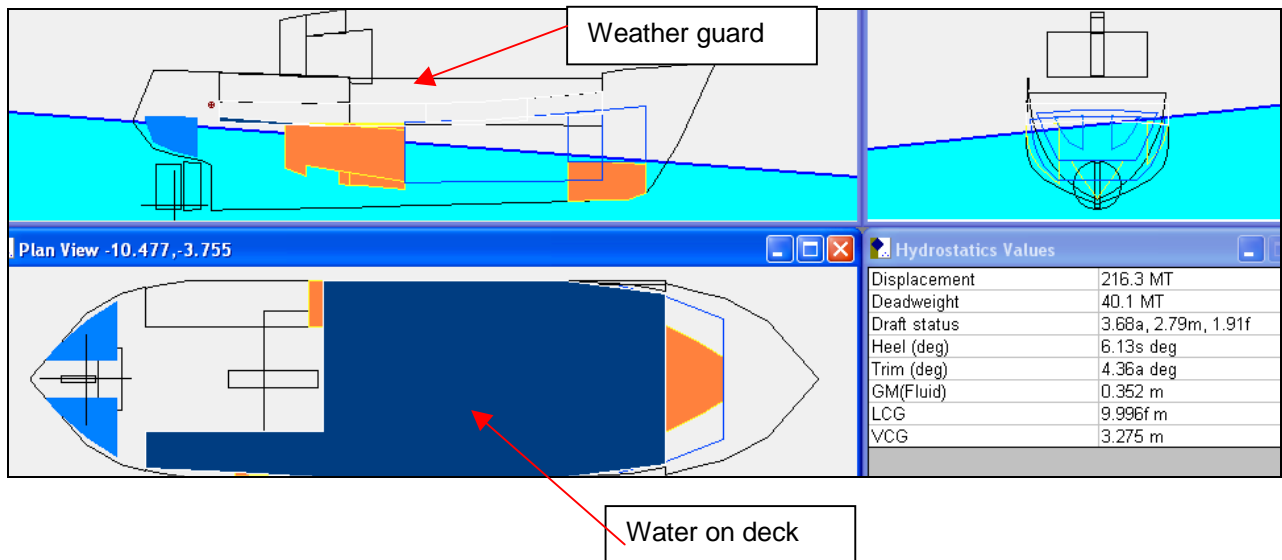
This situation corresponds to the stability case in which a wave washes over the bulwark, floods the deck and produces a rolling moment and the vessel thereupon capsizes. It is presumed here that the water-freeing ports that were admittedly sufficiently largely dimensioned on board still did not manage to allow the water to flow off fast enough. Although it was technically possible to stop the water-freeing ports, it could not be ascertained that these were blocked in closed position.
