**Investigation Report 607/07**

**Serious marine casualty**

**Personal accident on the tug**  
**BUGSIER 11**  
**on 17 December 2007**  
**in Brunsbüttel**

**1 December 2008**

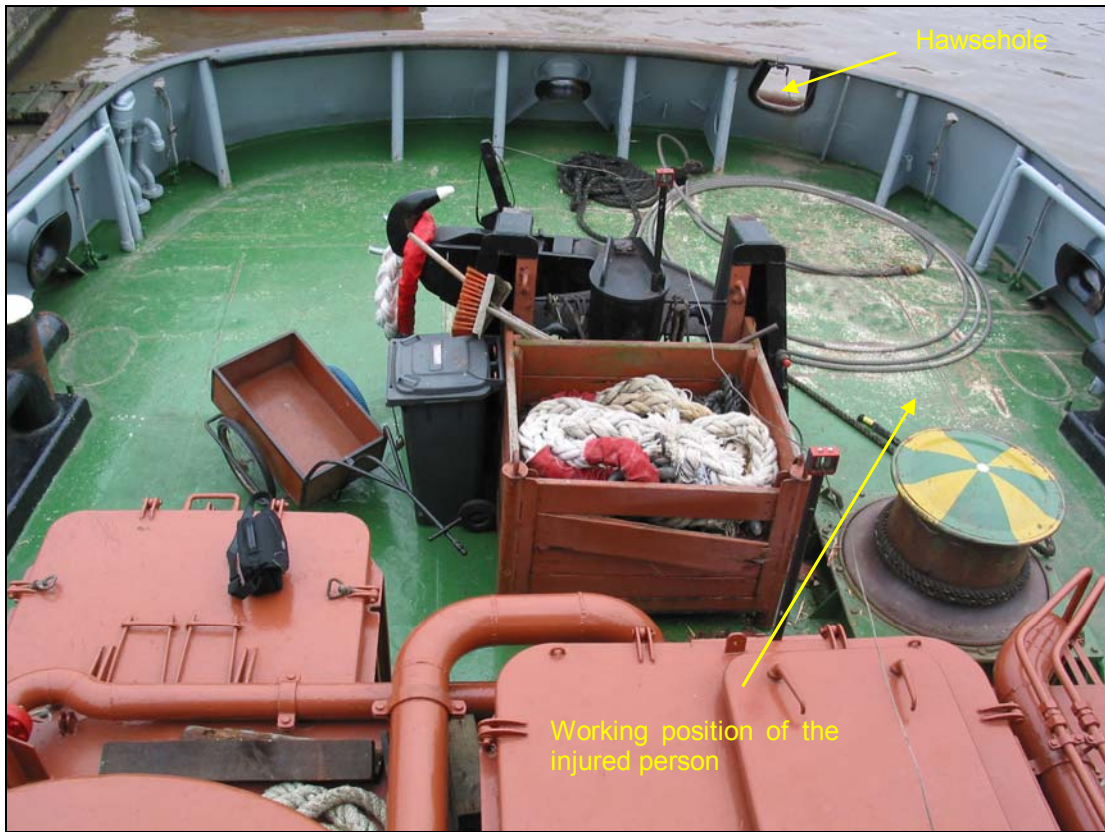
Figure 6: BUGSIER 11, plan view of stern

The only damage on BUGSIER 11 caused by the accident was to the storage crate located behind the towing hook. The cable had destroyed several wooden boards as it ran out (Figures 6 and 7).

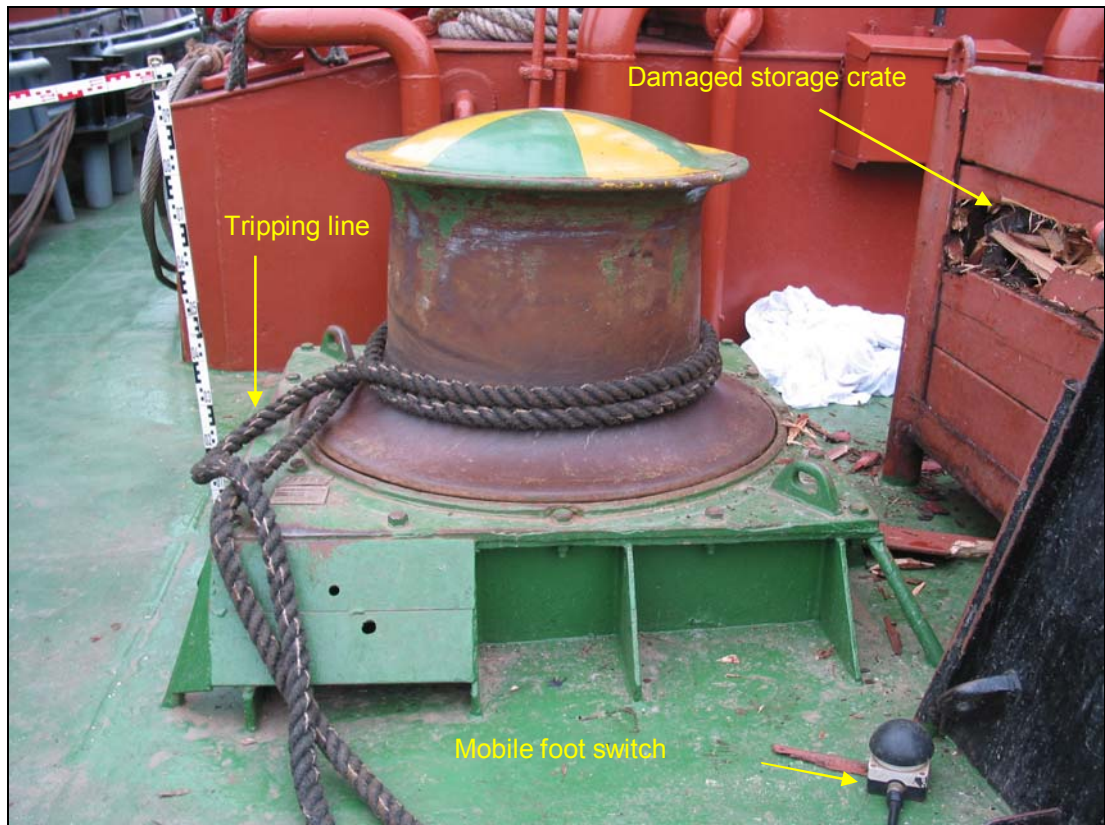
Figure 7: BUGSIER 11, capstan

Handling of the towing cable is supported by a capstan located on the port side. The capstan stands on a small platform and has a height of 0.94 m above the deck. The capstan only turns clockwise. It can be operated using a mobile foot switch. After being switched on, it turns a half rotation slowly, then switches automatically to a higher speed. Approx. 5 s are required for one rotation. This gives a speed of approx. 0.41 m/s.

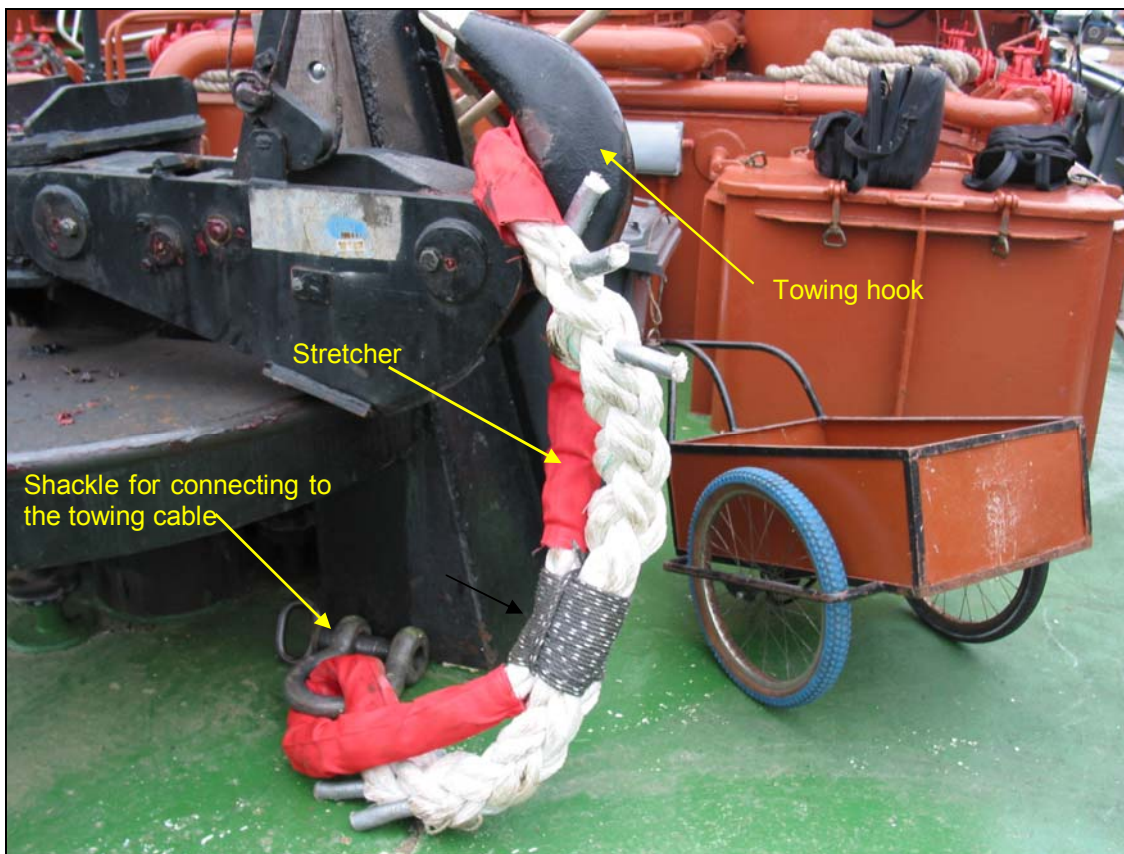
Figure 8: BUGSIER 11, stretcher on the towing hook

The towing cable had two different ends. One end had a spliced eye. This part was designed to be belayed on the vessel. The other end also had a small eye. A pressed-on sleeve was used as a connection on that part. The eye was protected by a thimble. For towing work, this eye was shackled to the so-called stretcher. The stretcher itself always lay fixed on the towing hook. Its job was to reduce the strain of the towing cable. The stretcher was made of Ti-Flex-HP rope, Ø 56 mm, 1.6 m long, endlessly spliced.

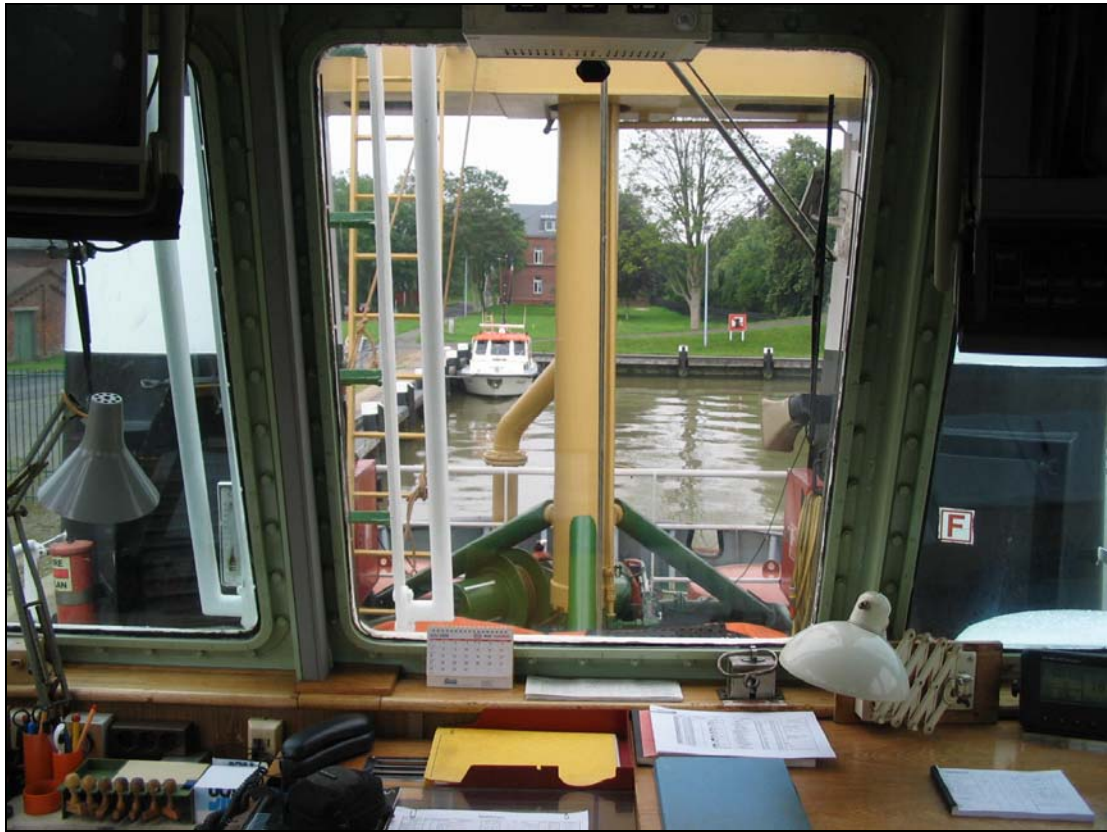
His direct visibility to aft was limited by the two funnels and the aft mast with the fire extinguish tower (Figure 3 and 9).

Figure 9: Field of vision of the tug master towards aft, limitation of the visibility by the funnels and the aft mast; above left the monitor

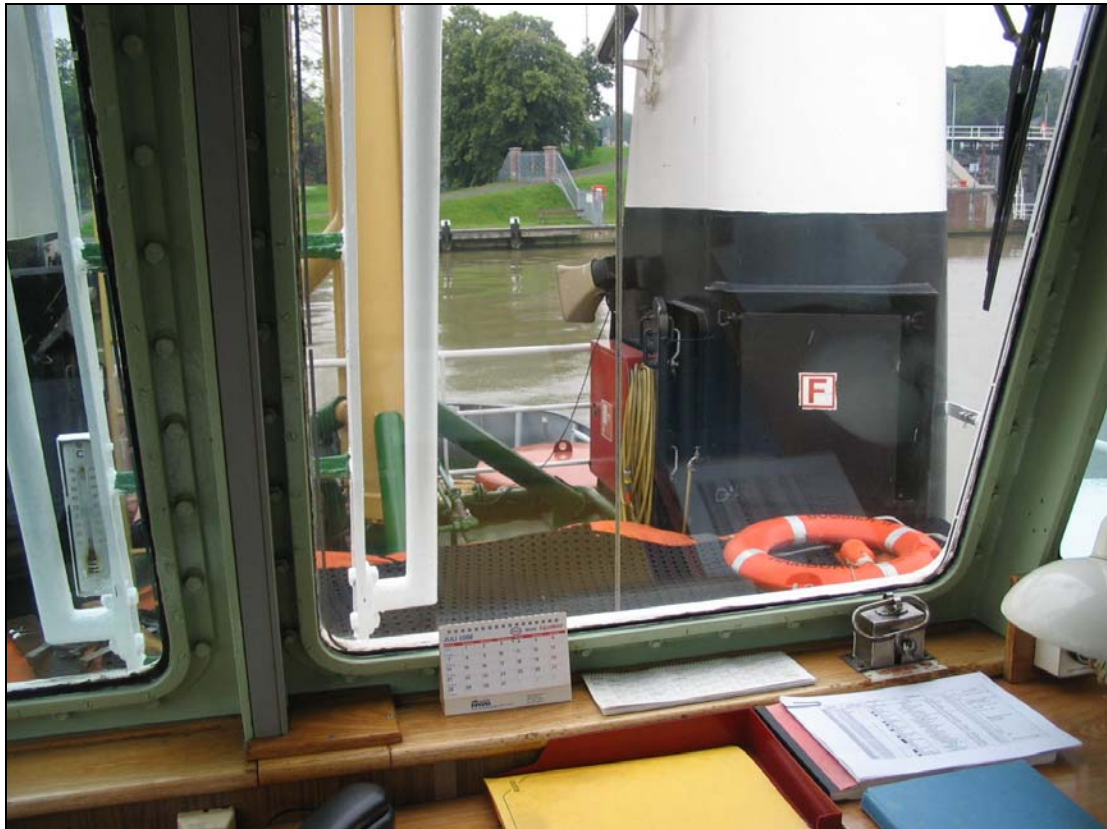
Figure 10: Field of vision of the tug master towards aft, if he makes one step from the control position to starboard

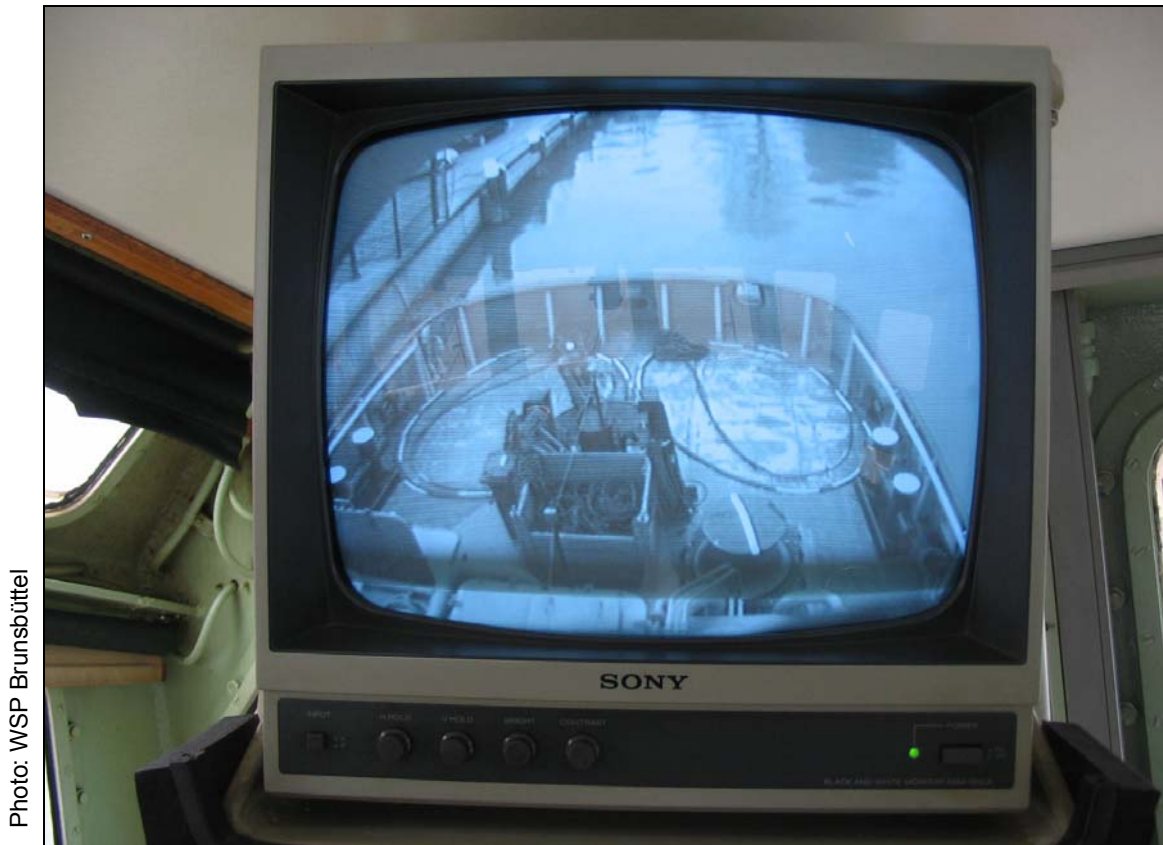
Figure 11: Close-up view of the monitor image of the aftship of BUGSIER 11

In order to improve the visibility on the aftship a camera is installed inwards the portside funnel, whose image is transmitted to the bridge by a cable on the monitor. The image displayed provides an overview on the aftship of the BUGSIER 11 (Figure 11). The monitor has a screen diagonal of 28 cm and is mounted at a distance of 160 cm to the tug master. An inspection of the work sequence on the aftship is thus only roughly possible. The camera does not provide the visibility on the aft manoeuvre station of any seagoing vessel since it can not pivot.

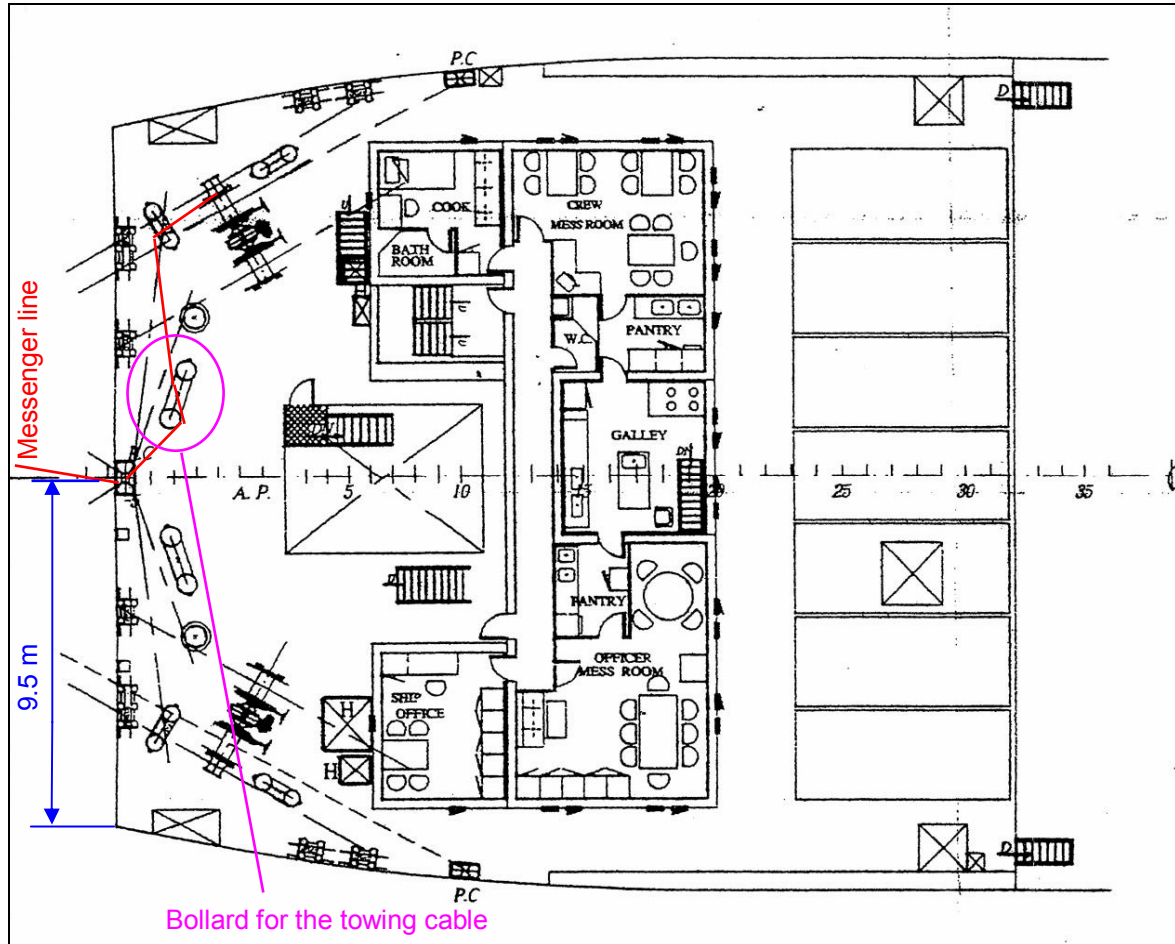
The port side double bollard had no stopper eye facing the central hawse to which a cable or chain stopper could have been secured. Also the second double bollard used for direction change was only equipped on the outward facing side with an stopper eye. For this reason it was not possible to stop the messenger line without further ado.

Figure 12: View of the poop deck on the SENANUR CEBI; guide way for the messenger line

The Federal Bureau of Maritime Casualty Investigation recommends to the operators of the SENANUR CEBI to carry out structural measures to improve the options for handling lines and cables. In particular, they should ensure that such measures could enable stopping or shifting of the messenger line.

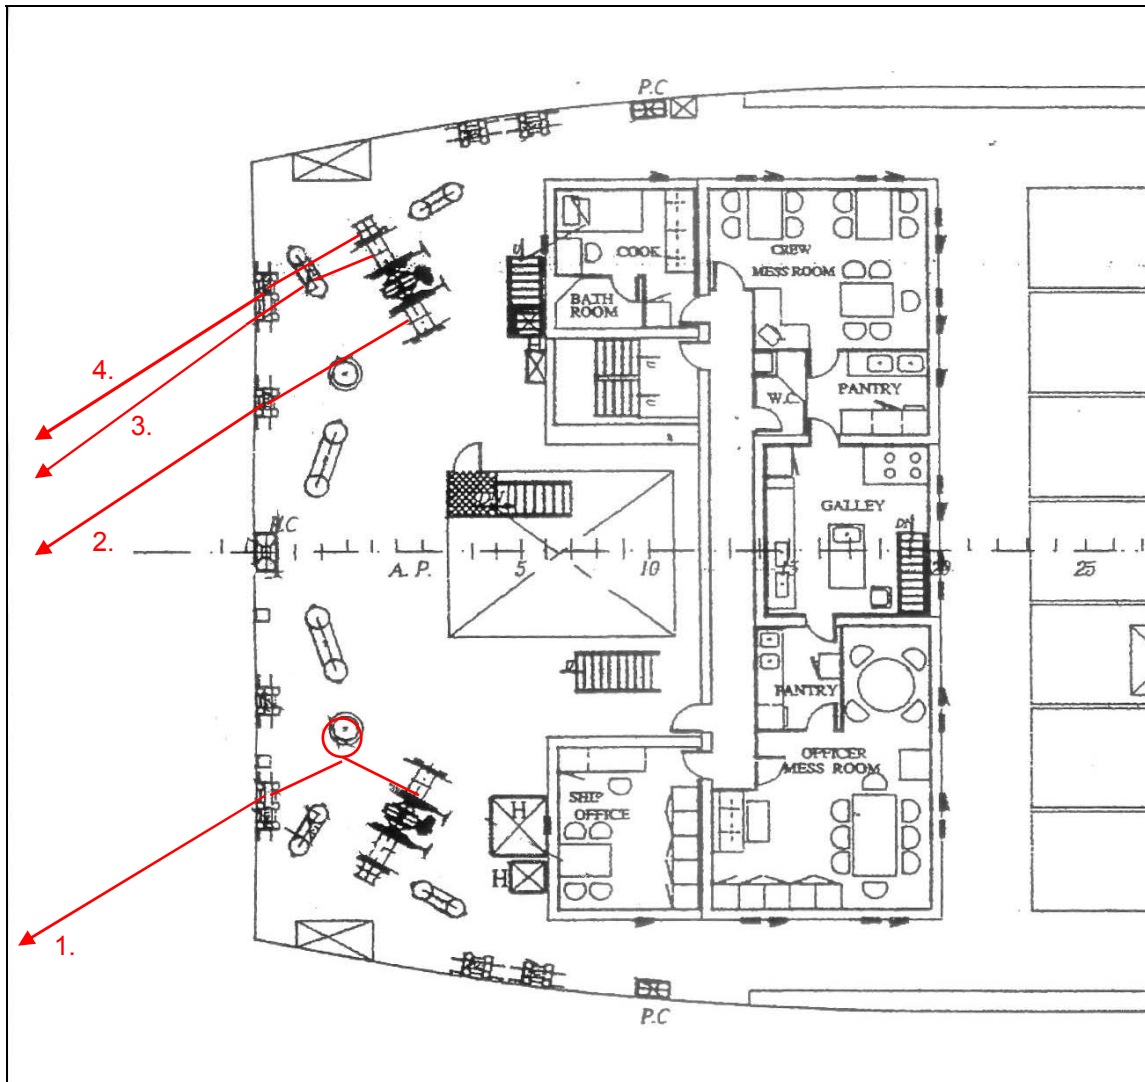
Figure 13: Stern lines at the time of the onboard investigation<sup>9</sup>, numbering denotes the sequence in which they were used
