Isle of Man Ship Registry

Casualty Investigation Report No. CA102

Collision between the Tanker British Cygnet and
Container ship Vera

2nd December 2006

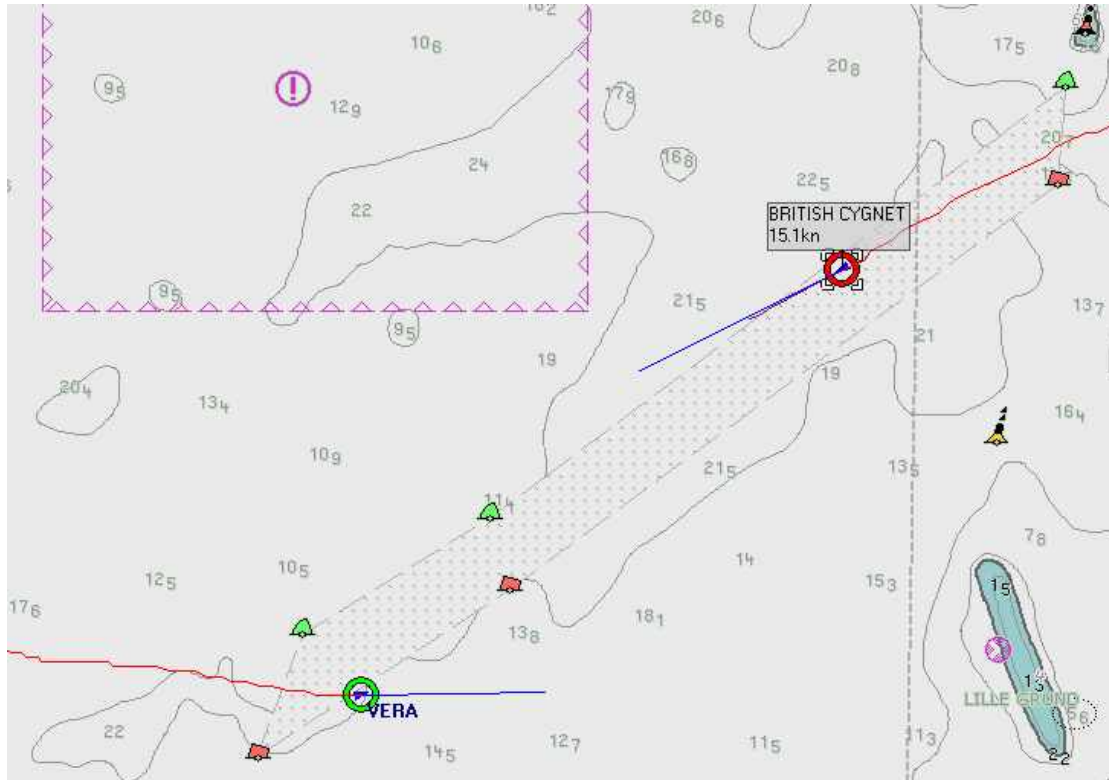
11.35 UTC Image from AIS record. (The Royal Danish Administration of Navigation and Hydrography)

- 11.35.35 The Vera passed out of the deep water channel over the southern boundary. Her course was easterly at 083 degrees and her speed was 12.3 knots.
- 11.36.14 Onboard the British Cygnet there was a brief conversation between the Master and Pilot about the vessel approaching the south western end of the deep water channel. This concluded with the assumption the vessel would remain outside of the deepwater channel. The Vera's easterly course was clearly indicated visually, by radar plots and on ECDIS and AIS.

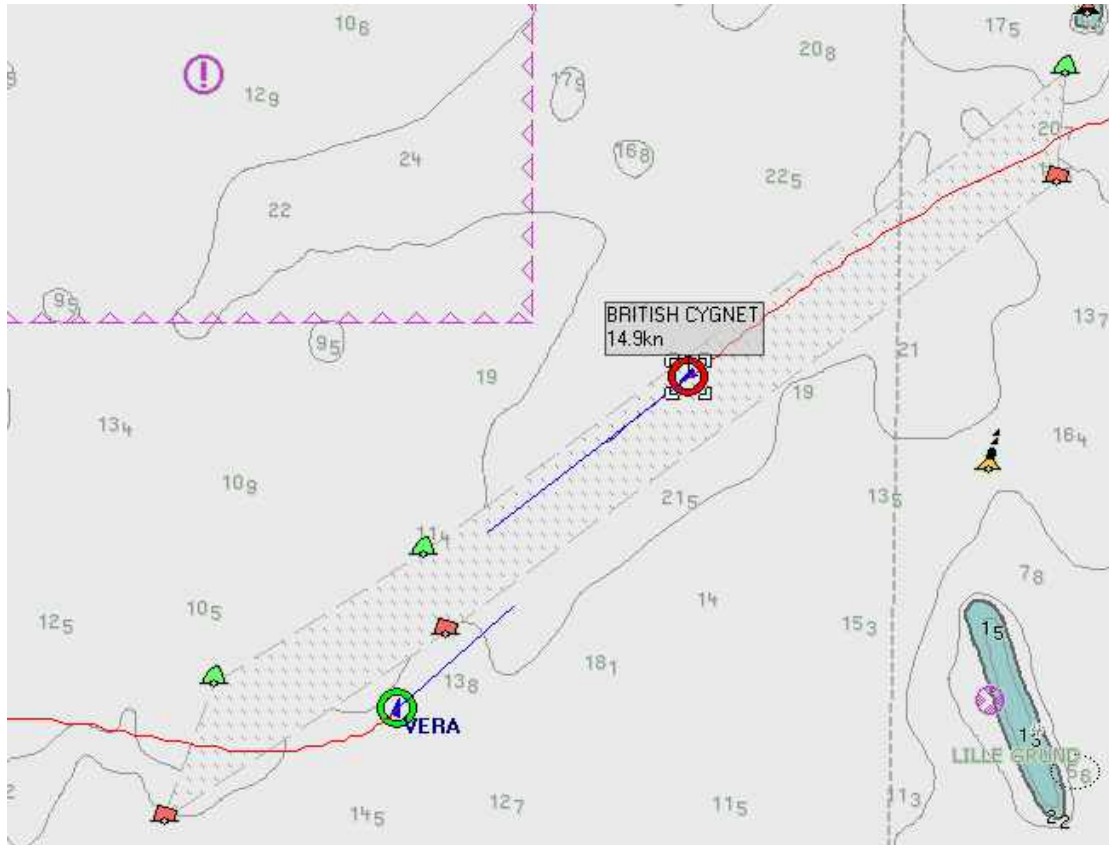
11.37 UTC Image from AIS record. (The Royal Danish Administration of Navigation and Hydrography)

11.37 The Vera altered course to port, heading back into the deepwater channel.

The British Cygnet was unsure of the Vera's intentions and in accordance with the ColRegs Rule 34 d) made the sound signal of 5 short and rapid blasts on the ship's whistle. She maintained her course of 234 degrees and speed of 14.9 knots. The pilot made a VHF call to determine the Vera's intentions, however this was not addressed to Vera and no reply was received.

11.37.35 The Vera re-entered the deepwater channel across its southern boundary on a course of 038 degrees and a speed of 8.2 knots. The Vera then passed about 20 metres north of the port hand buoy. She then continued to cross the channel with a course over the ground of 032 degrees and speed of 9.5 knots.

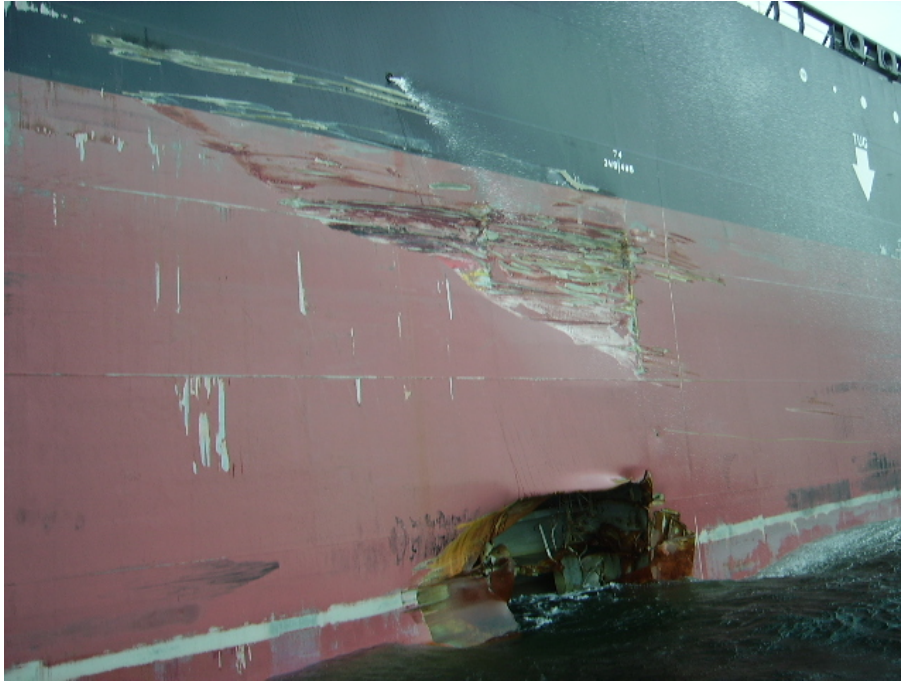
2.19 **Damage to British Cygnet**

Two water ballast tanks on the port side were breached and open to the sea. The cargo tanks were empty and inerted and were not breached.

Damage to MV British Cygnet (Isle of Man Ship Registry)
