Investigation Report 01/08

Serious marine casualty

**Grounding of the LT CORTESIA on
2 January 2008 on the Varne Bank in the
English Channel**

1. April 2009

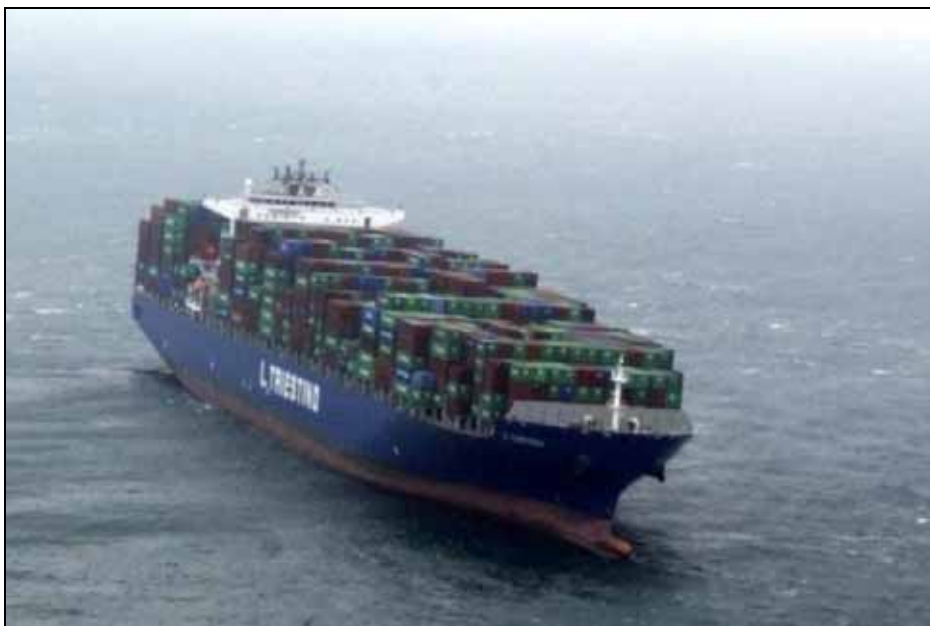
Figure 3: LT CORTESIA on the VARNE BANK (photo AFP)

There was no evidence of any oil or pollutant leaks or any container losses or personal injury. The damage to the ship was in the form of dents in the mid-ship area.

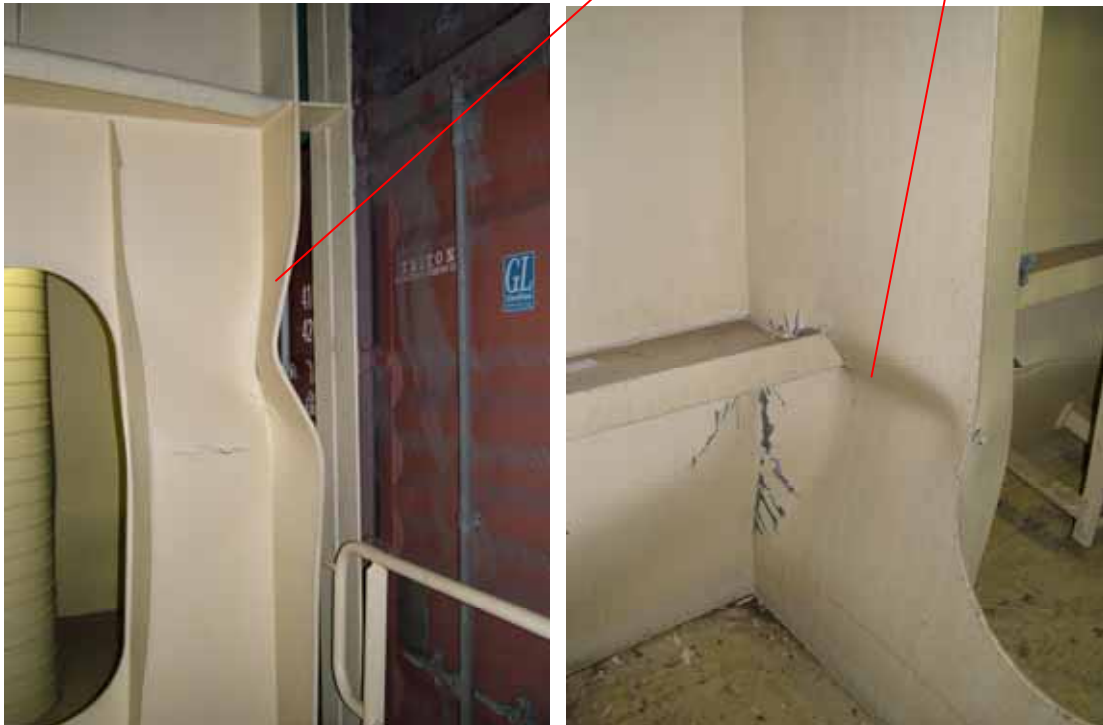
Figure 5: Damage to the frame bulkhead

Neither tanks nor the ship's base were damaged when the vessel ran aground. The only identifiable damage in the form of deformation was observed on frame 163 on brace struts and frame bulkheads.

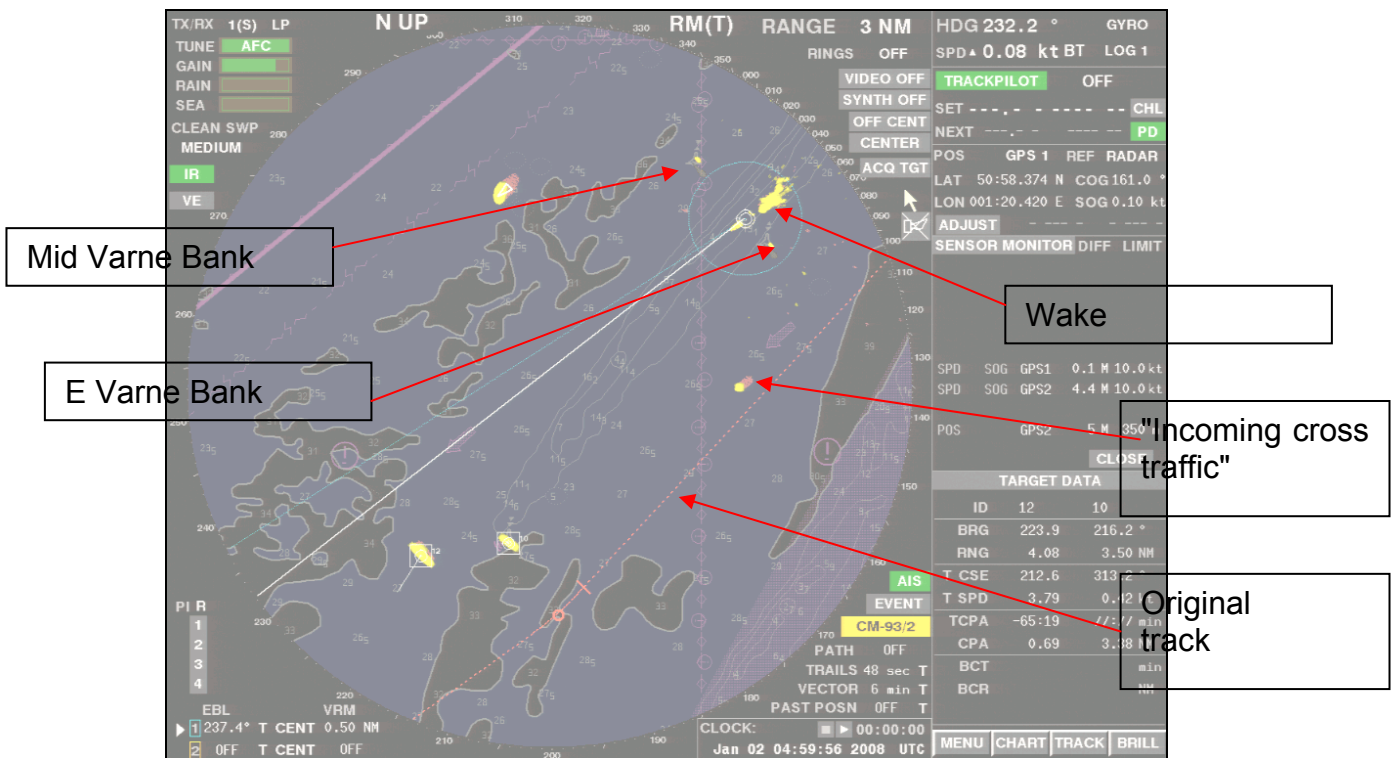
Figure 7: Radar image 04:59:56

No technical fault with the helm, the radar system or any other faults in the electronic navigational equipment were identified by the MAIB or the BSU. At the time of the first VHF call, the LT CORTESIA was already aground on the Varne Bank. The radar image showed at that time considerable wake behind the ship while sailing over ground at just 0.08 kn. The following, somewhat lightened radar image shows the "incoming cross traffic", the reason for the evasion manoeuvre.

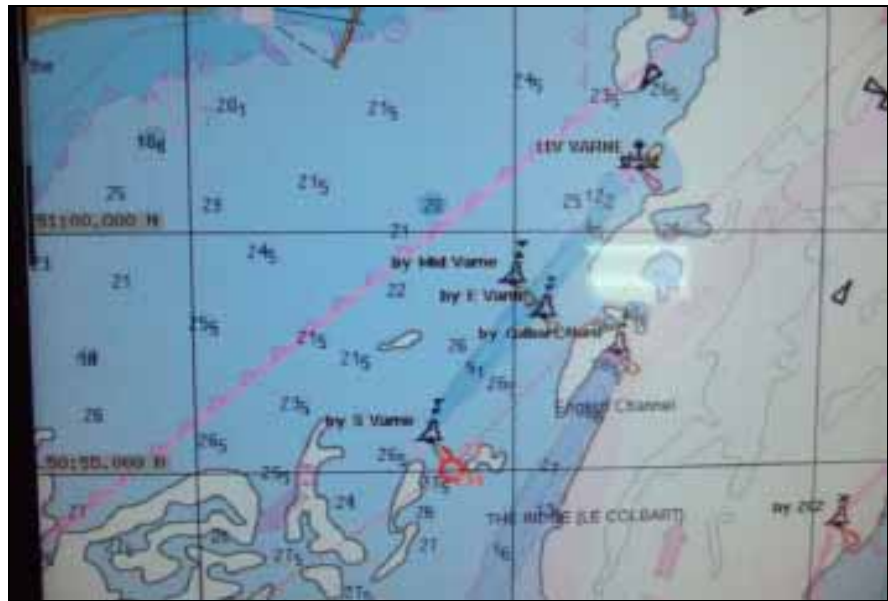
Figure 13: "Day" display type. Varne Bank shows up as dark blue. However, with the brightness configuration "NIGHT" selected at the time of the accident the buoy symbols are almost not visible and the display of the depth contours is low in contrast to such an extent that no differentiation can be identified between the shallower or deeper areas of the Shallow Contour.

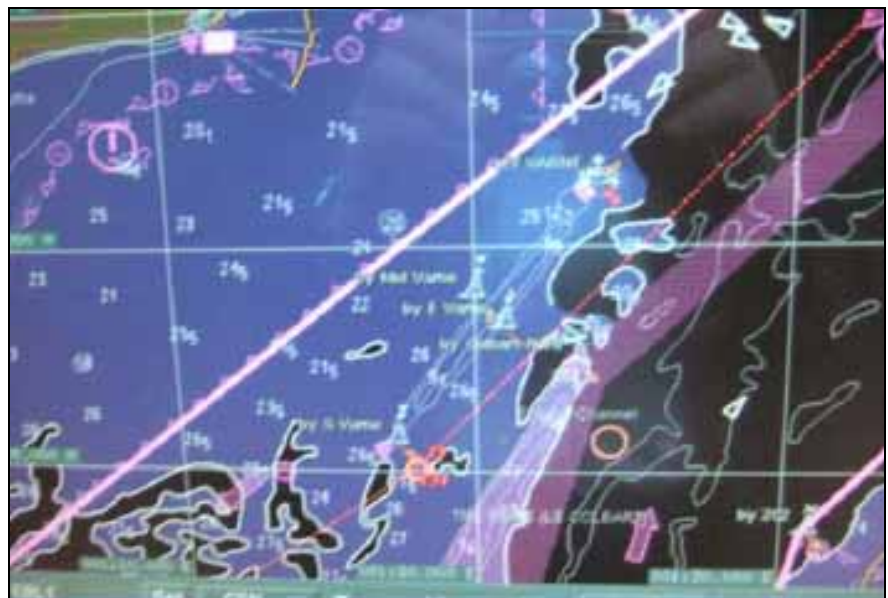
Figure 14: "Night" display type. No contrast against the surrounding area

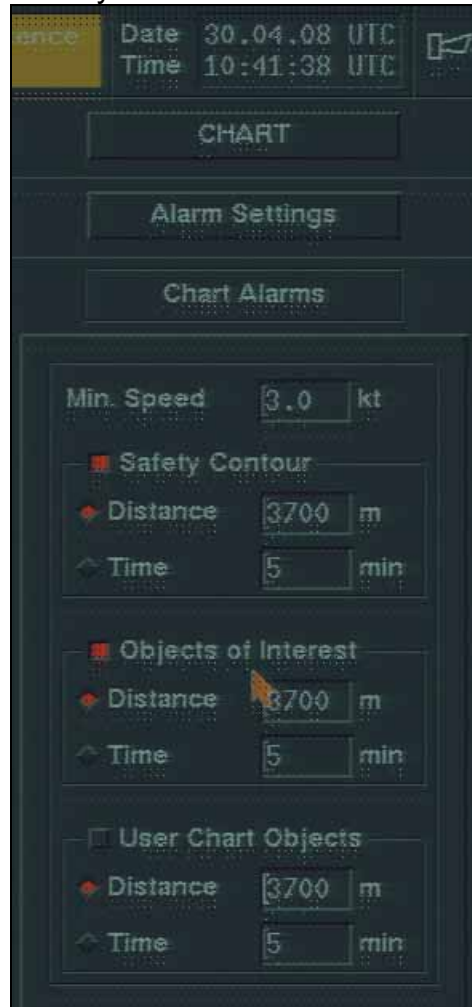
Figure 15: Menu for Chart Alarms on the Chartplot (later simulation)

The fact that no such alarm could be recorded on the Chartradar can only be caused, ultimately, by two factors, taking into consideration the fact that the Chartradar itself cannot trigger such alarms but rather "only" takes on the alarms of the Chartplot. Either the Chart Alarms in the relevant Chartplot menu were deactivated by the operator or raster data was being run on the Chartplot. In view of the data structure, no such monitoring can generally be linked with raster data.

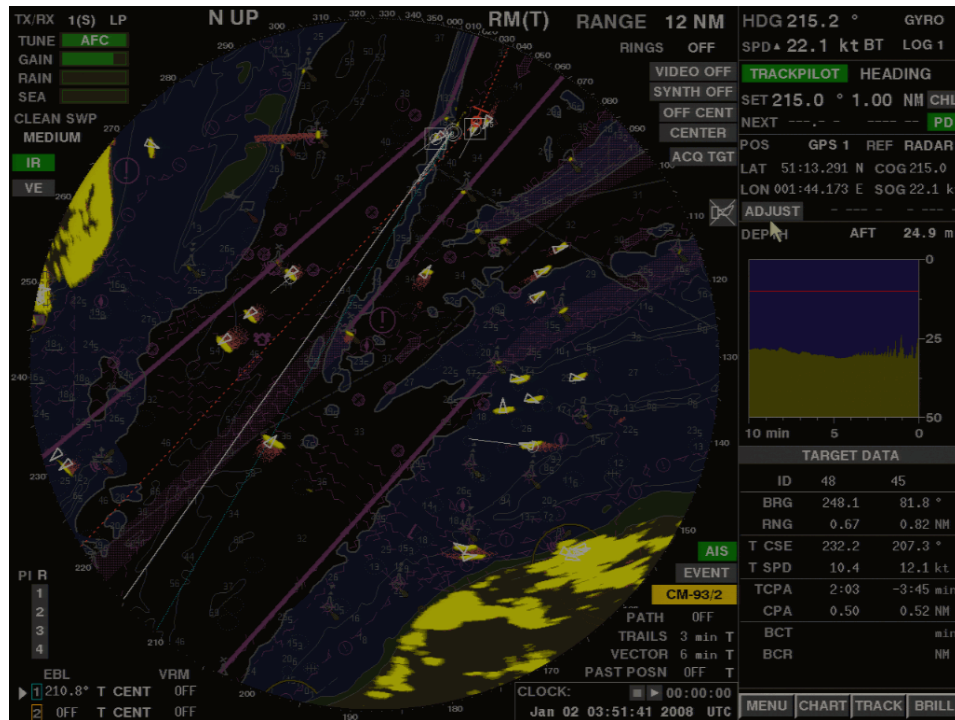
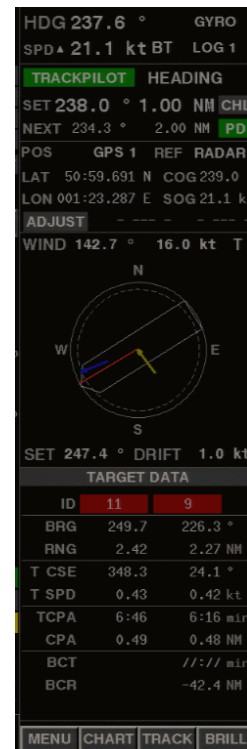
useful to avoid running aground. After 03:51, the second officer replaced this display with wind information, thus missing the depth information. (Compare the two figures below)

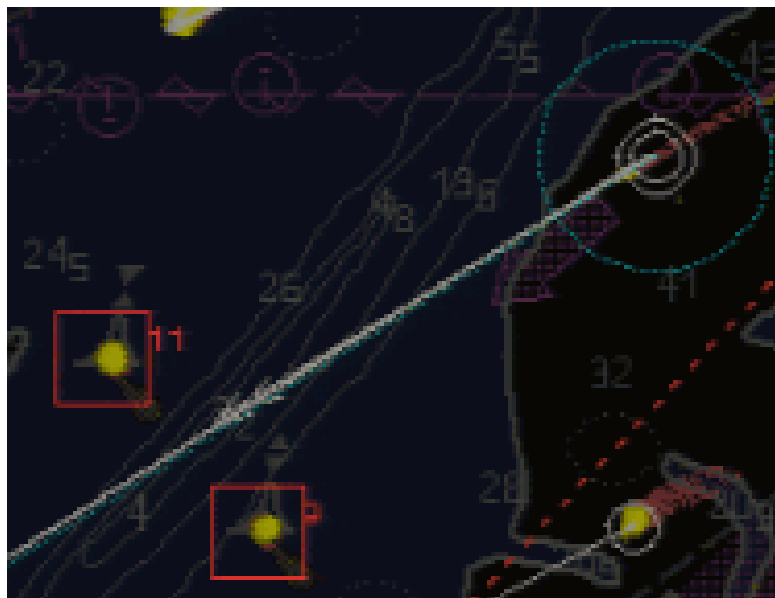
Figure 19: Cardinal buoys E Varne and Mid Varne at 04:44

- 04:44:00 At a distance of some 2.5 nm, the two shallow buoys E Varne and Mid Varne are acquired on the radar. As their relative motion moves into close range³⁷, the buoys are displayed as Dangerous Targets with the numbers 9 and 11 in the target data window. The True Speed of both buoys is given as 0.4 kn (see Fig. 17). Even if the LT CORTESIA were sailing at a speed over ground of 21 kn, the grounding incident could still have been avoided by changing course to port. As the figure below shows, the buoy symbols are definitely weak but can still be identified.

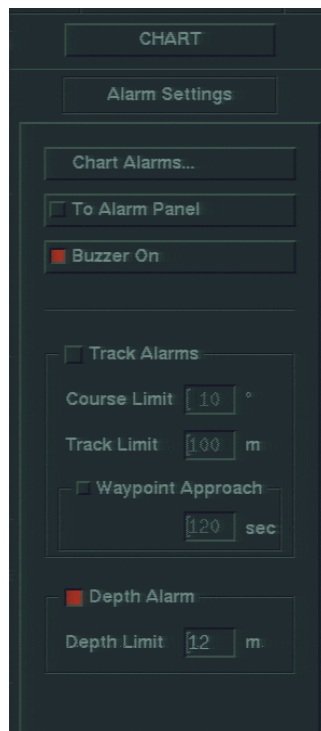
Figure 20: Menu for alarm settings on the Chartplotter

The fact that, during the grounding, the Depth Alarm did not show up on the Chartplotter leads to the conclusion that this function had already be deactivated on the Chartplotter. This means that setting the Depth Alarm to the 10 m specified by the crew would have been meaningless.

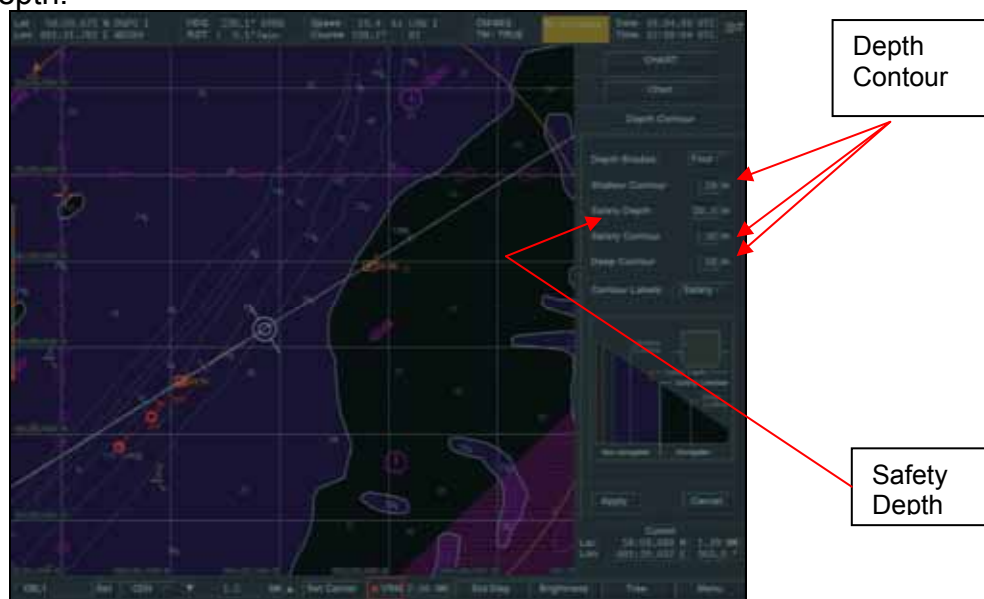
Figure 21: Night mode safety depth 30 m

In the case of the above "NIGHT" setting, the Varne Bank, as well as the buoy symbols, does not stand out, since they are in the unsafe area, where according to the definition no maritime shipping should take place and which should therefore be avoided

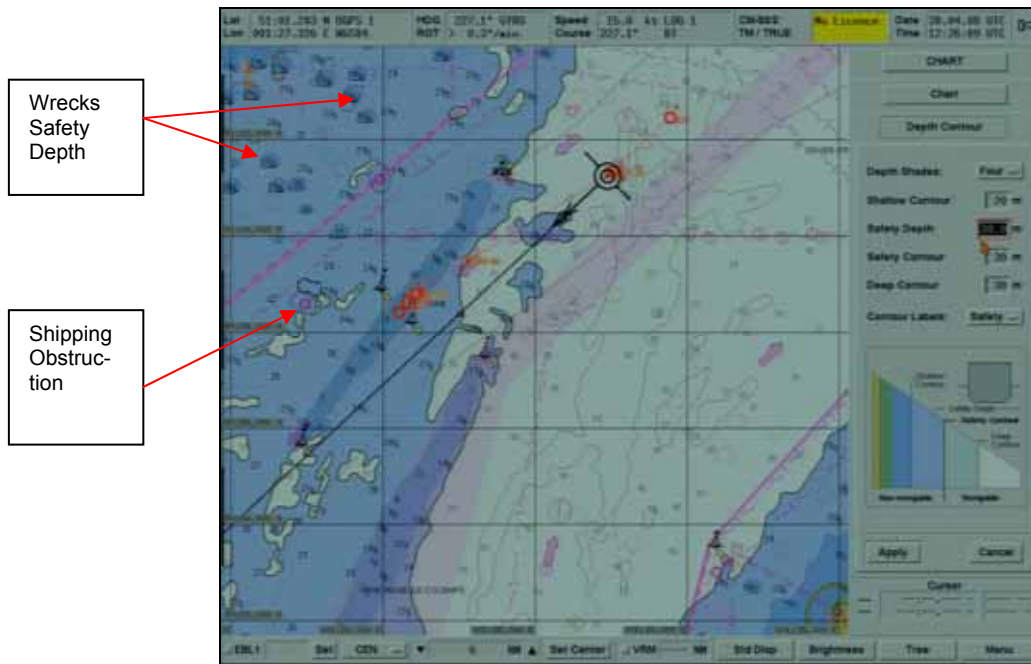
Figure 22: Day mode (Settings as figure 21, night-mode)

When set to day mode, as below, the Varne Bank is identifiable as dark blue, but it is still behind the Safety Contour:

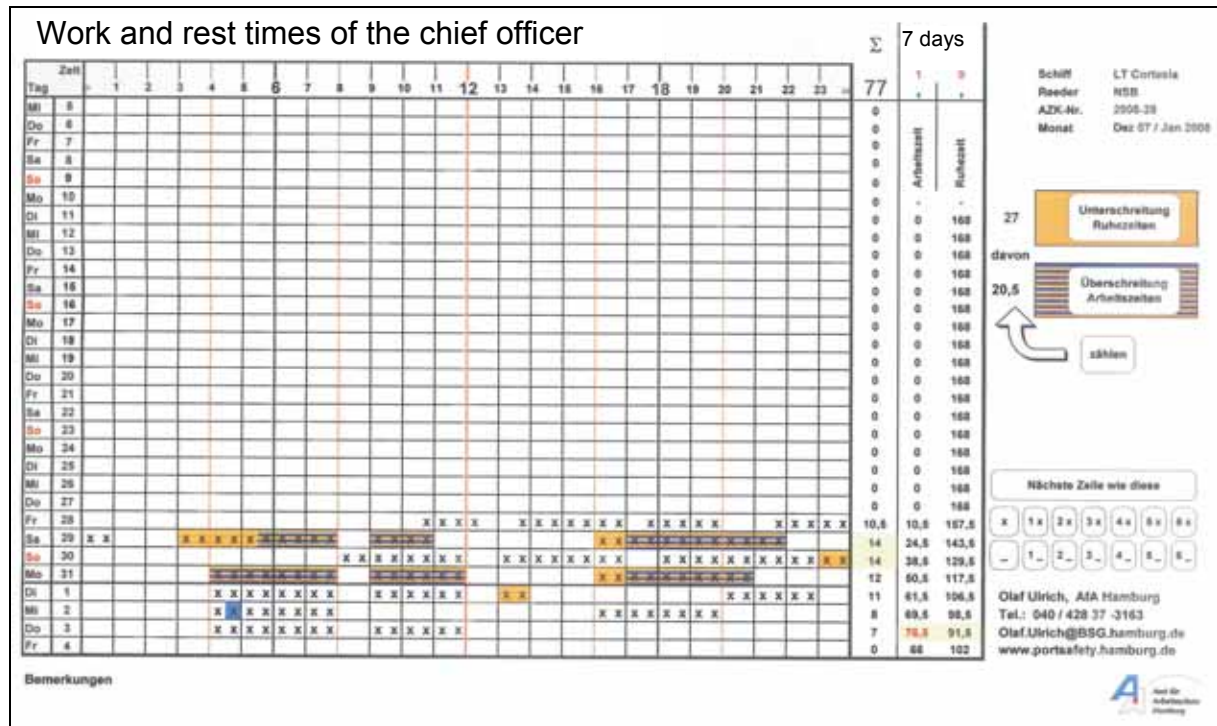
Figure 24: Work times of chief officer

The work times of the chief officer significantly exceed the maximum work times in accordance with the Seamen's Law. The work times on 29 December and 31 December 2007 are given as up to 18 hours in a 24-hour period.

The Federal Bureau of Maritime Casualty Investigation recommends that all operators of vessels sailing under the German flag observe the legally stipulated work and rest times for ship crews. If necessary, arrangements are to be made to relieve the chief officer by another work organisation, particularly in the case of coastal trading.
