Bundesstelle für Seeunfalluntersuchung
Federal Bureau of Maritime Casualty Investigation
Federal Higher Authority subordinated to the Ministry of Transport,
Building and Urban Affairs

Investigation Report 107/08

Serious Marine Casualty

**Engine Failures of HOPE BAY and Collision
between HOPE BAY and OCEANIC
on 12 March 2008 and Collision between
OCEANIC and JOSEF MÖBIUS on the Elbe
on 14 March 2008**

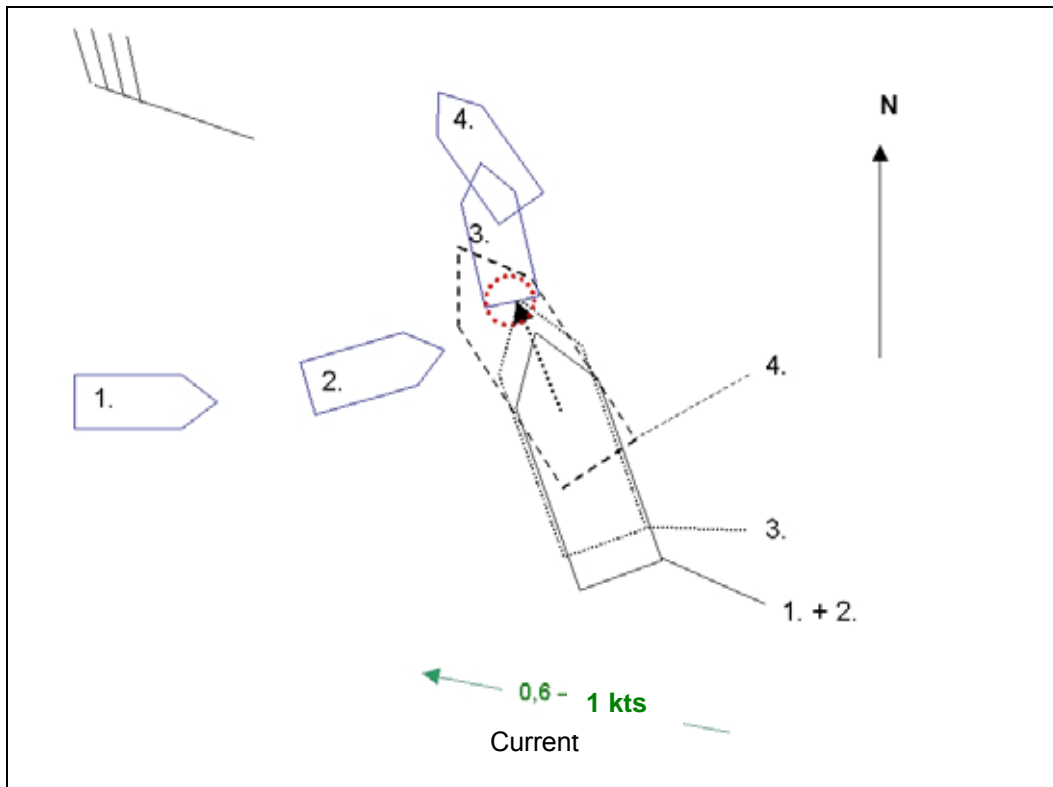
Figure 7: Approach of OCEANIC (blue) to HOPE BAY, with contact; representation corresponds to the statement by the tugs command; position 4: time of rupture of the messenger line

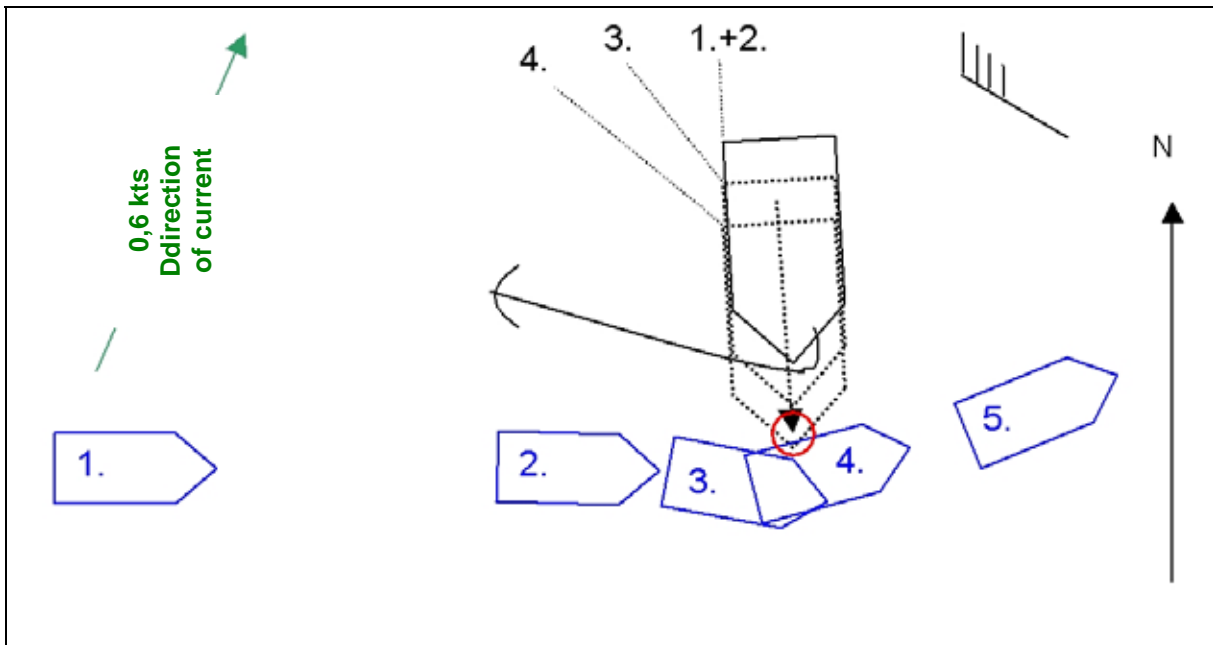
Figure 8: Collision between OCEANIC and HOPE BAY, representation corresponds to the statement by the OCEANIC command

According to the statement by the OCEANIC command, the manoeuvre had been planned with a passing distance of approx. 30 m. However, during the approach the distance had been reduced to such an extent that evasive action by the tug alone could not have prevented the collision. The reduction of distance was attributed to a forward movement of HOPE BAY. This had taken place unexpectedly as the anchor chain of HOPE BAY, on her starboard side, had been standing abeam to slightly aft.

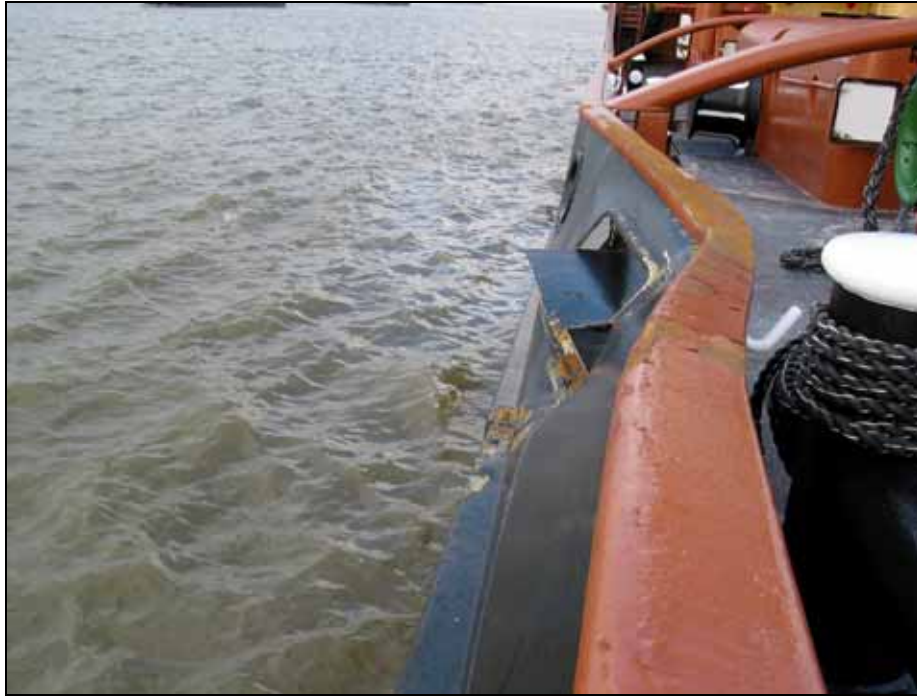
As a consequence of the collision OCEANIC sustained damage to a fuel tank at frames 21-22 and denting of the bulwark in this area, water ingress into the salvage store and a failure of the self steering gear. Approx. 30 m³ of diesel oil were spilled out through the hole in the tank. After berthing an oil barrier was set out round the tug.

Figure 9: Damage to upper deck on the port side of OCEANIC

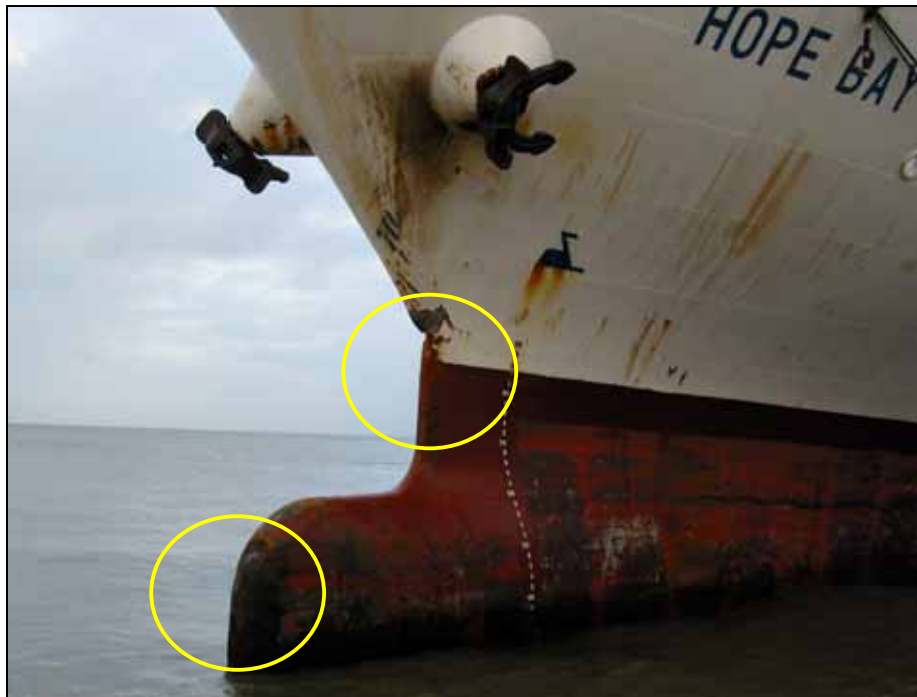
As a result of the collision HOPE BAY sustained a hole in the fore peak tank through which ballast water was spilled. No other damage has been reported to the BSU.

Figure 10: Damages to HOPE BAY

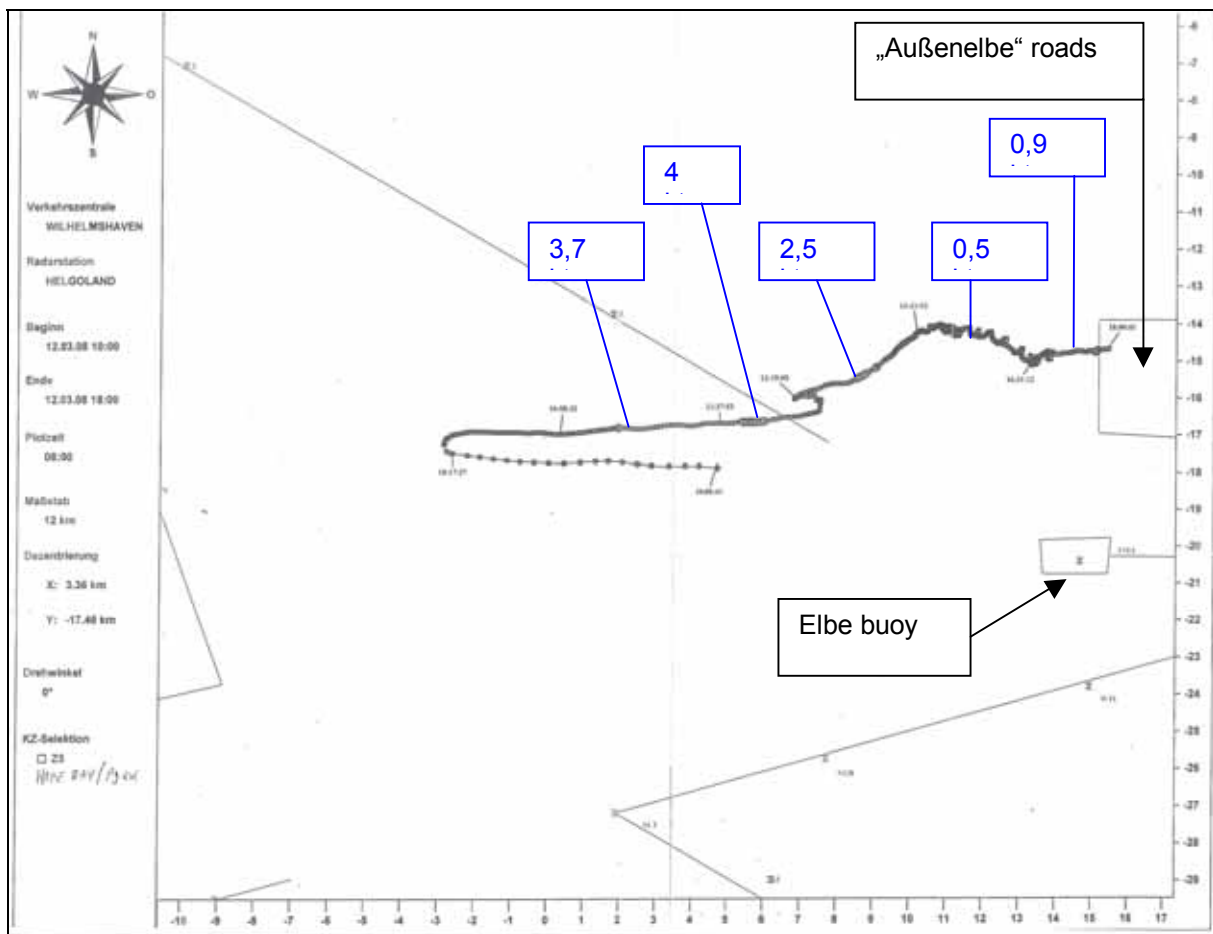
According to the records VTS Wilhelmshaven, i.e. German Bight Traffic (GBT), advised HOPE BAY to anchor at about 1115. The vessel command followed this recommendation at 1236, when it was ascertained after a test run of the engine that the vessel could not proceed with the voyage. By then the vessel had drifted about 6 nm eastwards. The anchor position was within the 30-metre depth contour. The maximum water depth in the way of the drift distance was about 35 m. After dropping the anchor HOPE BAY continued to drift at approx. 1.5 kts. The vessel command of HOPE BAY had first quoted a repair duration of 4 to 5 hours at 1255, i.e. a drift distance of a further 7.5 nm was first to be expected. Although the tidal current set against the direction of drift, the wind was expected to get stronger. Keeping the drift speed of 1.5 kts, the vessel would have been about 2 nm west of the 10-metre depth contour of Großer Vogelsand at 1800. Actually the drift speed slowed down.

Figure 12: Radar plot HOPE BAY of VTS Wilhelmshaven, drift speed inserted by BSU

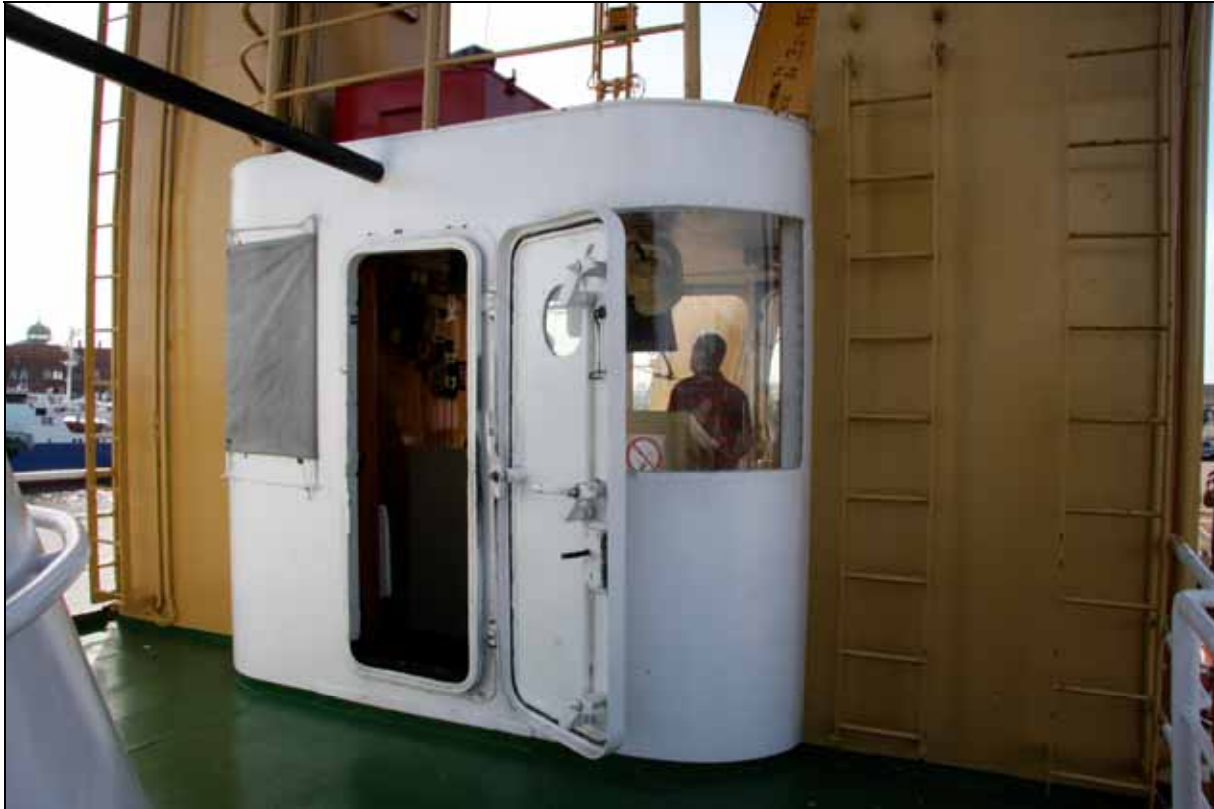
Figure 24: OCEANIC, looking aft to the aft bridge

The view to the towing deck is greatly restricted by the deck crane in its stowage position.

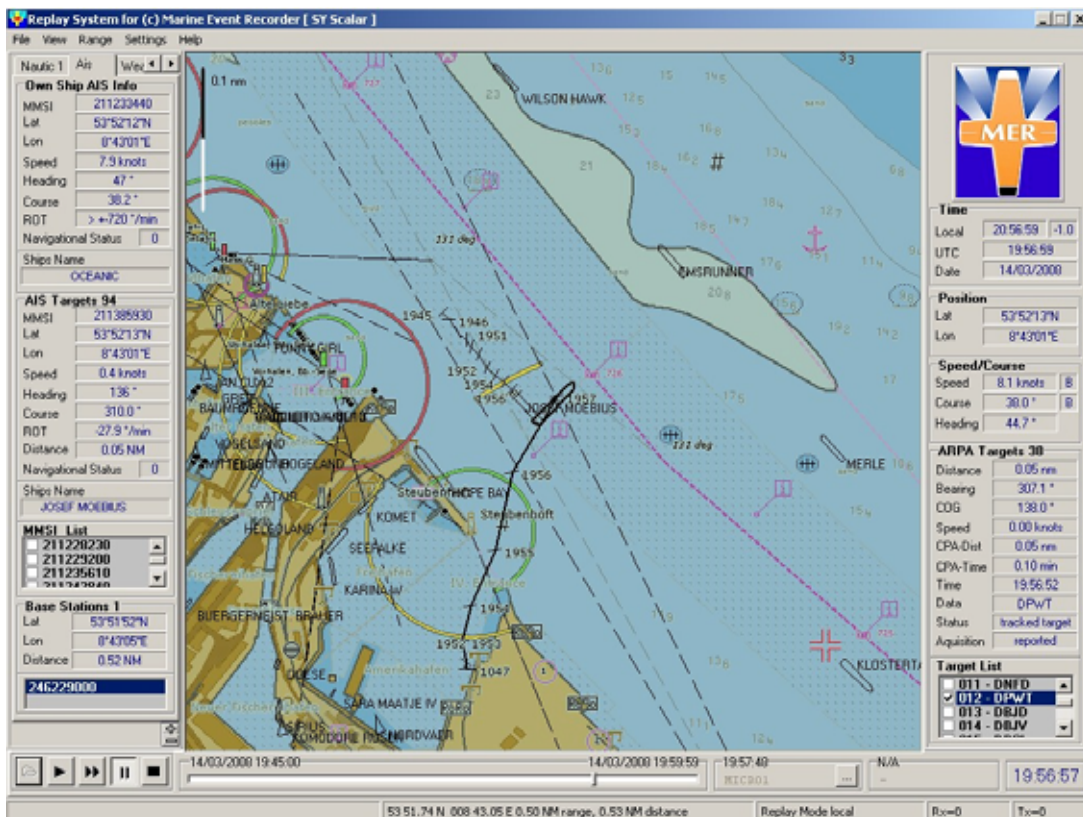
| 20.5649 | | | Collision of the two vessels, course of JOSEF MÖBIUS = 144°;

Course over ground of OCEANIC = 35°, Heading = 57.5° |

Figure 34: Image from VDR replay of OCEANIC, time 205659
