Investigation Report 149/08

**Serious marine casualty**

Forward tug WILHELMINE broaching to in front of MV PAVEL KORCHAGIN on 4 April 2008 in the Port of Hamburg

15 April 2009

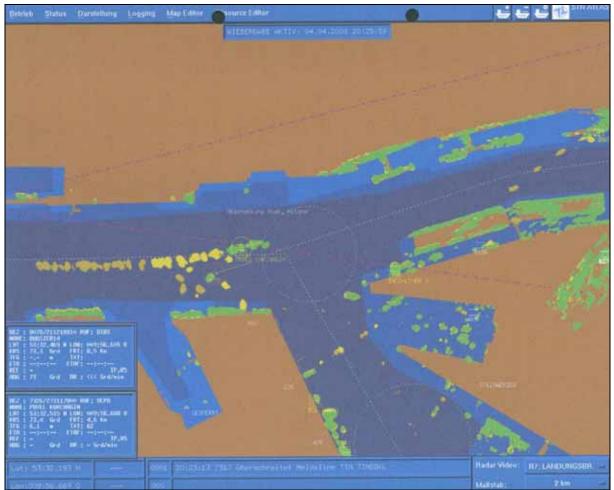
Figure 5: Vessel Traffic Service 2025:59

The current conditions are modelled by the Hamburg Port Authority's Department of Current Development and Hydrology. The results were verified against the real data of the measuring device at Teufelsbrück jetty. According to the results, the current at the scene of the accident was moving 0.5 m/s westwards with an outgoing tide, i.e. at the take-up of the hawser line, the PAVEL KORCHAGIN had a speed through water of 9.2 kn, if 8.2 kn is determined as the speed over ground (see Fig. 5 Vessel Traffic Service, and the Appendix).

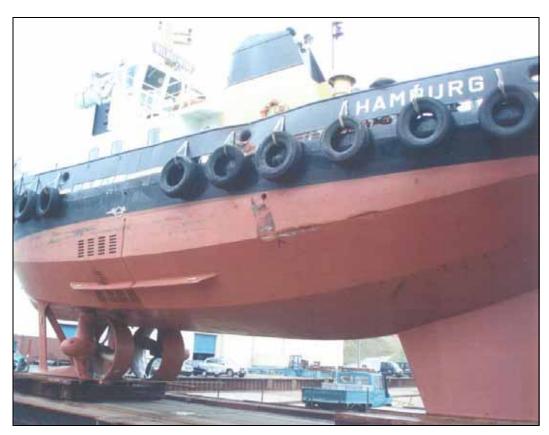
Figure 6: Underwater hull

Following the accident, the tug was moored with starboard side to the outside jetty in Neumühlen. During the mooring manoeuvre, a lowered line was probably caught by the port Schottel drive during an astern manoeuvre. Several tire fenders lay on the starboard stern deck. The floor was wet in the superstructure. Hoses and pumps lay in the alleyways. There were no leakages in the engine room and underwater hull (see Fig. 6). The port bulwark on the main deck at the stern was dented (see Fig. 7). The bulkheads 2.5 m from the forward ballast water tank were dented and frames 18 and 21 were deformed. The tug had obtained permission from the GL surveyor to sail to Rendsburg for repairs. The engine systems were in full working order. A flange was loose on the heating valve station. The paint had come off the shell on the inside in some places. Water had penetrated through the port engine room ventilators.

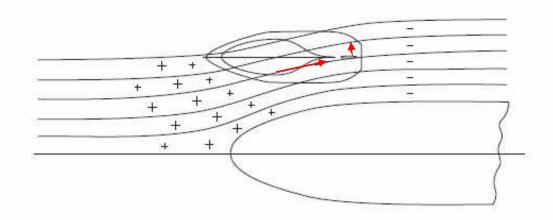
Figure 9: Bow wave

Fig. 9 indicates the angle of the current lines in relation to the tug and its skeg. The tug has to countersteer possibly  $15^{\circ}$  in order to remain parallel. On an ideal course, the WILHELMINE would have available the specified bollard pull of 30 t with an optimum position of the Schottel propeller for steering. The steering force of a rudder propeller tilted by the angle  $\delta$  against the direction of travel gives the following

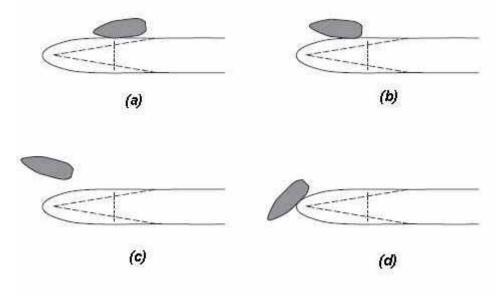
Figure 10: Course of the accident

For the take-up of the tripping line on the starboard side of the PAVEL KORCHAGIN, the tug WILHELMINE had to sail close to the front of the ship and the bow. Shortly before broaching to, at 2025:29, the speed over ground was 8.2 kn. Travelling against a current of 1 kt, both vessels had a speed through water of 9.2 kn. This speed is decisive for the calculation of the hydrodynamic longitudinal and transverse forces, as well as the yaw moments. At a maximum speed of 11.0 kn, the WILHELMINE had only little force reserves left to maintain distance (see Fig. 10a-10c). During this manoeuvre, the stern of the tug can swing unexpectedly to starboard when abeam of the ship's bow water line (see Fig. 10d) if this is not counteracted by sufficient rudder moments. The result was that, following a "Full Ahead" manoeuvre, the WILHELMINE broached to across the bow of the PAVEL KORCHAGIN. If there was any doubt, such a manoeuvre should have been aborted, especially as the speed was relatively high at the time of line take-up and the local physical effect cannot be calculated. The effective forces and moments can only be decreased by reduced speed.

The Federal Bureau of Maritime Casualty Investigation recommends the masters of assistance tugs for seagoing vessels and port pilots to establish towing connections only on minimum possible speed and intensify communication as regards when, where and on which speed towing connections should be established.
