# **Investigation Report 167/08**

**Serious marine casualty**

# **Grounding of the MV PACIFIC CHALLENGER to the east of Oro Bay/Papua New Guinea on 9 April 2008**

2 February 2009

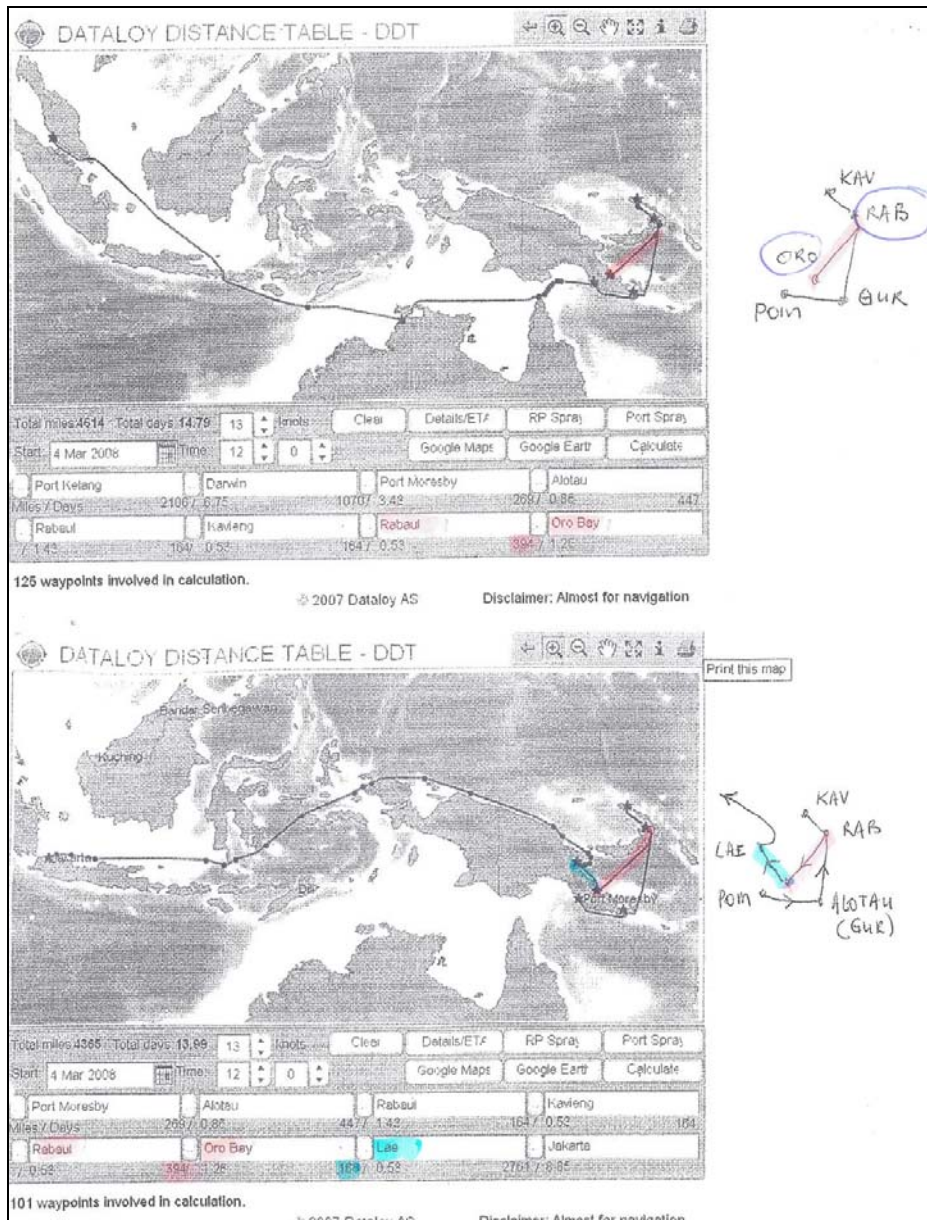
Figure 3: Distance data from the charterer

The distance between Rabaul and Oro Bay was specified in this correspondence as 394 nm and from Oro Bay along the NE coast of Papua New Guinea to the Port of Lae as 166 nm.

On board the vessel, all available navigational aids should always be consulted for position-fixing purposes. Planning data from third parties, e.g. charterers, and unofficial chart material, should not be used for navigation.

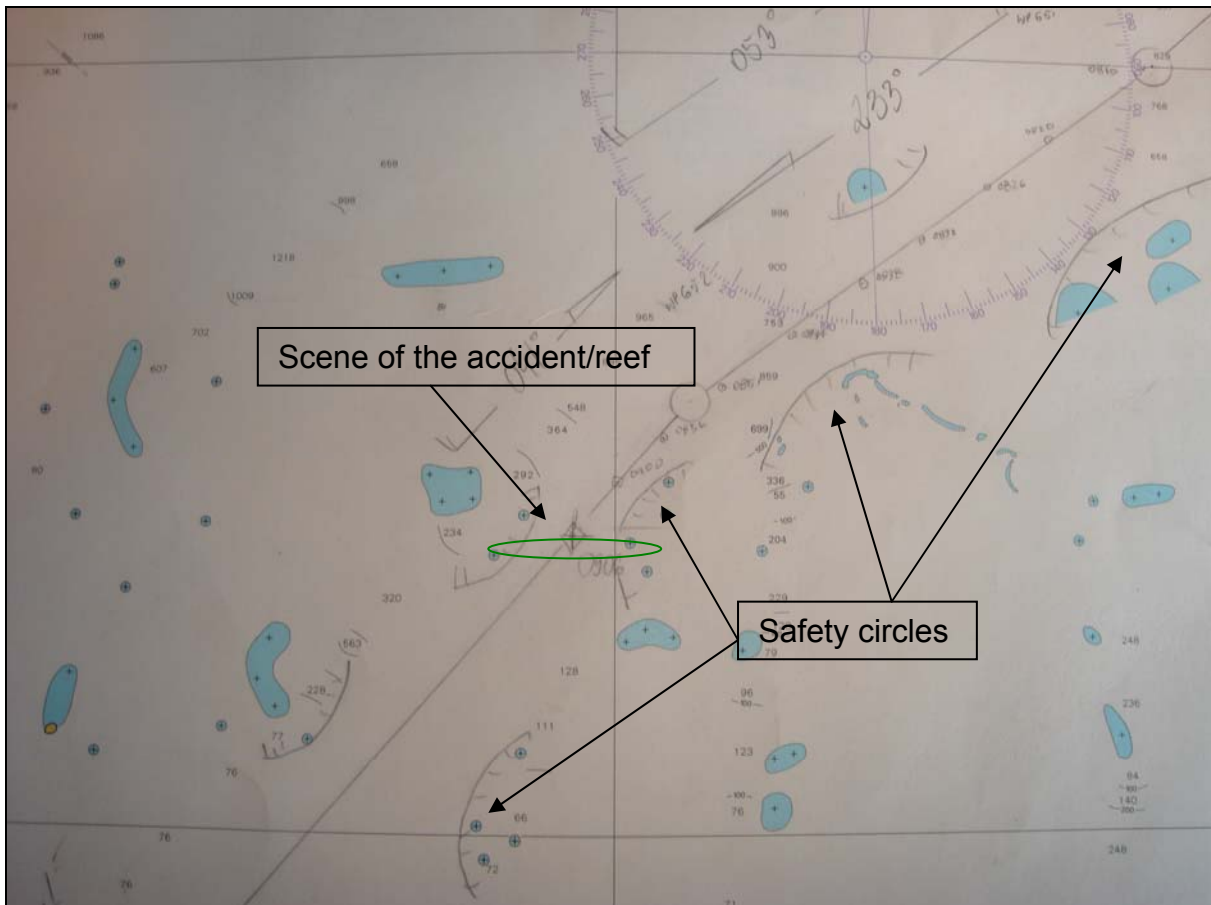
Figure 4: Chart section from on board

The vessel is not equipped with an electronic chart system. The Australian nautical chart AUS 520 to the smallest scale was used for navigation. The second officer had drawn safety circles on this chart to mark the indicated areas of shallow water/coral reefs.

On the morning of 9 April 2008, the third officer was on watch duty. The master, standing on port side, also additionally kept lookout. All charted shallows were identified abeam. The vessel was sailing at a speed of 15 kts on a course of 233°, which was subsequently changed to 221° over ground. (The already plotted

outbound courses 041° and 053° can be seen on the chart section in Fig. 4.) Around 09:00, an uncharted reef across the course line was, due to the heading into the sun, only spotted late. Despite immediate adjustment of the propeller to a reverse pitch, the ship ran virtually “non-braked” on to the reef. The grounding of the vessel went smoothly, everything remained upright and no other damage was detected.

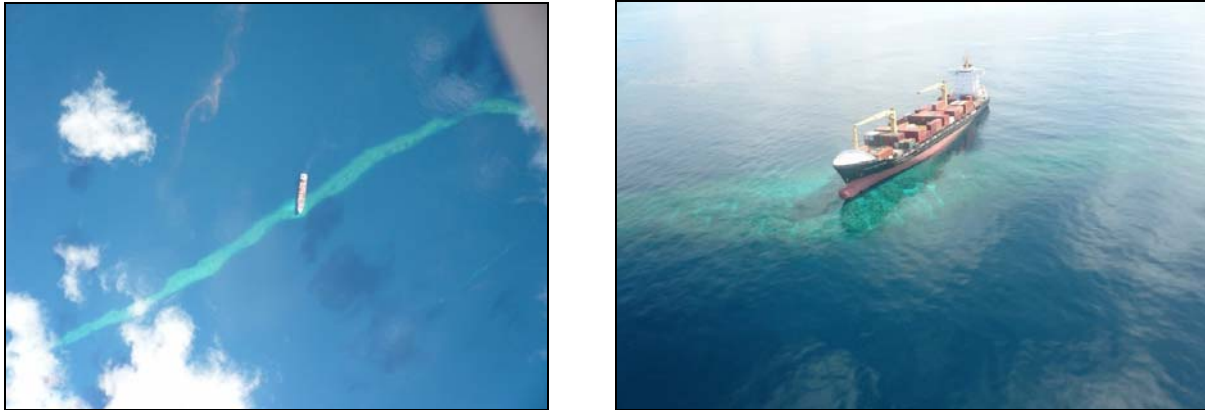
Figure 5: Reef from above  
(Source: shipping company)

All tanks were immediately checked and endeavours were made to come clear again under the vessel's own steam but were unsuccessful. It was only after the ship had been lightered by unloading of some containers that she was pulled clear again with the aid of tugs and hauled to the Port of Lae on 27 April 2008. At a shipyard in China, the double bottom was subsequently completely replaced up to around midship.

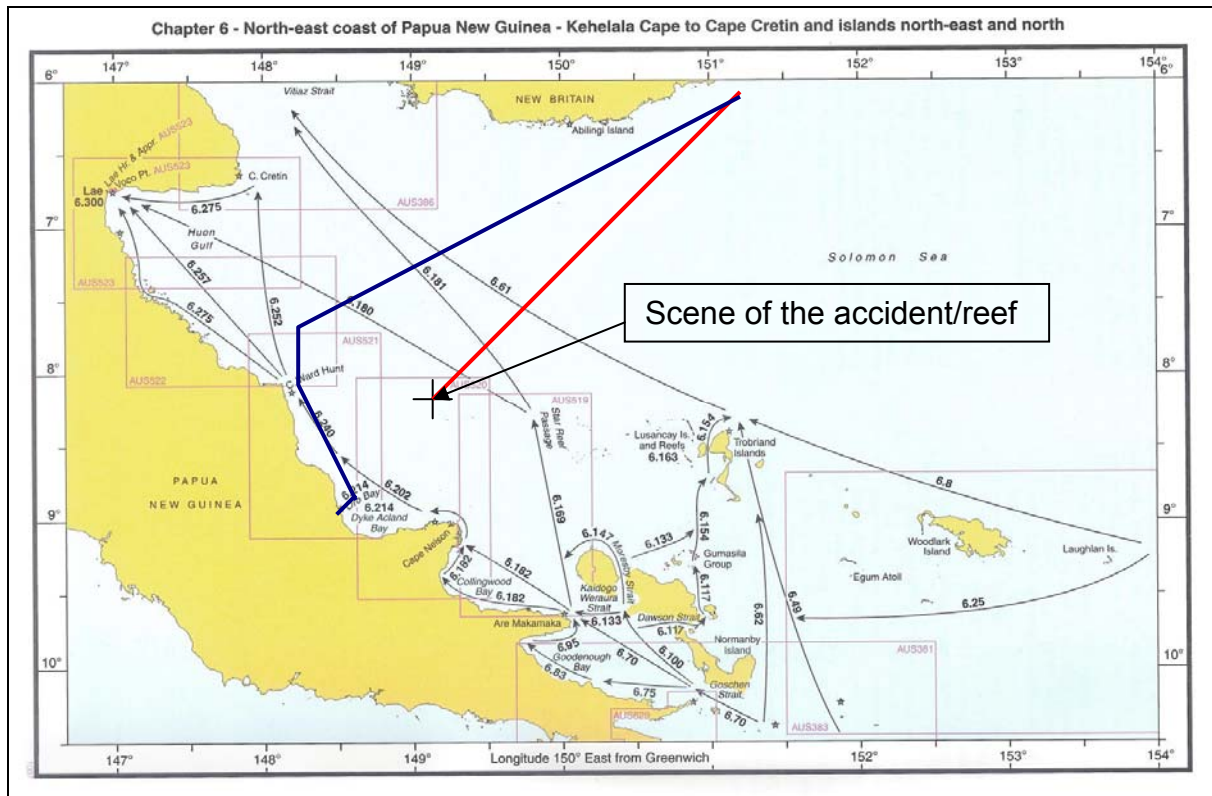
Figure 6: Section from Sailing Directions

Sailing into Papua New Guinean ports should be carried out via so-called preferred routes. These identified sailing routes have not been verified in accordance with IMO/IHO standards but do offer relative accuracy. To reach the Port of Oro Bay, route 6.240, coming from the north, runs past Cape Ward Hunt and then parallel to the coast.

If following the recommendation according to the Sailing Directions, the route (blue route) would be approx. 70 nm longer than the direct route (red route).

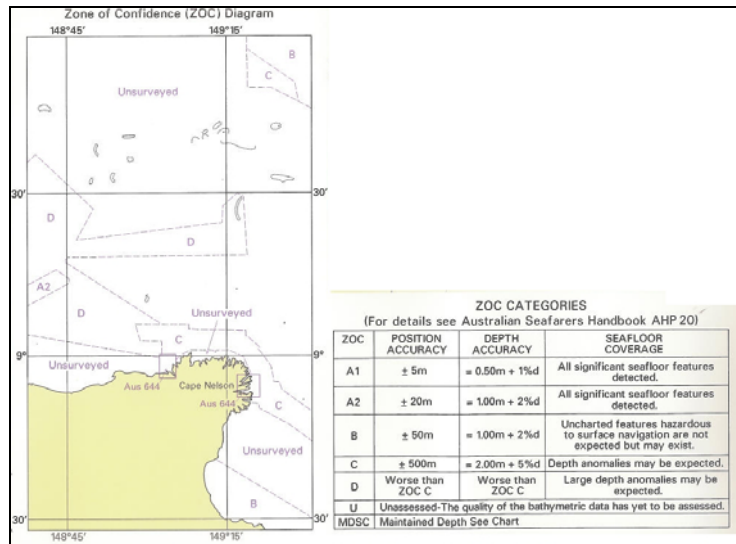
Figure 7: ZOC diagram from nautical chart AUS 521

It is not possible to determine from the available Australian nautical chart material when the sea areas were surveyed. However, on the nautical charts are spaces marked with notes about uncharted areas. The ZOC diagram legend also contains an overview and table of the accuracy of the positions and bearings:

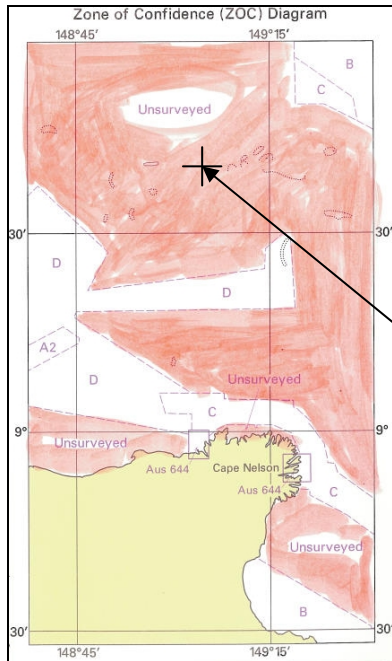
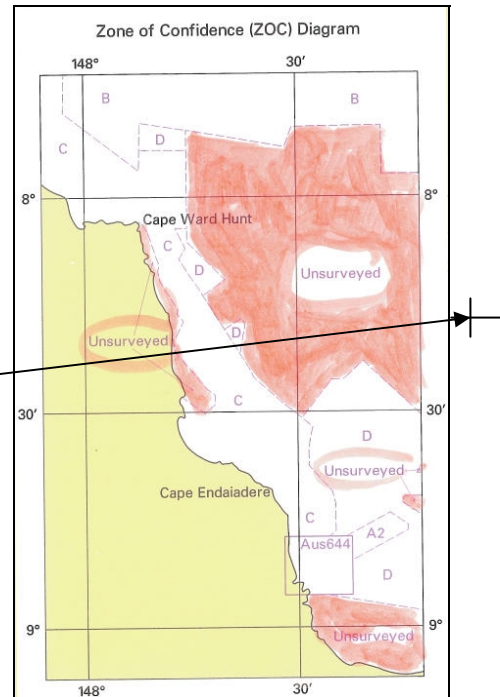
It is difficult to make out the precise boundaries of the unsurveyed area at first glance, so the area is therefore highlighted in red below:

In the case of the recommended route 6.240, coming from the north, then at Cape Ward Hunt along the coast to Oro Bay, the vessel would end up, in the worst case scenario, in zone "C". This is an area of sea described as:

Sea Area not completely surveyed,  
 depth anomalies may be expected;  
 position inaccuracy: +/- 500 m,  
 depth inaccuracy: 2m + 5% of the water depth

The chosen direct route to Oro Bay goes through zone "D" and zone "U" (UNASSESSED), which is defined as follows: "The quality of bathymetric data<sup>2</sup> has yet to be assessed."

The sea area in front of Oro Bay, which is indicated as "unsurveyed" on the nautical charts, is partially shown with depth specifications. During this investigation, it was not possible to determine when surveying was carried out and who surveyed the depths.

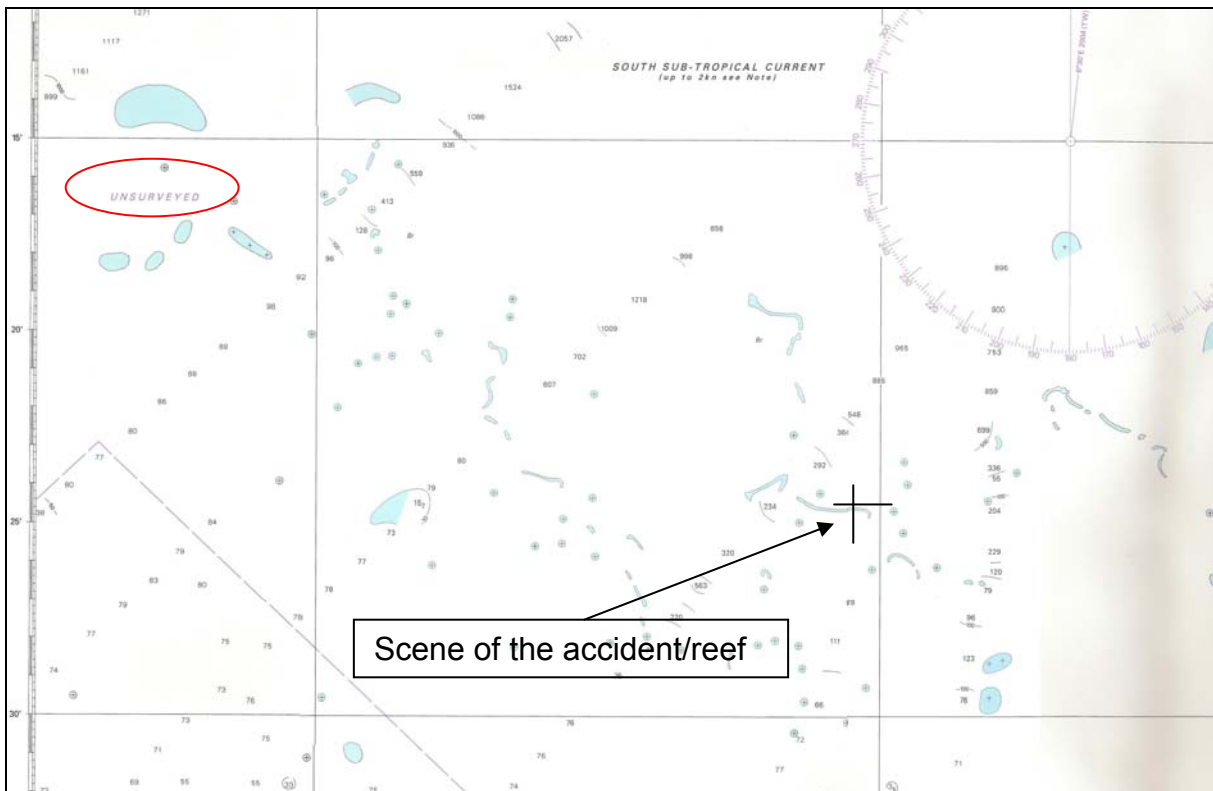
This notice is based on information of the Australian Hydrographic Service dated 29 August 2008. The nautical chart AUS 520, corrected according to Admiralty Notice to Mariners week 44/08 (2008-4083), shows the area now differently to the nautical chart according to Figure 4 on page 9:

Despite this resurvey, the area is still marked as "**UNSURVEYED**".
