## **Summary Investigation Report 180/08**

### **Near-collision and Grounding of the Sailing Yacht INTENTION IV on 3 May 2008 off Warnemünde**

2 March 2009

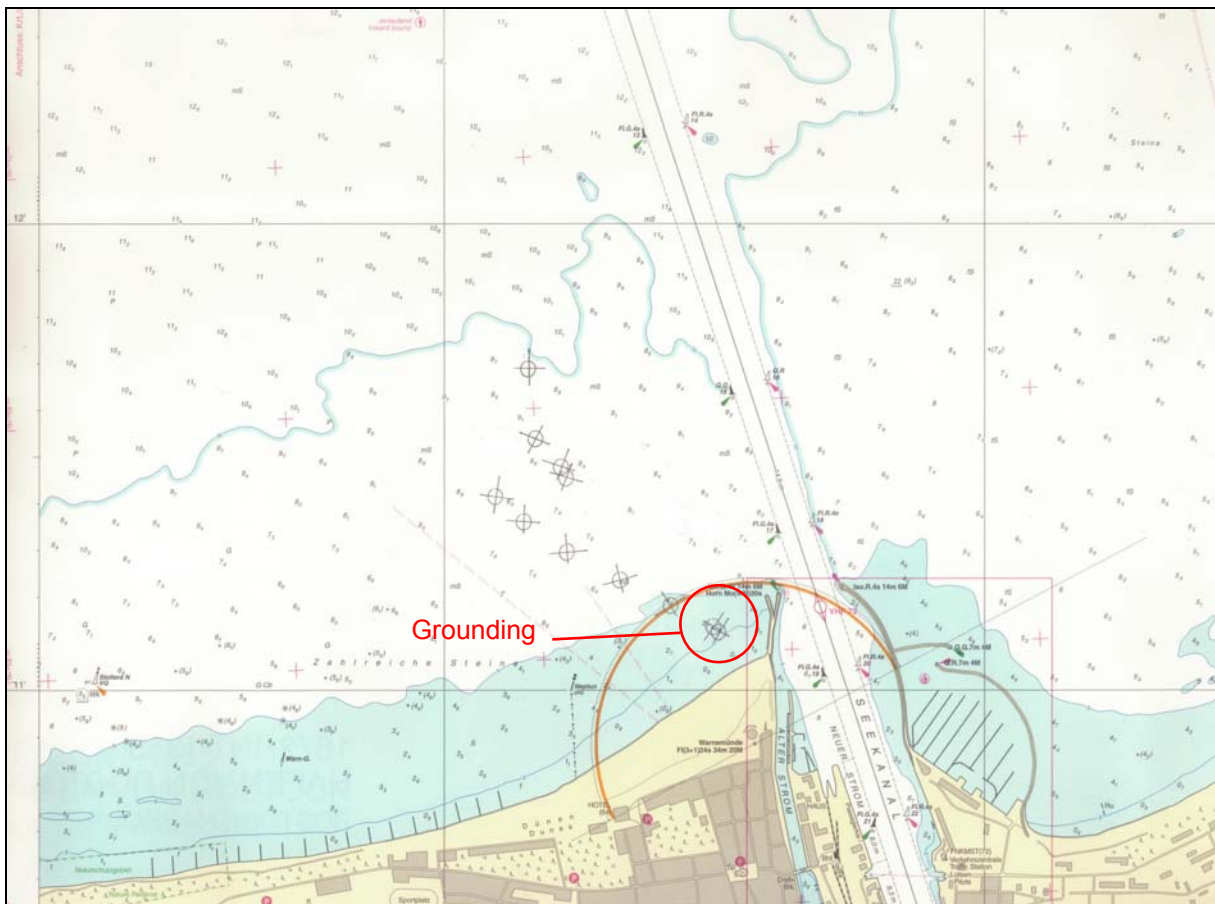
Figure 1: Course approaching the port and the position when running aground outside Warnemünde

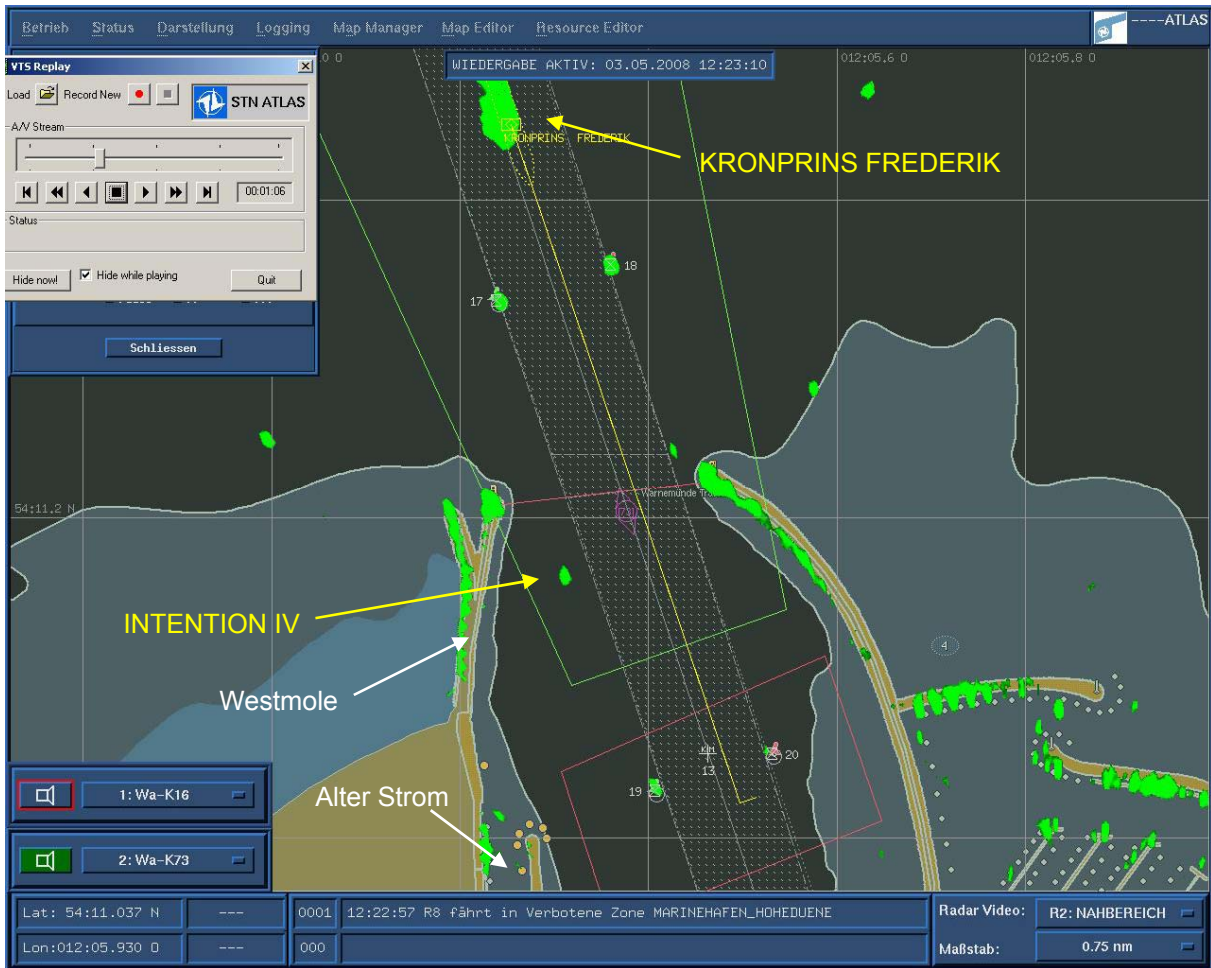
did not use the radio in order to report to the Vessel Traffic Service or keep themselves informed. Subsequently this led to a near-collision with the Danish-flagged ferry KRONPRINS FREDERIK, since they crossed into the Seekanal and therefore the main fairway in ignorance of the traffic situation.

Figure 3: Outbound passage of INTENTION IV, distance to KRONPRINS FREDERIK approx. 400 m, time 12:23:10

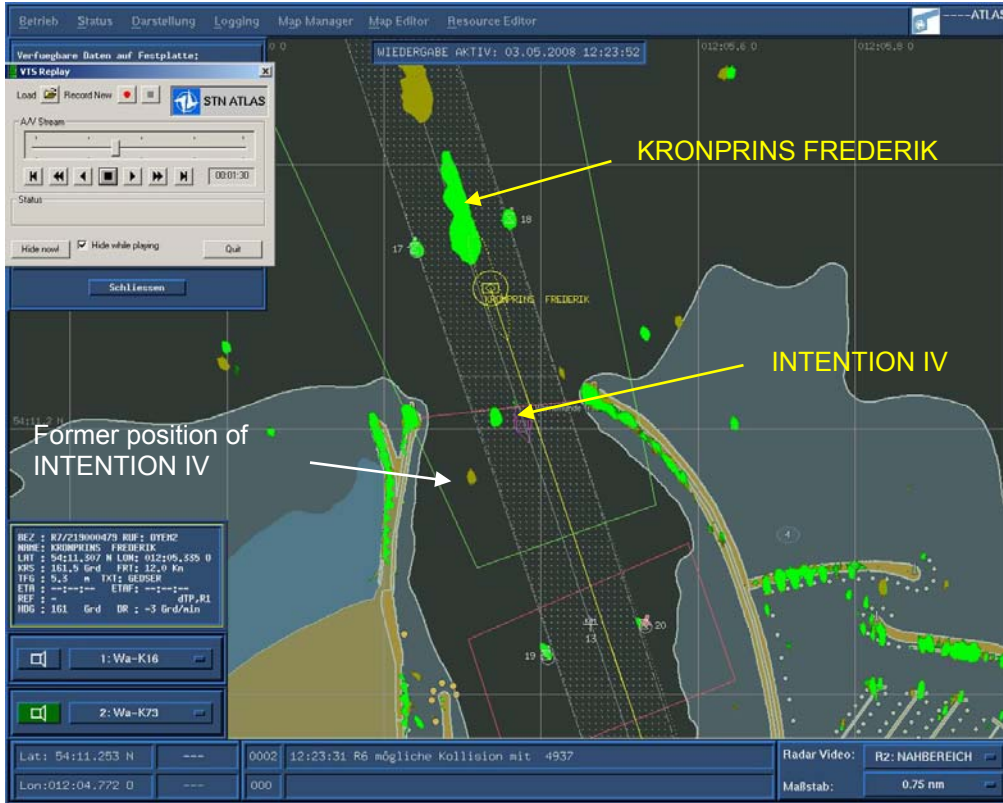
Figure 4: Outbound passage of INTENTION IV, distance to KRONPRINS FREDERIK approx. 200 m, time 12:23:52

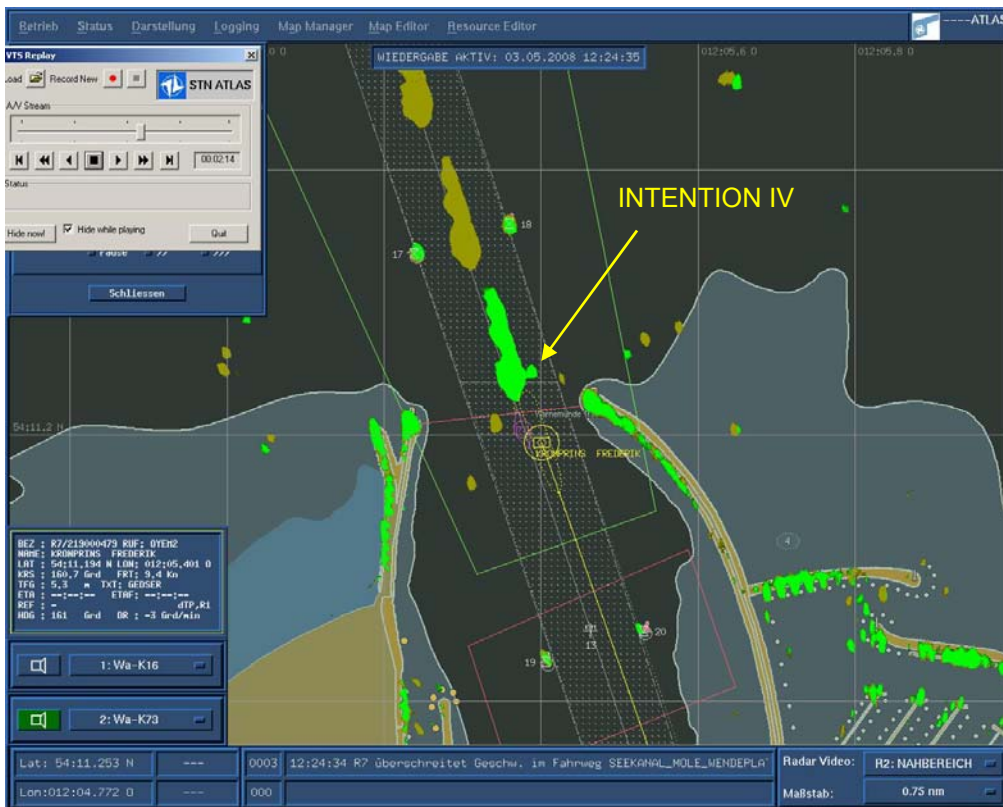
Figure 5: Outbound passage of INTENTION IV, time 12:24:35

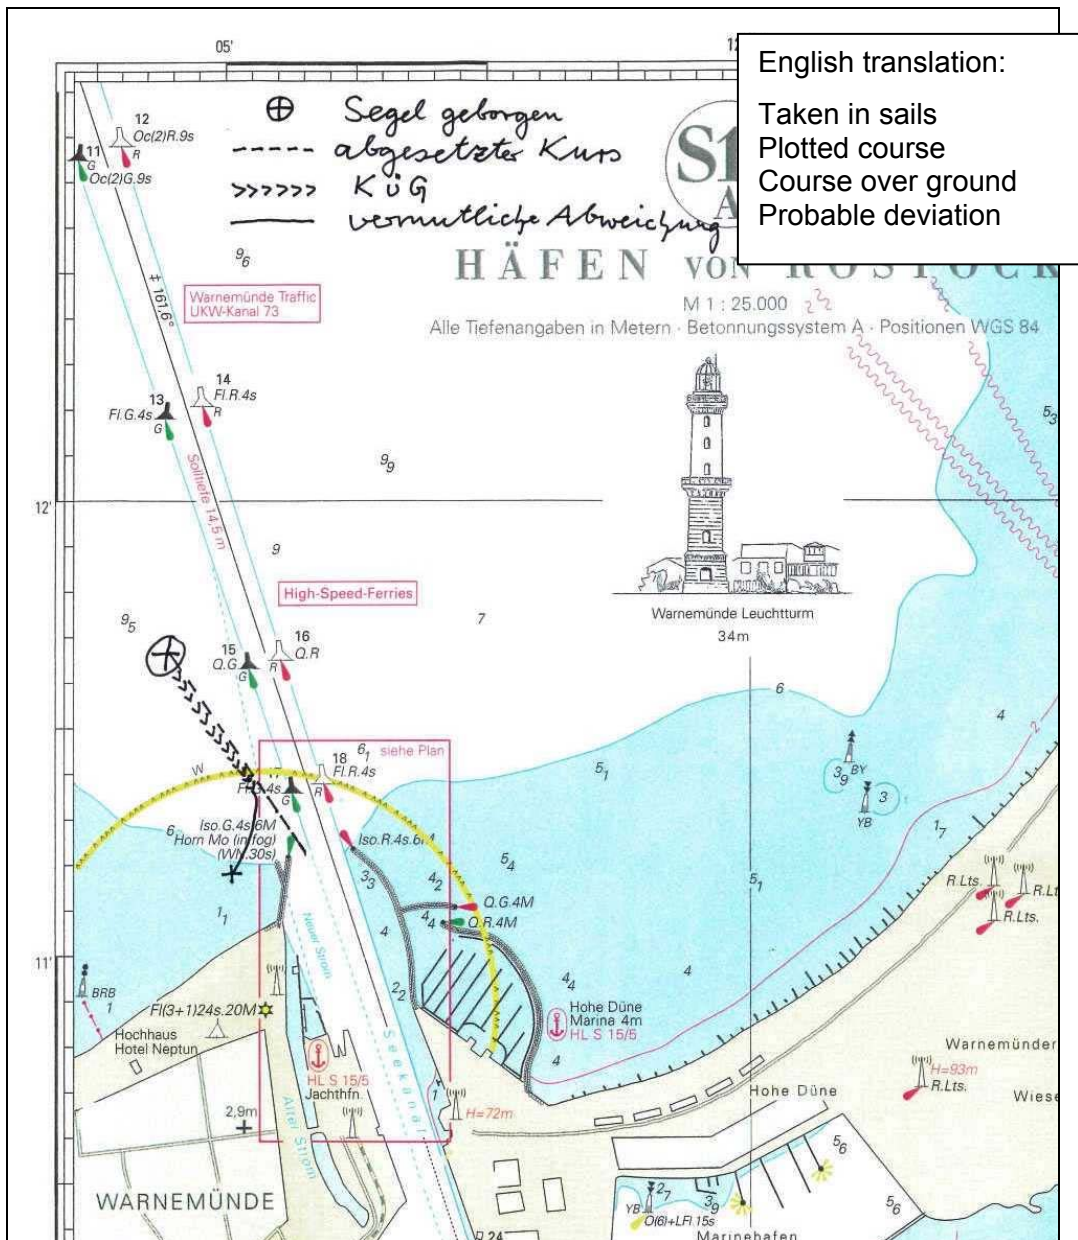
Figure 7: Course of the yacht according to statement of the skipper

The skipper also handed over a copy of the logbook page from the day of the accident. Due to the circumstances that the entries on one hand only contained time, course and speed and on the other hand neither the start position nor, after a manoeuvre timeframe of 25 minutes, an interim position had been entered, no conclusions could be drawn about the actual course taken between the radar data recorded by VTS Warnemünde.

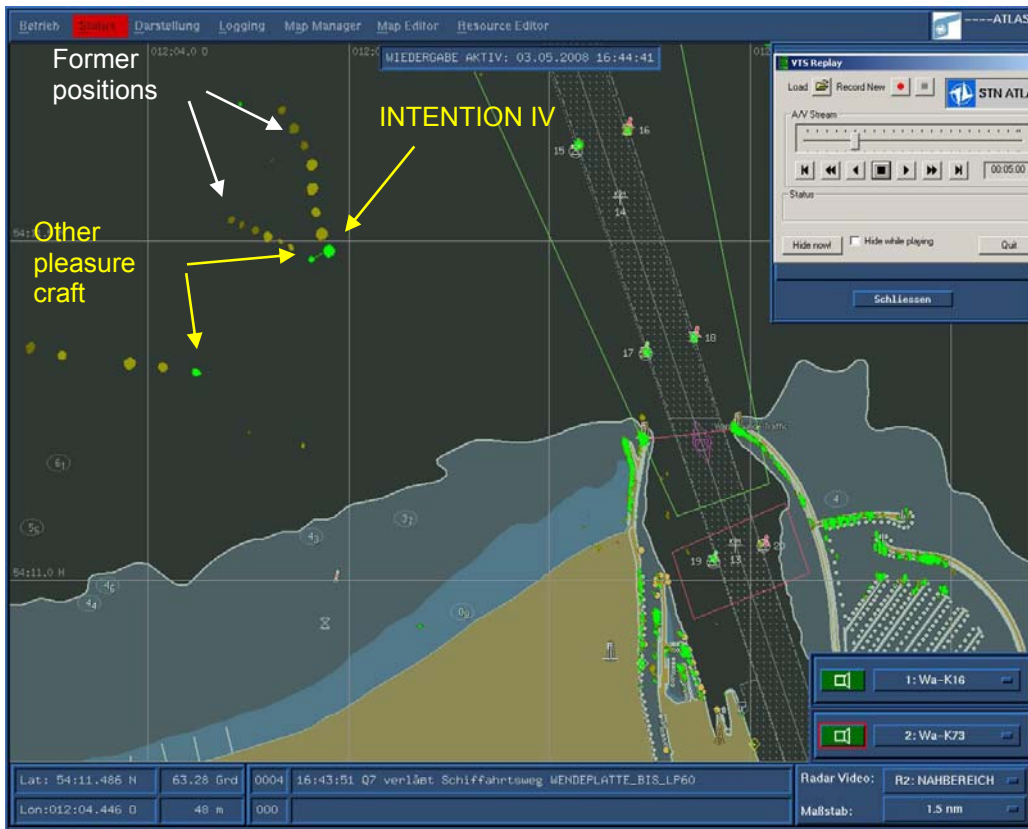
The inbound passage of INTENTION IV had also been recorded by the Vessel Traffic Service. During the inbound passage there was apparently a close quarters situation with another pleasure craft (see Figures 8 and 9).

Figure 8: Inbound passage of INTENTION IV, time 16:44:41

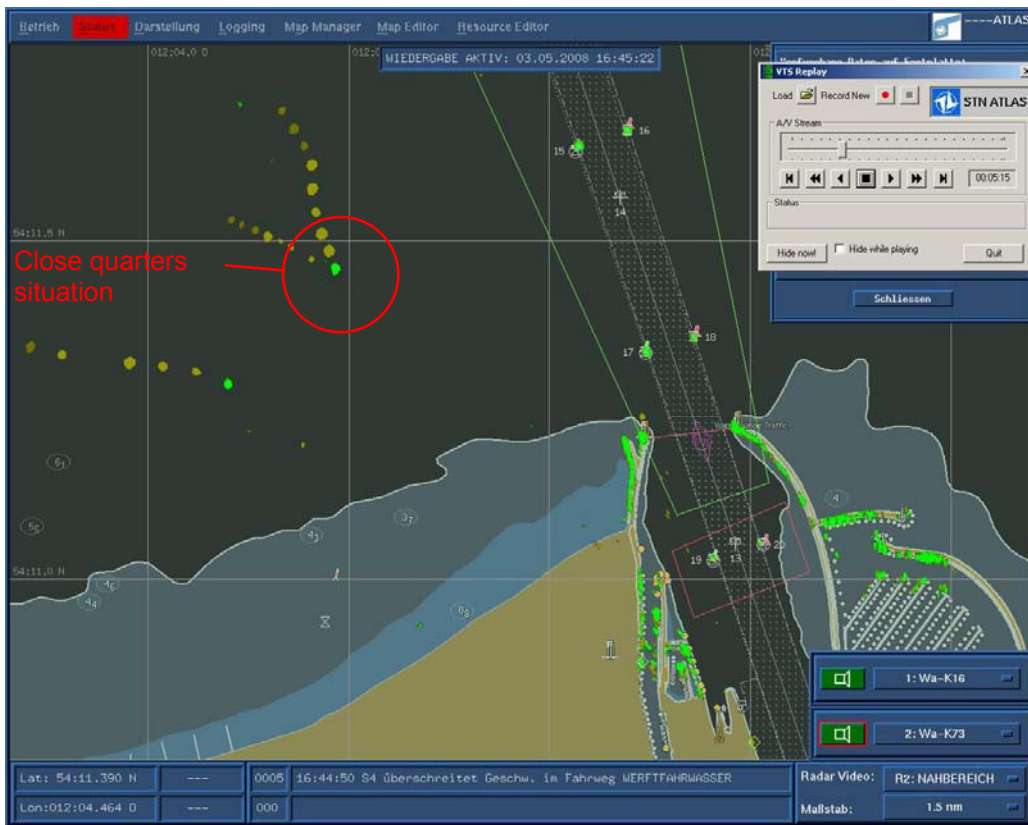
Figure 9: Inbound passage of INTENTION IV, close quarters situation with another pleasure craft, time 16:45:22

With the weather conditions prevailing on the day of the accident, local variations in visibility distances were possible. For instance the close quarters situation between 1644 and 1646 was not noticed by any of the crew members of INTENTION IV.

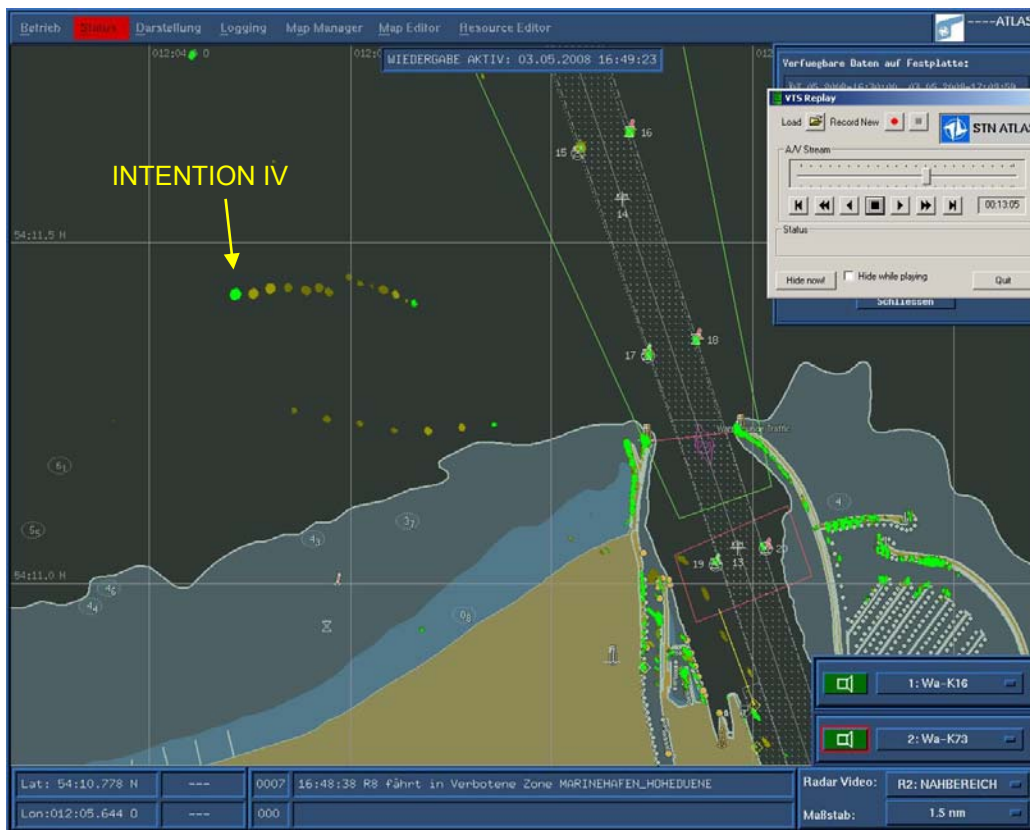
According to an entry in the logbook, from 1650 the yacht proceeded under engine. At this time the skipper said that he instructed the helmsman to steer a course of 145°. According to the radar record, from 1650 onwards a course of 145° was not steered for a significant amount of time. Instead the general course of the yacht from 1650 was 119°. If the yacht had been steered on a course of 145°, this course would have led even further away from the entrance between the two moles.

Figure 10: Inbound passage of INTENTION IV, time 16:49:23

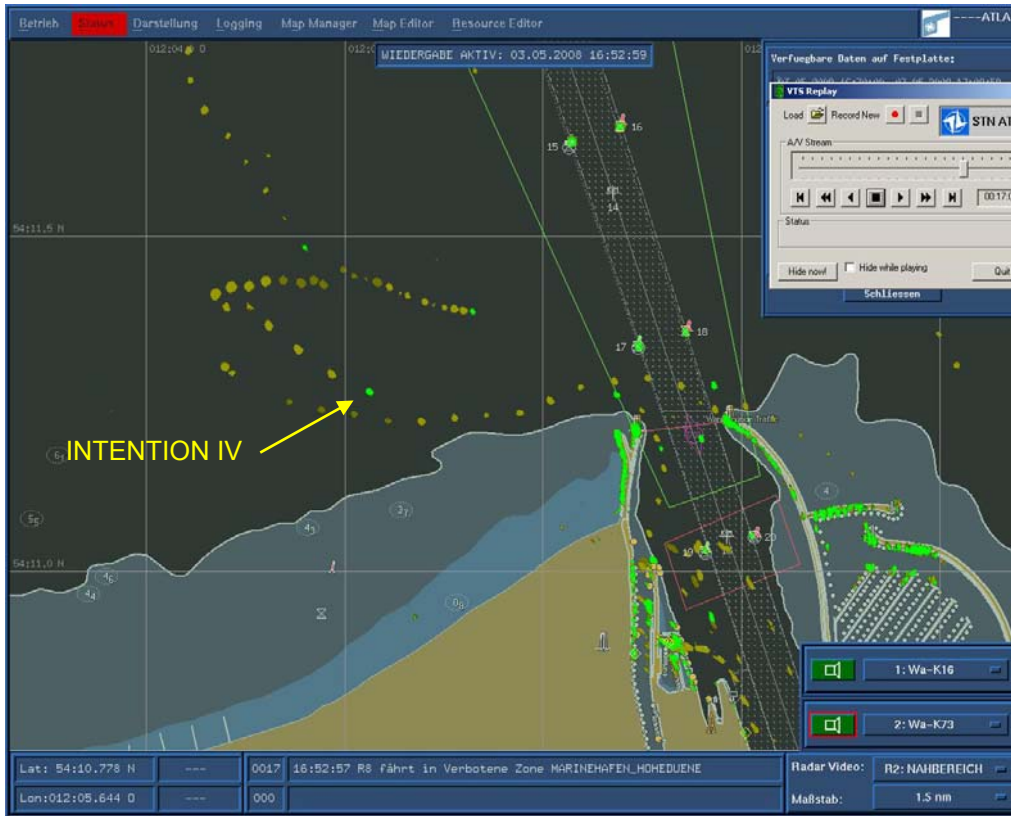
Figure 11: Inbound passage of INTENTION IV, time 16:52:59

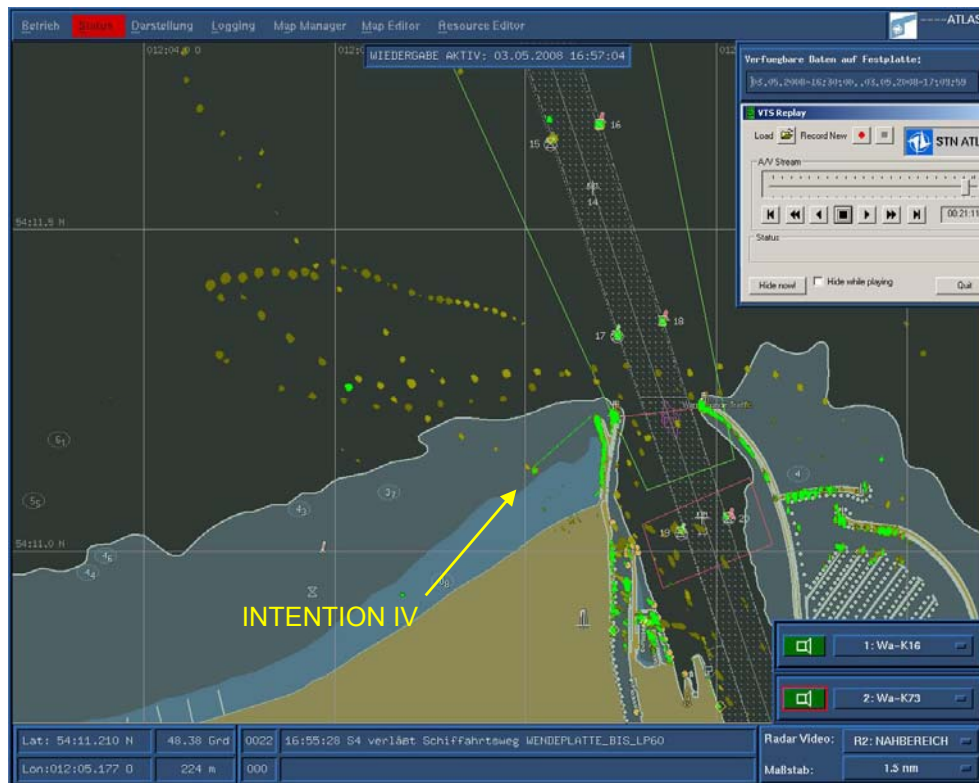
Figure 12: Grounding of INTENTION IV, distance to the mole 224 m, distance to the beach 171 m, time 16:57:04

The shallow water alarm function of the echosounder was not used. According to the opinion of the investigators an alarm after crossing the “5 Metre Depth Line” could have prevented a grounding.

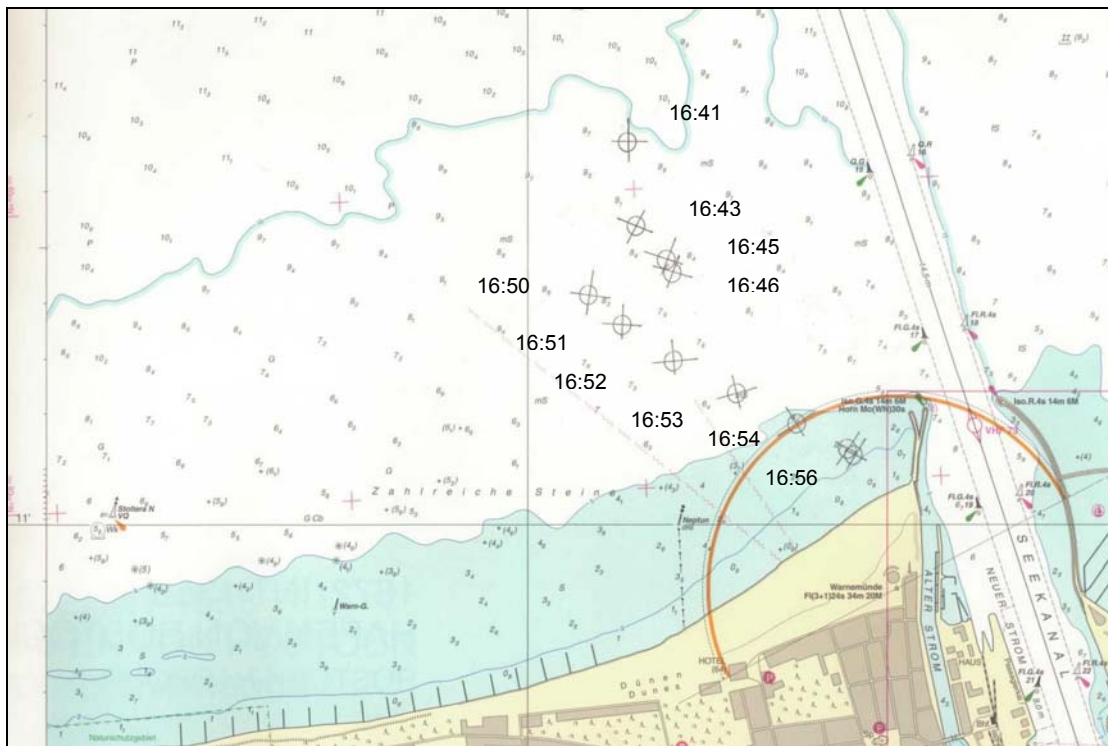
Figure 13: Positions of INTENTION IV copied from the radar record of the VTS
