Bundesstelle für Seeunfalluntersuchung
Federal Bureau of Maritime Casualty Investigation
Federal Higher Authority subordinated to the Ministry
of Transport, Building and Urban Affairs

Investigation report 211/08

**Collision of the RoPax ferry FINNLADY
with the Skandinavienkai
on 16 May 2008
in Travemünde port**

17 August 2009

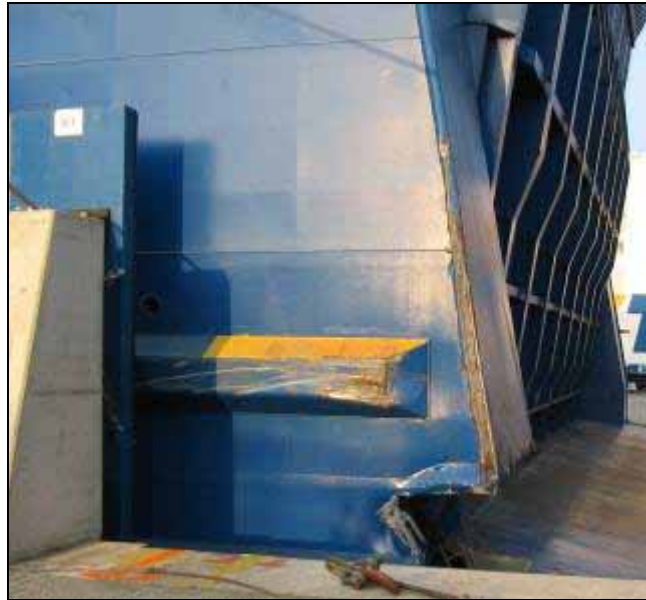
The FINNLADY showed damage on both sides in the area of the transom. On port side, the shell plating was damaged over a surface area of approx. 1 m² by the contact with fender piles at pier 6 (see Fig. 3).

Figure 3: Damage to the port-side shell plating of the FINNLADY

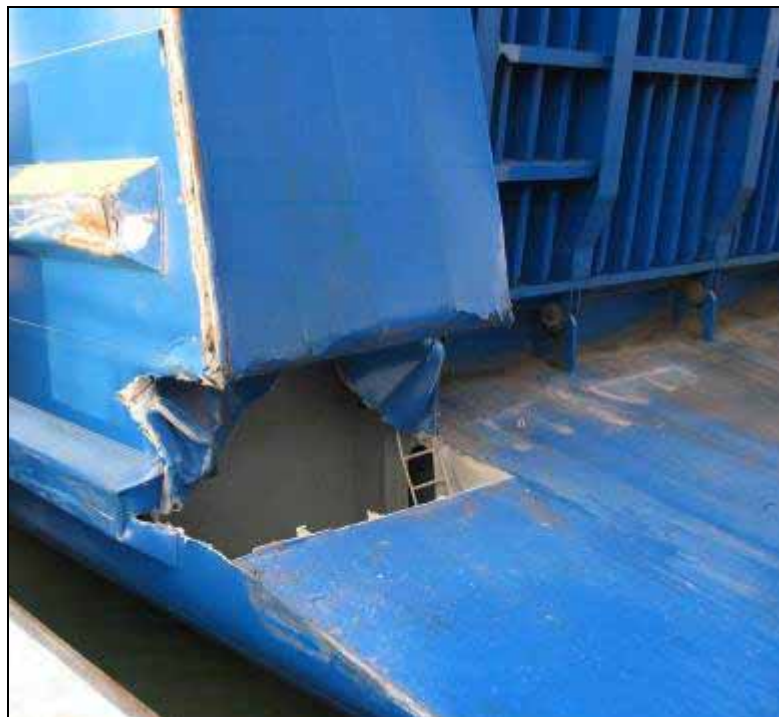
Level with the cofferdam, the plating over a surface area of approx. 2 m x 1.5 m above the water line had been ripped open (see Fig. 4).

Figure 4: Damaged cofferdam on the port side of the FINNLADY

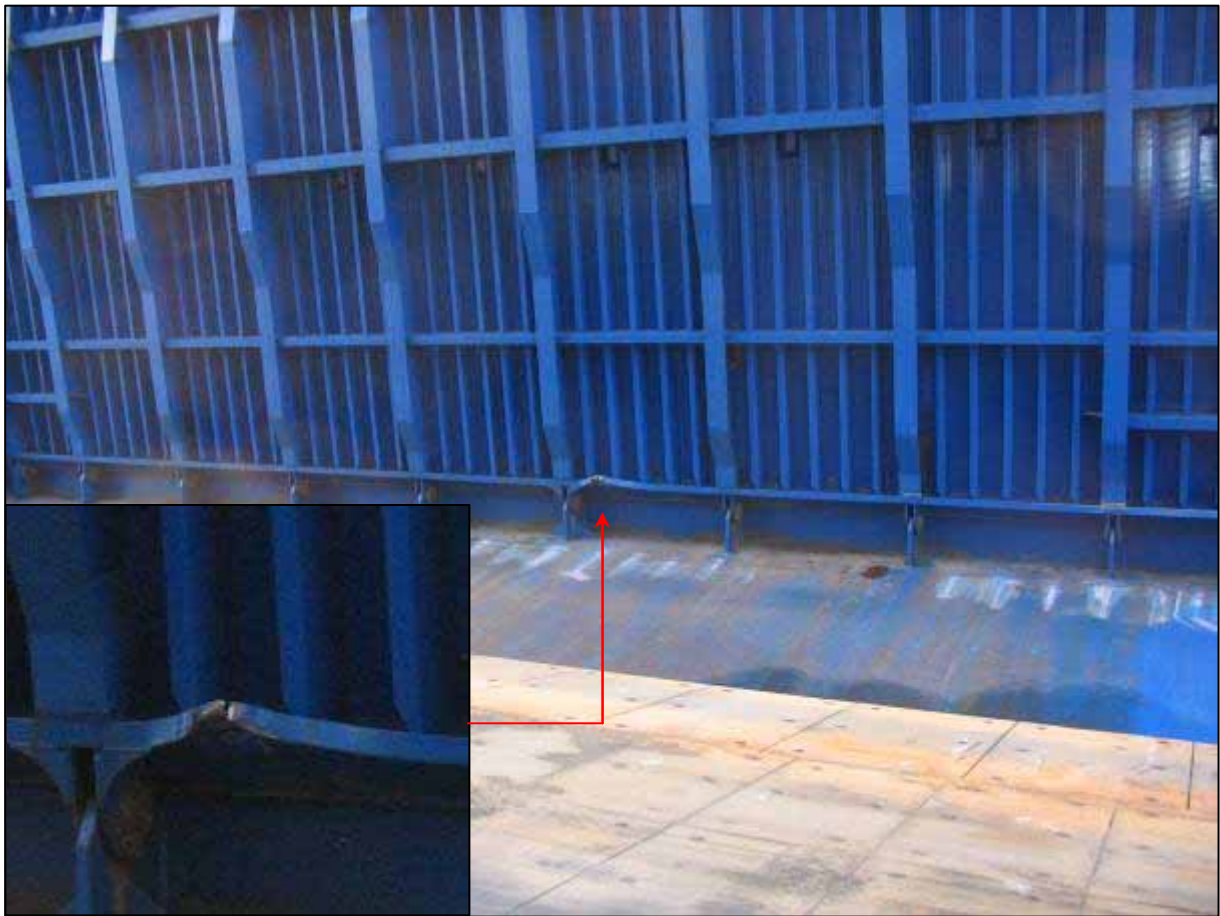
On the lower of the two stern ramps, the flange and stiffener were damaged in the midship area (see Fig. 5).

Figure 5: Damage to the stern ramp of the FINNLADY

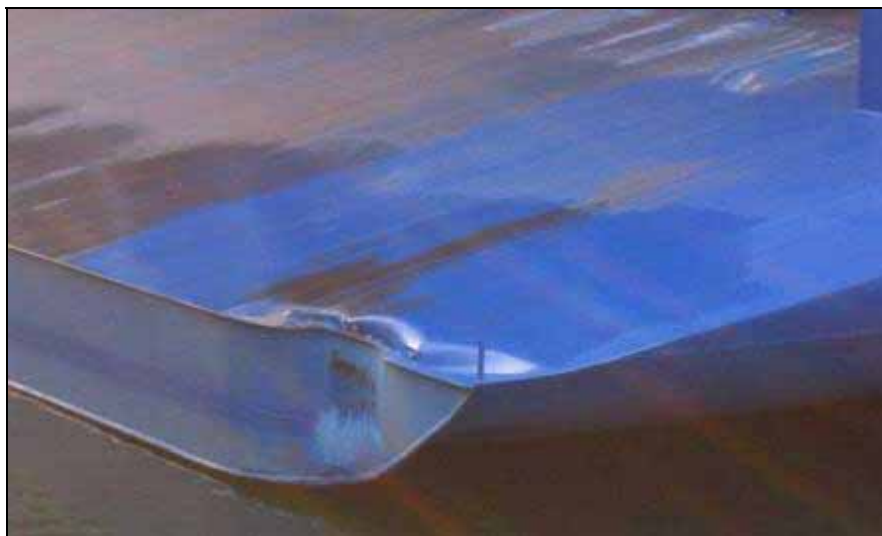
On the starboard side, the plating in way of water ballast tank 16C was buckled along a length of approx. 1 m (see Fig. 6).

Figure 6: Damage to the transom on the starboard side of the FINNLADY

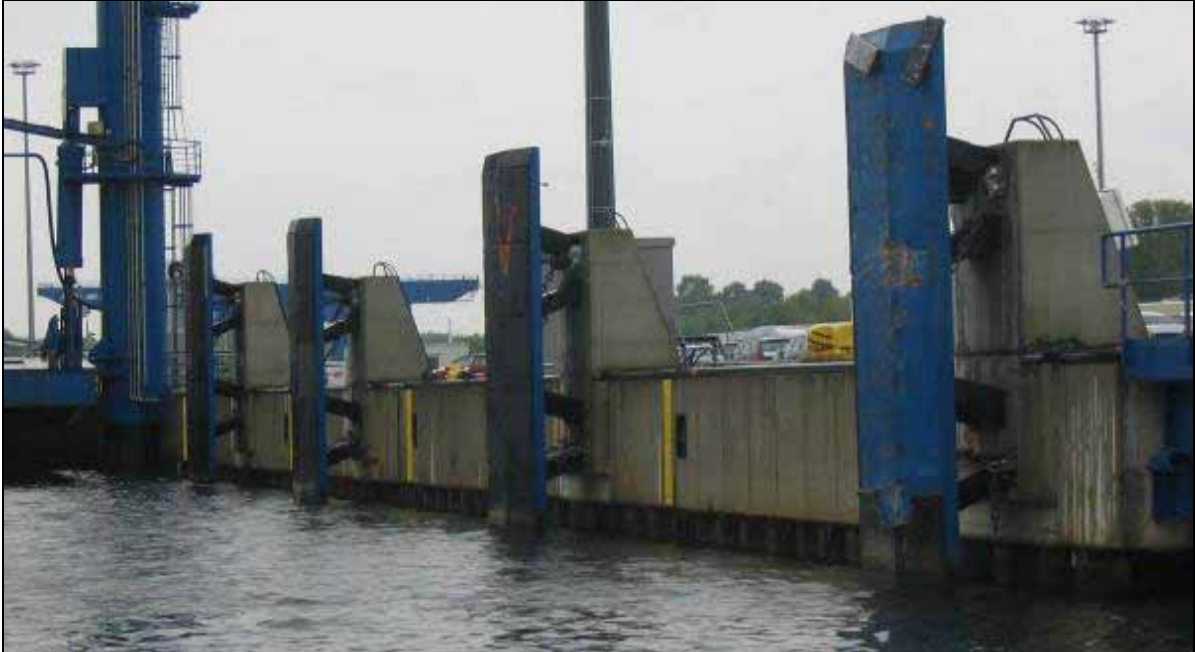
The FINNLADY initially hit the pier fender piles, partly causing considerable deformation. Numerous rubber fenders were torn off (see Fig. 7) and pieces of concrete were knocked out in some places.

Figure 7: Damage to the fender piles

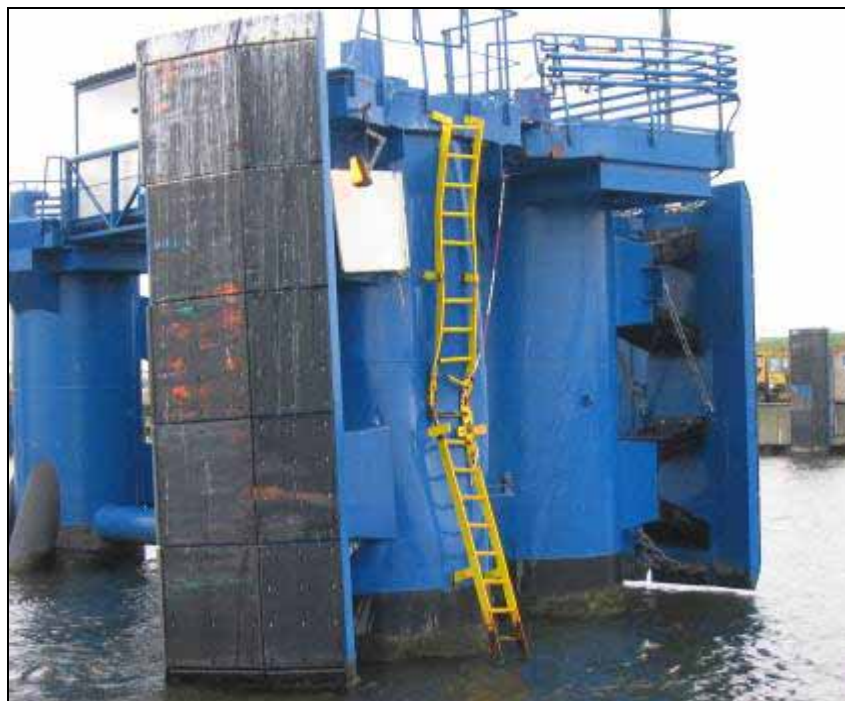
The steel structure of the foremost fender pile in front of pier 6 was damaged, whereas it could not be ruled out that the pile had been damaged prior to the accident (see Fig. 8).

Figure 8: Damage to the foremost fender pile

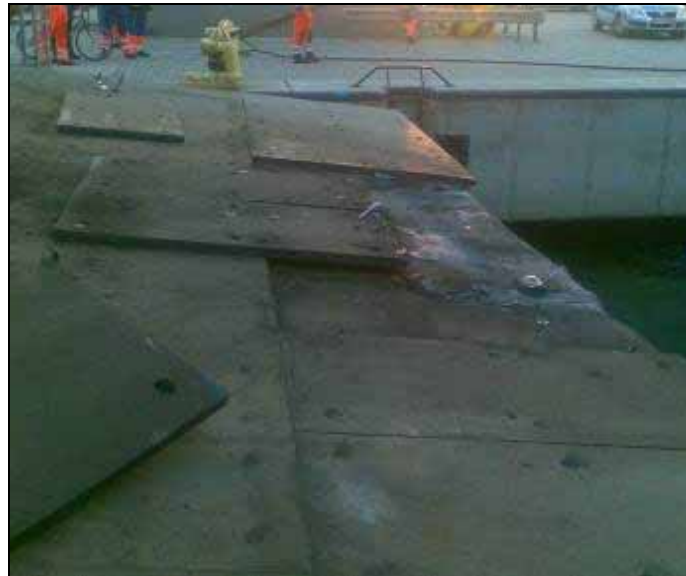
Several platings were partly ripped off the anchoring of the lowerable loading bridge at the pier as a result of the stern impact of the FINNLADY (see Fig. 9).

Figure 9: Damaged plating on the loading bridge

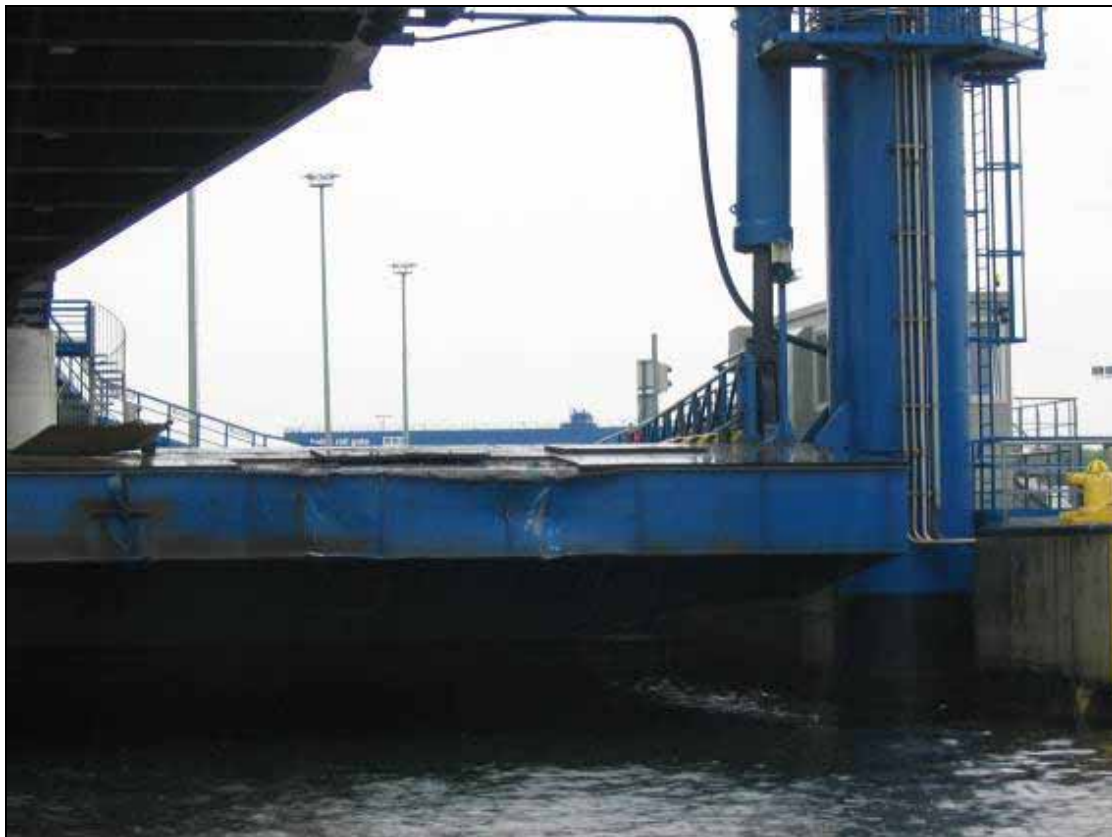
The steel substructure of the bridge was buckled (see Fig. 10). The bridge hydraulics could no longer be operated following the collision.

Figure 10: Damage to the steel substructure of the loading bridge

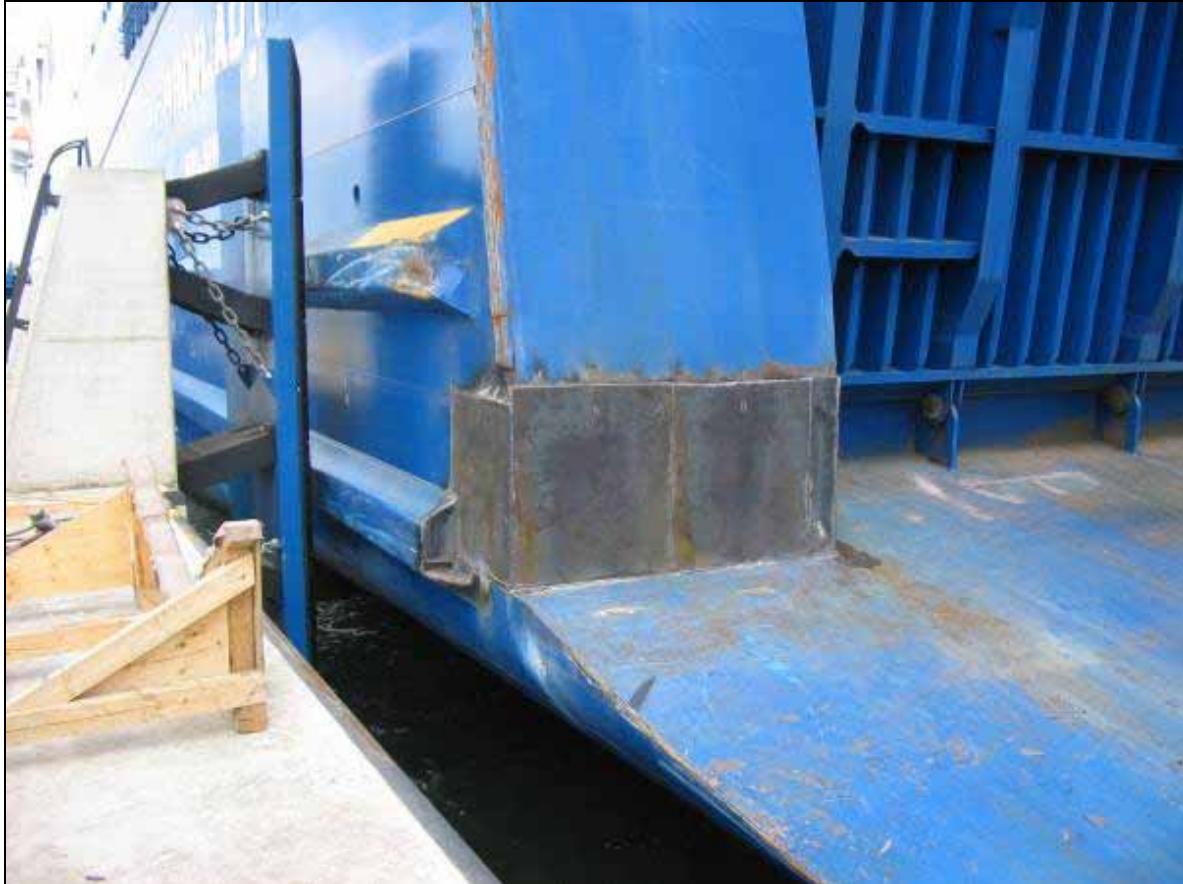
Figure 11: Emergency repairs to the damaged cofferdam

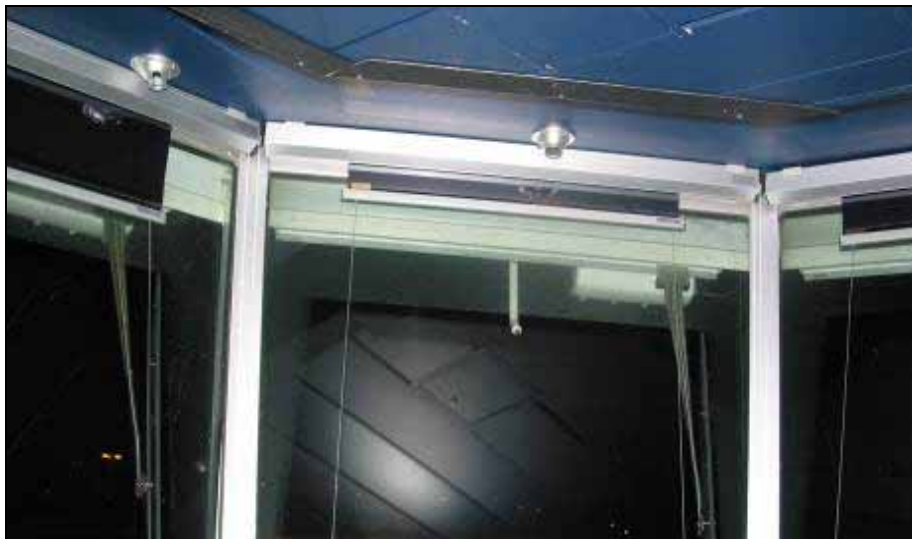
The bridge windows can be shaded with roller blinds (see Fig. 16). The sun was low at the time of the incident (sunset: 2115). The blinds had not been pulled down on the evening of the incident.

Figure 16: Bridge windows with roller blinds

Irrespective of the level of knowledge of individuals in terms of dealing with faults in the main propulsion system, it would also have been necessary on the FINNLADY to use the window blinds to counteract any glare caused by the setting sun. The video recording of a propeller alarm (cf. attachment) shows how the manufacturer has set up the alarm so that it stands out (flashing, illuminating). The fact that this clear alarm supposedly went unnoticed on the monitoring panel leads to the conclusion that the bridge wing was not optimally prepared for the mooring manoeuvre. The wing should have been darkened using blinds at least in some places.

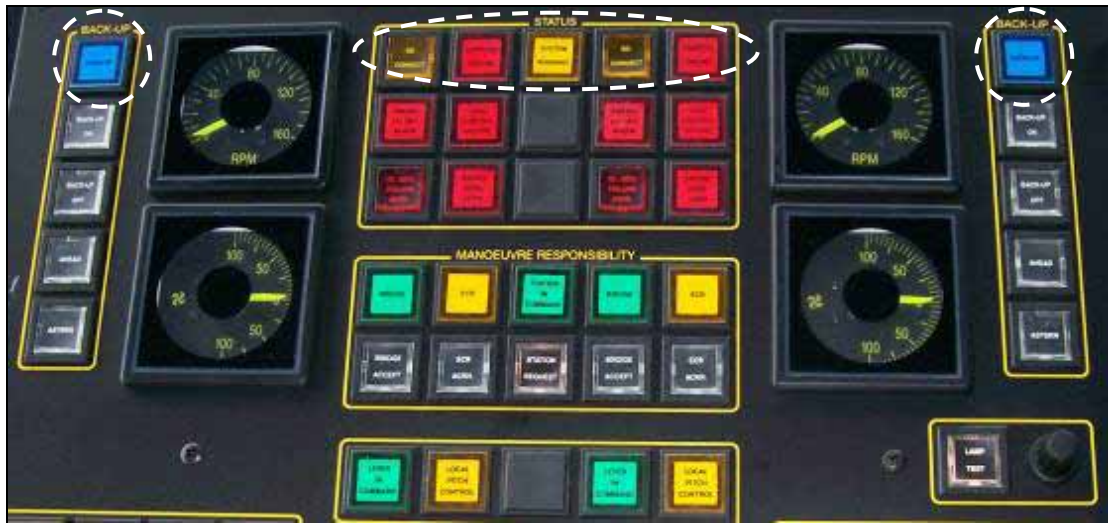
In the event of a fault in the CPP system, an alarm is output both on the bridge and in the ECR on the monitoring panel (see "Alarm simulation" video). The bridge panel has an indication lamp for CPP alarms ("SYSTEM WARNING", see Fig. 23), which flashes yellow three times in an alarm situation and then is permanently illuminated. Depending on which of the two propellers is affected by the malfunction, a red lamp "CONTROL FAILURE" lights up on the left-hand or right-hand side of the "SYSTEM WARNING" indicator. At the same time, an acoustic alarm (buzzer) is generated. In the default setting, the buzzer stops after six warning tones at second intervals³. The red button then stops flashing and remains illuminated. This default setting also applies to the engine control room panel, which, in contrast to the bridge panel, does not have a "SYSTEM WARNING" field.

Figure 23: Section from the monitoring panel on the bridge

On the day of the incident, the alarm was not attributed on the bridge, because the acoustic alarm had already stopped after six seconds, and the relevant flashing and/or illuminated alarm fields on the console were not noticed due to the glare caused by the setting sun. In the ECR, the alarm was correctly attributed but there was no communication with the bridge team. As a result, six minutes elapsed before the system was successfully reset. This meant that the starboard CPP was only functioning again a minute before the collision, which, given the small distance to the pier, was not at all sufficient to avoid a collision.

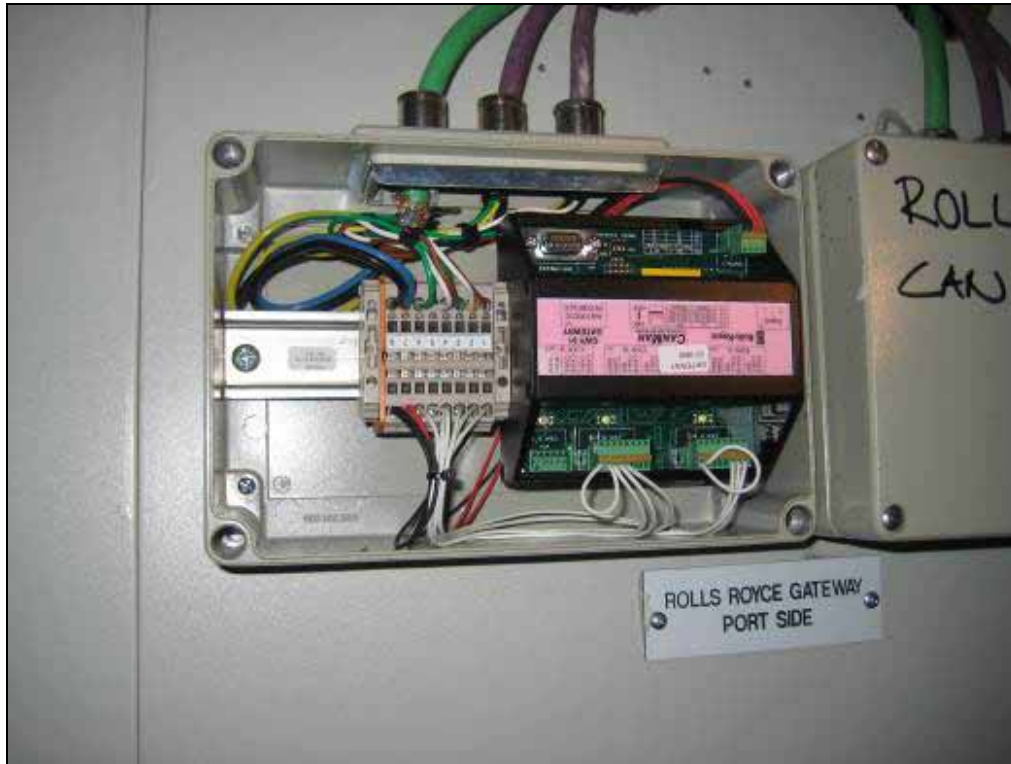
However, a check of the CAN-BUS box on board the FINNLADY revealed neither dirt nor inadequate cabling (see Fig. 24), which meant that the fault that occurred on the FINNLADY could not be linked to the CAN-BUS.

Figure 24: CAN-BUS box on the FINNLADY, open

In a store room in the passenger area on Deck 9, one of the two CAN-BUS housings was opened for inspection (see Fig. 24). The condition of the cabling and its feed-through into the housing, the way in which the cables had been secured, the strip terminals and a larger electronic module (CanMan gateway) on the mounting rails were found to be fault-free. The various strip terminals and the associated cable clips were all secure. There was no noticeable indication of thermal loading on any items of equipment.

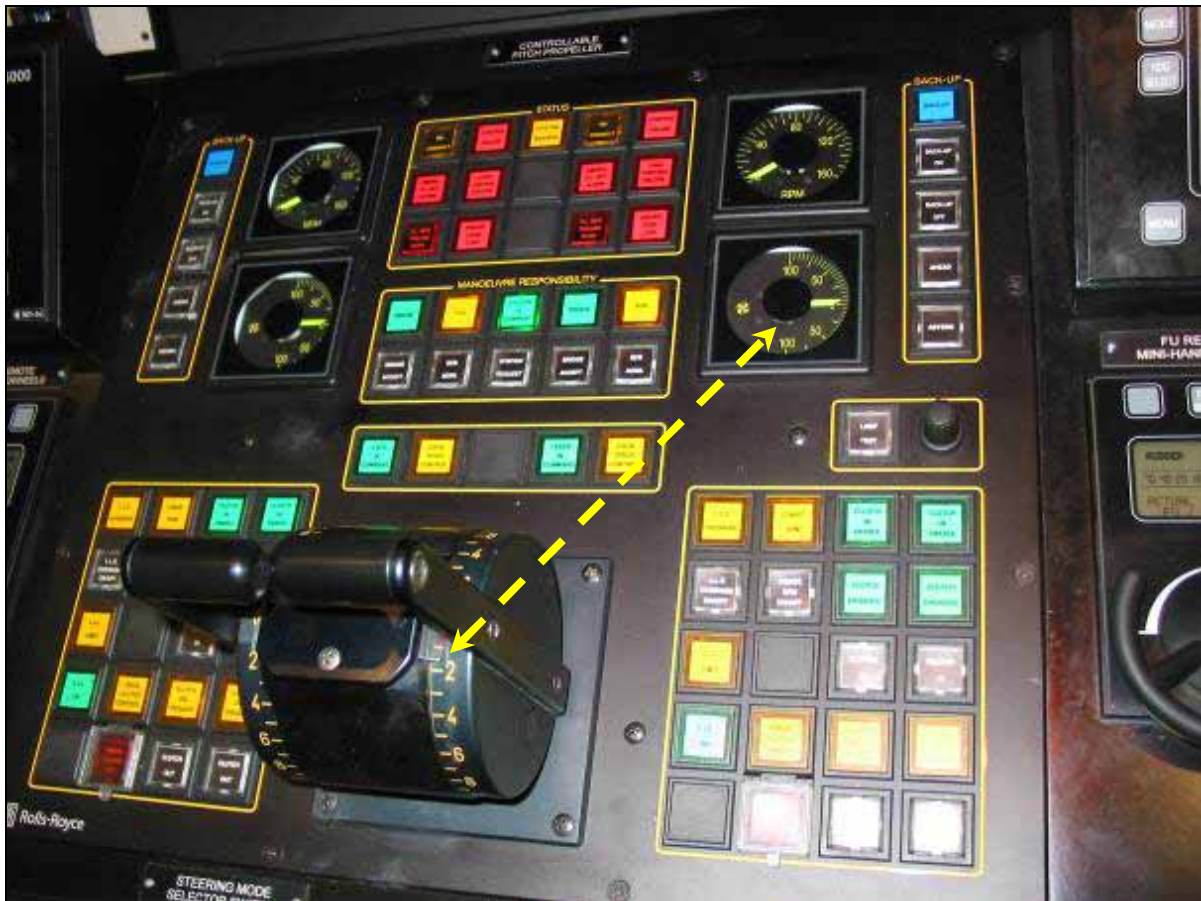
The above presentation of the significant VDR information shows that the starboard CPP system failed at 1946 at an actual astern pitch shortly before the completion of the turning manoeuvre, which triggered an alarm (see Fig. 26). This is verified by both the printouts of the fault printer ("CPP STBD Cont Fail"¹¹, "CPP System Warning") and the recorded bridge noise. From that point on, the actual pitch (-31.7) no longer corresponded to the ordered pitch (-35.8). It is important to note here that the above VDR pitch display differs considerably from the analogue pitch display in the overview panels on the bridge: whereas the digital pitch display shows exact numerical values and has two different pitch indicators (red for the ordered value and green for the actual value), the analogue pitch display on the bridge only ever shows the actual value. The Master of the FINNLADY therefore did not have detailed VDR information, but instead had to - as is customary on the bridge - monitor the displayed pitch value using the selected speed level (see Fig. 31).

Figure 31: Analogue pitch display and control lever on the bridge

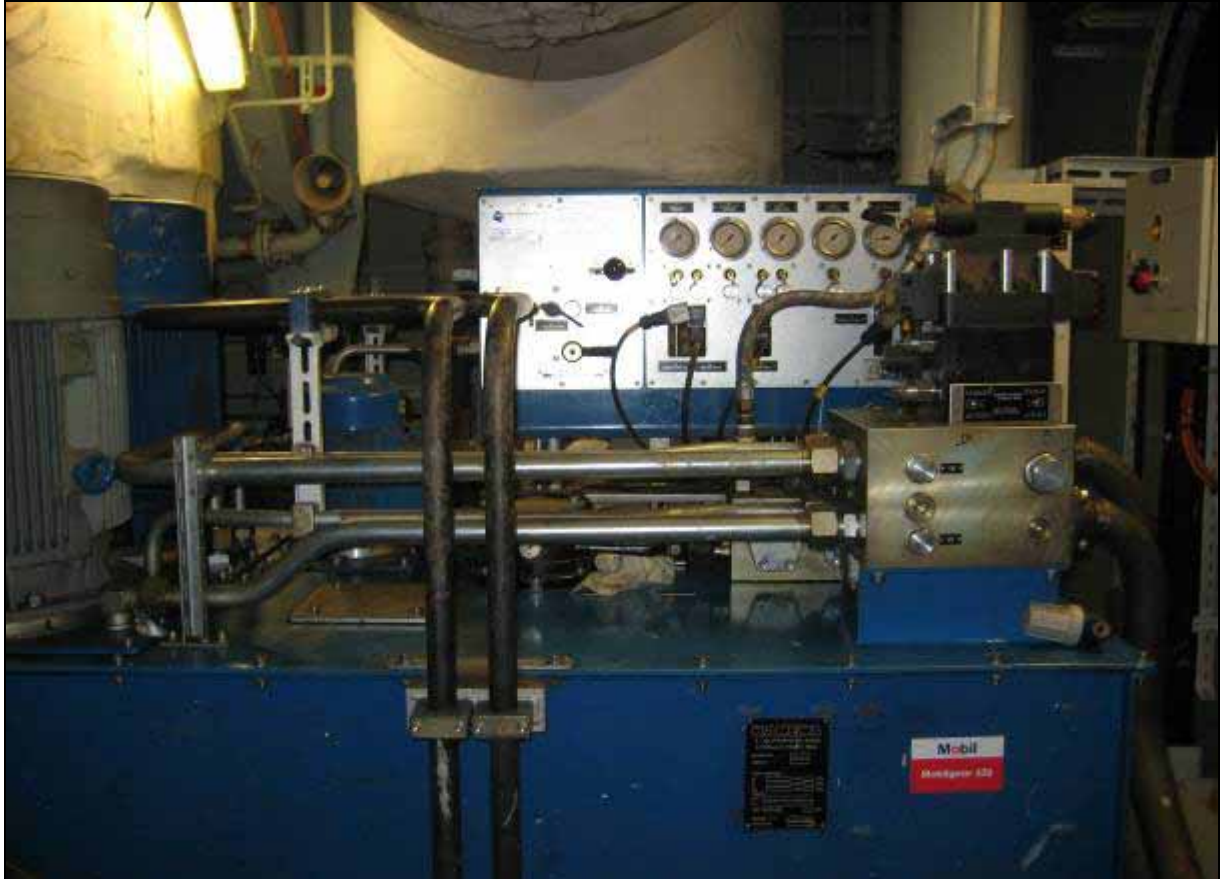
The CPP system's hydraulic valve block was also visually inspected (see Fig. 36).

Figure 36: Hydraulic valve block

Here too, no special findings were determined. The instrument panel, the various controls and the switch devices for emergency operation of the propeller pitch adjustment function were in fault-free condition and clearly labelled.

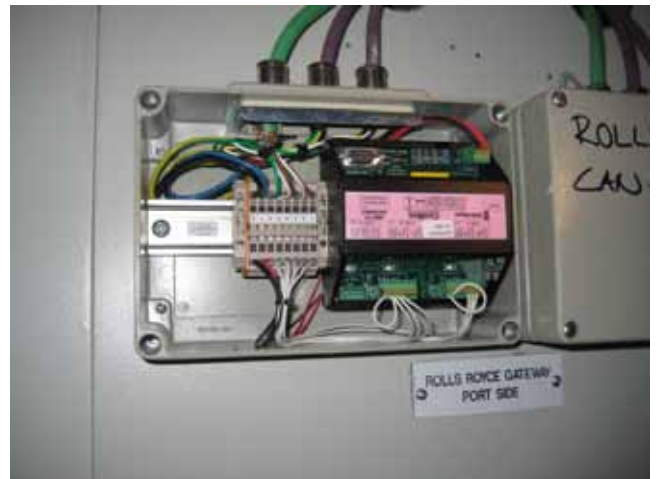
Fig. 16: CAN-BUS housing (opened-up)
