Investigation Report 212/08

Serious Marine Casualty

**Accident resulting in severe injuries to 2 people
caused by three broken lines while making fast
CMS RUILOBA
on 18 May 2008 in Bremerhaven**

1 September 2009

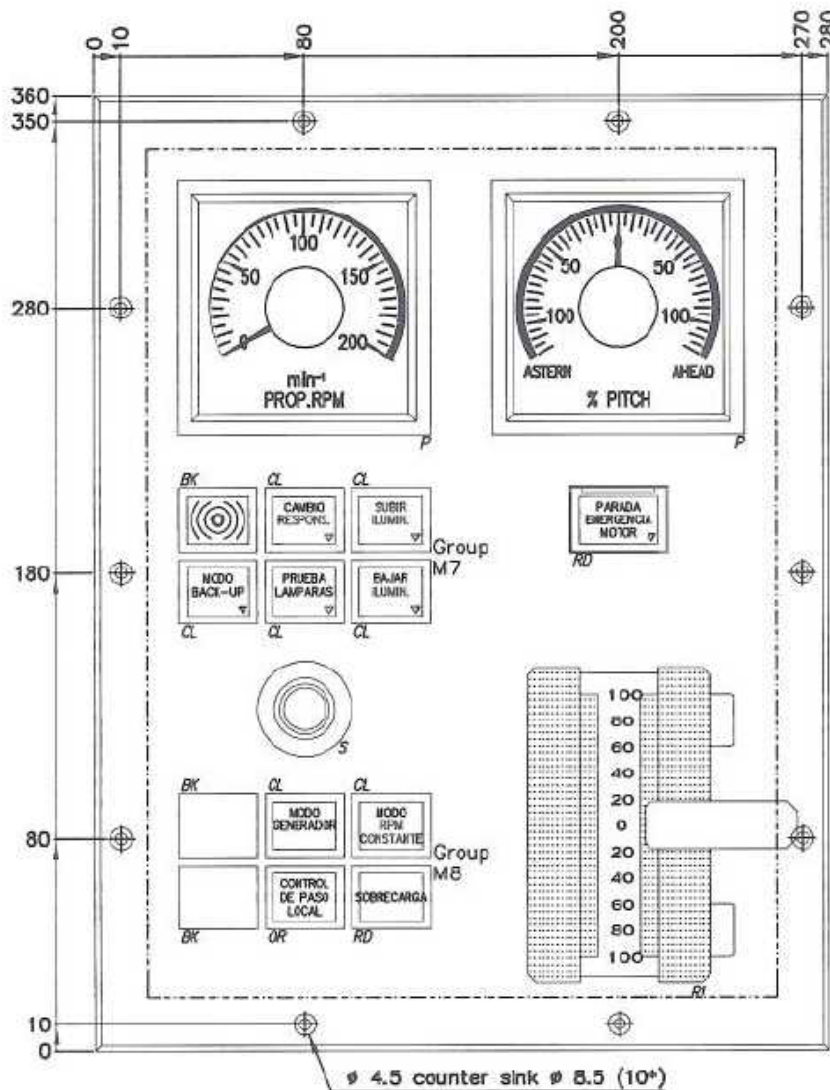
Figure 11: Bridge Control Panel

On the RUILOBA it could have been like this, that the wing station had been left behind by the Master with the control lever in the zero position in order to switch control to the bridge. Once he got there, the Master called the Chief to say that the engine control could be transferred from the bridge to the engine control room. This, according to the statement of the Chief, was reported as not being possible since the control lever was not in the zero position.

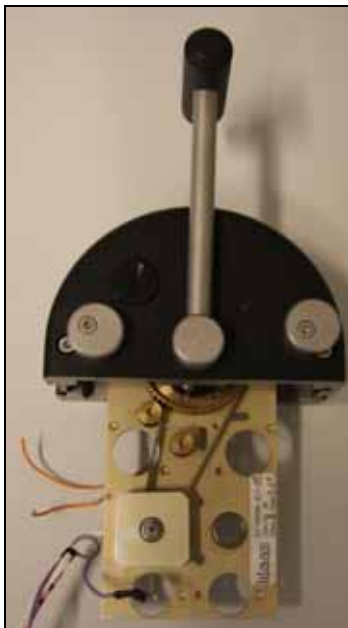
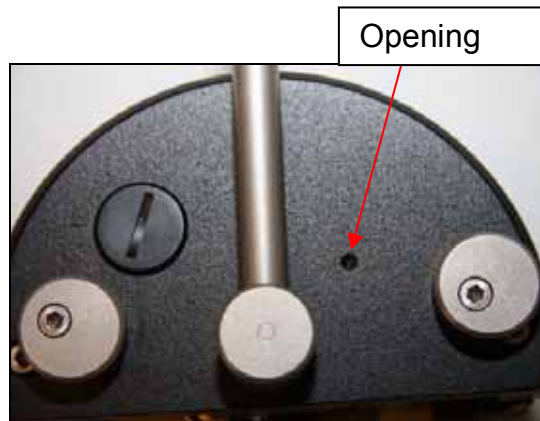
Figure 13: Driving Lever Construction Figure 14: Driving Lever Brake Position

At the BSU the control lever of the type LF 120, from the manufacturer Lilaas, was disassembled and photographed (see Fig. 13 ff). With an inbus key (see Fig. 14), a leaf spring fixed to one side can be moved. The opening in the casing for the inbus key is nondescript at first glance. An instruction manual could not be shown to the BSU. The company Lilaas did not want to make a statement to the BSU. On the leaf spring there is a 90° offset roller, which through the tension of the spring presses against a cogwheel (see Fig. 16). On the cogwheel there is a groove (see Fig. 15), which sets the zero position and locks the lever. The smoothness of running of the cogwheel is set with the leaf spring. The leaf spring can be set with a 1.5 mm inbus key so that the zero position is hardly noticeable. The cogwheel is connected via a toothed belt to a potentiometer, which conducts the current to a regulator (see Fig. 13).

In the directive 96/98/EG and its continuations, the driving lever is not listed as ship equipment. Therefore there are no uniform type approval specifications regarding style and inspection criteria. The rules for construction of the largest classification societies stipulate that driving levers must be type-approved. The inbuilt driving lever of the manufacturer Lilaas of type LF 120 had a type certificate issued by Det Norske Veritas and had also been tested for vibration. Despite this, during the accident investigations, the ease of movement and the barely noticeable zero position had been evident. During the initial inspection and test run this fault would have most likely become noticed and would have been removed. It is therefore probable that the ease of movement had resulted on its own over the course of the one year ship operation through vibration. Resetting the lever movement would have been swift and easy with a 1.5 mm inbus key. Obviously this function was not known to those on board and an operating manual was not available. Also the suppliers Lilaas and Wärtsilä, like other manufacturers, could not show the BSU an operating manual⁶. The adjusting screw on the other hand is rather nondescript and not easily recognizable as such on the casing (see Fig. 14).

The BSU recommends to the Norwegian company Lilaas, manufacturer of control levers for engine control, to make available operating and maintenance manuals. The manufacturers of main engines are recommended at handover to check all manuals for their completeness. This also includes documents of the suppliers.

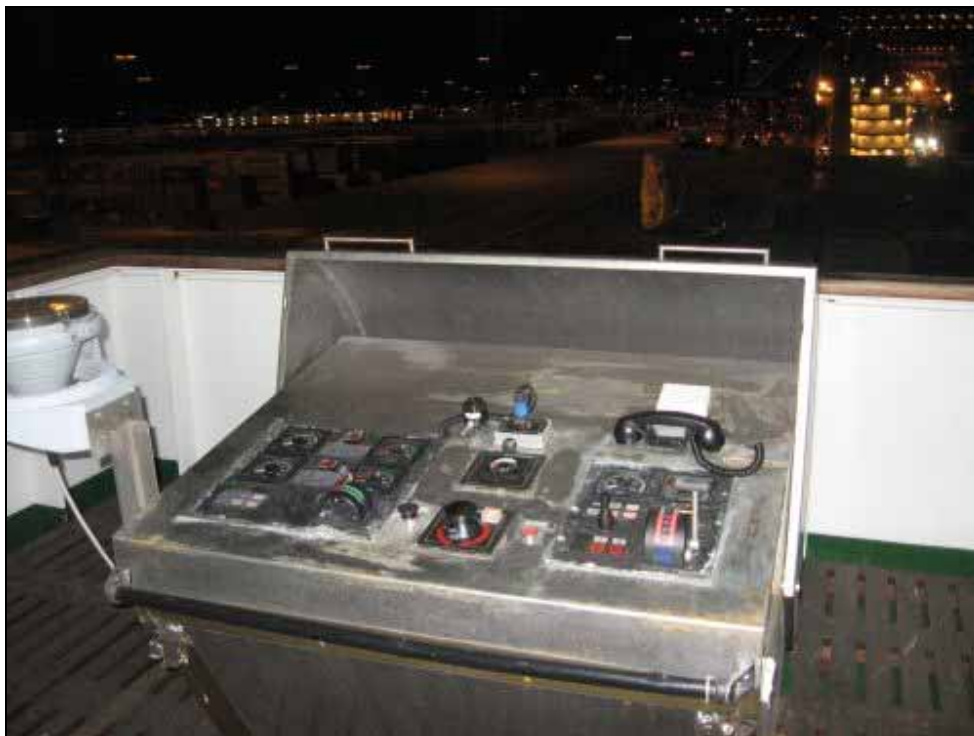
Figure 21: Bridge Wing - Port side

At the stern two seamen were severely injured on the legs when, following the mooring manoeuvres that were executed from the port wing control station, a stern line, fore spring line and aft spring line broke and the RUILOBA set itself in motion. For this the position of a control lever must have been changed. The control levers are located in the bridge wing stations, the conning station in the wheel house and the engine control room (ECR). On the bridge were the Master, Second Officer, the Pilot and an Service-engineer. The engine control room was manned at least with the Chief. At the time of the accident the control station on the port bridge wing was in operation (see Fig. 21) because from here the Master had allegedly tried to return the vessel back to position.

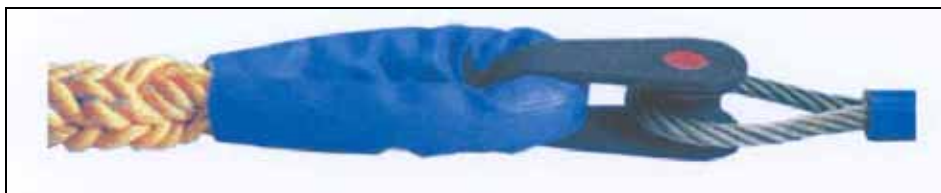
Figure 22: Connection Forerunner Line

According to their technical specifications, the winches of the manufacturer, IBERCISA, are suitable for handling mooring lines of steel wire and chemical fibre. Noticeable were the long forerunners of the wires, each approx 50 m. This combination is unusual and does not correspond to the recommendations of the OCIMF (Oil Companies International Marine Forum). According to this a forerunner should be a maximum of 11 m (6 fathoms) long and have a 35 % higher breaking strength than the wire, because synthetic fibers wear out faster than wire. Further, the rope ends should be connected with a fairlead shackle (see Figs. 22 and 23). For this, the eye of the synthetic rope should be covered, for example with a leather protection. Due to the different expansion characteristics of the materials, steel wires with forerunners are recommended as springs and brest ropes, while fore and aft lines should be from synthetic fiber. The mixing together of the different materials in both spring lines and fore and aft lines should be avoided so that the load is evenly distributed.

The Marine Insurance and Safety Association recommends in its bulletins F5 and G3, on the basis of good experiences with polyamide, to use this as the material for forerunner. In addition for the winch operation there should always be one person available. Locking the winch lever is prohibited. The so-called slippage⁷ on the capstan heads is to be avoided and the cables are not to be left constantly on the capstan heads. They are to be put on bollards and secured. Instead of slippage on the capstan head, the winch is to be used for slackening the line. For synthetic fibre ropes there is the danger of sticking and uncontrolled sweating. Through this the surface becomes smooth so that there is the danger of accidents because of sudden slipping. Any chafing is to be avoided which means the ropes must not be led over/across sharp edges/corners, in order to avoid abrasion and breakage. When knotting lines a breaking strength loss of 50 % must be reckoned with. A person should never be situated beneath a cable under load. When heaving in, the loose part must immediately be rolled up or stored away behind the person at the capstan head to reduce the danger of stumbling.

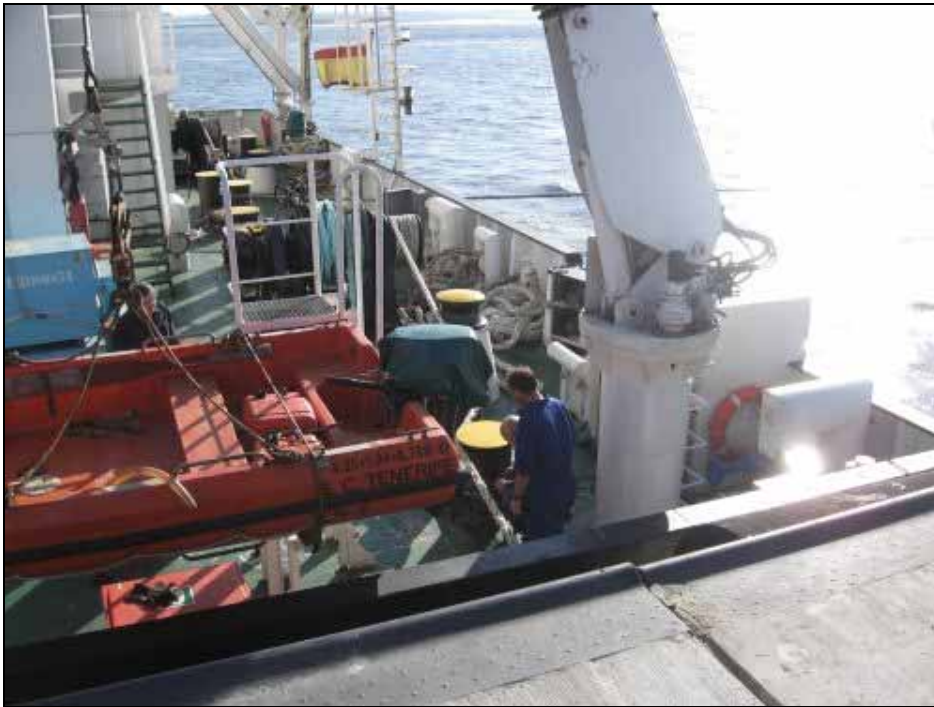
Figure 24: Stern of the Vessel

determined. As can be seen in Fig. 24, the distances and spaces at the stern between fairlead, bollards, centre roller and winch are comparatively narrow to find protection spaces. This makes it more difficult to take avoiding action during danger situations.
