**Bundesstelle für Seeunfalluntersuchung**  
**Federal Bureau of Maritime Casualty Investigation**  
Federal Higher Authority subordinated to the Ministry of Transport,  
Construction and Urban Affairs

**Investigation Report 250/08**

**Collision of M/V RABA with  
Special craft ARTUR BECKER  
on 1 June 2008  
Northwest of the Wittow/Rügen Peninsula**

**2 June 2009**

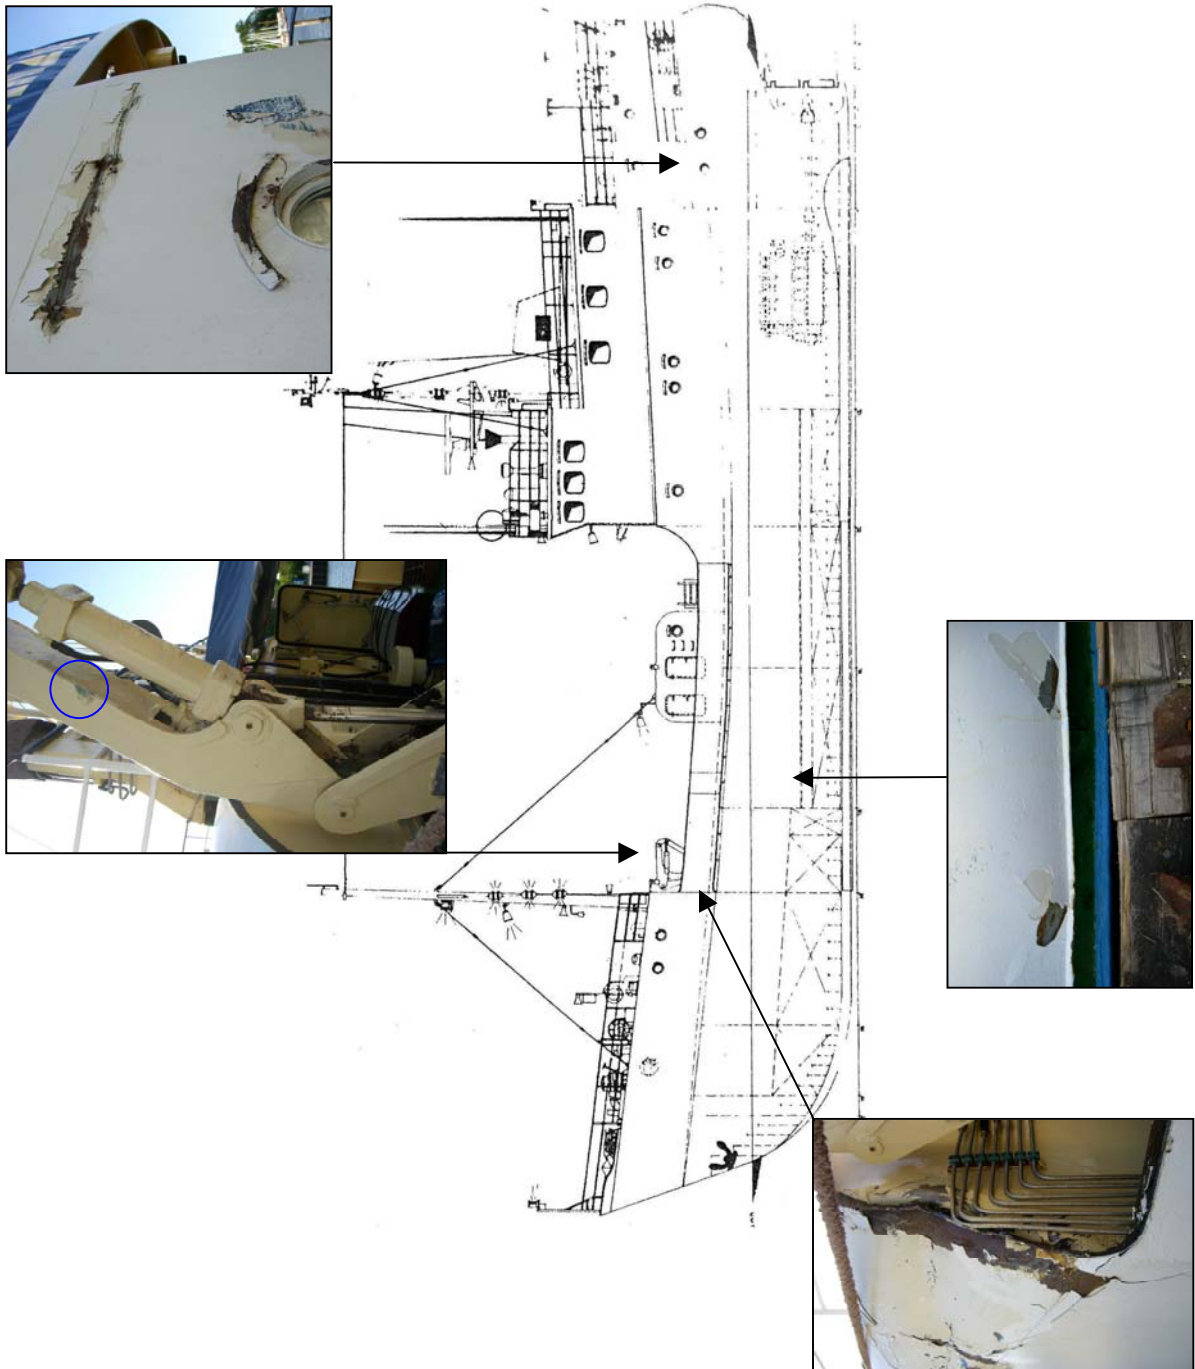
Figure 4: Damage on the ARTUR BECKER

The port side of the ARTUR BECKER was damaged above the water line in the collision (see Fig. 4). On the aft superstructure there were deformations, and the plating was torn open.

The aft area was pushed in for ca. 1.3 m<sup>2</sup> in the region where the shell plating joined the deck.

The colour paint coating of the hydraulic crane on the main deck was cracked or chipped off in several locations. The hydraulic pipes at the aft bulkhead showed slight deformations.

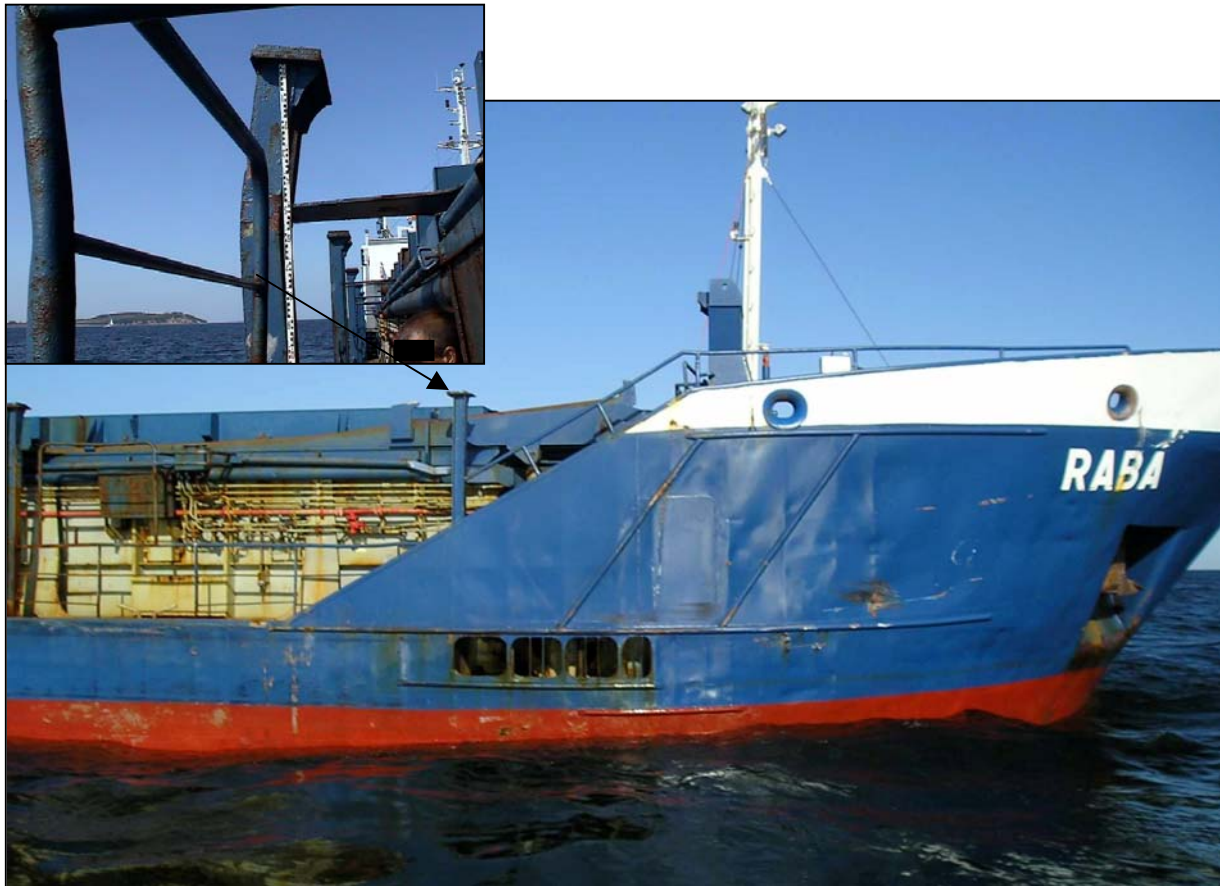
Figure 5: Damage to the bow of the RABA

The RABA was damaged on her starboard side above the water line. The shell plating from bow to amidships showed the signs of scraping and deformations, and a steel pillar as well as parts of the railing were pushed inward (see Fig. 5).

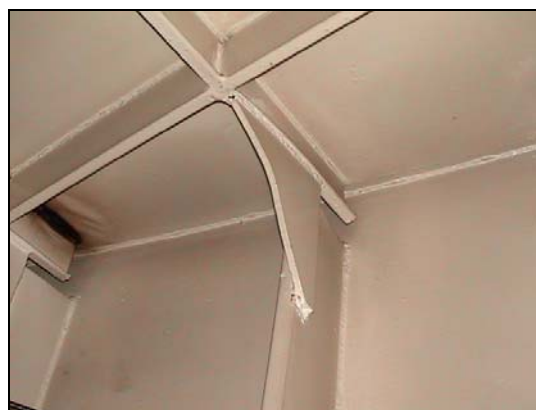
Figure 6: Deformation of the frames on the RABA

The bulkhead between the bosun store and the bow thruster room was deformed as well as the frames in that area (see Fig. 6).

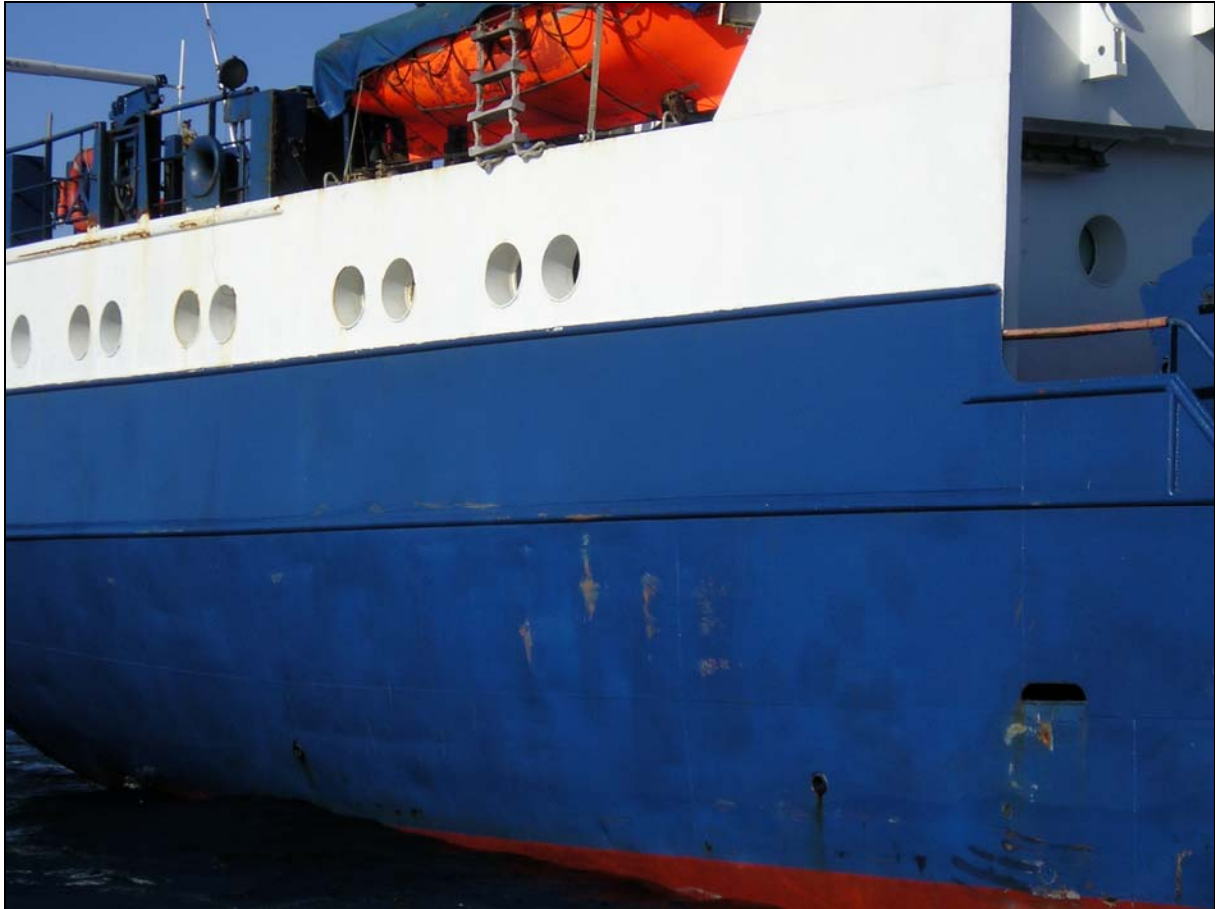
Figure 7: Damage to the stern of the RABA

Also on the starboard side of the stern there were abrasions on the shell plating (see Fig. 7).

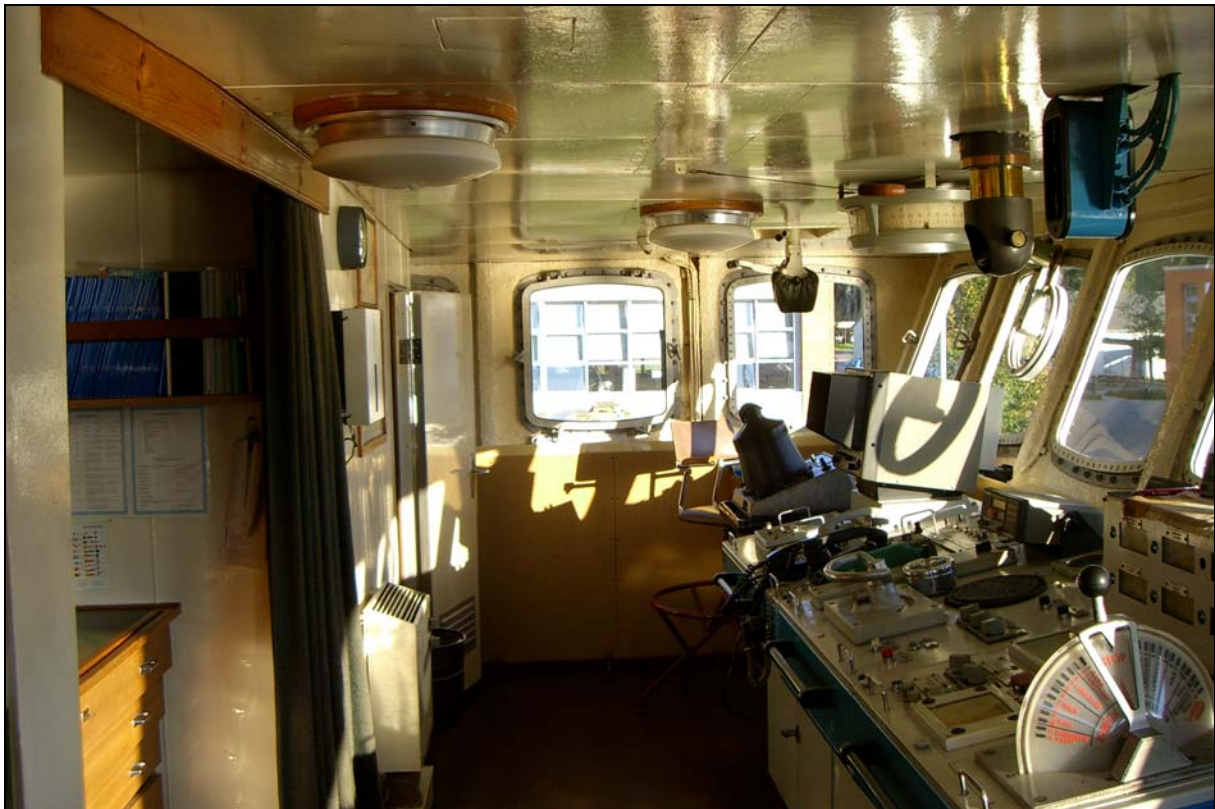
Figure 9: Wheelhouse of the ARTUR BECKER, view to port

The left one of the three side windows on port is covered, however, when the door to the control room on the bridge of the ARTUR BECKER is open (see Fig. 9).

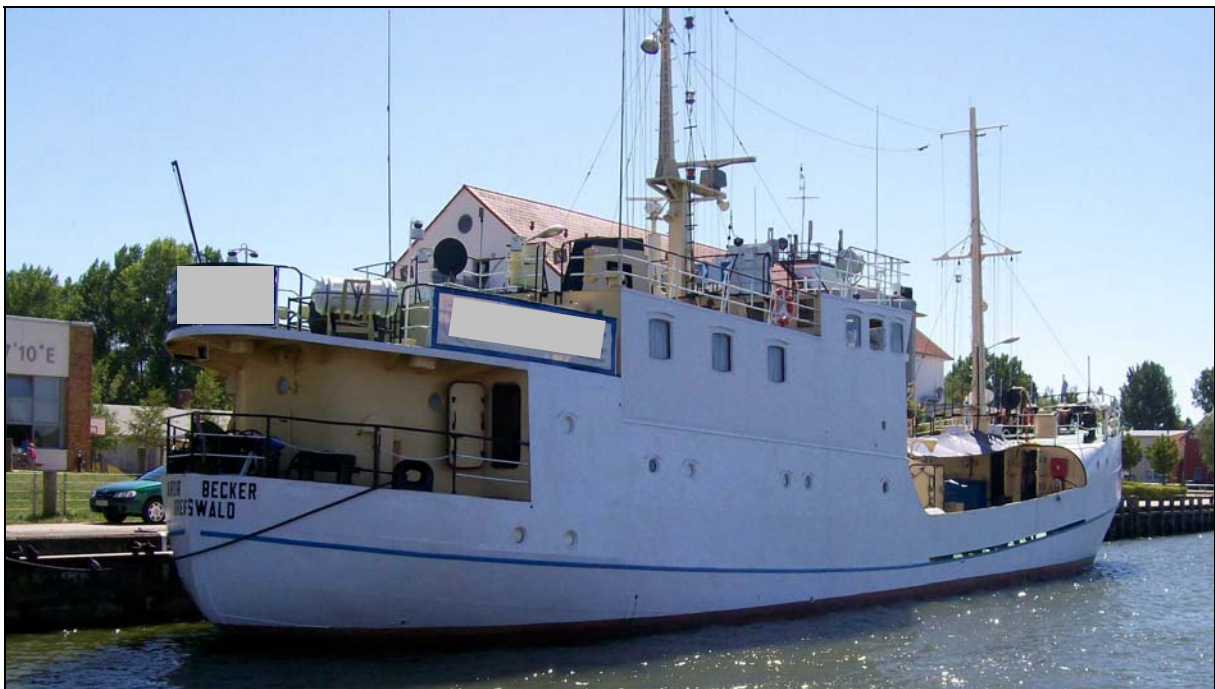
Figure 10: Stern area of the ARTUR BECKER

Because of the raised stern (see Fig. 10) the direct view astern is only possible to a limited extent (see Fig. 11).

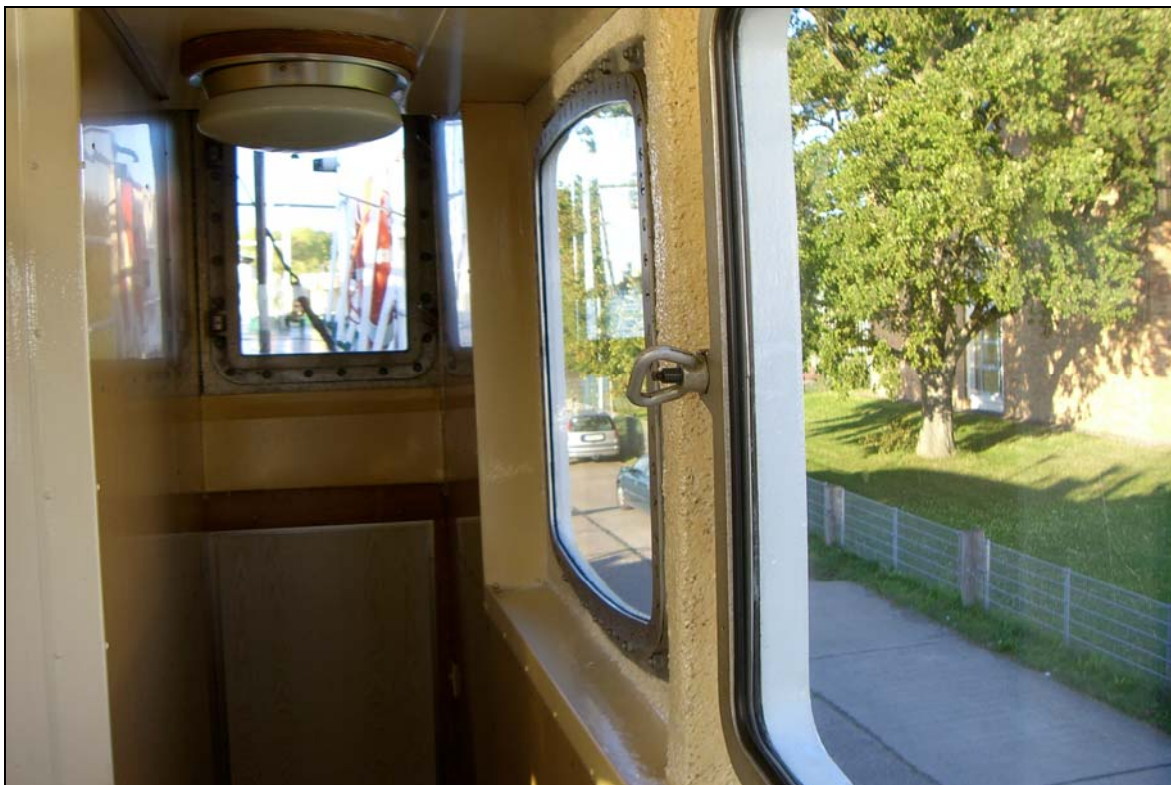
Figure 12: View astern through both the port bridge window and the aft window

A diagonal view astern, however, is possible through the other three side windows without problem (see Fig.12).

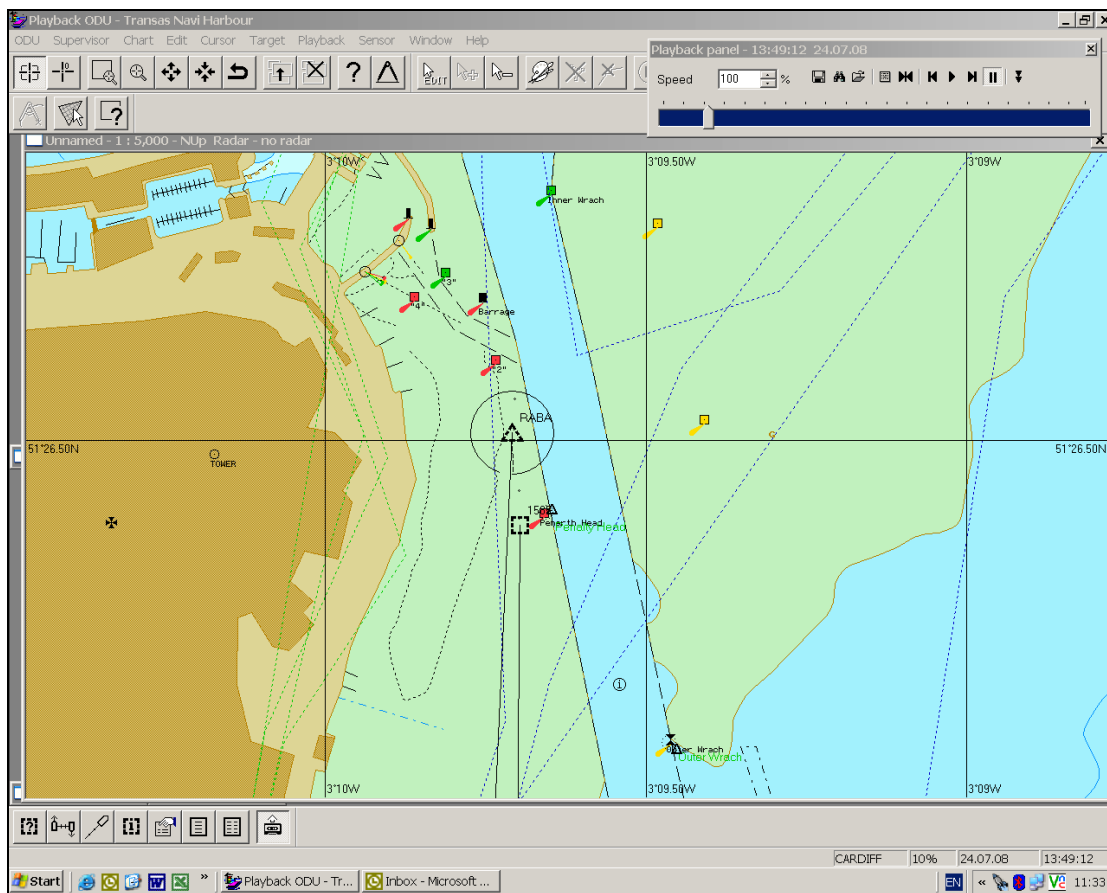
Figure 13: Record of the Vessel Traffic Service (Port of Cardiff) from 24 July 2008

Since there had been an increasing number of defects identified on the RABA in spring 2008 during two port controls<sup>4</sup>, the BSU made contact with the British Maritime and Coastguard Agency (MCA). Through the MCA they became aware of deficiencies concerned with, among other things, incomplete voyage planning, an insufficient determination of compass deviation and numerous shortcomings in protective equipment. On 24 July 2008, the RABA came to the attention of the MCA when she passed a port fairway buoy on the wrong side while she was sailing out of Cardiff (see Fig. 13).

In transmissions by the ship's command to the Vessel Traffic Service he was not certain about the vessel's position. The MCA took this as a reason to issue what is called a "Cause for concern (C4C) report" and to list the RABA for another Port State Control. It remained unclear whether the vessel's crew in Cardiff was identical to that on 1 June 2008 (the day of the accident).

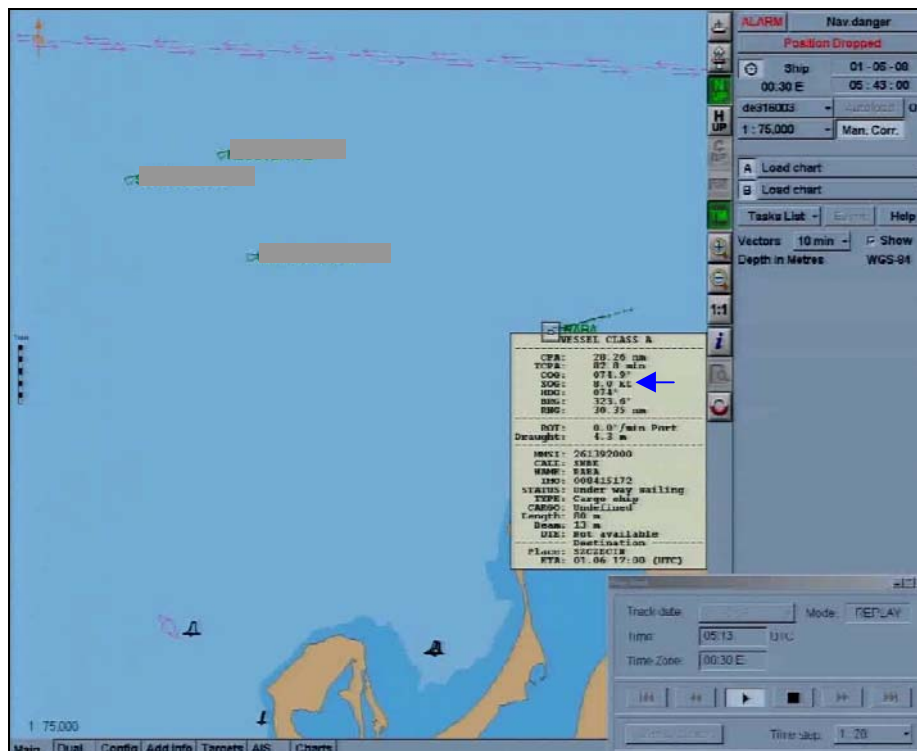
Figure 16: AIS record at 0643:00

From the VTS records, regardless of the existing technical limitations of AIS, nonetheless reliable facts can be concluded with respect to the following circumstances: On the RABA, course and speed were maintained until shortly before the collision (see Fig. 16, RABA at 8 kts speed).

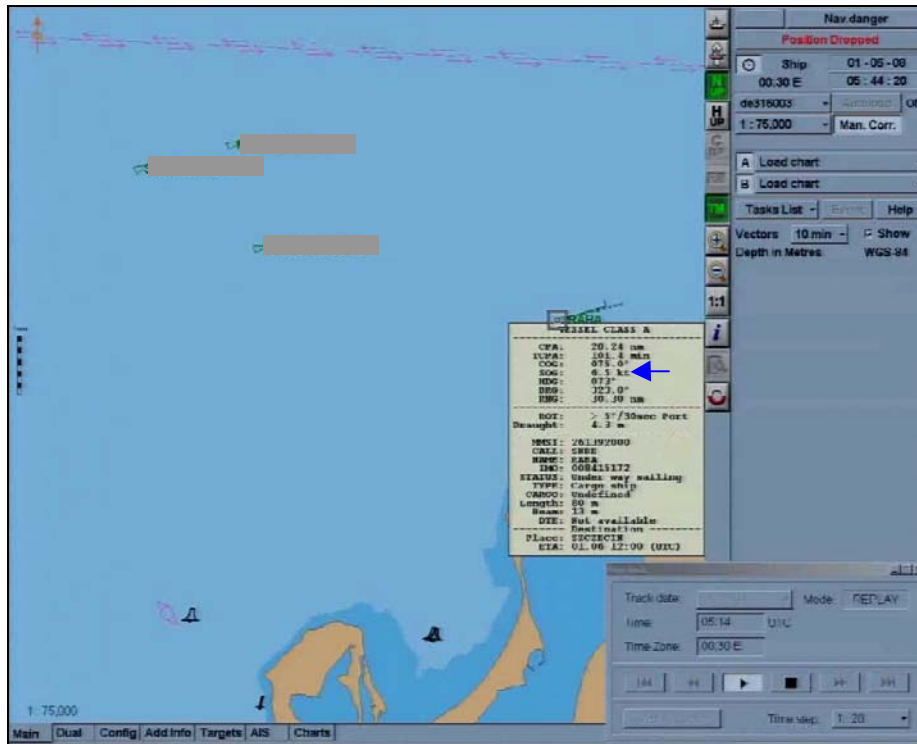
Figure 17: AIS record at 0644:20

0643:20 and 0644:20 a Rate of Turn (ROT) of  $> 5^\circ$  to port was shown (see Fig. 17) but the Heading changed to starboard in the same timeframe from  $073^\circ$  to  $086^\circ$ . Whether and how much the change of heading was caused by hydrodynamic interaction shortly before the collision with the ARTUR BECKER could not be clarified anymore after the event. However such an interaction would have been possible, which is why the heading records, in contrast to the Rate of Turn, can be regarded as plausible. The BSU is not familiar with the type of AIS installed on the RABA. It may be assumed however that the RABA does not have available its own interface for a Rate of Turn Indicator. Hence it can be further assumed that the Rate of Turn record is purely a calculated outcome from the heading readings. This makes all the more incomprehensible the display according to which the originally determined heading values a starboard manoeuvre is shown, but at the same time as the Rate of Turn shows a change to port of  $> 5^\circ$ . This contradictory display constitutes a deviation of the guidelines of the International Maritime Organization (IMO) for onboard AIS installation<sup>6</sup>. The reason for this malfunction is not known to the BSU. Through the extensive analysis of all the recorded AIS data at least it could be excluded that immediately before the collision a port manoeuvre was initiated or displayed after a time delay.

Immediately before the collision speed was reduced (see Fig. 17, RABA at 6.5 knots). An evasion manoeuvre was not initiated.

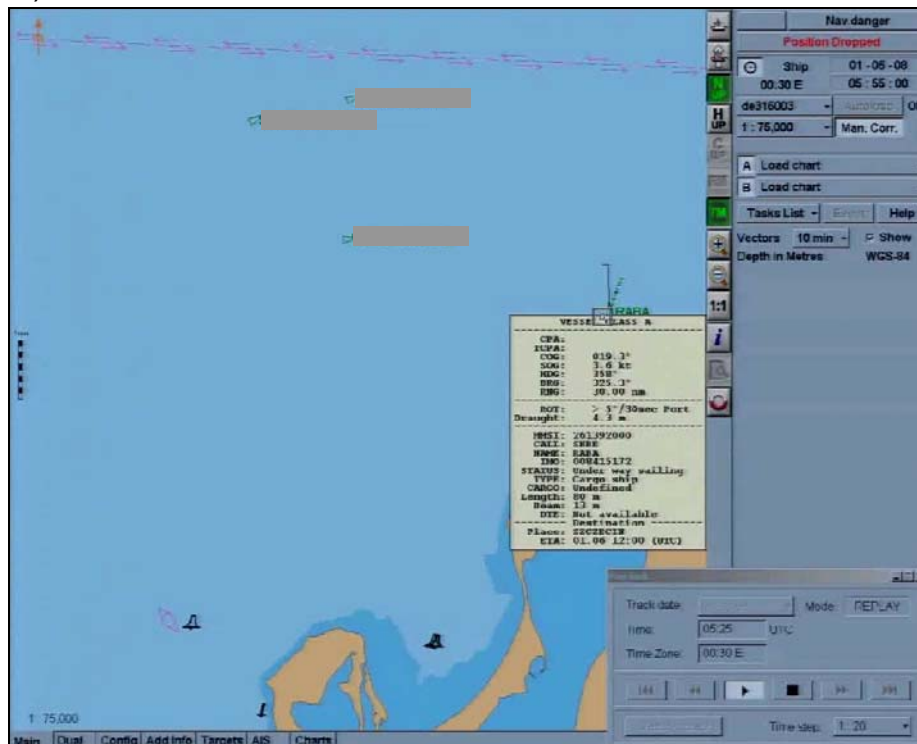
Figure 18: AIS record at 0655:00

Only after the accident is a port manoeuvre evident on the recorded heading data (see Fig. 18).

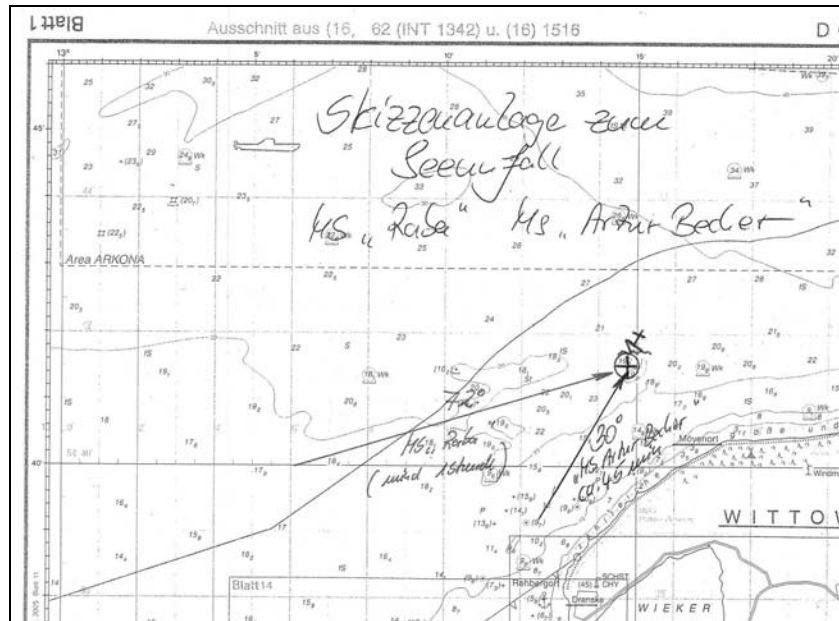
Figure 19: Copy of the nautical chart with voyage courses, excerpt from the Water Police's files of the enquiry

around 0645 no vessel position was determined. The course of 030° has been charted during the police interrogation after the collision (see Fig. 19).

The approach of the two vessels (see Fig. 19) did not constitute an overtaking situation since the RABA from the view of the ARTUR BECKER did not approach from a direction of more than 22.5° abaft her beam and therefore was not positioned in a manner that would have meant that, at night, only the stern light of the ARTUR BECKER but none of the sidelights would have been seen (see rule 13 b COLREGs). Furthermore, the RABA approached with a constant bearing forward of abeam (see Fig 21). The two vessels, from the beginning of the voyage of the ARTUR BECKER, found themselves in a crossing situation.

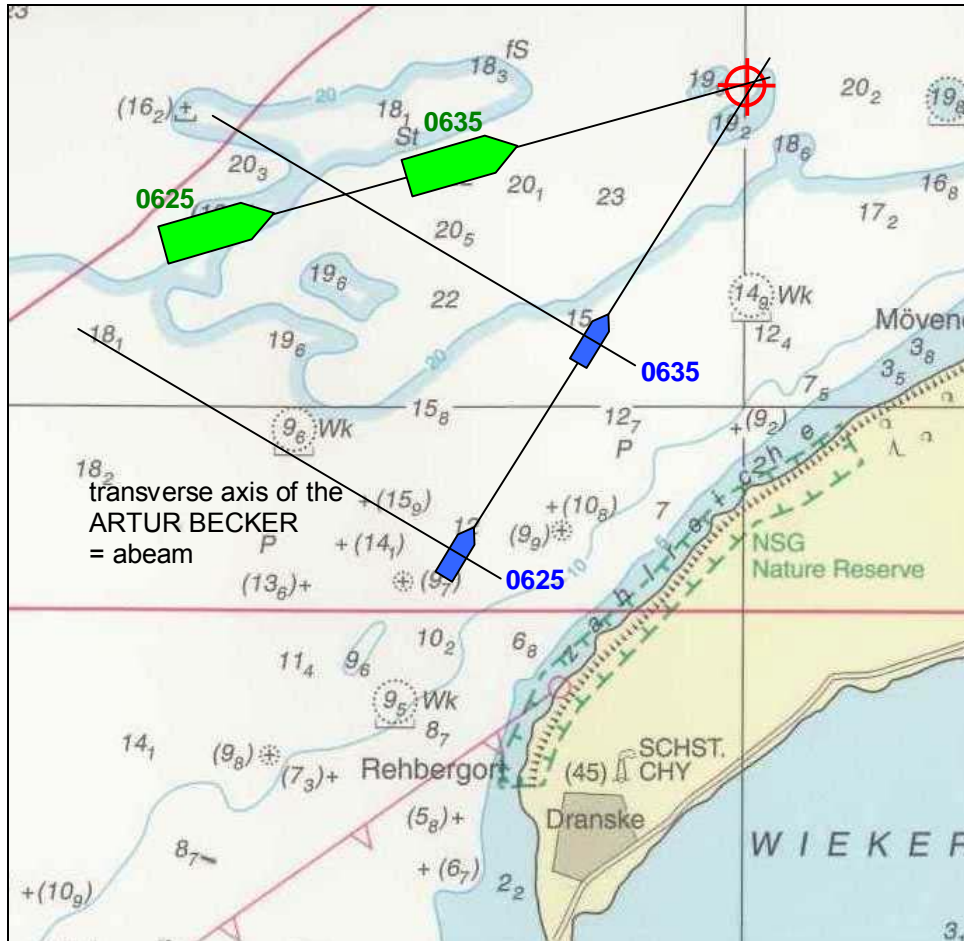
Figure 21: Detailed outline of the approaching ships from 0625 on

The following figure 21 shows an outline of the voyage courses from the beginning of the constant bearing (0625) until the collision. It is evident that from the time when the ship's command of the ARTUR BECKER first noticed the RABA (about 0625), the RABA must have always been forward of abeam to the ARTUR BECKER.
