Bundesstelle für Seeunfalluntersuchung
Federal Bureau of Maritime Casualty Investigation
Federal Higher Authority subordinated to the Ministry of Transport,
Building and Urban Affairs

Investigation Report 254/08

Serious Marine Casualty

**Stranding of
CMV NORFOLK EXPRESS
on 30 May 2008
in the Gulf of Suez**

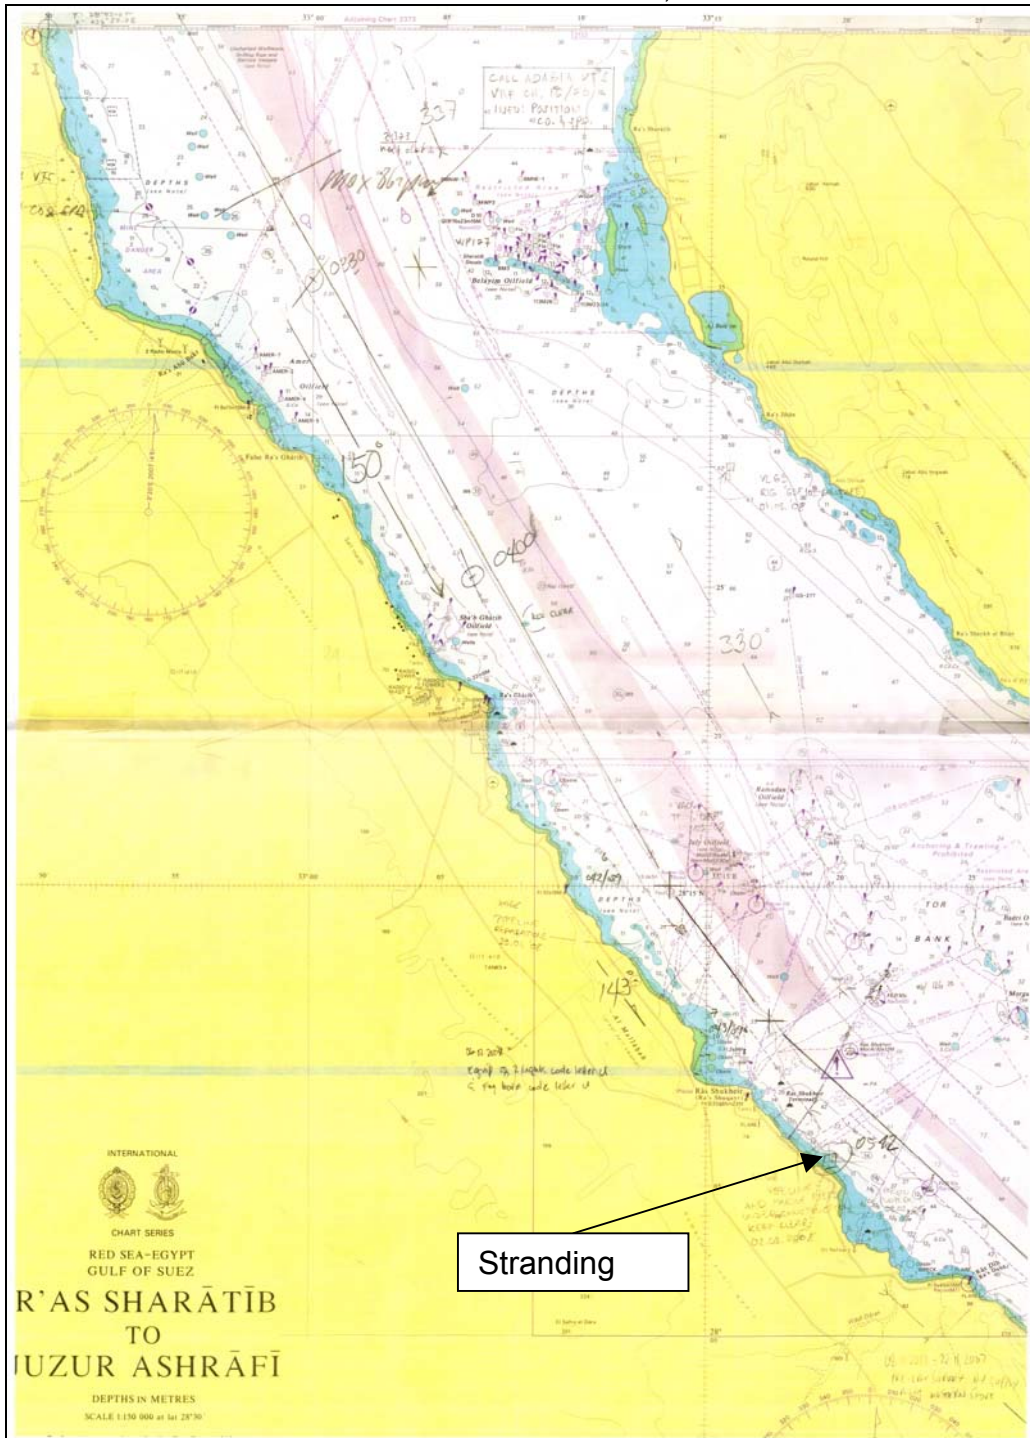
Figure 1: Chart used

The British Chart BA 2374 with a scale 1:150,000 had been used on board, although Chart BA 333 with a scale of 1:50,000 should have been used. According to the statement by the representative of the vessel operator the vessels had always been equipped with the largest chart scales.

On NORFOLK EXPRESS the Officer on watch during the 0000 to 0400 watch had carried out the voyage planning (see Figure 1 and Figure 9). It could not be explained why Chart BA 333 (see Figure 10) had not been used. If it had been used, it would have been necessary to change the chart in the subject sea area.

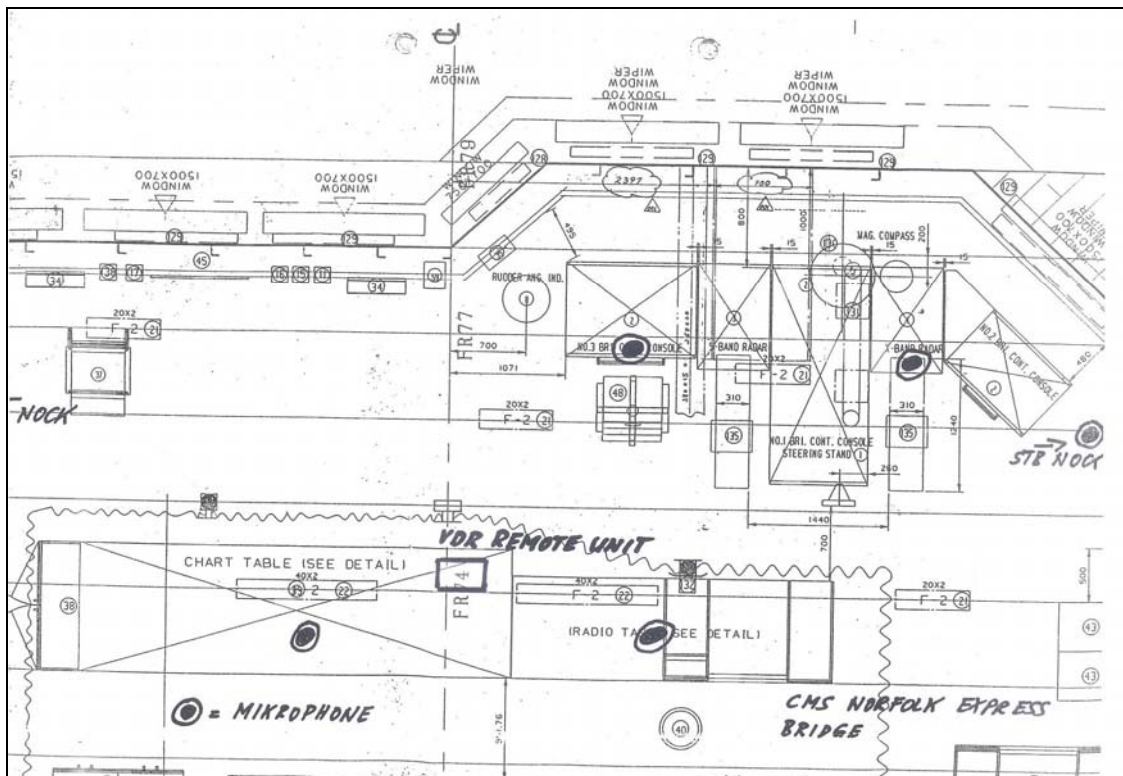
Figure 4: Bridge plan with VDR microphones

After this the Officer on watch had proceeded to the radio station (see Figure 4) that is located starboard aft next to the chart table. There he had read his emails on the computer and in between observed the radar display. He had been deep in thought at the time and later could no longer remember exactly what happened up to the accident. The Vessel Traffic Service (VTS) had suddenly called and drawn attention to the risk of stranding. He had thereupon proceeded to the starboard radar set and ascertained that the speed dropped to 18.5 kn, possibly due to the shallow water

This procedure does not comply with the vessel operator's safety management system. In so far after the accident the vessel operator sent a circular letter to all vessels stating that the stipulations according to STCW 95 for manning the lookout and the recommendations of the flag state regarding constant operation of the watch alarm system were to be observed strictly. The national specifications are contained in the recommendations of the See-BG [Marine Insurance and Safety Association] for the design of the bridge of sea-going vessels and the building and inspection regulations of Germanischer Lloyd. According to these the watch alarm system is to be based on interval checking and be adjustable up to intervals of 12 minutes. The acknowledgement keys are to be provided at various workplaces on the bridge, e.g. conning positions, chart table, radio station.

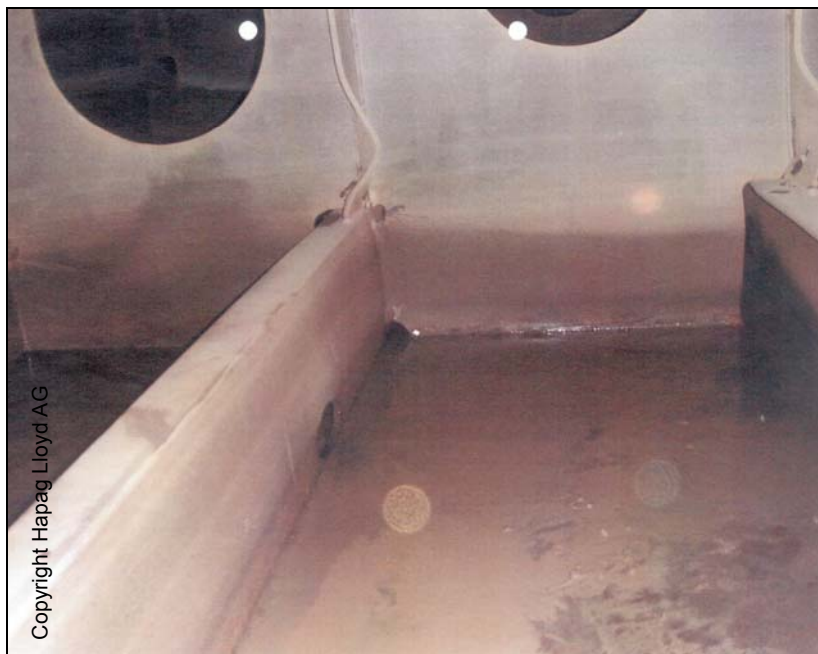
Figure 5: Bottom damage with deformations

NORFOLK EXPRESS was inspected at the scene of the accident after stranding. An underwater inspection of the rudder and propeller was carried out. No damage was discovered. The crank web clearance was recorded and the rudder was tested. The fore peak tanks 1 and 2 were checked from the inside by the crew. Tanks 3 starboard, 3 centre, 3 port, 4 starboard, 4 centre, 5 starboard, 5 centre, 5 port, 6 centre, void space (frames 76-79) were examined by the surveyor and the inspector from the interior (see Figure 5 and Figure 6). All the tanks and bottom plating were firm so that the vessel was in a condition to proceed to the next port for a further underwater survey. No oil escaped to the exterior. The double bottoms and the tanks were tight.

Essentially the damage consisted of bending of the longitudinal frames, webs and pipes as well as cracked welds. The webs could partly be repaired by horizontal carlings (inside planks). Some longitudinal members and steel plates had to be cropped out and replaced.

The vessel continued its voyage on 17 June 2008 and reached the port of Jebel Ali (Dubai) on 24 June 2008 where all the cargo was discharged. After this the damage to the bottom (bumping) of NORFOLK EXPRESS was repaired in the yard in Singapore and the vessel class was confirmed up to 31 October 2010.

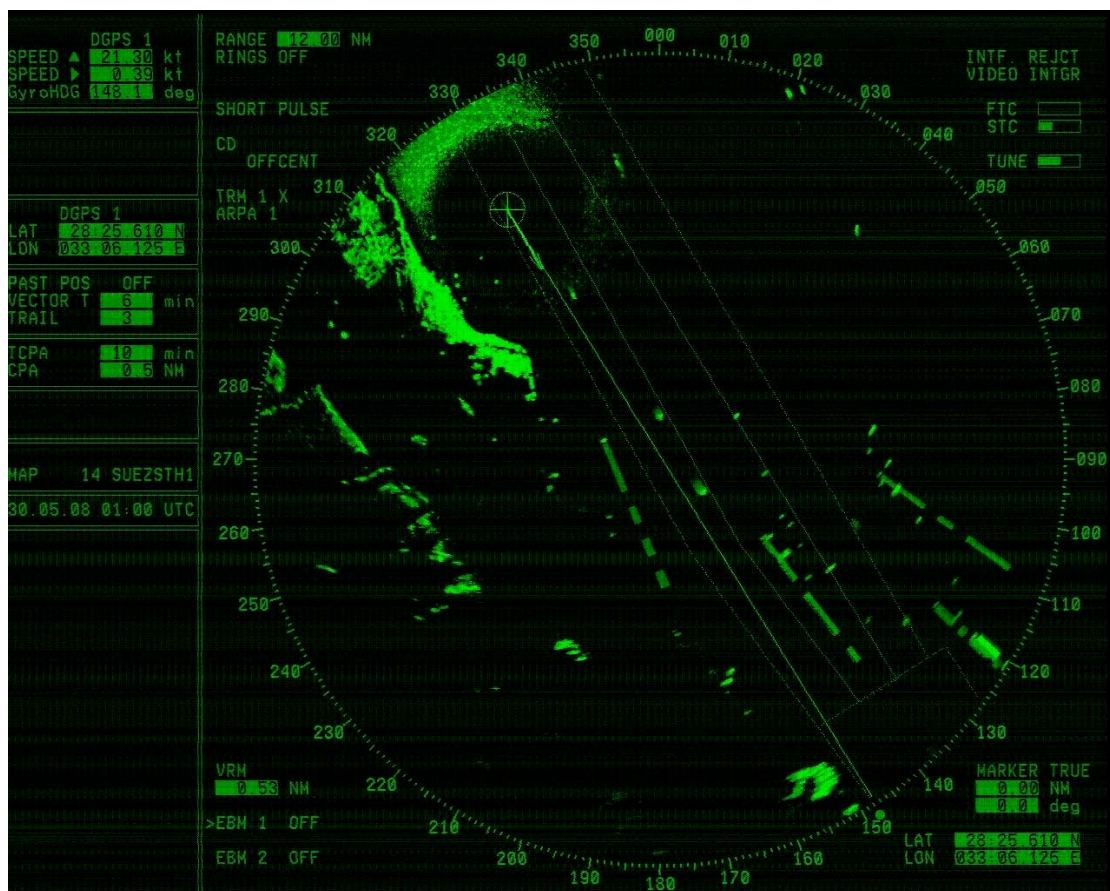
Figure 7: Radar image 0400

He came onto the bridge at 0400 and proceeded to the right side of the conning position in front of the S-band radar set. At the time the watch was handed over at 0400, the VDR recorded the image of the X-band radar set shown in Figure 7. After one minute he switched off the X-band radar antenna. The VDR recordings subsequently only showed the stand-by image of the X-band radar set. The radar images of the S-band set were not recorded by the VDR.³

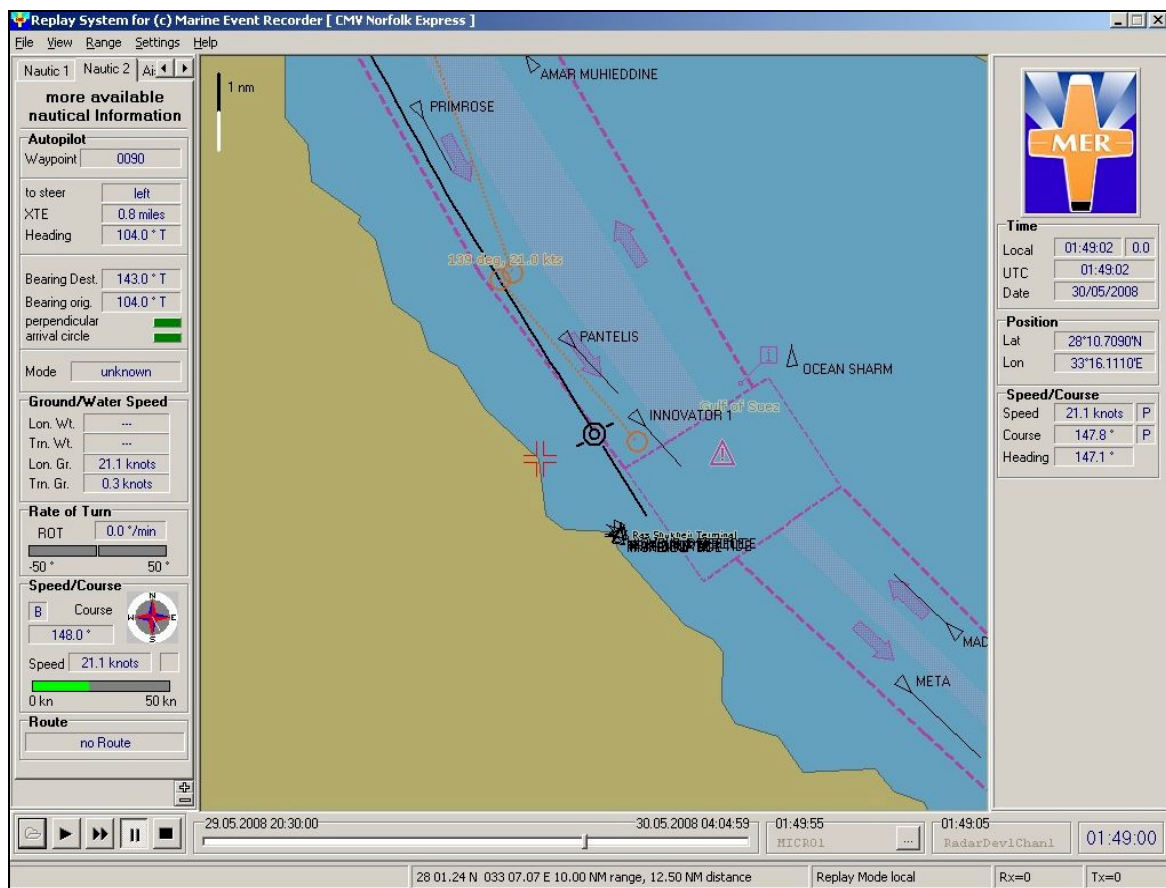
Figure 11: Traffic situation 0449 (chart generalised)

At about 0430 he went back to the old steering course of 148°. At 0449 he overtook the INNOVATOR 1 at a distance of 1 nm on the port side. He had proceeded to the radio station that is located starboard aft in the bridge and called up emails. These concerned relationship problems. He had signed on aboard the NORFOLK EXPRESS in Hamburg two weeks before the accident after a two-month leave. As a result of the emails his thoughts were at home and consequently he can no longer remember the events exactly.
