Investigation Report 302/07

**Very serious marine casualty**

**Personal accident with stern line  
on the MS NORTHERN FAITH  
on 4 July 2007  
in port of Koper**

15. November 2008

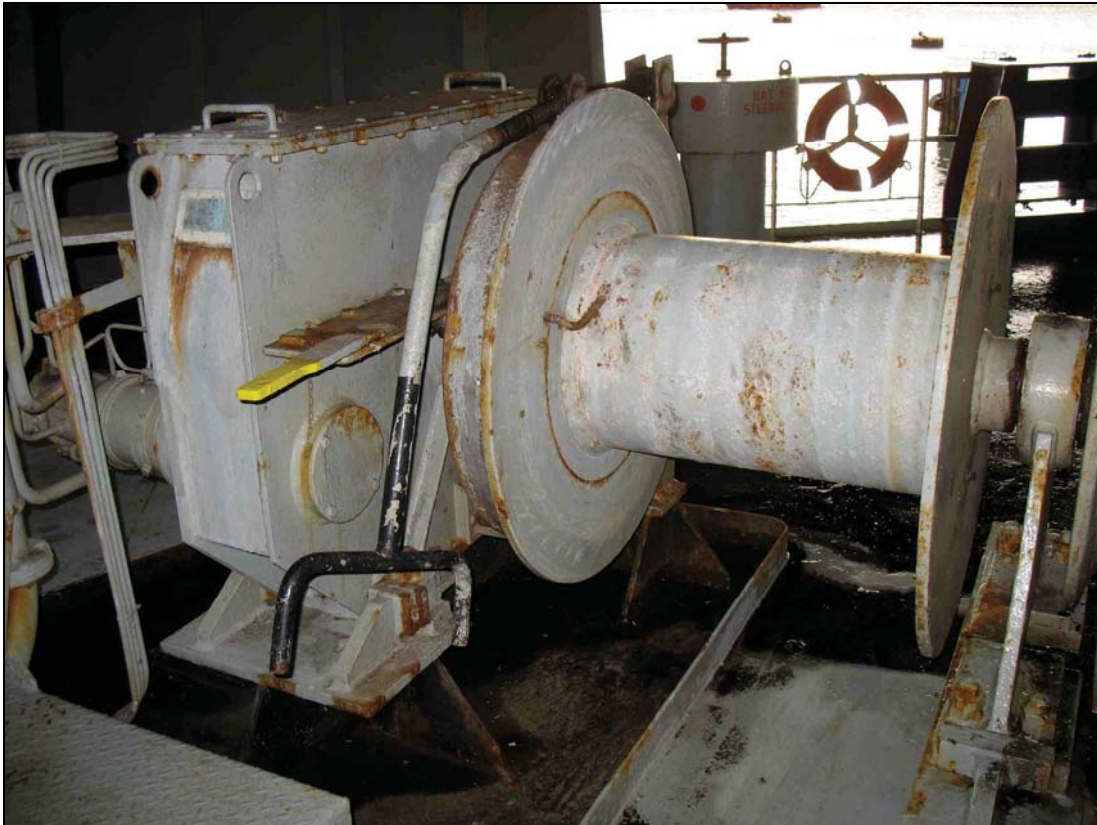
Some mooring lines were destroyed on board the NORTHERN FAITH and two winches were damaged (see Fig. 4 and 5). There was also external damage from contact by the bow with the pier. There was also minor damage to the pier.

Figure 4: Bent brake rod on the port winch

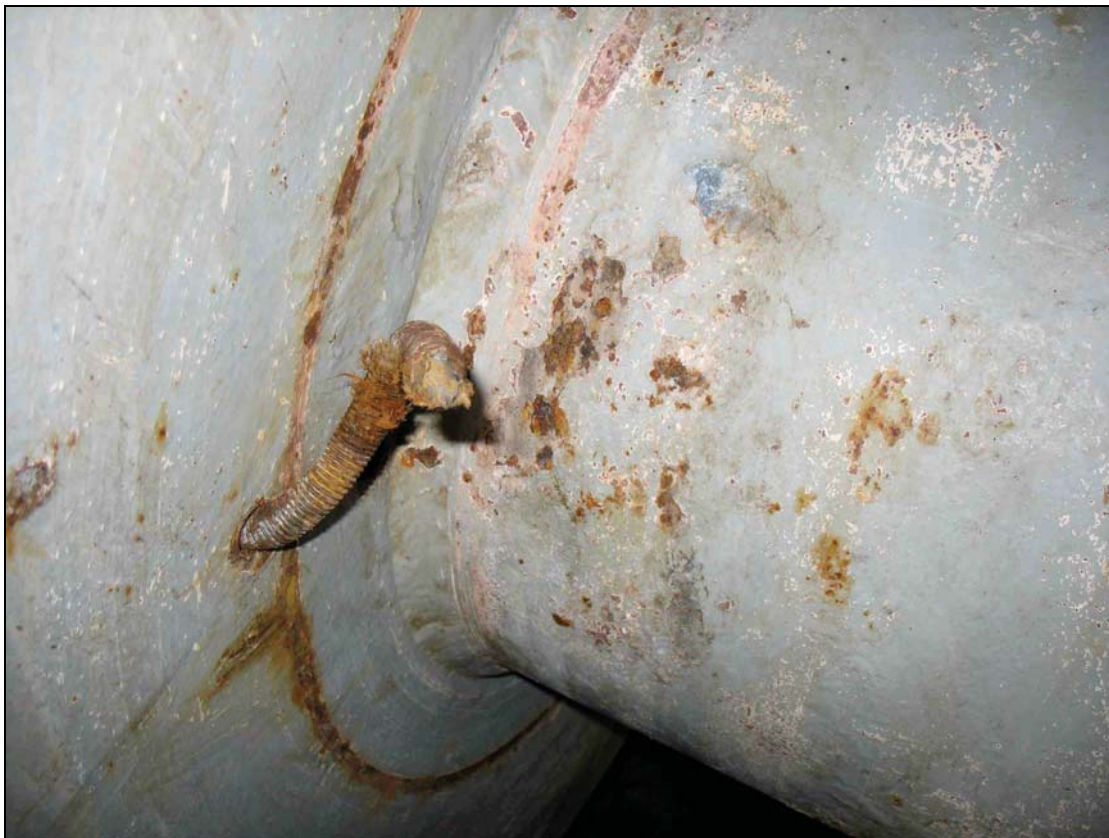
Figure 5: Ripped out bolt pin for holding the line end on the winch drum

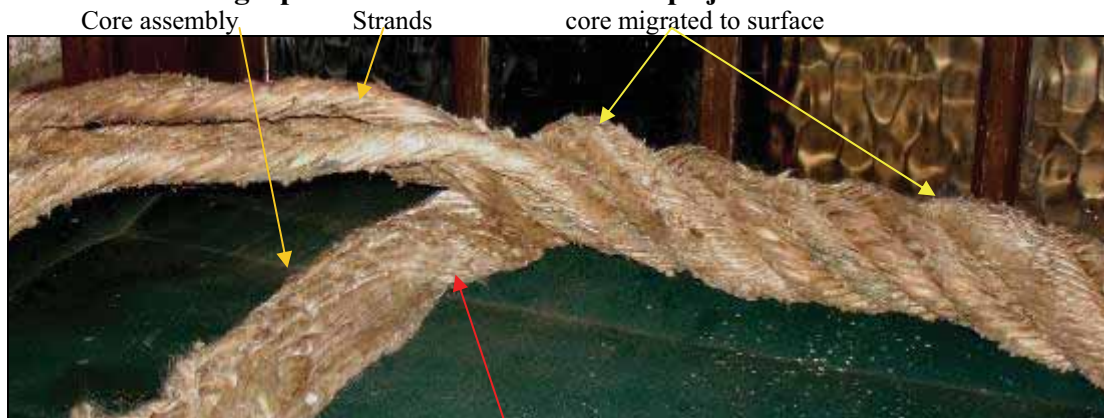
**Photograph 1 General view of the rope just behind the fail zone**

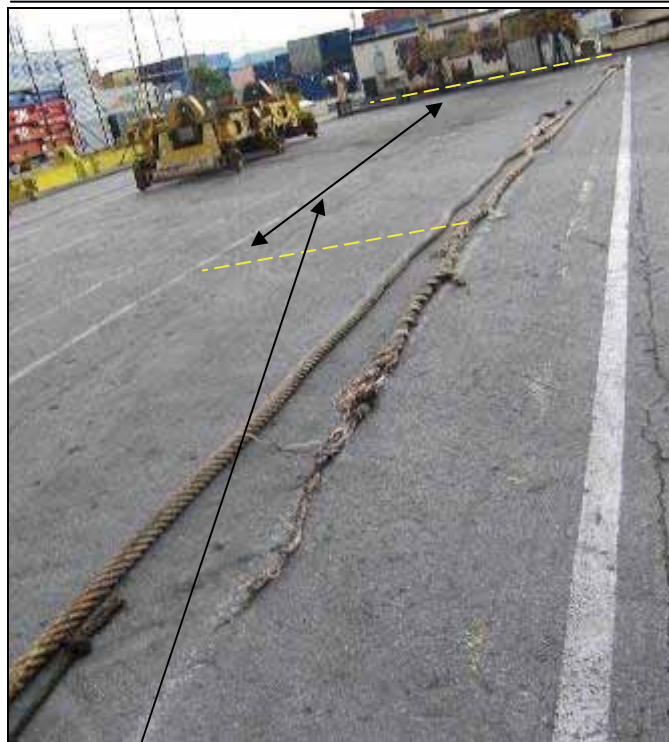
**Photograph 2** General view of failure, looking towards pier bollard eye

The failure is located about 20 metres from the pier bollard eye and thus would probably have been located within the 'free length' of the line, between the pier bollard and deck winch/ fairlead at the time of the accident.

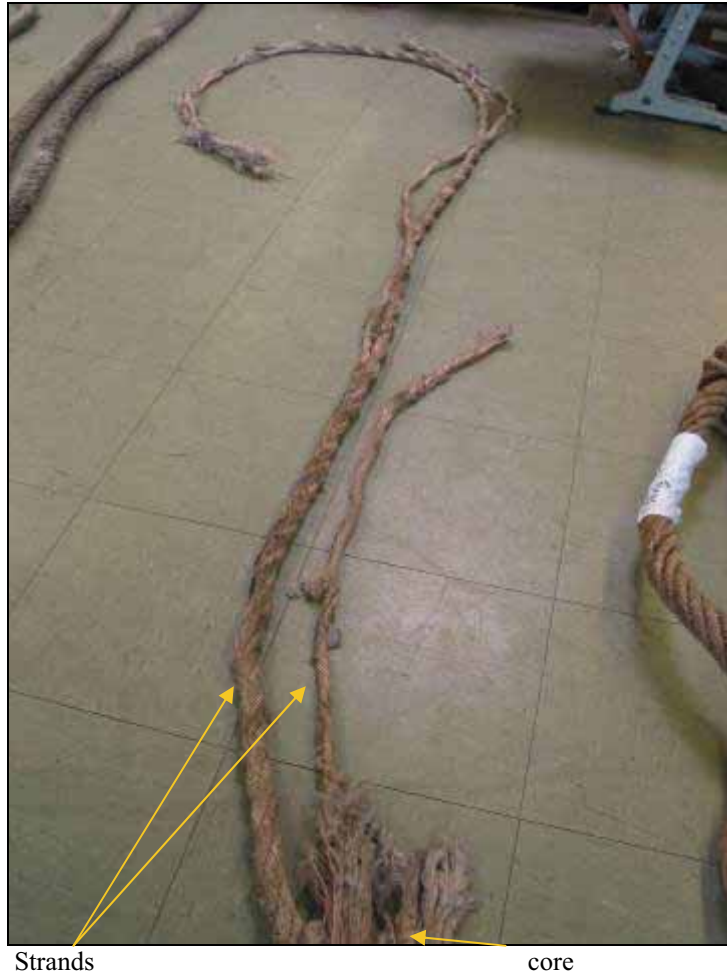
**Photograph 3 General view of one half of the fail zone**

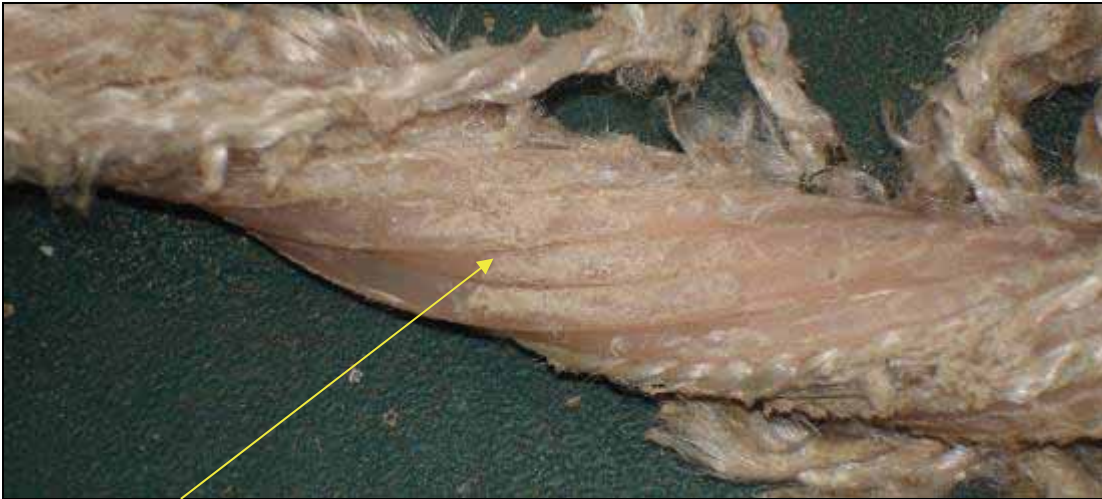
Condition of a strand in fail zone, 1 metre behind position A of figure 1

External abrasion

Both images reveal that the rope yarns of the strands had been subjected to severe external abrasion, resulting in either complete removal [photo 4] or fused material [photo 5]. Inspection of all the strands revealed that a general melding of the textile and monofilament components had occurred, indicating a failure under elevated temperature and/or pressure conditions.

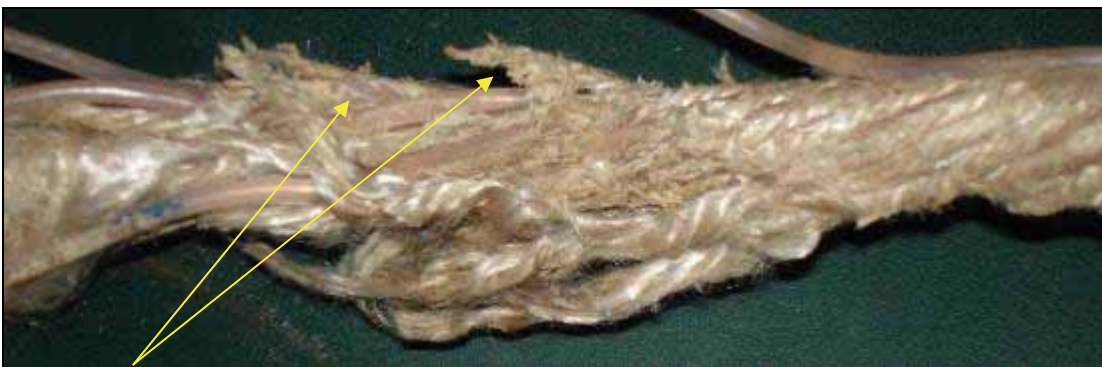
Condition of a strand 1 metre downstream of position D of figure 1

Fused rope yarn material

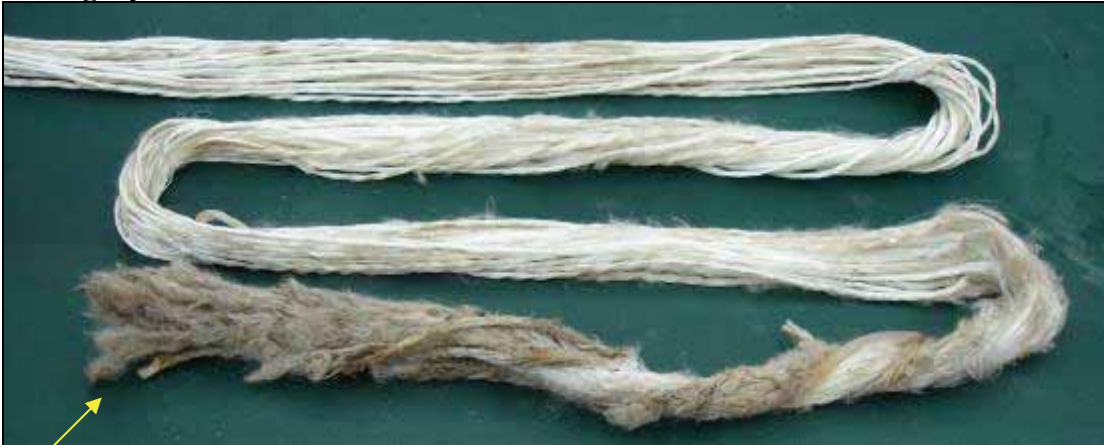
**Photograph 6**

Fail point

The rope yarns are relatively clean and in reasonable condition up to about 400 mm from the actual fail point. As the fail point is approached, contamination increases and the overall condition declines rapidly. These are indications of external abrasion having occurred.

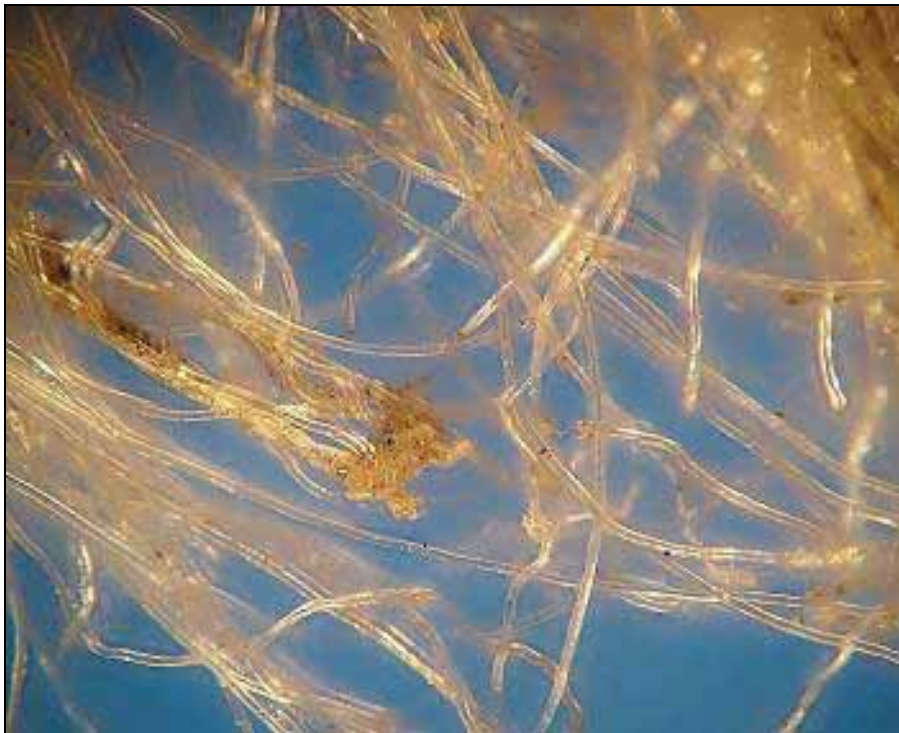
**Photograph 7      Fused filaments from core fail point of figure 1**

A cluster of fused filaments is seen in the centre of the image. Darker spots are also seen which could be charred material or contamination. The image is evidence of excessive heat being present at the time of failure.

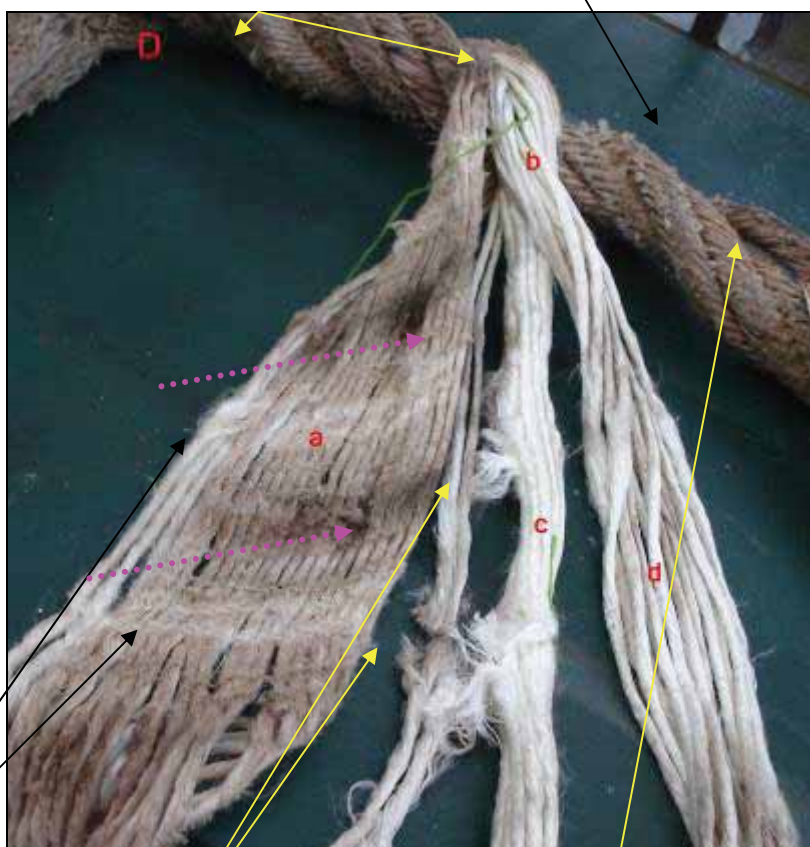
melded cluster of 4 strands

Localised compression

localised failure

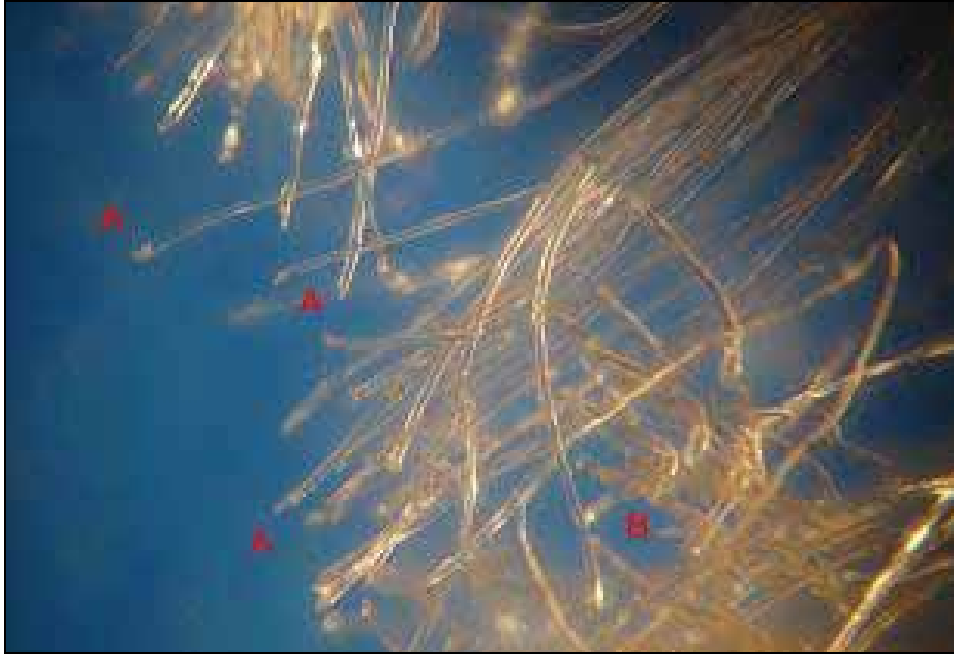
**Photo 9 Failed filaments from inner rope yarns of core assembly**

At 'A', the failed ends have a shape that is typical of ductile tensile failure. At B, folding and flattening of filaments is seen [ the image is slightly out of focus]. This indicates that pressure has been a factor in these failures of the internal rope yarns

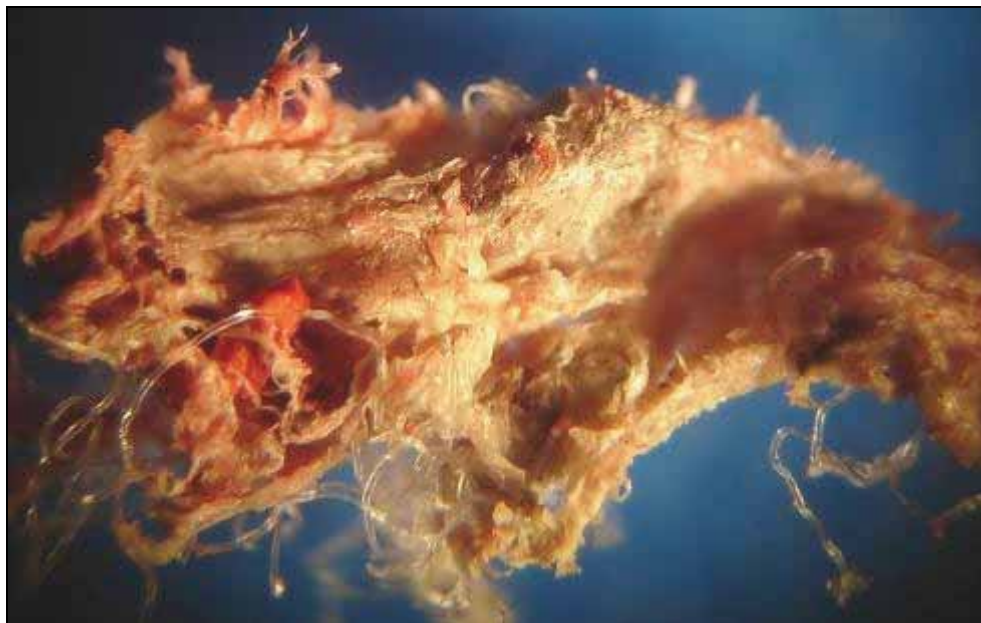
The blue and red discolourations on the fail zone of the line appear to be paint residue that matches the colour of the ship. If this is the case, then it is proof that the line rebounded off the ship after breaking.

**Photograph 11 Red particle embedded in fused matrix of rope filaments**

It was concluded that these areas of contamination were most likely to be paint that had contaminated the rope when the rope had made high energy contact with the vessel during the recoil after the failure.

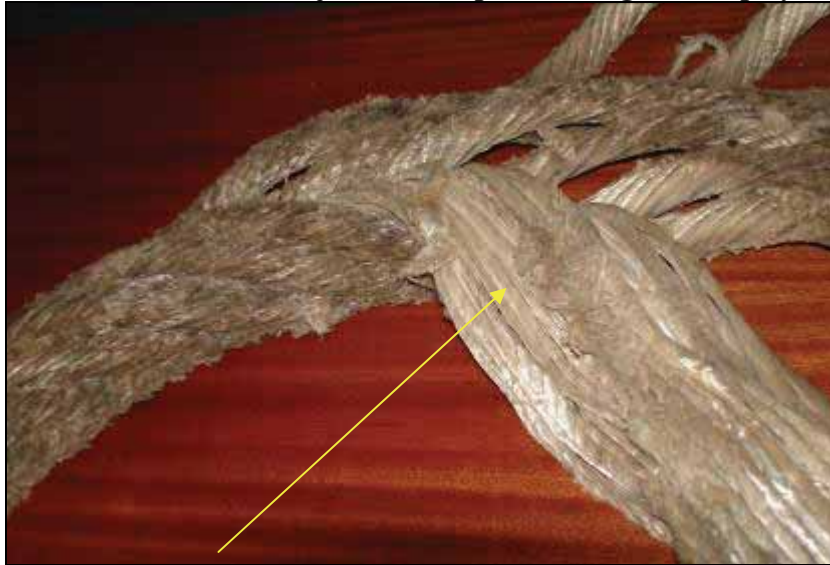
**Photo 12 Unraveled ‘adjacent’ sample showing core rope yarns**

Severe damage to cluster of core rope yarns

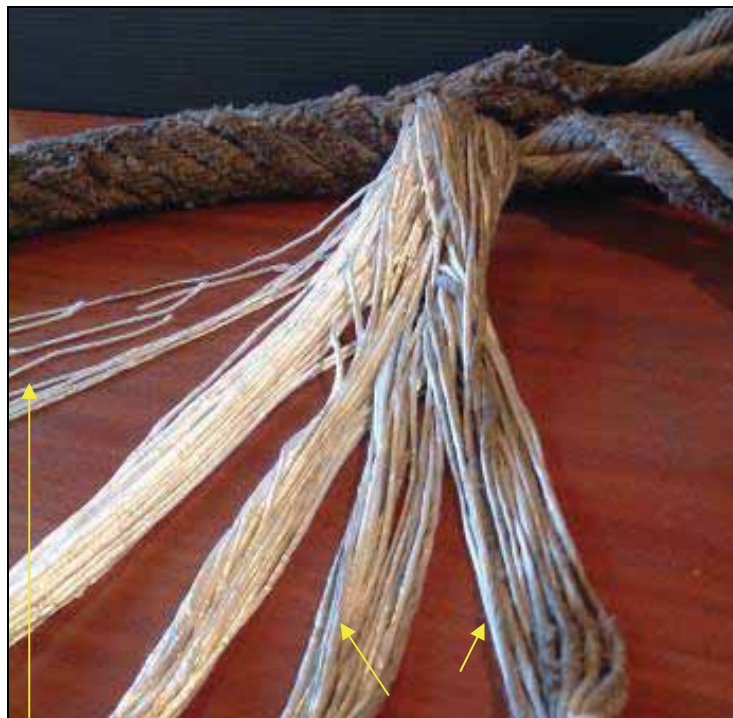
**Photograph 14** 'Clear of fail zone' sample unraveled to expose core rope yarns

Broken small diameter rope yarns

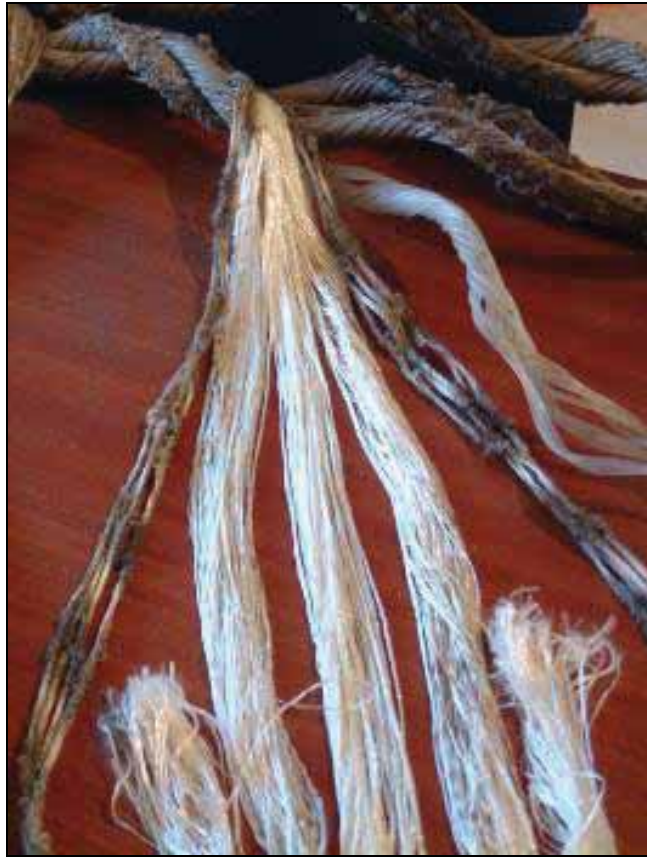
**Photograph 15**  
**Strand from 'clear' sample, unraveled to core reveal textile yarns**

Damage to the rope yarns and textile yarns were seen, but it was thought not to be of much use for the present investigation to perform further tensile testing.
