Summary Investigation Report 31/09

Very serious marine casualty

**Accident with subsequent loss of life on board
the fishing vessel TANJA on 6 February 2009 at
the port of Burgstaaken (Fehmarn)**

1 December 2009

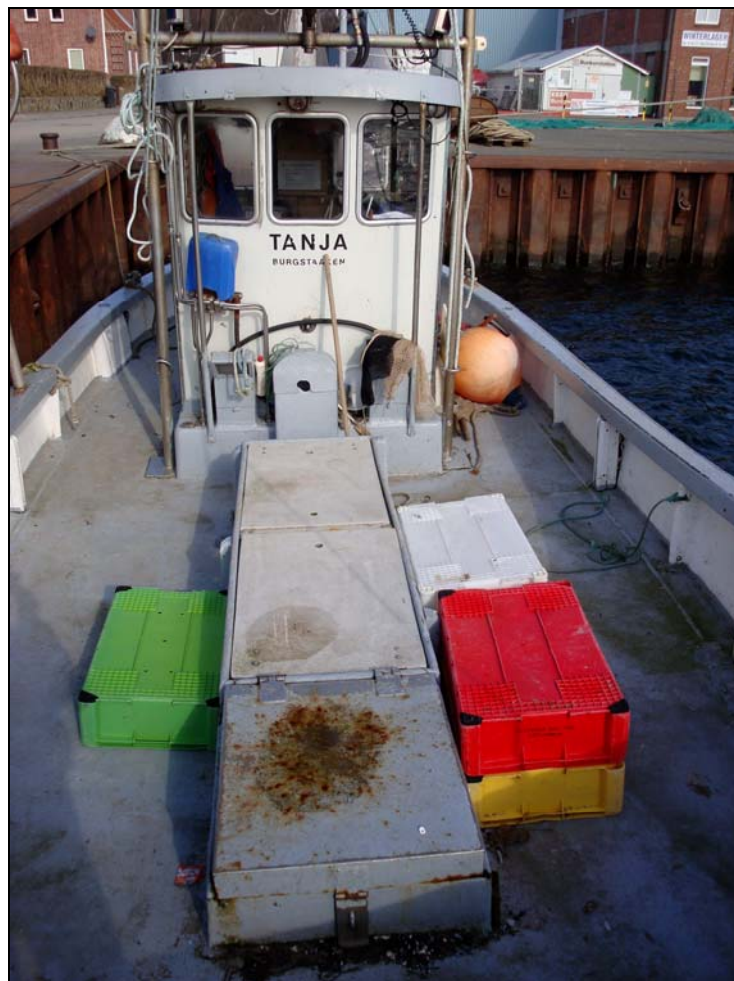
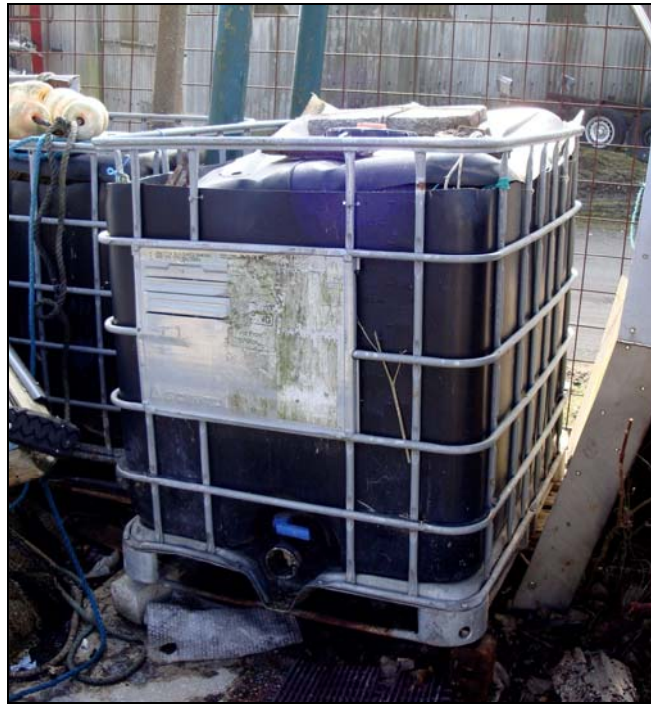
According to a witness, on the morning of the accident the 84-year-old part-time commercial fisherman subsequently involved in the accident used the cargo-handling gear to load an IBC container packed full with set gill nets on board. This was put on the main deck on the cover of the fish compartment. Since the IBC container was wider than the cover of the fish compartment, the bearing surface was temporarily extended with plastic crates (see **Figs. 3 and 4**).

Figure 3: Cover of fish compartment with extended bearing surface

Figure 4: IBC container

For the owner of the TANJA clearly did not consider what impact it could have on the righting behaviour of the fishing vessel if, for example, the IBC container, which was temporarily placed on the cover of the fish compartment, toppled over or if the vessel was exposed to non-calculated heeling moments while using the swinging boom.

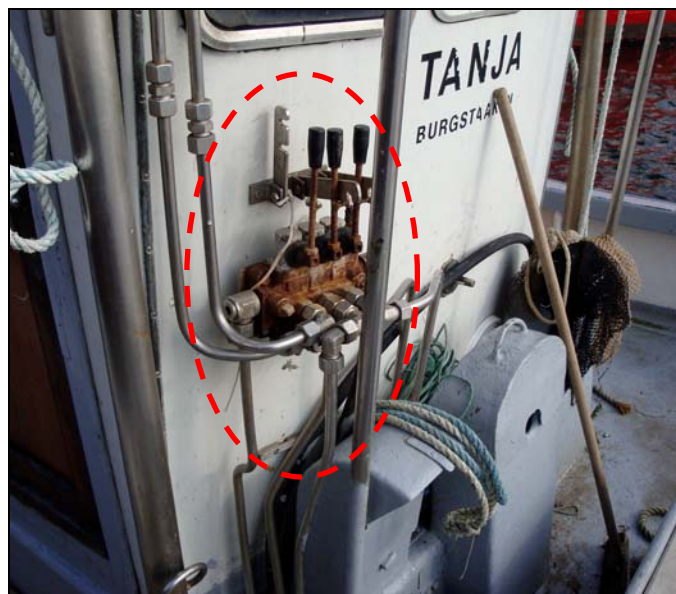
Figure 5: Operator console for the cargo-handling gear hydraulics

The fisherman subsequently sailed – in line with usual practice – alone to the inshore fishing grounds, where he laid about one third of the nets and then returned to port. Two witnesses who happened to be in the vicinity helped him transfer the IBC container ashore. To that end, while the fisherman operated the hydraulic drive of the cargo-handling gear's winch, which was on the starboard side of the forward edge of the wheelhouse (see **Fig. 5**), and used it to raise the load, the two witnesses hauled the container onto the pier.

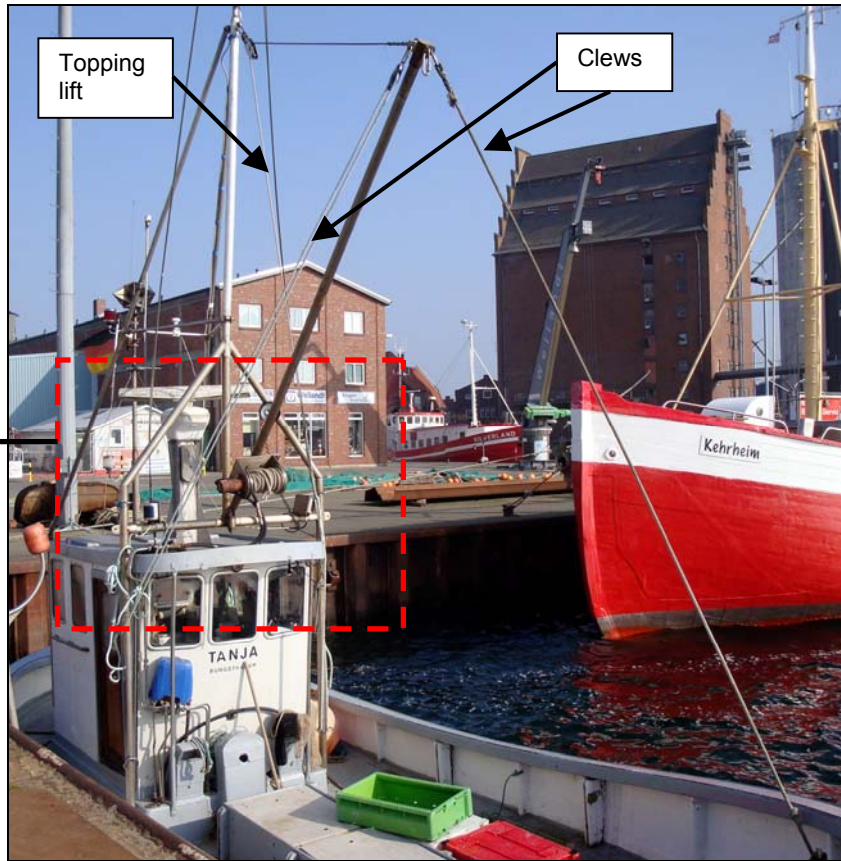
Figure 6: cargo-handling gear (complete)

The lifting gear used on board is of a lightweight tubular construction; it was probably installed subsequently in the 1990s and functions on the principle of a swinging boom (see **Fig. 6**). The mast structure consists of two vertical supports which run port and starboard along the forward edge of the deckhouse and are each bolted on the main deck with a foundation plate (see **Fig. 8**). These supports are interconnected above the deckhouse by a crossbar; they then meet in a Y-shape further above and support the actual mast, which is welded onto the crossbar. The topping lift block is attached to its upper end. The topping lift⁴ consists of a combination of wire and fibre cordage (outlined red in **Fig. 7**), clews⁵ and load rope consist of fibre cordage.

The cargo-handling gear was not technically approved. At no time was the lifting gear recorded during periodic surveys (every four years, see art. 45 para. 1 (2) UVV See⁶) of the fishing boat by the See-BG or Germanischer Lloyd (GL) on its behalf. Accordingly, in the last survey report of the See-BG dated 7 August 2008 as well as in all previous reports, the number '2' (= 'not applicable') was entered under 'Lifting gear for fishing operations'.

Even a cursory survey of the cargo-handling gear of the TANJA would have shown clearly that this would in no way meet the requirements of a technical approval. For example, a dubious combination of fibre and wire ropes was used for the topping lift. The load hook on which the load rope was tied did not have the required safety clip. The attachment of the mast to the deck was inadequate. Information concerning maximum permissible loads was not shown on the lifting gear. Technical documentation on the installed 'home-produced' equipment did not exist.

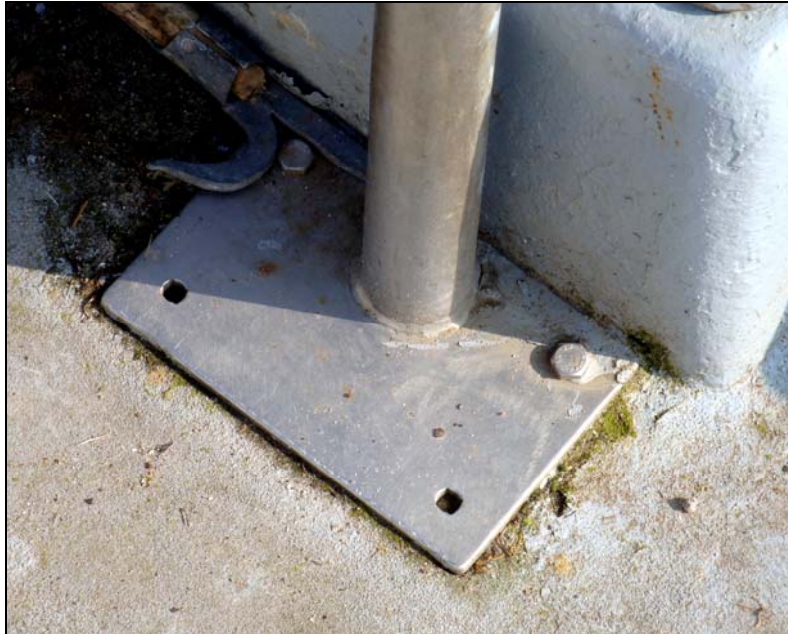
Figure 8: Foundation plate of the starboard mast support

During the visual inspection of the mast structure it was noted that the foundation plate of the starboard support was bolted to the floor of the main deck at only two of four possible points (see **Fig. 8**).

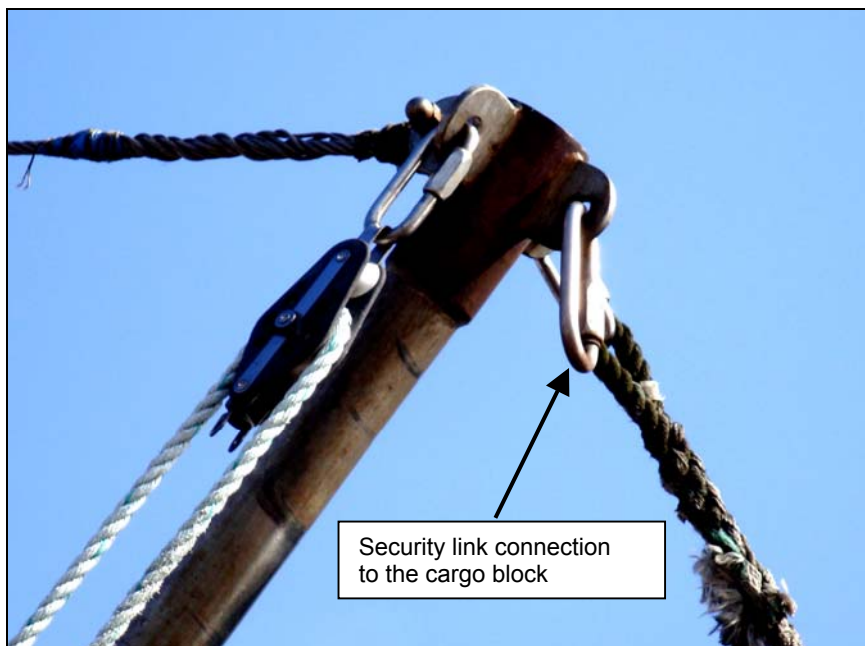
Figure 9: Boom head with attached security link

The cargo block with its ring that broke during the accident as well as the starboard clew tackle and the eyelet of the port guy was fitted to the boom head with a so-called security link, which was equipped with a screw lock (see **Fig. 9**).

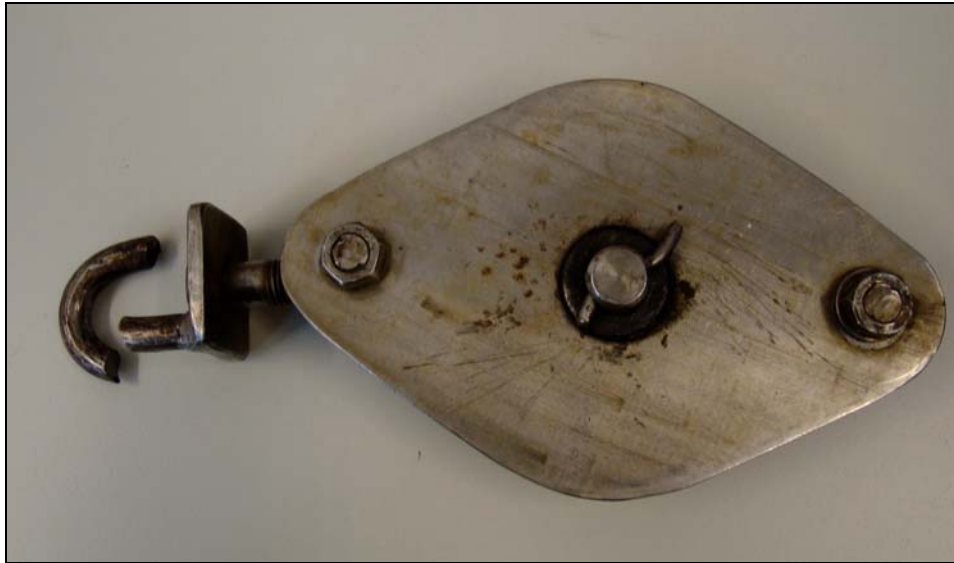
Figure 10: Cargo block with lifting eye

The block is made of stainless steel. A lifting eye can be found on one side of the block (see **Fig. 10**).

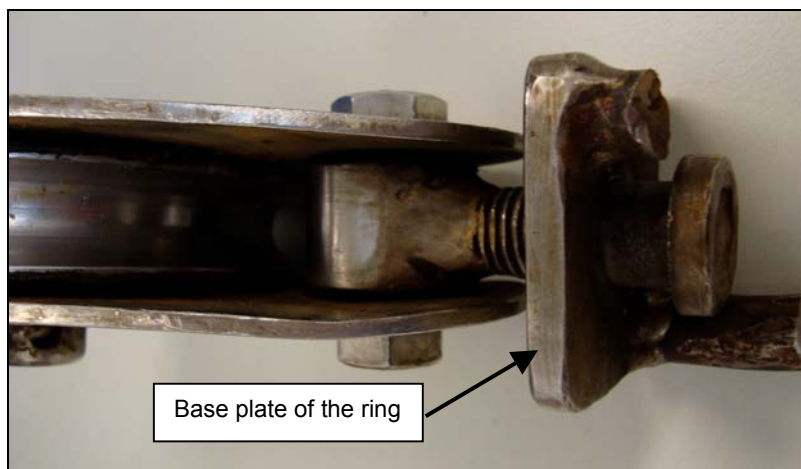
Figure 11: Ring mounting (close-up from the side)

A bushing joint is fitted to the screw that holds the block together on the side of the ring. Another screw is welded onto this bushing joint, the head of which is inserted in the base plate of the ring (see **Fig. 11**).

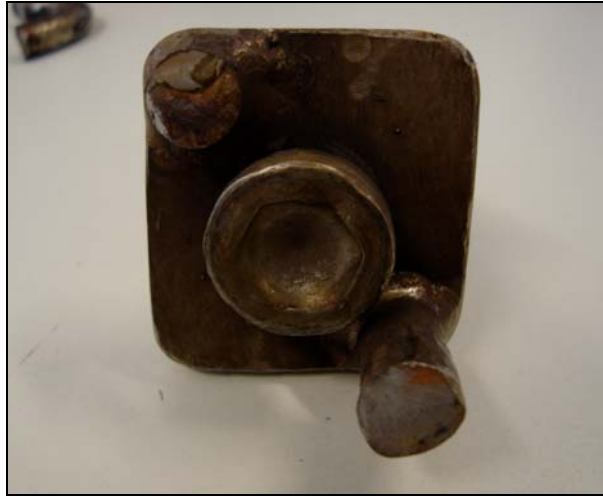
Figure 12: Ring mounting (top view of fracture)

The screw welded onto the bushing joint is a socket screw, the head of which is largely ground down (see **Fig. 12**).

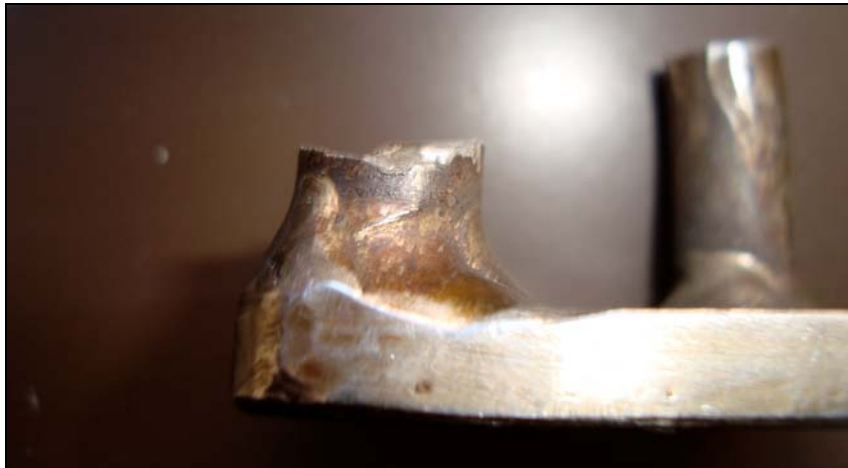
Figure 13: Foundation plate of the ring (side view)

Figure 13 shows the foundation plate of the ring with the rest of the welded and broken ring bracket. The primary fracture is located close to the weld on the left side.

Normal production procedures were not used for either the hook or the ring attached to the block. The ring consisted of austenitic steel with good welding properties and chromium steel not suitable for welding. Several serious problems emerge when welding chromium steels such as this, which often lead to cracks immediately after the welding process. In addition, welding causes these steels to be prone to intergranular corrosion. This type of corrosion resulted in damage to the bracket, which then fractured under load without deformation. The welding of this ring is to be regarded as a serious error and the primary cause of the damage.

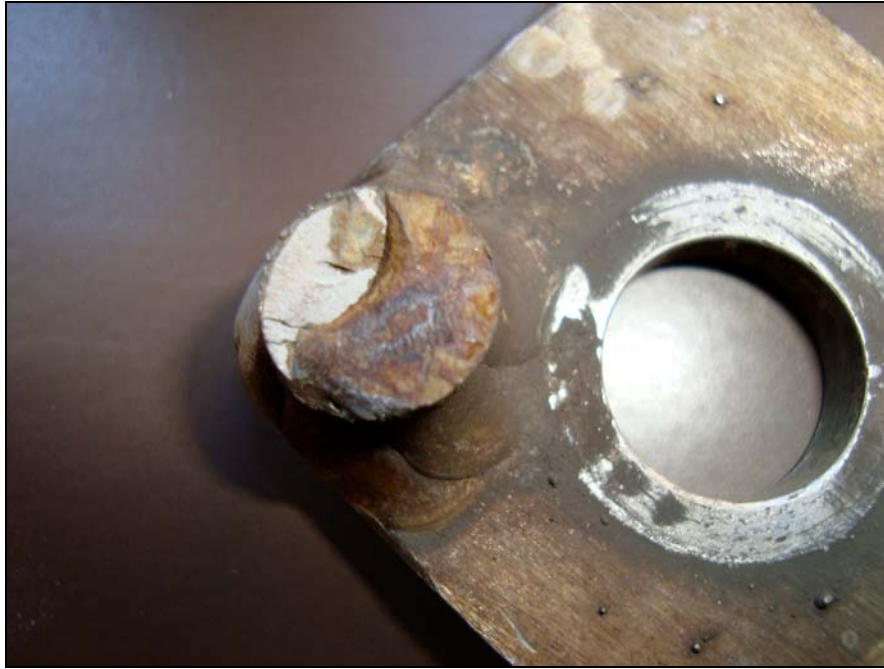
The fracture surfaces of the bracket are shown in **Figs. 14** and **15**. The primary fracture (**Fig. 14**) is partly rusted. When looking through a magnifying glass, a crystalline structure is visible in both the non-rusted and rusted area. Evidently, the fracture happened in two stages, where the older part of the fracture is slightly rusty. The secondary fracture (**Fig. 15**) is about 20 mm from the weld. The position and direction of the fracture corresponds with the expected behaviour of the bracket after breaking on the opposite side.

Figure 14: Close-up of the primary fracture surface

The primary cause of the accident, which was the improper welding of the ring on the cargo block, could be clearly identified due to the expert's opinion. Due to the fact that the approval and technical inspection of the lifting gear was not performed at all, this flaw was a fortiori not accounted for by the authorities.

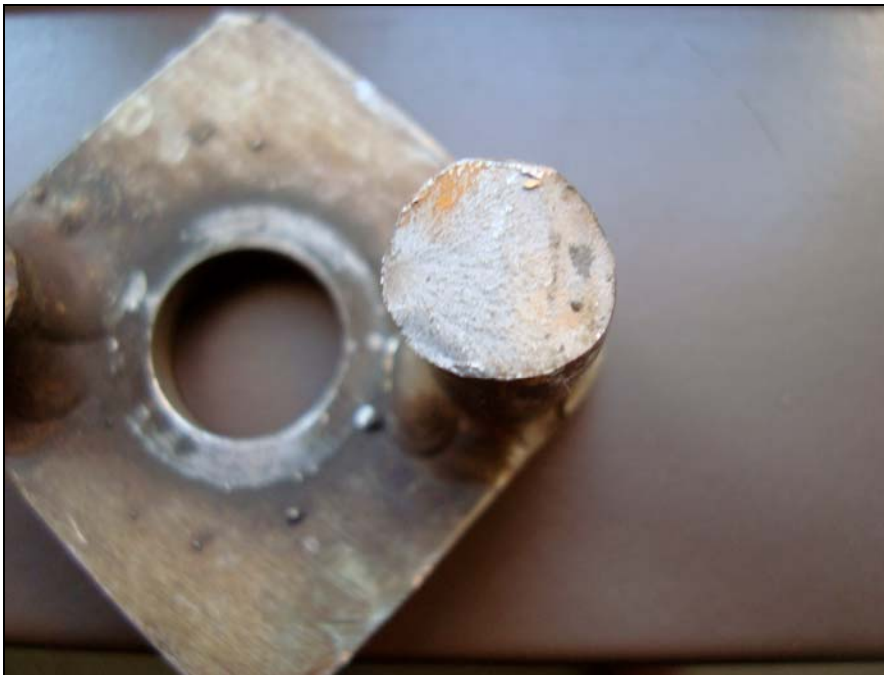
Figure 15: Close-up of the secondary fracture surface

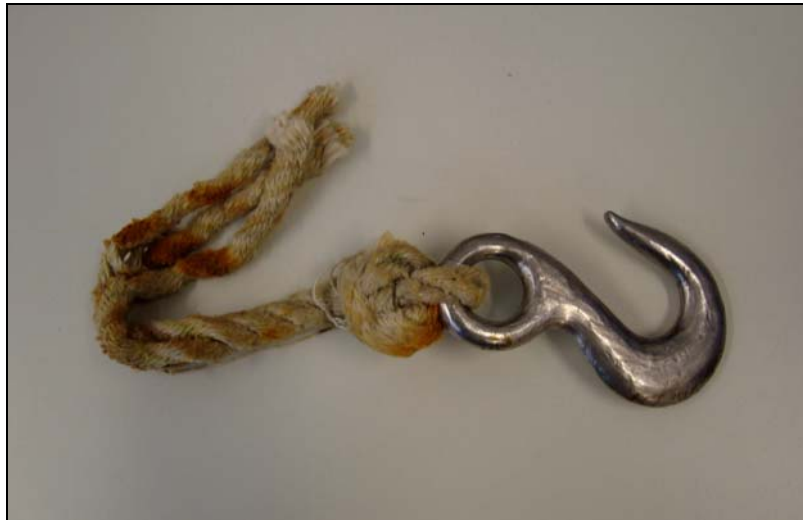
The load hook is made of austenitic chromium-nickel steel and can be seen together with the short piece of rope in **Fig. 16**. Upon examination we initially see that the safety clip, which every hook must have according to DIN requirements, is missing.

Figure 16: Hook with rope tied on with a knot

The rope is made of synthetic fibre and has three strands. The ends of the rope were sheared and the strands had loosened. The rope showed clear signs of wear (**Fig. 19**). Rather than being spliced, the rope was attached to the hook with a knot (**Fig. 16**). Measured close to the knot, the rope diameter is about 15 mm. A burning test showed that it is a polyamide rope. According to DIN ISO 1140, it concerns a Synthetic Fibre Rope Form A with three strands, a nominal diameter of 16 mm and a minimum breaking strength of 51.8 kN.

The load rope was tied to the ring of the hook with a knot. This knot does not meet the requirements for cargo-handling gear since experience shows that knots reduce the load capacity of rope by one third.

Usually a safety factor against breakage of 5 is applied for rope used for running rigging. The hook and rope would have thus had a load capacity of about 1.2 t if a splice was used for the connection. The load capacity was reduced to approximately 0.8 t because of the knot.

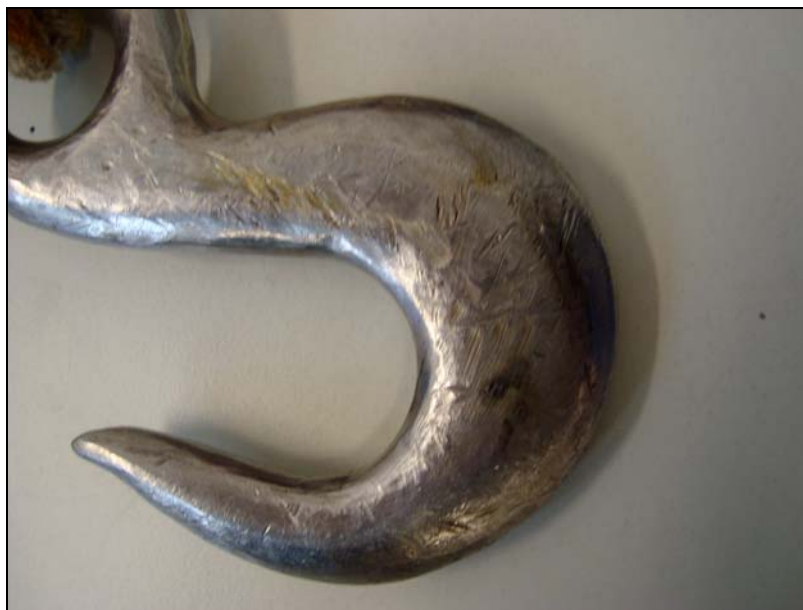
Evidently, the hook has been manually machined. Rough grinding marks of the kind caused by an angle grinder are present (**Fig. 17**).

Figure 17: Close-up of load hook

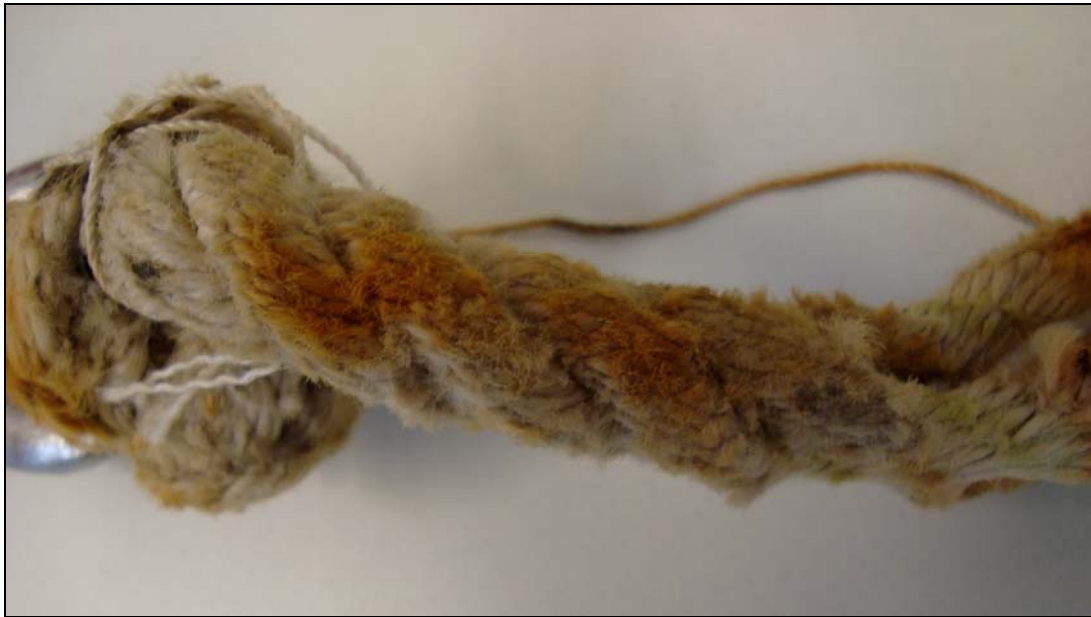
Figure 19: Worn rope

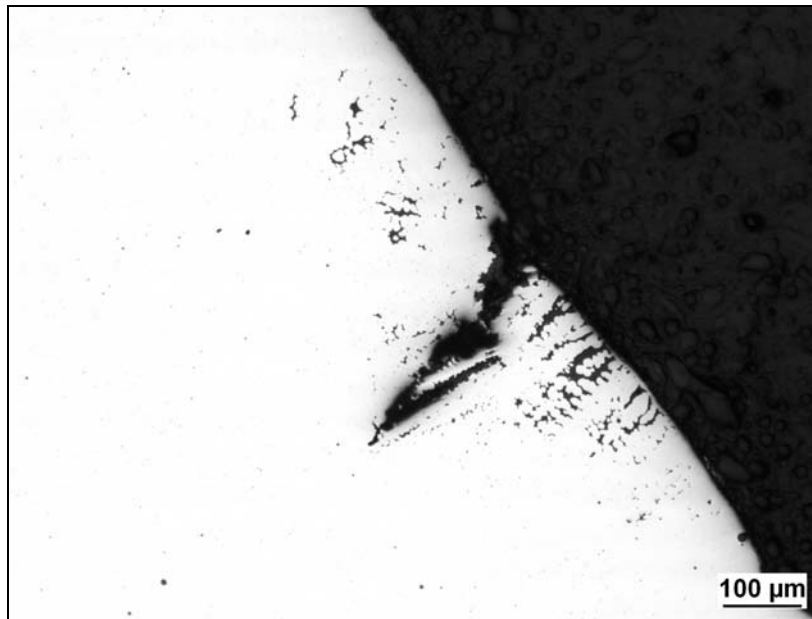
The metallographic analysis showed the typical pattern for the two materials. A fillet weld was used around the bracket. Increased hardness due to the welding was not visible. Intergranular corrosion had occurred next to the melting line and in the area of the primary fracture (**Fig. 20**).

Figure 20: Intergranular corrosion

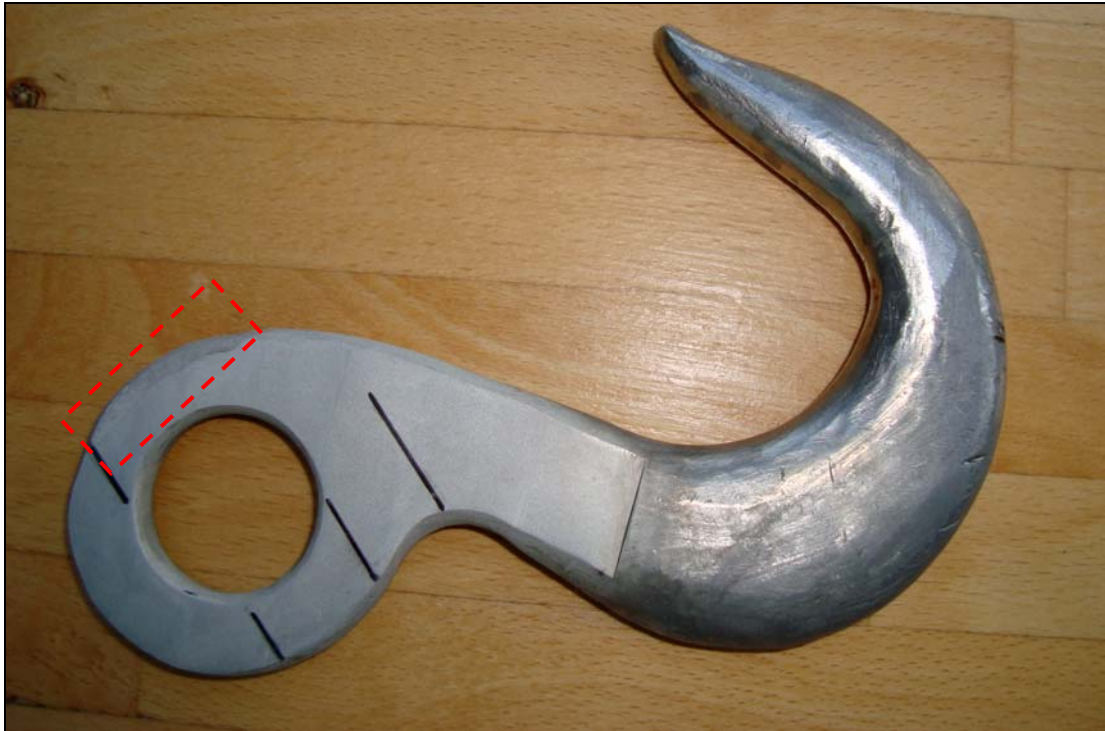
A load test was conducted on the load hook. To that end, it was clamped in a tensile testing machine with two shackles and pulled. The hook began to bend outwardly at a load of approximately 20 kN. The test was aborted at a tensile load of 30 kN. The surface of the hook was then machined in the area of the ring. The machined surface was finely ground and a macroetch was created. The main deformation direction in the hook was thus determined. Moreover, the etching revealed a corrective weld at the ring of the hook. The hook can be seen in **Fig. 21** on the next page of this report. The corrective weld (outlined in red in **Fig. 21**) stands out clearly from the base material above the ring.⁷ The deformation direction was visible only through a magnifying glass. It is marked in the photo with black ink.

Figure 21: Hook with corrective weld (outlined in red) and rolling direction⁸

As can be seen from the analysis of the rolling direction, the hook was made from a metal sheet. The absence of the safety clip should, at any event, have been challenged. The first plastic deformation of the hook begins at 20 kN. For hooks, a test load of 1.5 times the load capacity is typically used. The first deformation occurs at just above the test load. Therefore, it can be presumed that the load capacity of the hook is some 1.2 t.
