**Bundesstelle für Seeunfalluntersuchung**  
**Federal Bureau of Maritime Casualty Investigation**  
Federal Higher Authority subordinated to the Ministry of Transport,  
Building and Urban Affairs

Investigation Report 47/08

**Serious marine casualty**

**Collision**  
**of the MV SCHLESWIG-HOLSTEIN**  
**with the Skanseodde Lighthouse**  
**in Fredericia on 31 January 2008**

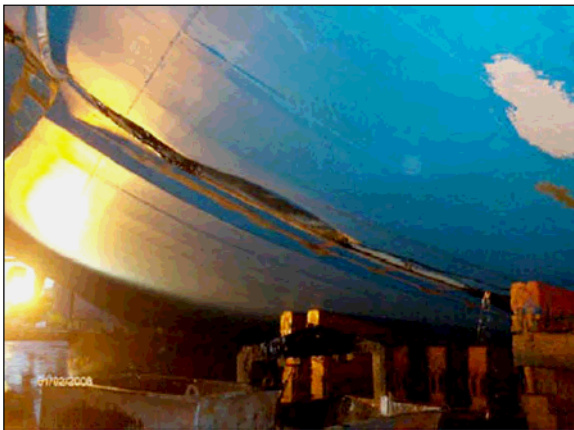
Figure 3: Keel plate

Damage is located at frame 12 and include the keel plate and up to the shell plate strake G.

There is a penetration of approx. 100 x 500 mm into the separator room in East side.

There is a penetration of approx. 100 x 4000 into the sludge tank in East side.

##### Keel plate:

A + B plate strake	4000 x 2000 x 14 mm
C plate strake	6000 x 2000 x 12 mm
D plate strake	1800 x 2000 x 14 mm
E plate strake	2600 x 2000 x 14 mm
F plate strake	2000 x 2000 x 18 mm AH36
G plate strake	3000 x 2000 x 12 mm

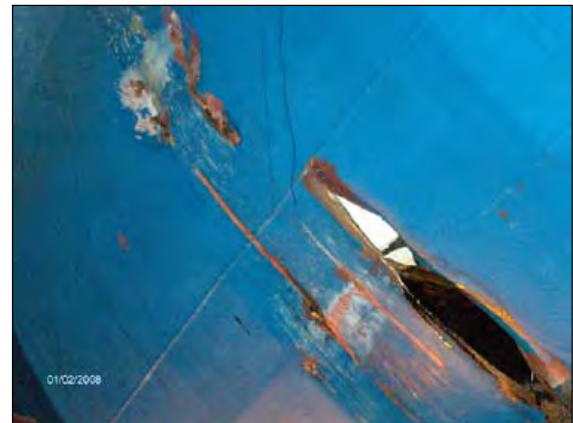
Figure 4: Shell plating

Furthermore indentations are present in the range of the void space 106 and electrical stores.

To crop and replace the following amount of steel (Grade A):

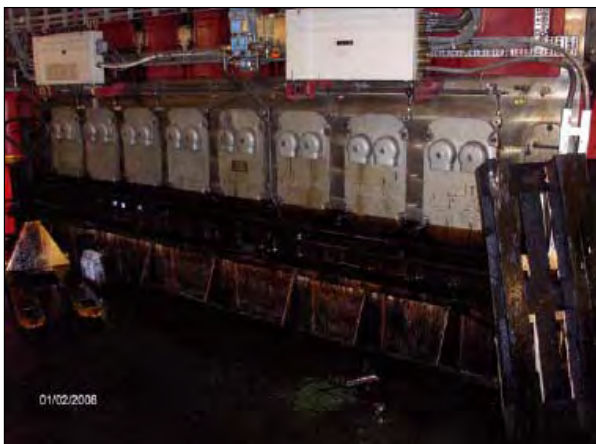
Figure 5: Engine room

The complete compartment has been floated with water and mixed with sludge from penetrated sludge tank in separator room.

Approx. 20 pieces of electrical motors are damaged.

Water/oil has entered lower part of the main generators number 4 and 5.

Pumping out of seawater and sludge from tank top in engine room section 5.  
Cleaning of compartment from approx. 60-70 cm above the gratings and all the way to tank top. (s. fig. 5 and 6)

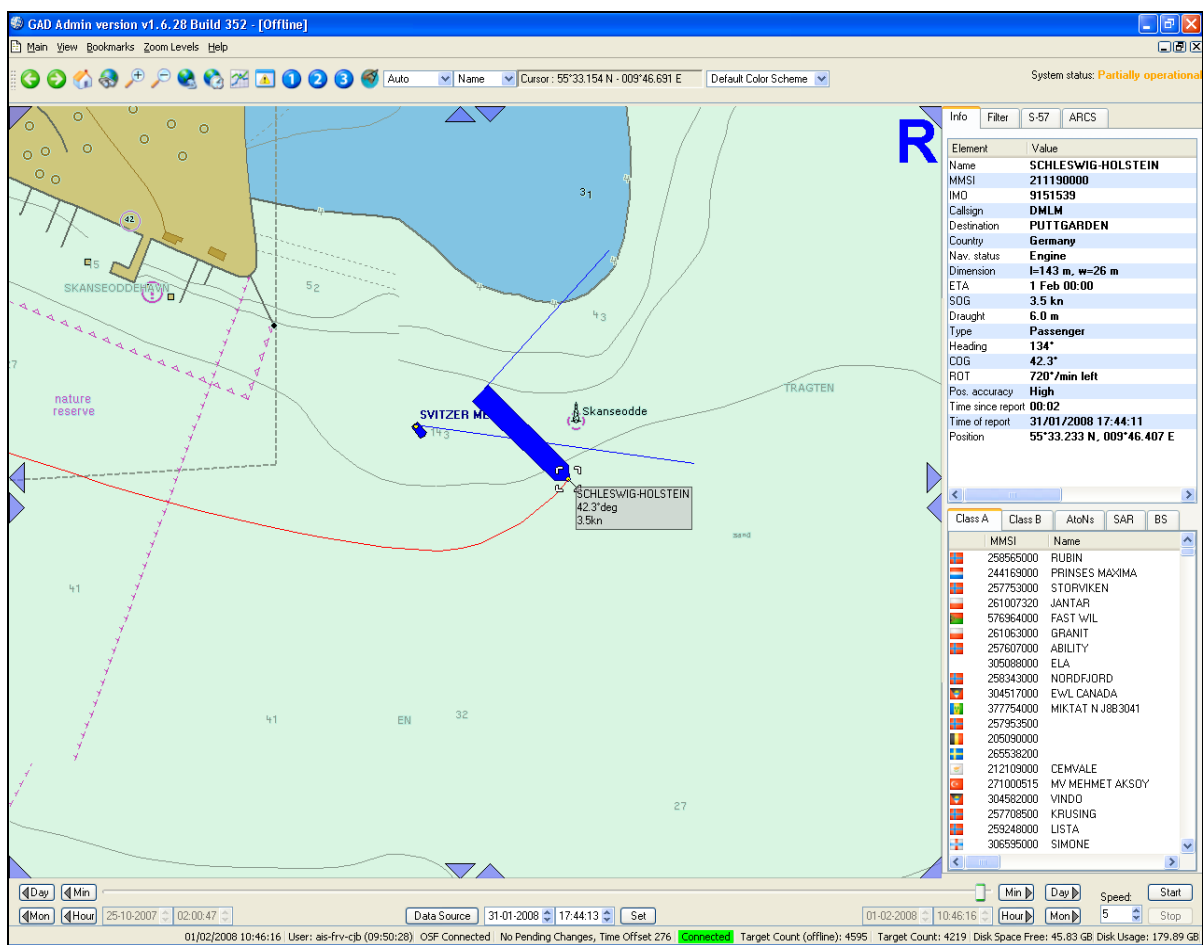
Figure 14: AIS place of collision

The department for the investigation of marine casualties of the DANISH MARITIME AUTHORITY provided the BSU with extensive data material (AIS, ENC)<sup>6</sup> as well as statements of the tug masters involved and the pilot. The radio communication between the pilot and the tug masters was not available. According to the AIS recordings, at 17:44:11<sup>7</sup> the SCHLESWIG-HOLSTEIN was sailing on a heading of 134°, course over ground (COG) of 042.3°, with speed over ground of 3.5 kn and rate of turn (ROT) of 720°/min to port, which is not plausible (see Fig. 14<sup>8</sup>). The difference of 92° between heading and COG is conspicuous. The tug SVITZER MENJA is located to starboard aft of the SCHLESWIG-HOLSTEIN. Fig. 15 reveals that the vessel drifted immediately to the north after having left the floating dock, without having reached the plotted line of leading lights.

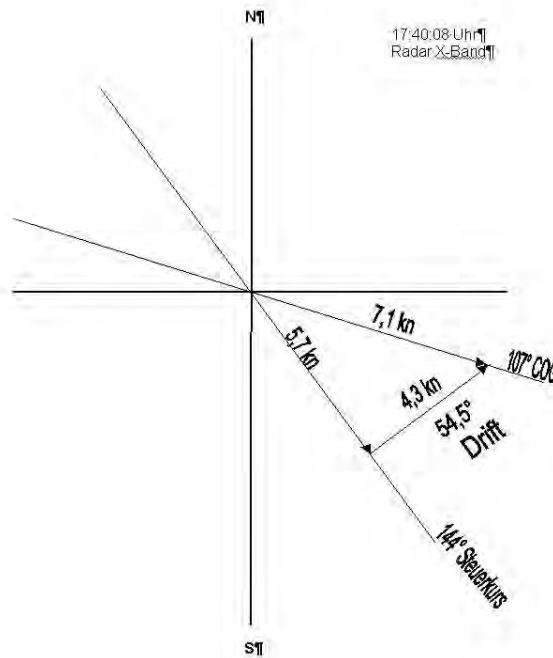
Figure 24: Sketch of drift at 17:40:08

and the heading were shown by the gyro compass. The installed GPS receivers of type DEBEG NT 200D are not type approved by the administration according to the new GPS performance requirements which dictate that COG and SOG also have to be tested. However, no significant errors have been observed with this constellation. GPS was chosen as speed sensor because the measurements of the speedlog would be disrupted by the pod drives. According to the performance requirements for radars, the proper speed should stem from an approved sensor that corresponds to IMO requirements for the corresponding stabilisation mode ground or sea. The accuracy of COG and SOG can therefore not be verified. Inaccuracies can arise in particular when there are quick changes of movement. Overall, the drift appears plausible.

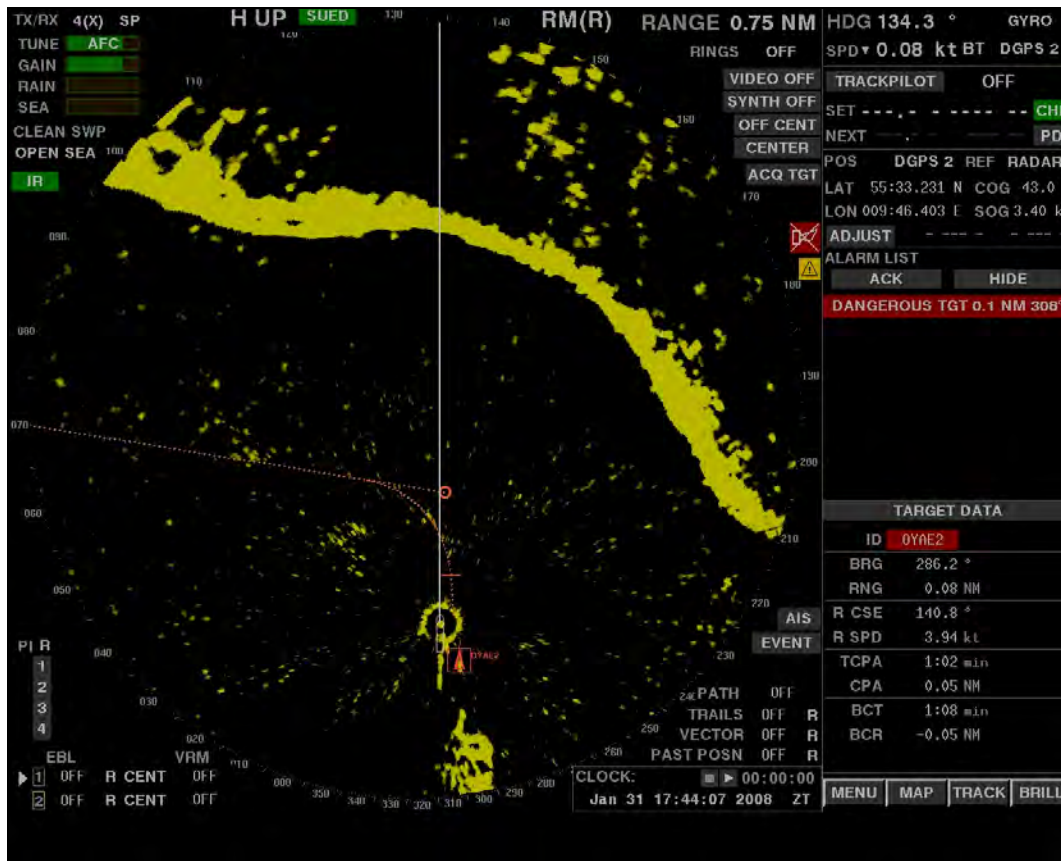
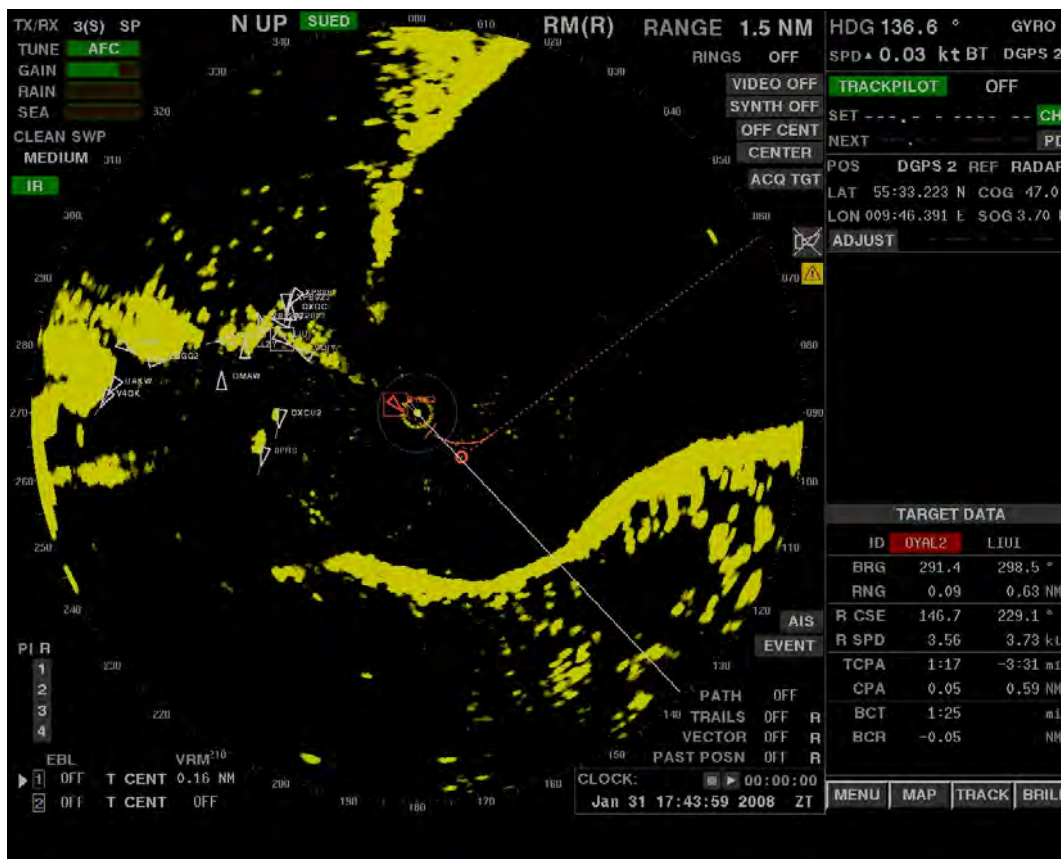
Around 17:44 the SCHLESWIG-HOLSTEIN collided with the Skanseodde lighthouse. Shortly before the collision, the values on the X band system show HDG=134.3°, SPD=0.08 kn astern, COG=43.0°, SOG=3.4 kn (see Fig. 29). This gives a drift calculated by the system, that corresponds approximately to COG and SOG since speed amounts to zero. Due to the position of the pod drives, a resultant rate of turn of 13.9°/min to port is achieved (see Fig. 26). The steel structure of the lighthouse was destroyed by the collision.

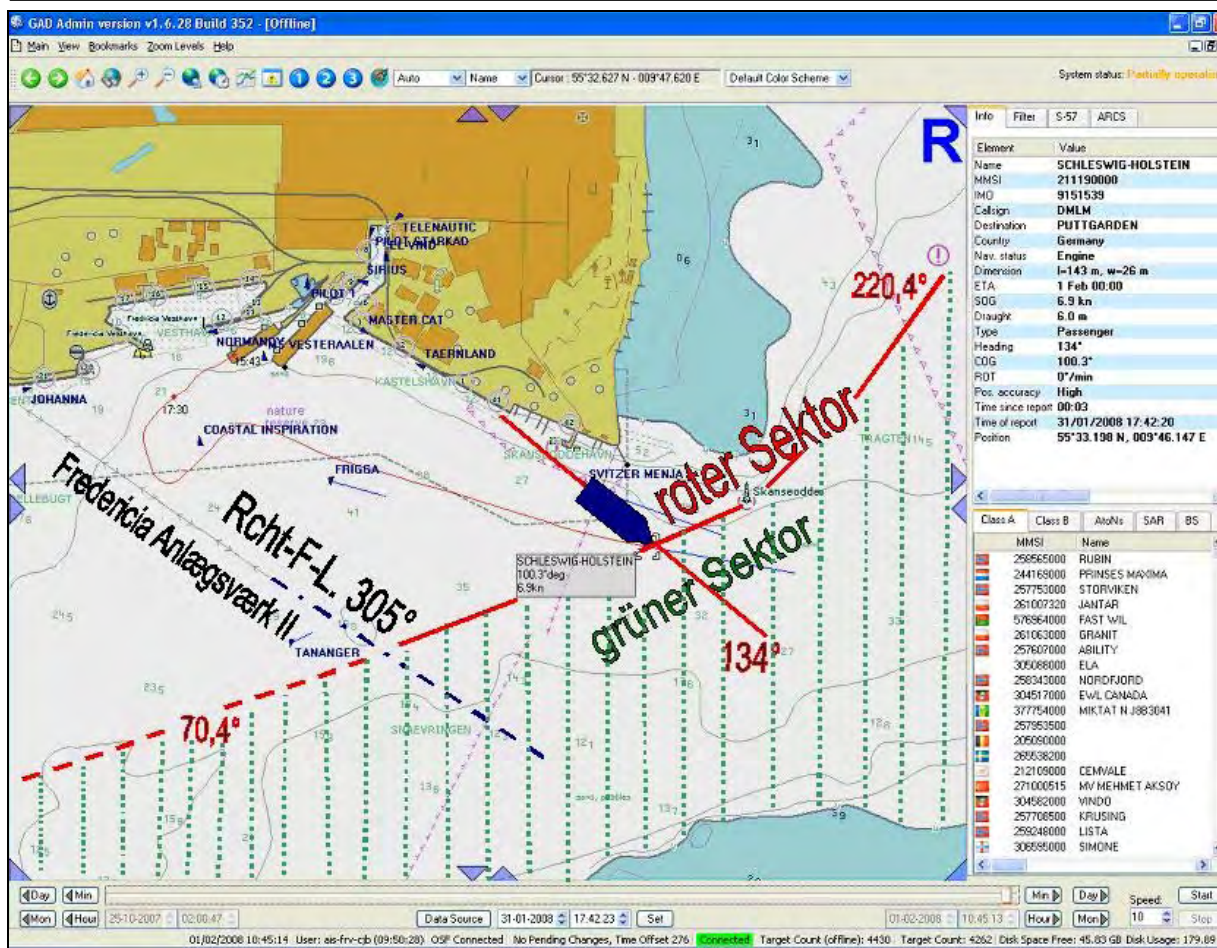
Figure 33: Sketch of the Fredericia leading light line and the Skanseodde sectors

The observation of the navigational data reveals that the SCHLESWIG-HOLSTEIN drifted quickly to the north after having left the dock and releasing the tugs. The drift was not sufficiently counteracted to clear the port facilities and to keep to the centre of the Belt near Snævringen. The ship was navigated by sight to reach the planned track. The sectors of the Skanseodde lighthouse were the deciding reference points for the manoeuvring master to keep safe fairway. According to his own statement, the sector changed from green to red. However, according to evaluations of the AIS and VDR recordings, they never left the red sector of the light marked on the paper chart. It is possible that the master was confused by the solid green light of the Shell oil pier on the SE dolphin of the refinery 5 kbl NW of the Skanseodde lighthouse which is stated in the lighthouse directory with a nominal range of 4 nm.

It would have been better to navigate by sight and keep to the Fredericia Anlægsværk II leading light with leading light line  $305^\circ$  and the green sector of Skanseodde on bearing  $070.4^\circ$ - $220.4^\circ$  (see Fig. 27). However, this would have not been possible for the master alone who was manoeuvring at the same time because he had no visibility aft from the conning position. It would have been helpful here to use the installed electronic nautical chart (ECDIS) to gather quickly more information about the situation.
