Investigation Report 510/08

Very serious marine casualty

Fatal accident on board the CMV CHICAGO EXPRESS during Typhoon "HAGUPIT" on 24 September 2008 off the coast of Hong Kong

1 November 2009

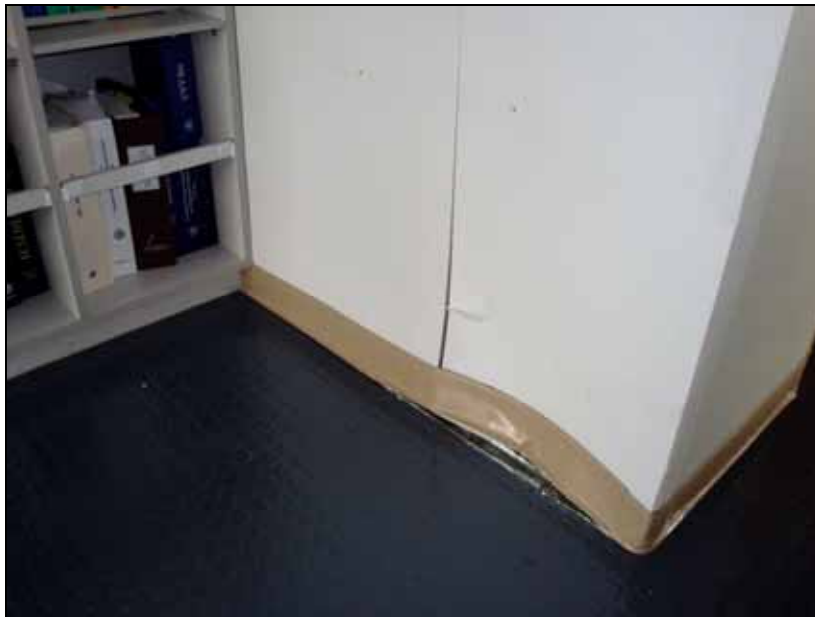
Figure 7: Deformed interior panelling at floor level¹⁷

¹⁷ Note: Such or similar deformations can be found in various places at floor level. The dents shown here are situated in a corner behind the area of the chart table (where the Master was found).

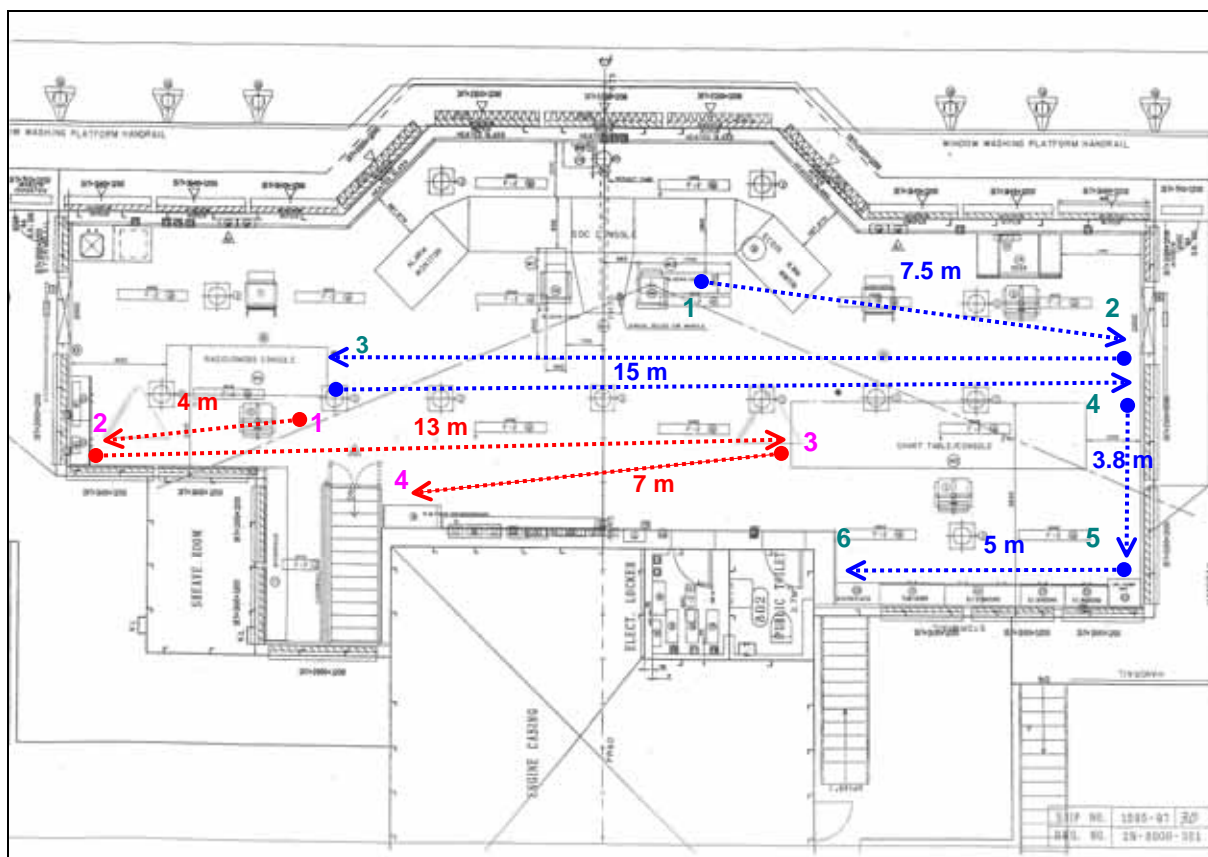
Figure 15: Path of the fall of the **AB and the **Master****

Since it was dark on the bridge at the time of the accident and the two uninjured witnesses of the course of the accident were, during the extreme rolling of the vessel which led to the accident, primarily concerned with not losing their own footing or, as regards the OS (Helmsman), regaining it as quickly as possible, the drawing depicting the paths each fall took in **Fig. 15** is based on assumption. However, the respective start and finish positions are regarded as definite. The intermediate impact positions are confirmed at least to the extent that there are more or less distinct dents or scuff marks on the bridge panelling or panelling on the bridge furniture, which were caused on impact by the AB or the Master.

The distance between the impact positions, the serious injuries of the casualties and the in part significant deformations on the console and bridge panelling illustrate just how severely the accident victims were affected by the acceleration and forces during their fall.

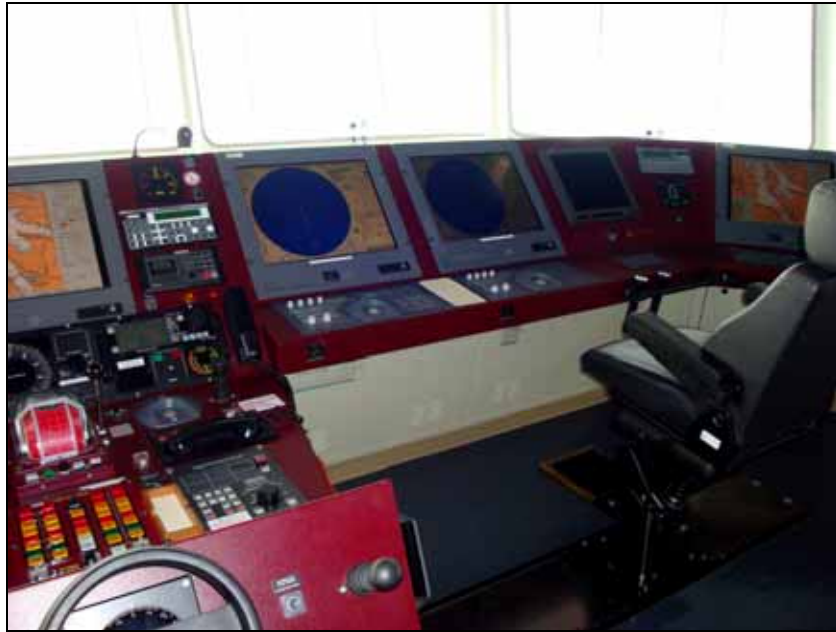
Figure 16: Radar position on the starboard side

As regards the starting position of the Master (in front of the radar screen on the starboard side of the vessel command console), it transpires that there was no handhold where he was situated (see **Fig. 16**). Despite there being handrails across the entire width of the vessel command console at various points, rather than being continuous, these are interrupted by large areas without any handhold whatsoever. **Figure 17** shows the console is only partially equipped with handrails – in the example on the port side.

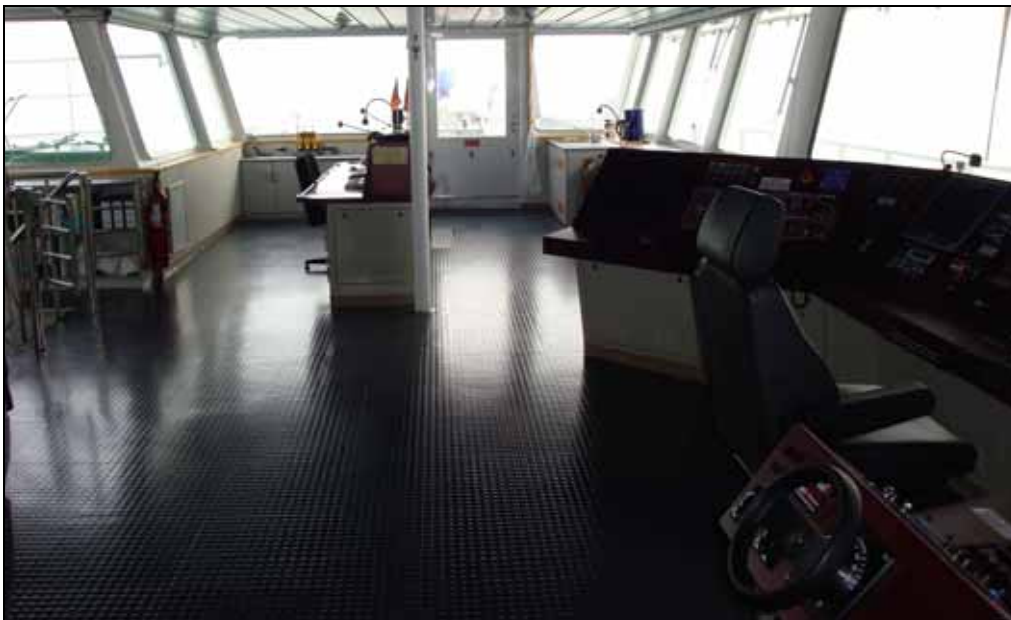
The inadequate fitting out of the bridge with handholds is finally shown by the examples in **Figures 20** and **21** below. Large sections at the side and aft of the bridge, the forward edges of the chart table and the GMDSS console as well as the front sides of the vessel command console have no handrail.

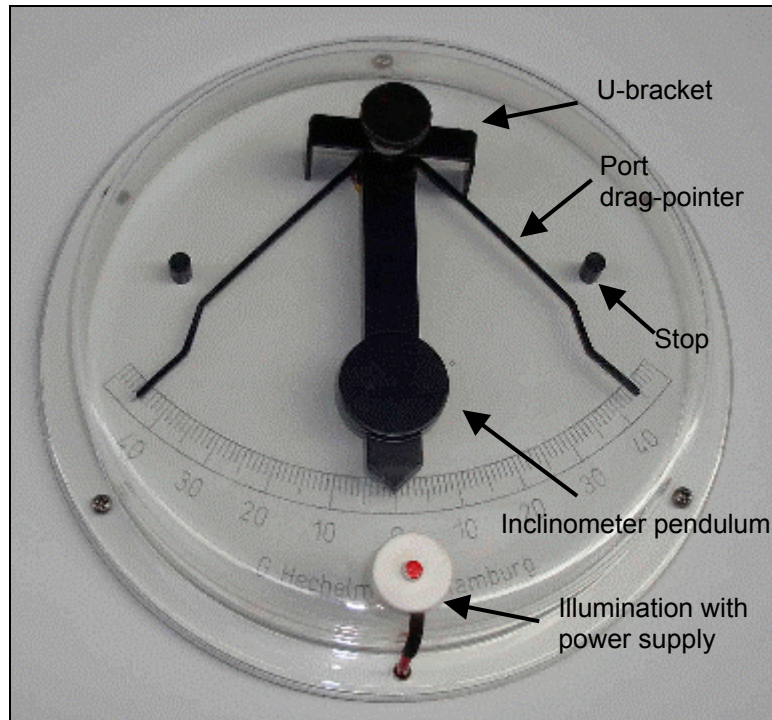
Figure 29: Photo of the inclinometer on the bridge of the CMV Chicago Express

side to side. The indicator on the inclinometer on the bridge remained at about 44 degrees on each side (see **Fig. 29**)³¹.

It was thus concluded that the roll angle on board actually amounted to 44 degrees. However, at the beginning of the investigation the expert informed the BSU of his doubts that the roll angle could be accurately recorded by such a device in a situation of this nature. Following that, the BSU acquired an identical device and provided this to the expert. Closer examination of the structural properties of the inclinometer confirmed the above hypothesis and resulted in the following.

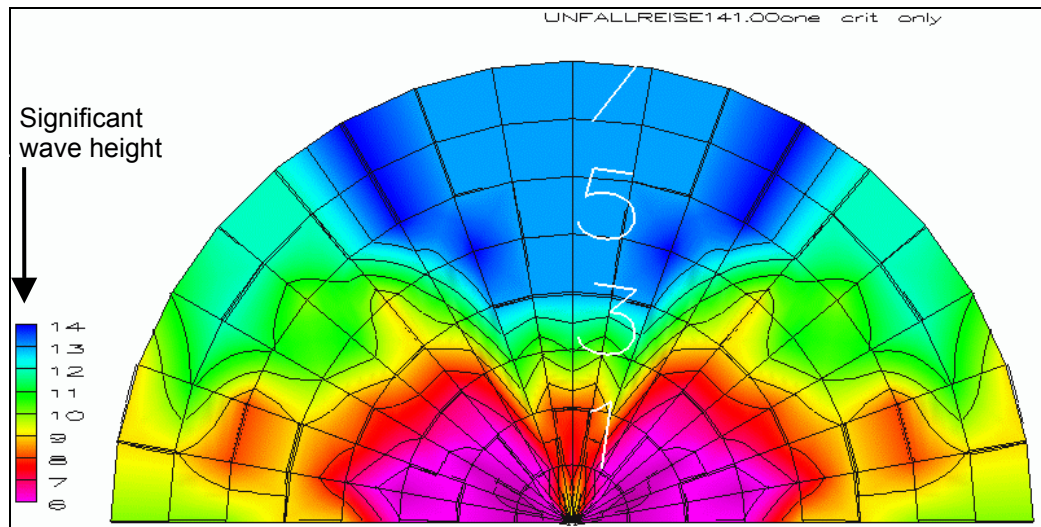
Figure 30: Calculated significant wave heights at a roll angle of 35 degrees³²

Figure 30 shows the results of the calculations in the form of a polar coordinate diagram. This shows the respective significant wave height highlighted by colour for a natural swell for a period of 9.5 s, which at the different speeds and courses would lead to a roll angle of at least 35 degrees. The significant period of 9.5 s corresponds to a situation equal to that also calculated in the weather expertise from the DWD. The calculations permit some interesting conclusions about the accident. It clearly follows that for a situation which corresponds roughly to the prevailing conditions at the time of the accident an extremely large roll angle must have occurred. This is the case if the vessel is slower than a certain minimum speed while there is a sufficiently quartering head sea. In that respect, the calculations are clear. This also shows that in other situations, in which the vessel's speed is much higher, such a large roll angle cannot have occurred because the significant wave height required for this would be much higher. At the same time, the calculations also show that such large roll angles cannot be reached at lower speeds precisely at those times when it is possible to keep the vessel sailing sufficiently accurately against the sea.

At the same time, the calculations have demonstrated that the vessel was far removed from resonance conditions in the accident situation; therefore, roll resonance due to parametric rolling can definitely be ruled out as a possible cause of the accident.

The large roll angle calculated in the critical situations is clearly caused by the direct roll excitation of the sea, which emerges if the course is at a sufficient angle to the sea together with **simultaneous** low roll damping due to a low speed. The calculations have shown that other causes can be ruled out with a probability bordering on certainty.
