Bundesstelle für Seeunfalluntersuchung
Federal Bureau of Maritime Casualty Investigation
Federal Higher Authority subordinated to the Ministry of Transport,
Building and Urban Development

Investigation Report 548/08

Serious Marine Casualty

**Collision between MV BELUGA SENSATION
and MV JEROME H while moored at the pier
in the Kiel Canal on 26 October 2008**

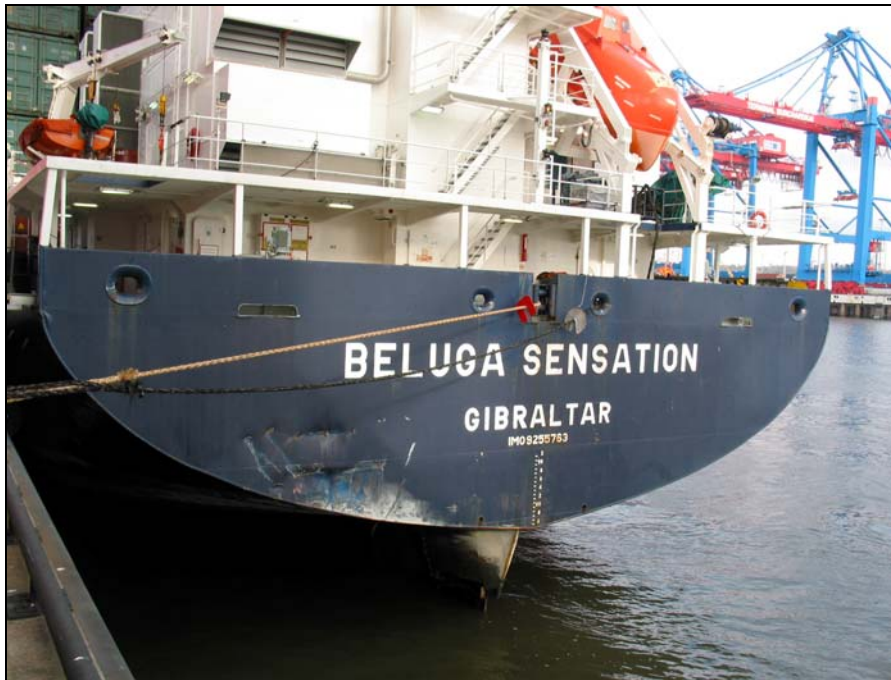
At 060059, the speed astern was 3.8 kts. At 0601, the port aftship collided heavily with the quay installation of Messrs Voith. The vessel then propelled herself along the pier with increasing speed and after reaching approx. 4.4 kts collided with the JEROME H while she was moored at the Voith Pier. The force of the impact was so great that all six mooring lines broke and the JEROME H drifted with her stern foremost to the opposite side of the Kiel Canal, where she came to a halt with her aftship against the sheet piling just west of the Holtenauer Bridge. The crew of the JEROME H was below deck at the time of the accident and was able to start the main engine and move to a berth in front of the silo in the Nordhafen unaided. At 0603, after the steering problems were no longer evident, the BELUGA SENSATION was also able to moor at this pier without further problems.

Figure 3: BELUGA SENSATION, damage to stern

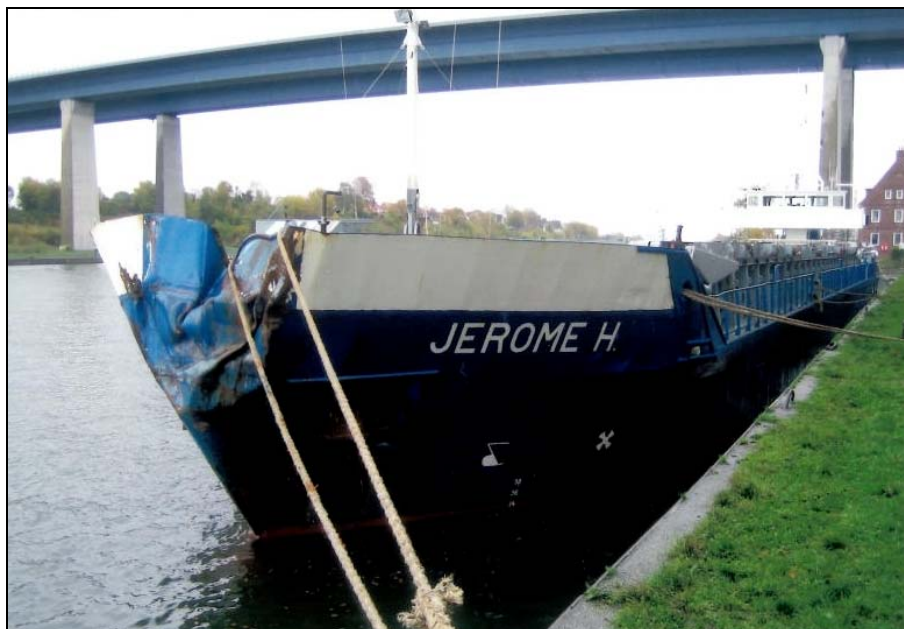
Figure 4: JEROME H, damage to stern

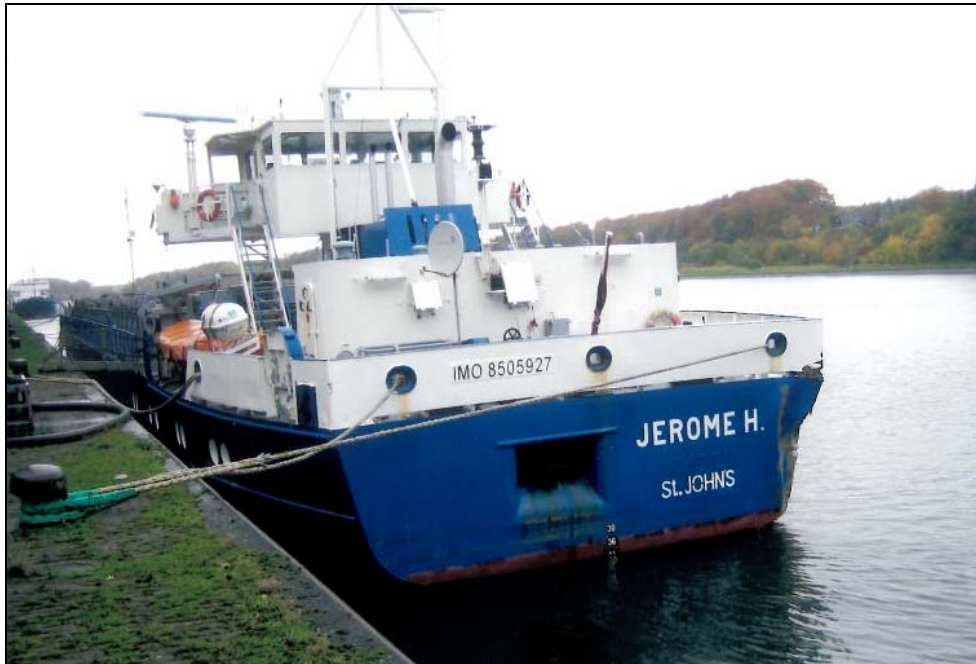
Figure 5: JEROME H, damage to stern

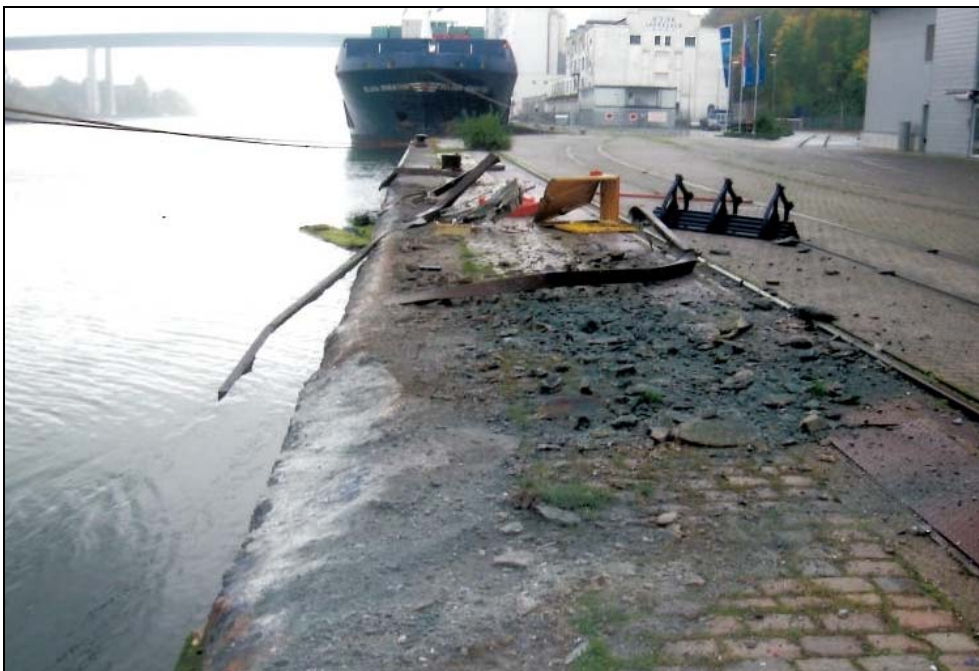
Figure 6: Damage to the pier

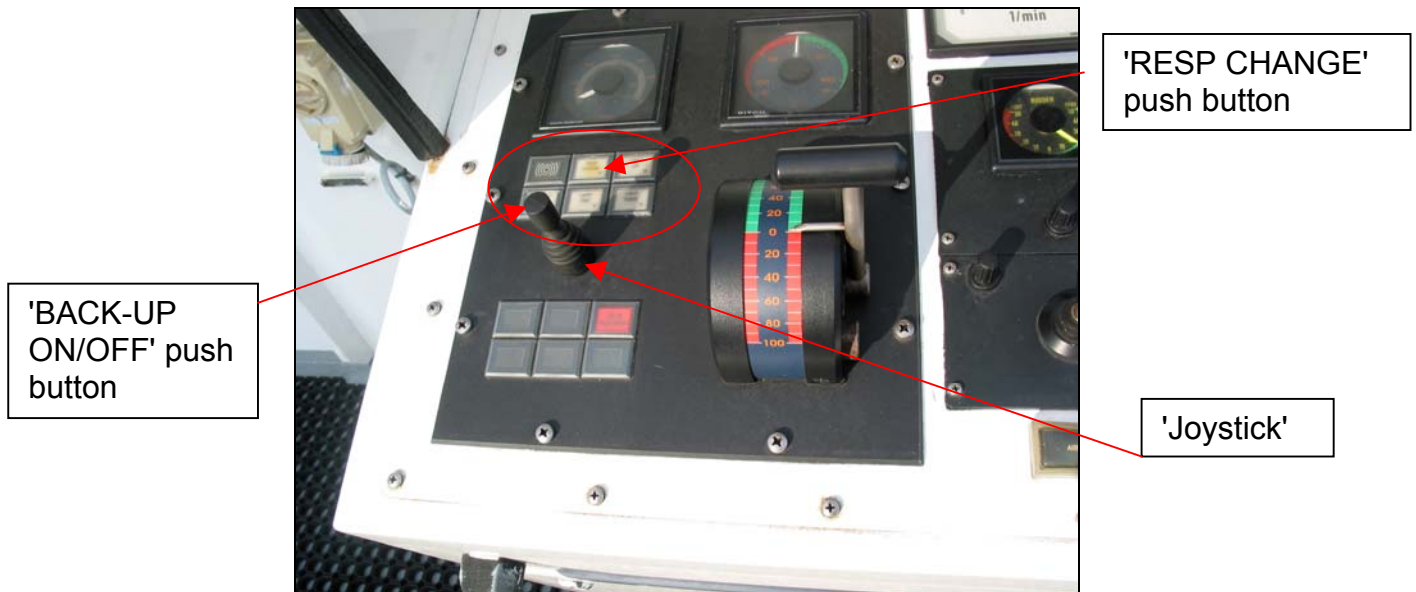
Figure 13: Starboard bridge wing conning position

The Chief Officer stated that he probably pressed the 'BACK-UP ON/OFF' push button instead of the 'RESP CHANGE' push button without realizing it at the conning position in the starboard bridge wing, where it was dark. Following that, the controllable pitch propeller switched to 'full astern'. It was not possible to switch the steering system back to normal mode by operating the joystick and re-pressing the 'BACK-UP ON/OFF' push button as well as other buttons on the conning positions. Only later, after the main system ('RESP CHANGE' system) was reactivated in the engine control room, was it possible to operate the vessel in the normal steering mode.

- Installation of indirect lighting in the conning positions of the bridge wings to avoid confusion between the control buttons.
- Signal leads should not be arranged directly adjacent to one another on the terminal strip.
- Change the position of the heating elements that prevent condensation.
- Periodic functional check of the electrical systems.

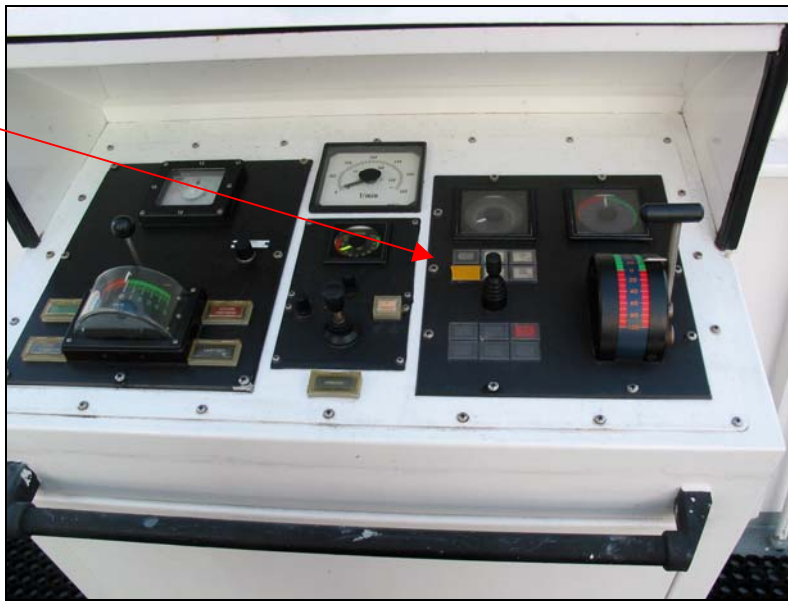
Figure 14: Port bridge wing conning position

During the shipboard investigation by the BSU on 28 October 2008, it was found that the 'BACK-UP ON/OFF' push button on the control panel in the port bridge wing was masked with adhesive tape. The Master stated that he stuck this adhesive tape on the push button after the accident only in the port bridge wing to prevent anyone from pressing it again erroneously.

Adhesive tape

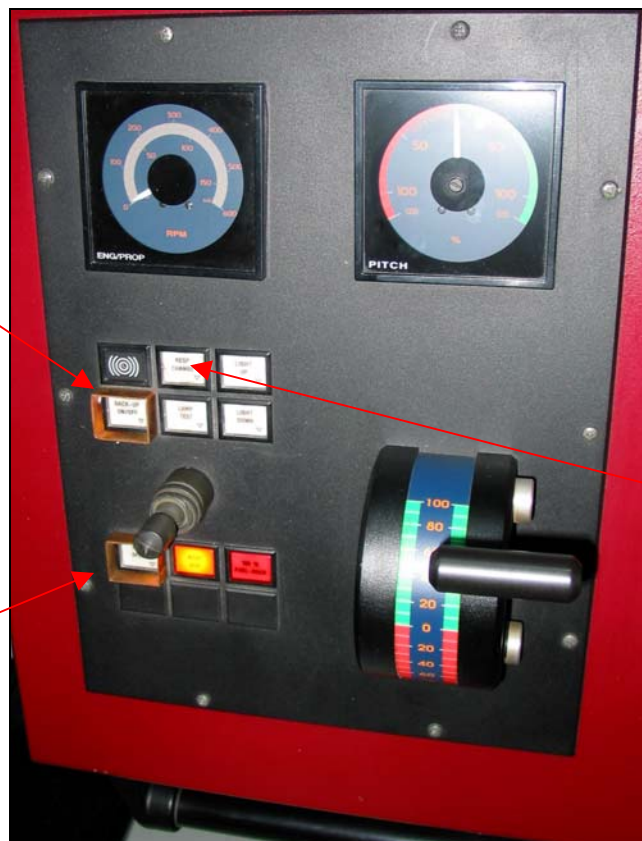
Figure 15: Conning position amidships

At the main conning position amidships, a piece of copper sheet approx. 1 cm in height was fitted around the 'BACK-UP ON/OFF' push button and the 'FIXED SPEED' button. It was not possible to determine why this was done.

'BACK-UP ON/OFF' with copper sheet

'FIXED SPEED' push button with copper sheet

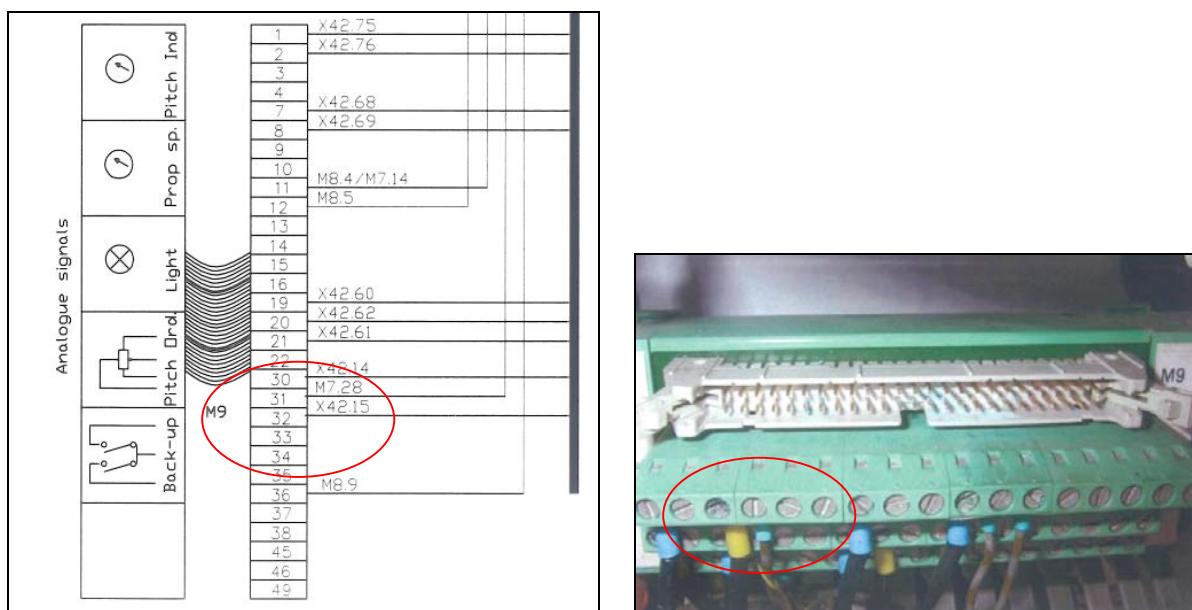
Figure 16: Wiring diagram and board in the port bridge wing conning position

When the 'BACK-UP' system was activated, the pitch of the controllable pitch propeller moved to 'full astern' independently (about 110-120% AS) rather than assuming the current pitch; moreover, it was not possible to control it using the joystick. An inspection of the electrical components revealed that a short circuit on a board in the port bridge wing between the connection points No. 31 (24 V to Back-up) and No. 32 (Back-up Astern) was responsible for this malfunction.

The switching system for the 'BACK-UP' mode is designed so that all three cables of the conning positions converge in the board of a control box on the bridge. The consequences of a short circuit would therefore have always occurred regardless of which of the three 'BACK-UP ON/OFF' push buttons had been pressed.

The short circuit was undoubtedly caused by moisture entering the console in the port bridge wing. Due to the corroded contacts, it is assumed that a concealed defect had been progressing gradually for some time. According to the crew, the 'BACK-UP' system was routinely checked when setting sail. However, the fault only became apparent after the coincidental activation of a 'BACK-UP ON/OFF' push button.

- The crew of each vessel was instructed to inspect the terminal strips and heating in the wing conning positions and report accordingly to the vessel operator. Similarly, the seals and the condition of the wing conning positions are to be inspected regularly. The scheduled maintenance system for the vessels has been supplemented by this paragraph, which requires regular testing and inspection of the wing conning positions. A prescribed inspection and further assurance of the proper state are thus additionally ensured.

- Vessels of Beluga Shipping that are fitted with the same CPP backup system and wing conning positions have had additional heaters installed in the wing conning positions to prevent oxidation to the greatest possible extent. The wing conning positions of every other vessel in the fleet were also inspected and upgraded where necessary.
